ESB Networks Historic Cable Fluid Losses: Preliminary Site Assessment

Location 12: Carrickmines – Poolbeg 220 kV – June 2015

February 2020

Report Ref: GCU0257001/001

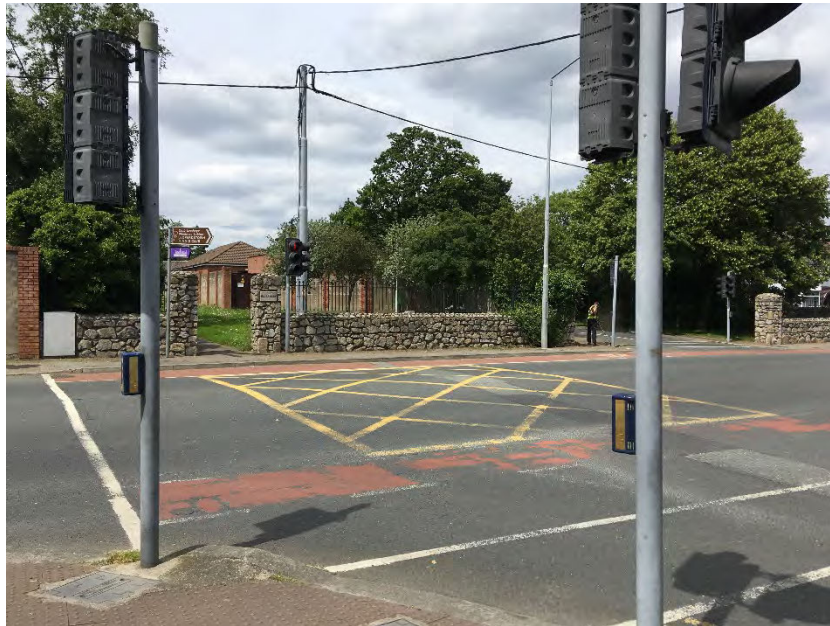
Photograph 1 – Leak location; west side of Brewery Road

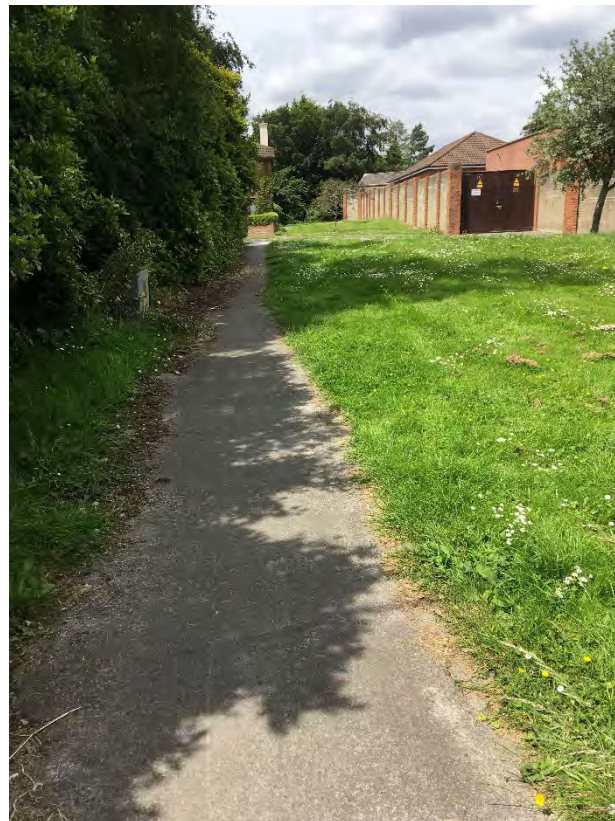
Photograph 2 – Cable route west of leak location

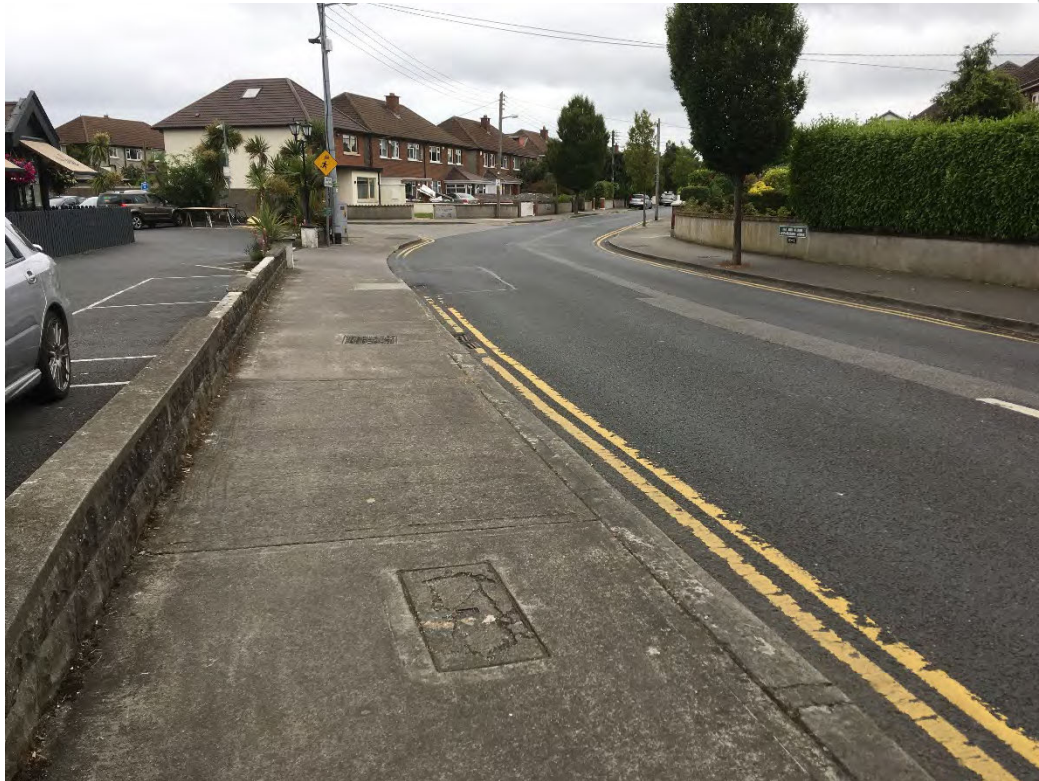
Photograph 3 – View east along Leopardstown Avenue

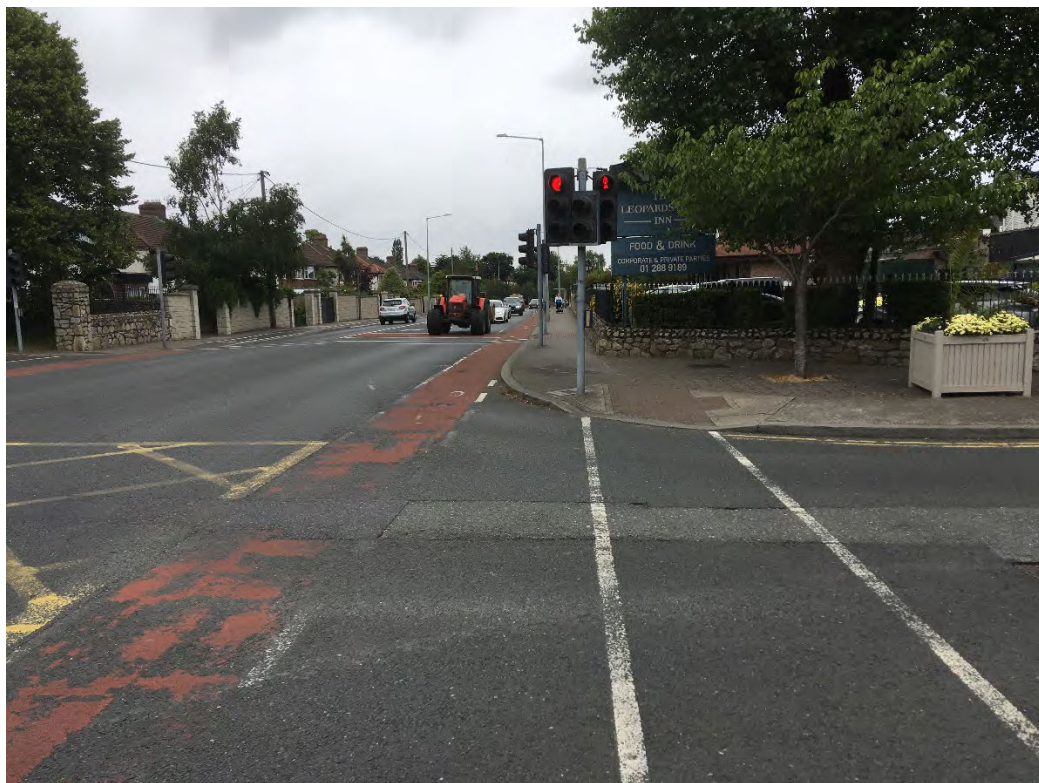
Photograph 4 – Brewery Road looking north from Leopardstown Avenue
