# Preliminary Site Assessment

Site 23 Bedford Row - Francis Street 38 kV (September  
2011)

Electricity Supply Board

Project number: PR-427640\_ACM\_RP\_ENV\_010\_4

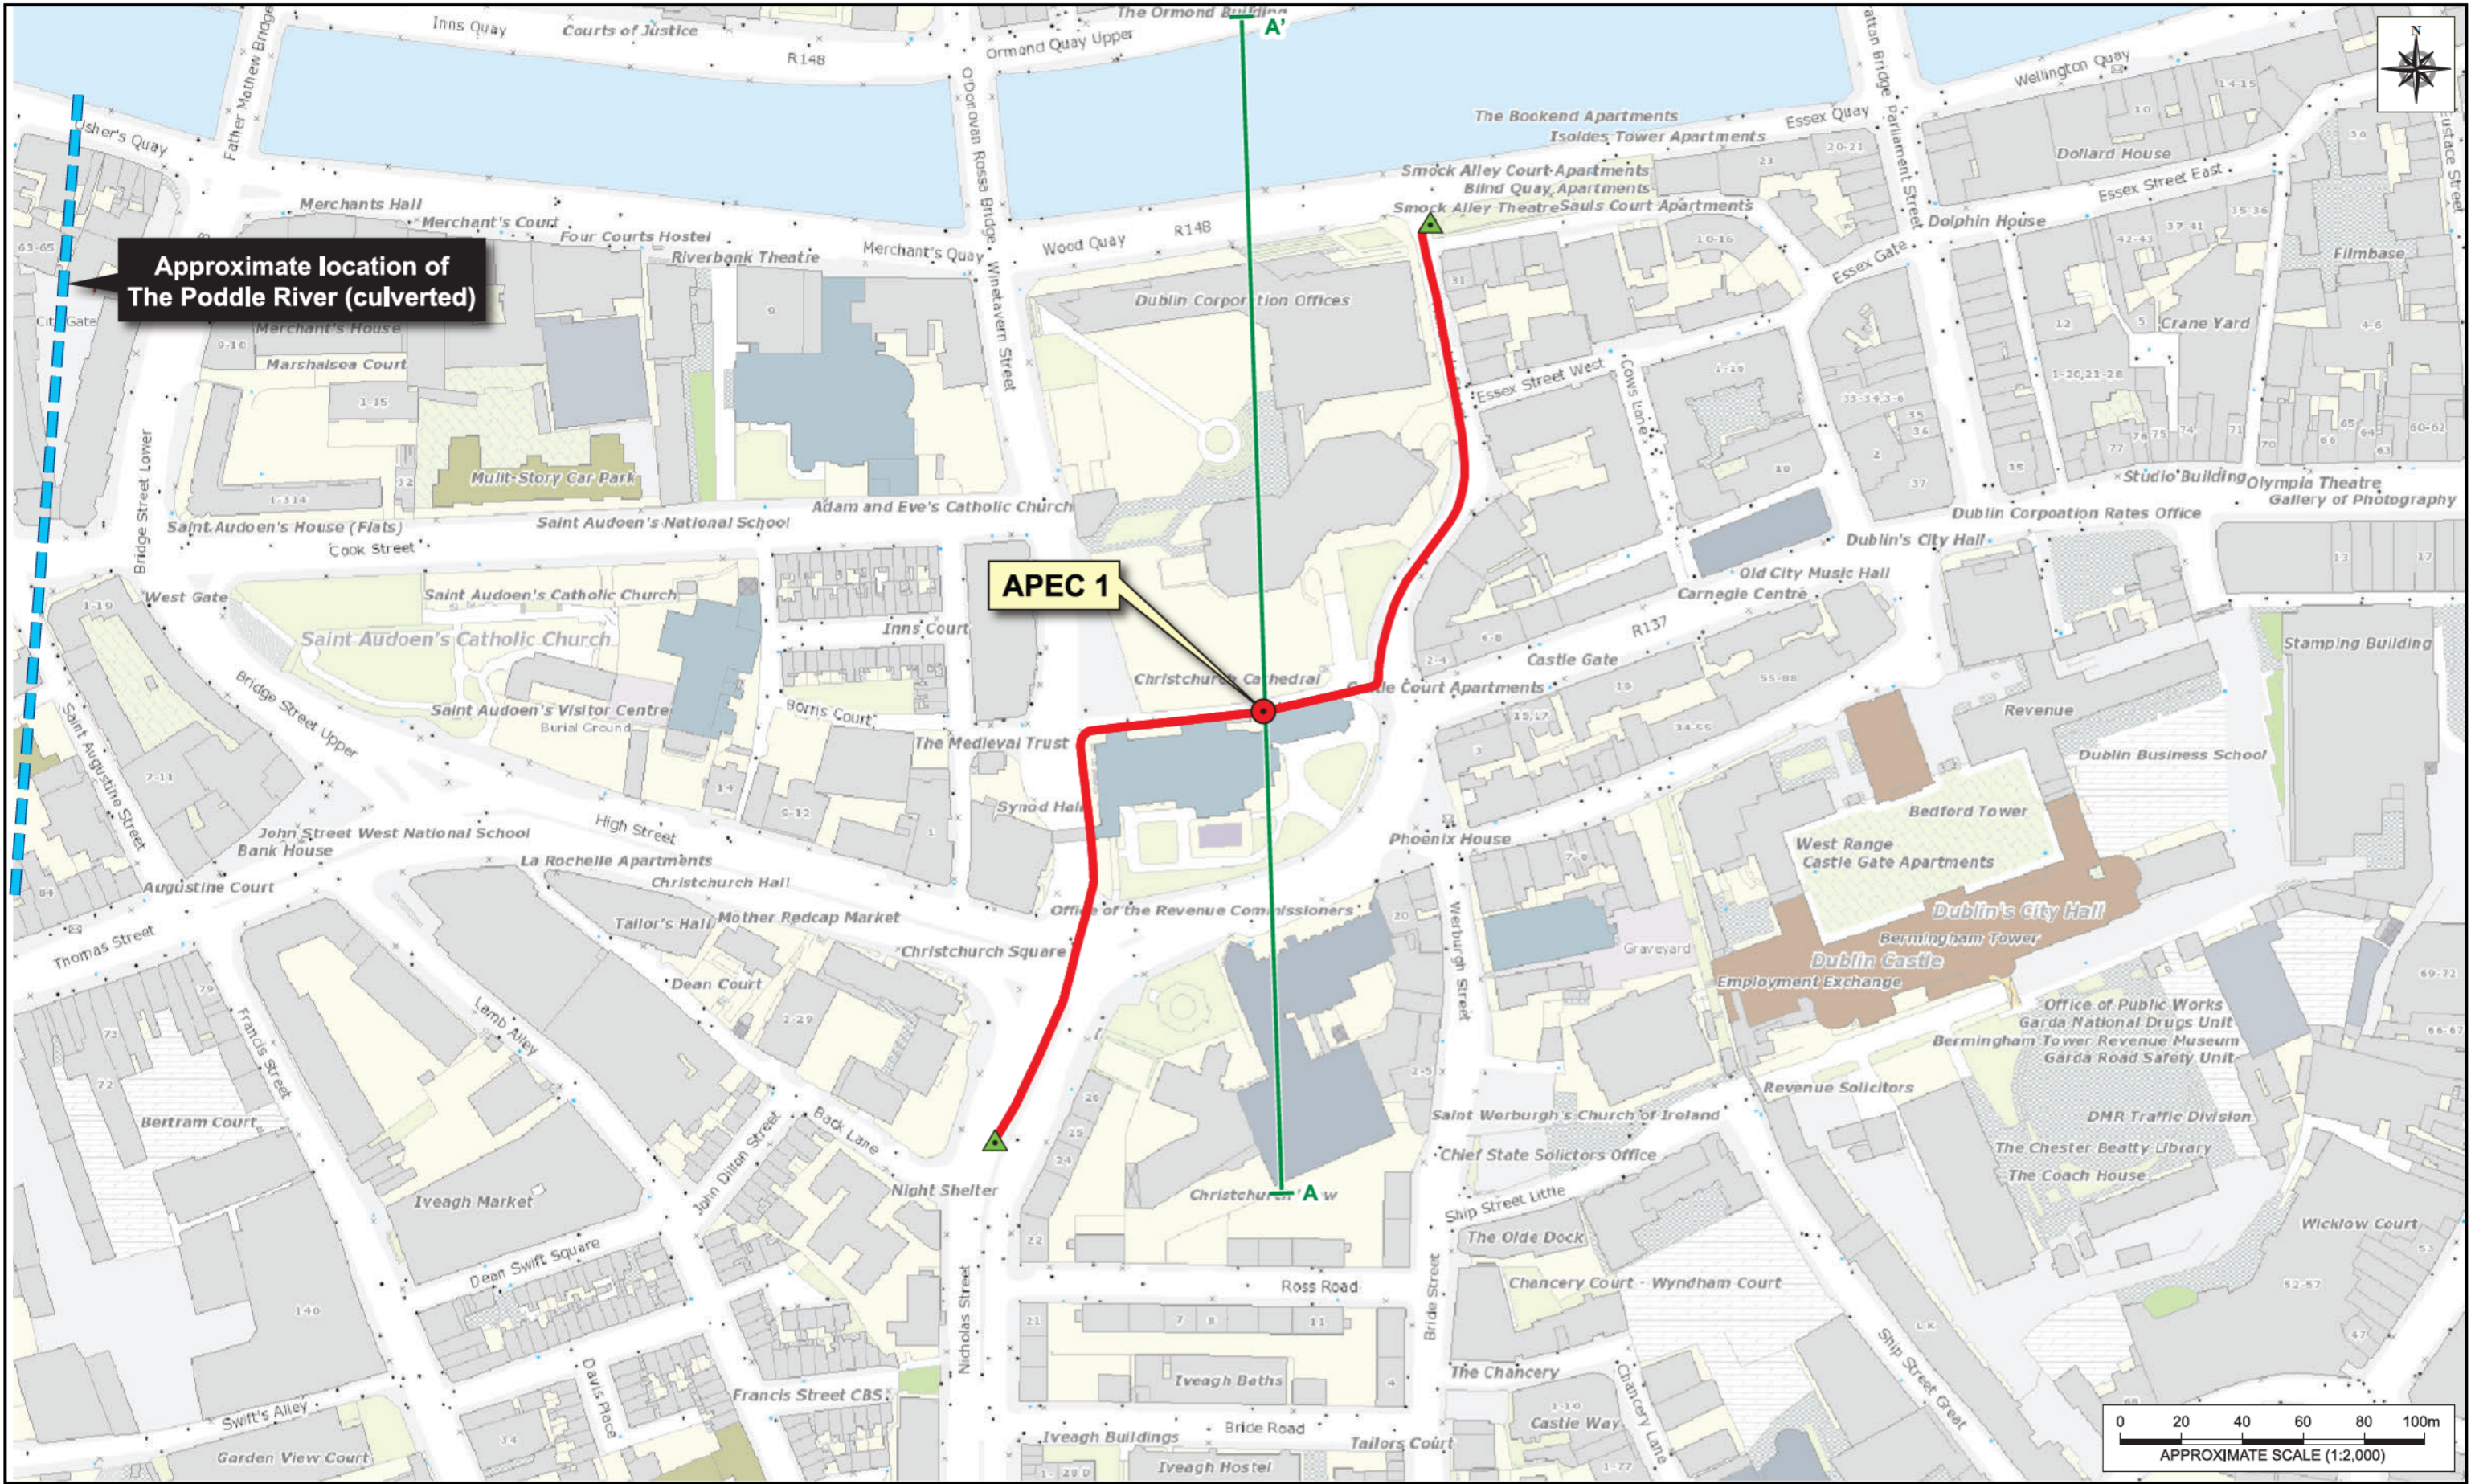
Figure 2. Areas of Potential Environmental Concern

Based on the assessment works completed, the primary Area of Potential Environmental Concern (APEC) for this site comprises the leak location identified by ESB. This is presented in Figure 2 and a description is provided in Table 7.

APEC 1

Leak Location		Joint Section of Leak
	200 m marker from Leak Location		CSM Cross Section

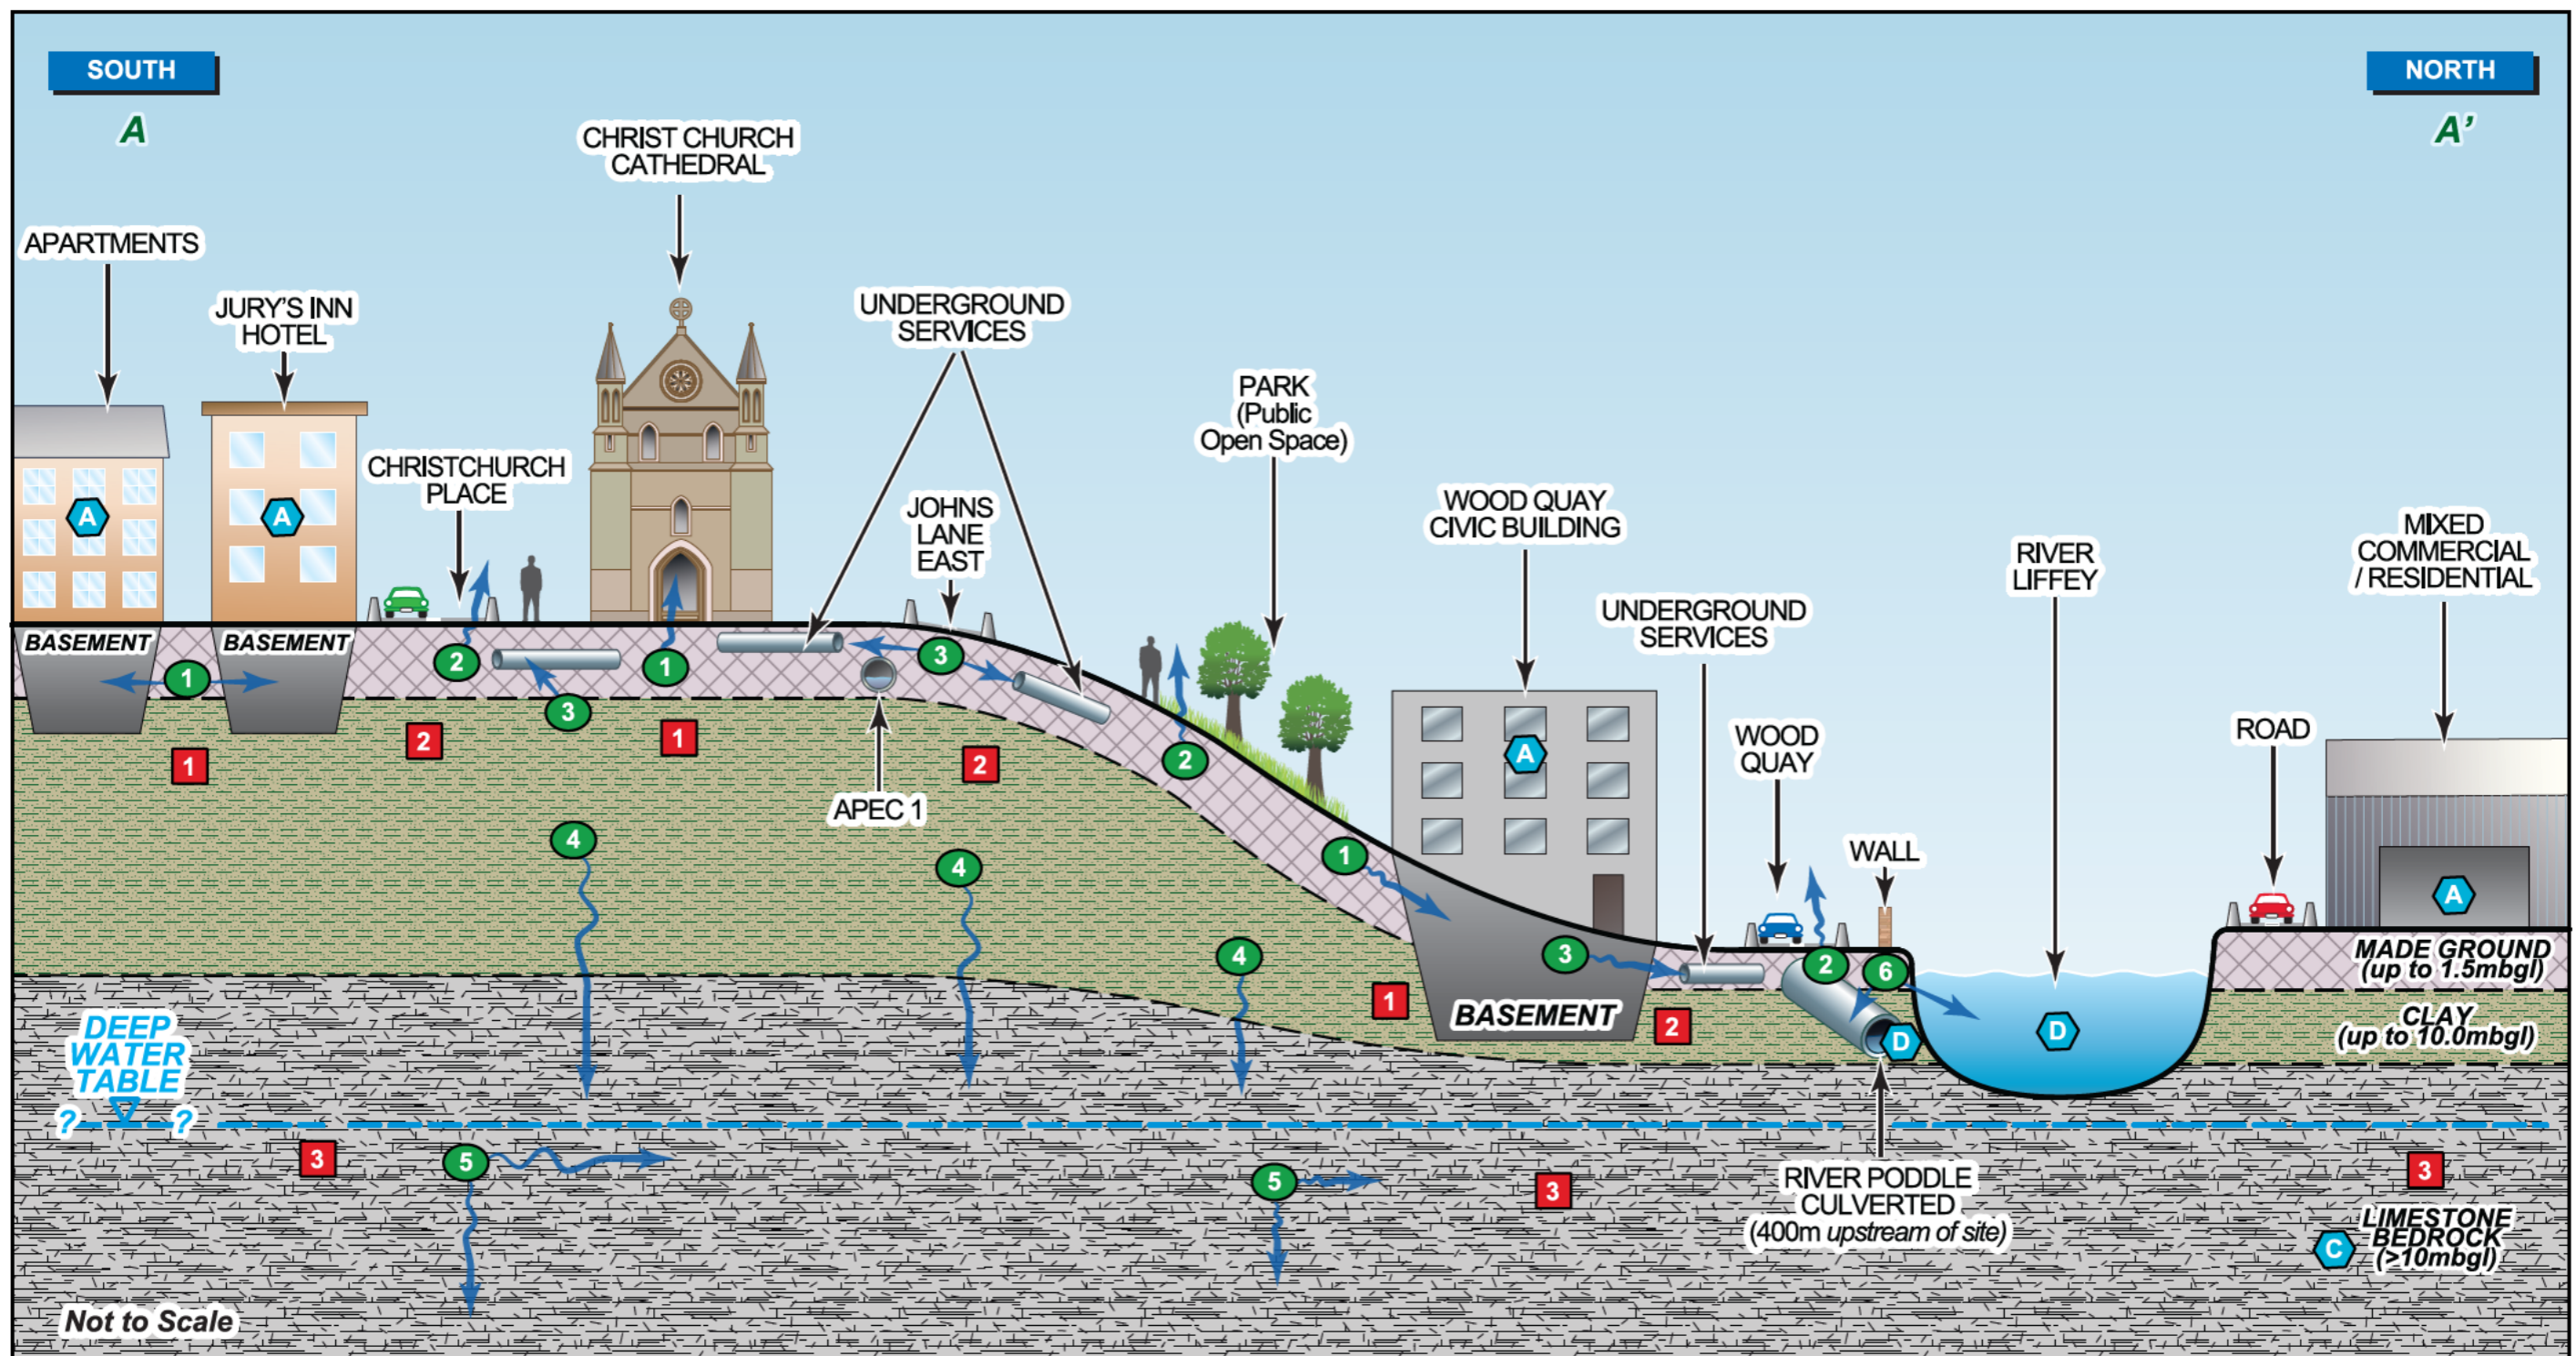
Figure 3. Conceptual Site Model

LAB (NAPL)	Migration of ground gas generated from the degradation of the cable fluid to above ground buildings.	Site users in a commercial/low to high density residential scenario.	Severe	Low Likelihood	Moderate	If a significant source of LAB NAPL is present on groundwater, there is potential for ground gas to be generated from degradation processes. The likelihood of ground gas being generated in significant quantities is considered to be low, however given the potential severity of the impact, further assessment would be required to fully evaluate this potential risk.
LAB (NAPL)	Permeation of LAB NAPL through plastic water supply pipes.	Site users in a commercial/low to high density residential with plant uptake scenario.	Medium	Unlikely	Low	Public water mains likely to be present in the vicinity of the leak, servicing commercial and residential properties have the potential to be impacted. However, the WHO drinking water guideline (DWG) for the relevant aromatic fraction <sup>2</sup> is 0.09 mg/l and as the solubility limit of LAB is 0.041 mg/L (OECD) i.e. less than the DWG, LAB cannot dissolve into the water supply above this level. Furthermore, water will be moving rapidly in the pipe under pressurised conditions making it unlikely to reach the solubility limit.  ESB has consulted with Irish Water (statutory body responsible for water supply) regarding the potential risk for cable fluid present in the vicinity of water supply pipes. Following review of their records, AECOM understands that Irish Water do not have concerns regarding impact of

The preliminary CSM developed for the site looked at potential source-pathway-receptor linkages identified during the assessment works and identified a moderate risk to site users due to the potential for ground gas generation resulting from degradation of LAB NAPL (if present).

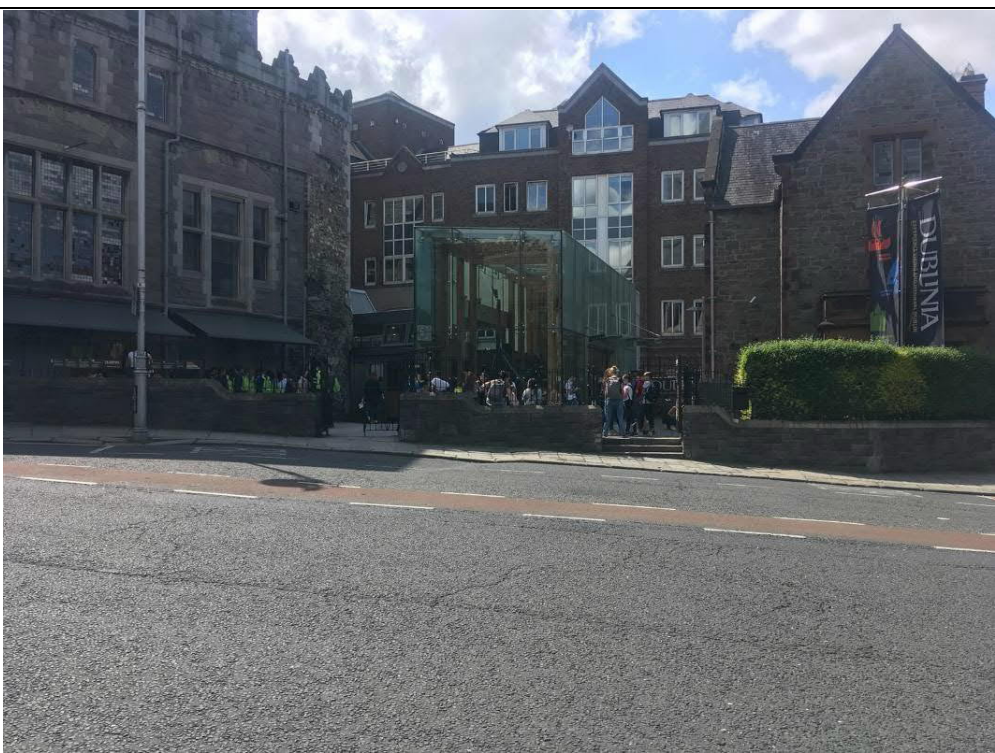
<p><b>Description:</b>  Facing west along Winetavern Street. Dublinia, a museum and coffee shop is located.</p>

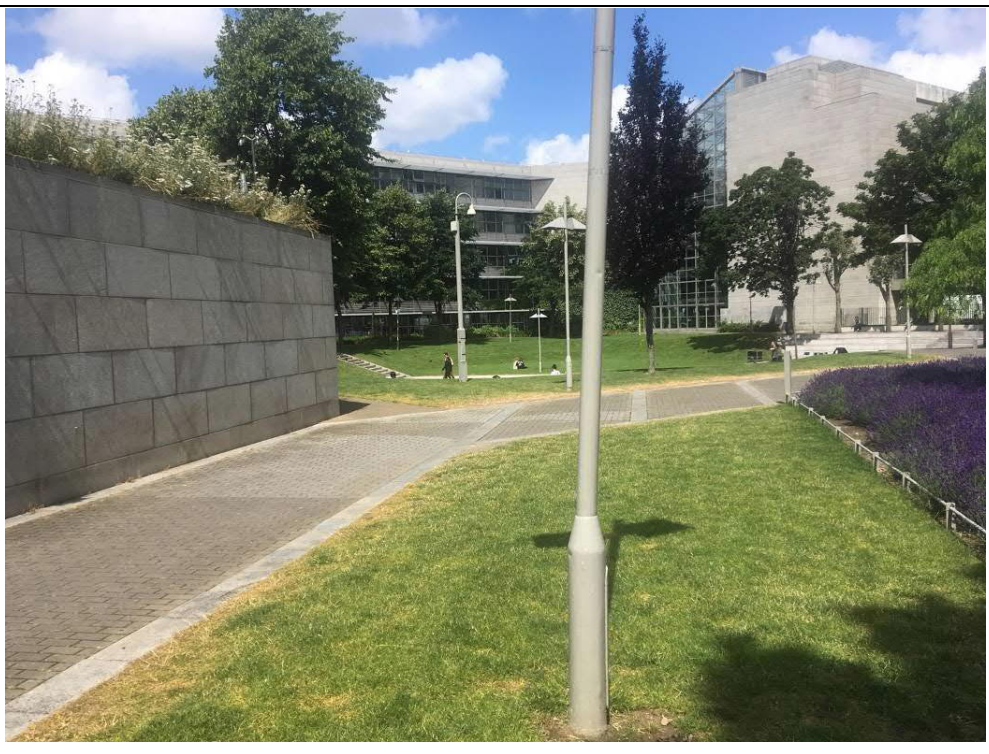
<p><b>Description:</b></p> <p>Public open space north of the indicative leak location.</p>

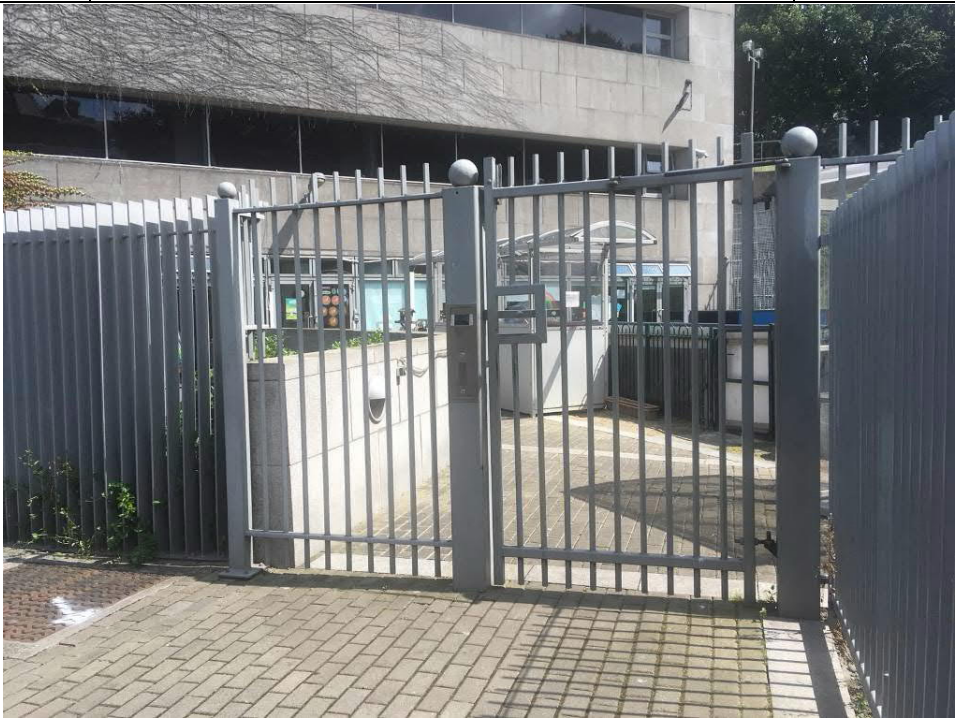
<p><b>Description</b></p> <p>Location of a children crèche/nursery north of the site. Park of Dublin Corporation Offices.</p>

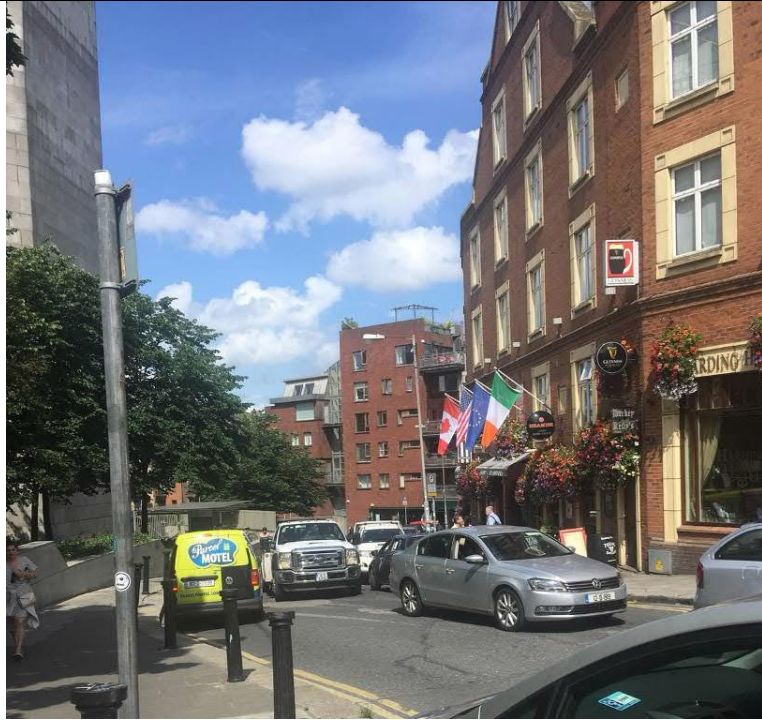
Facing north along Fishamble Street. Mixed use residential and commercial cafes and bars. Downward gradient towards the Quay.

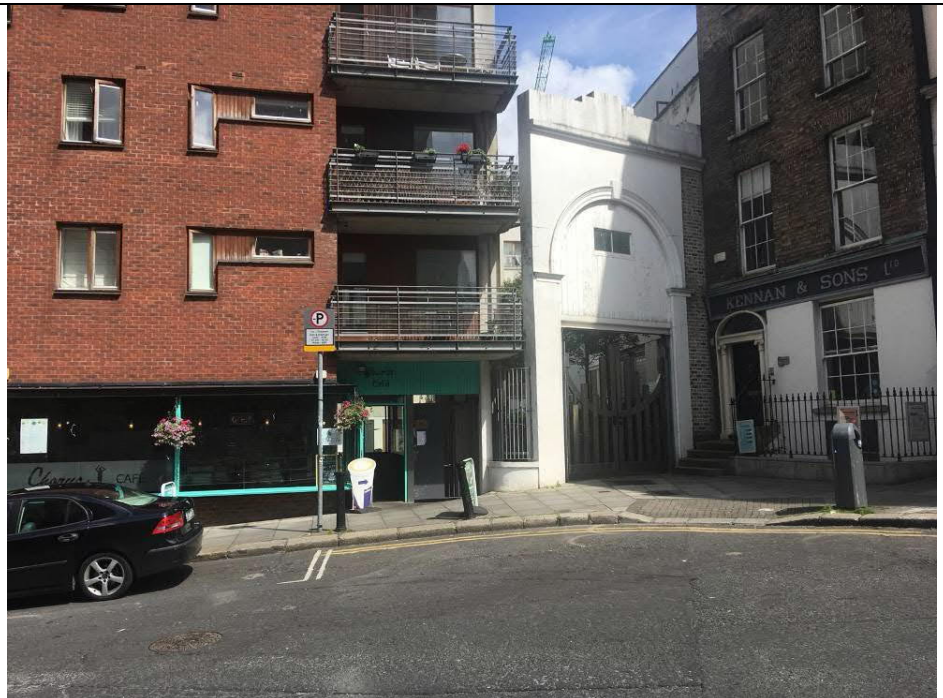
Facing north along Fishamble Street. Mixed use residential and commercial cafes and bars. Downward gradient towards the Quay.

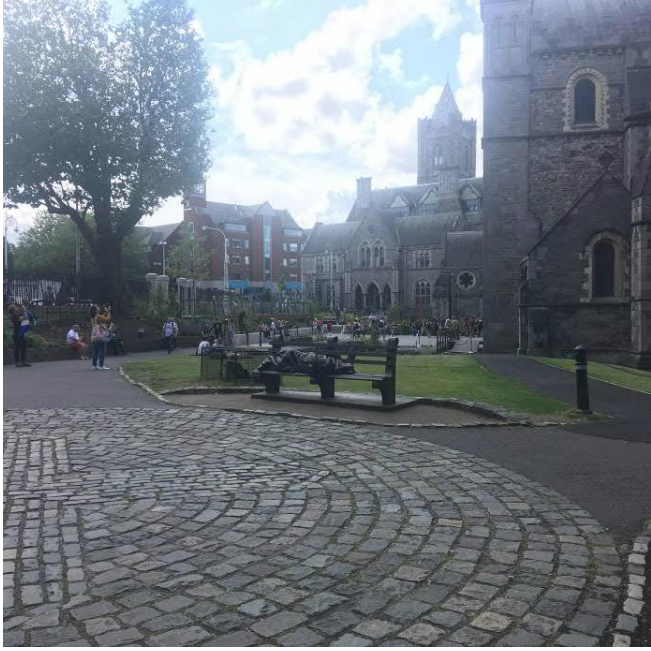
<b>Description</b>  Open public space within Christchurch, south of the site.
