Preliminary Site Assessment Report for Sallynoggin Road, Sallynoggin, Co. Dublin

ESB Site Ref: 26
Deansgrange - Sallynoggin 38kV

Project Title: ESB Networks Historic Fluid Filled Cable Loss
Environmental Assessment

Report Ref: Stage 1 Preliminary Site Assessment Report for Sallynoggin Road, Sallynoggin, Co. Dublin. EPA Ref: 26 Deansgrange – Sallynoggin 38kV

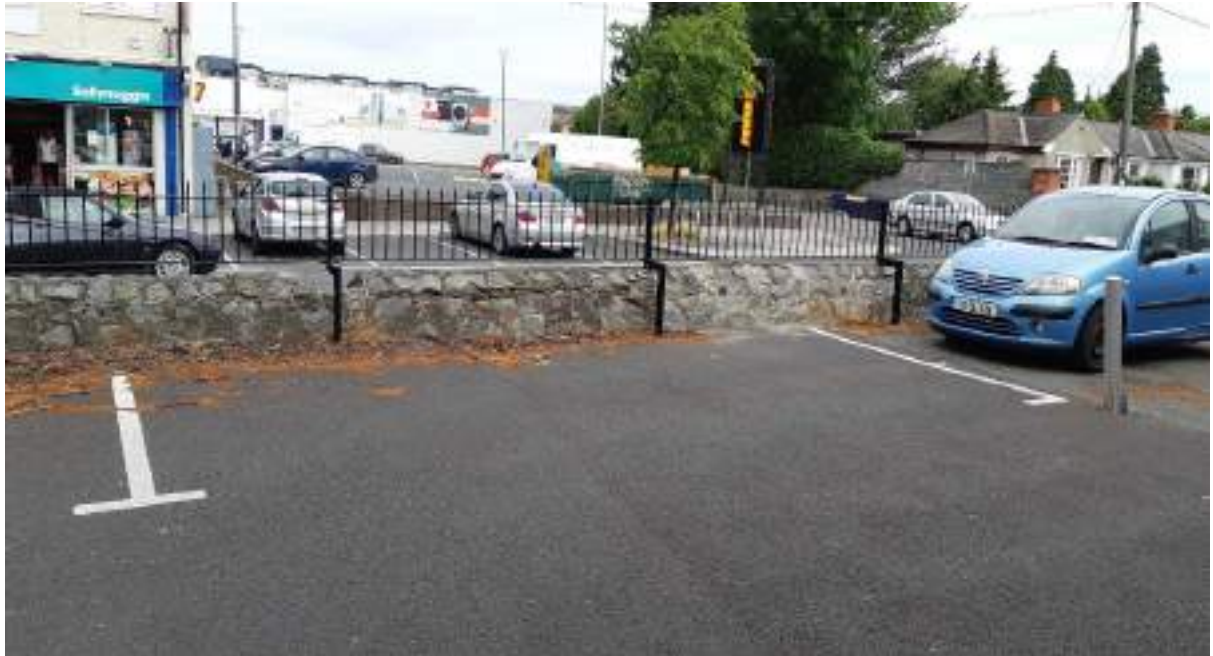
The leak is understood to have occurred inside the car park boundary wall which runs parallel to the Sallynoggin Road (Photos 1-2) and is believed to have been on-going for a period of up to 24 months before it was repaired in February 2019. Surfacing of the car park in this area is in excellent condition and further repairs were observed to a low wall (0.5m) which is topped with metal bars. This wall separates the premises from the pavement of the Sallynoggin Road (Photo 3). The surface of the car parking area at the leak location is circa. 2m higher than the concrete pavement immediately beyond the low boundary wall. There is a large, mature tree close by in the corner of the car park within a surrounding gravel/soil bed.

Photo 1: Presumed location of Leak Point (GSI Ref: 26) is beneath car park of Davies Bathroom and Tile Design showrooms, close to junction of Sallynoggin Road (background) and Pearse Street. Tarmacam surfacing has been re-laid over part of the carpark and there is evidence that boundary wall with Sallynoggin Road is repaired. Surface of car park is elevated (circa +0.5m) above footpath and road located behind wall.

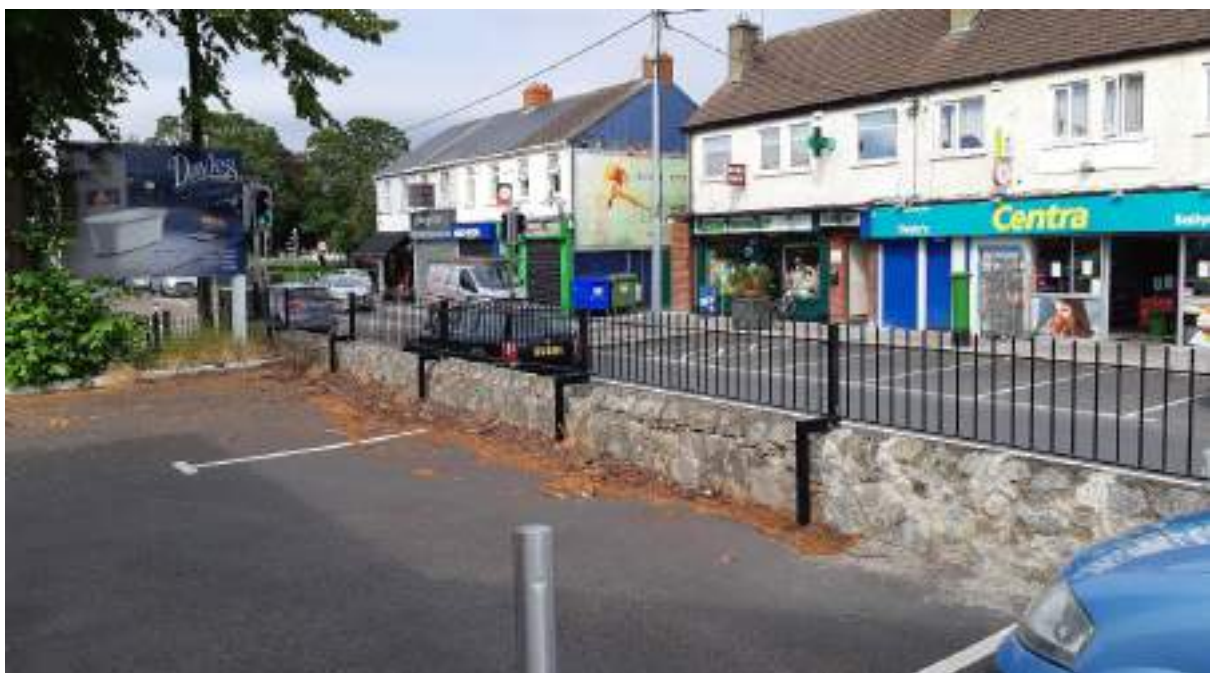
Photo 2: View of leak site (looking southeast) with wall repair. From here, cabling crosses over Sallynoggin just to RHS of visible traffic light.

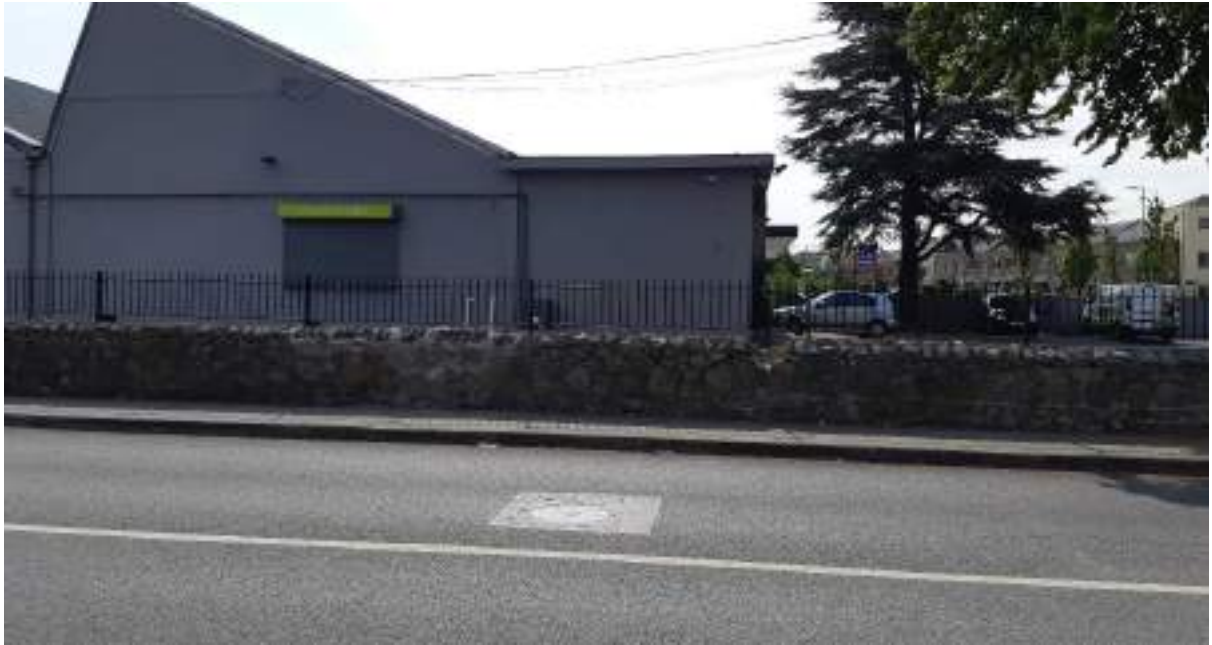
Photo 3: View of repaired wall and Davies Showroom from Sallynoggin Road. Leak site is far side of repaired wall.

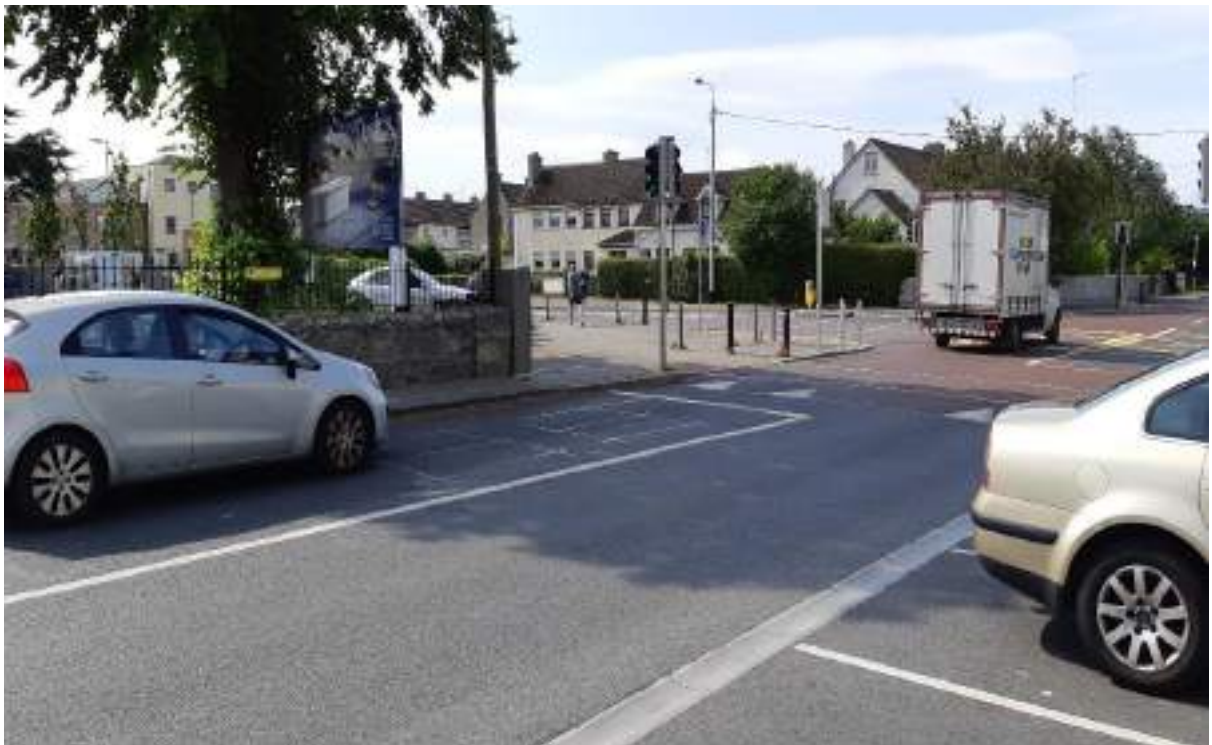
The known leak point (ESB Ref: 26) is located close to the junction of Sallynoggin Road and Pearse Street in the administrative area of Dun Laoghaire-Rathdown (Photo 4). Sallynoggin Road is dominated by large commercial units and showrooms on its northern side and smaller commercial premises and residential units on its southern side. According to maps provided, the leak occurred within the carpark area of Davies Bathroom and Tile Design showrooms, which occupies a long-established, warehouse-type premises with a main entrance off Pearse Street just southeast of the junction with Sallynoggin Road. There is a cluster of shops on the Sallynoggin Road opposite the intersection with Pearse Street including a Centra, a pharmacy and a pizza take away. Adjacent to these shops almost directly across the road from the leak site is a car park associated with a large Power City outlet.

Photo 4: Junction of Sallynoggin Road with Pearse Street to LHS. Cable is understood to cross from left to right on near side of visible traffic light

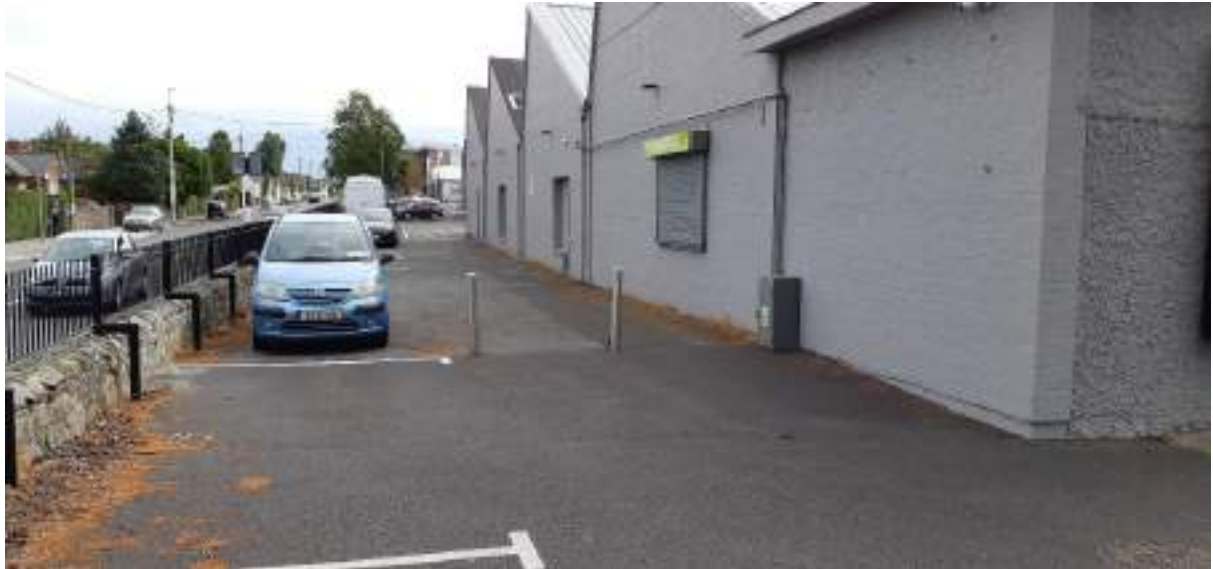
The underground cable route follows the direction of the road in a north easterly direction albeit the route appears to be located inside boundaries of premises that front onto the road (Photos 5-6 indicate north eastward route). The terrain generally rises in this direction towards a major roundabout approximately 400m north of the leak point.

Photo 5: Leak site. Route of cabling is understood to run north eastwards parallel to Davies showroom (inside of boundary to Sallynoggin Road)

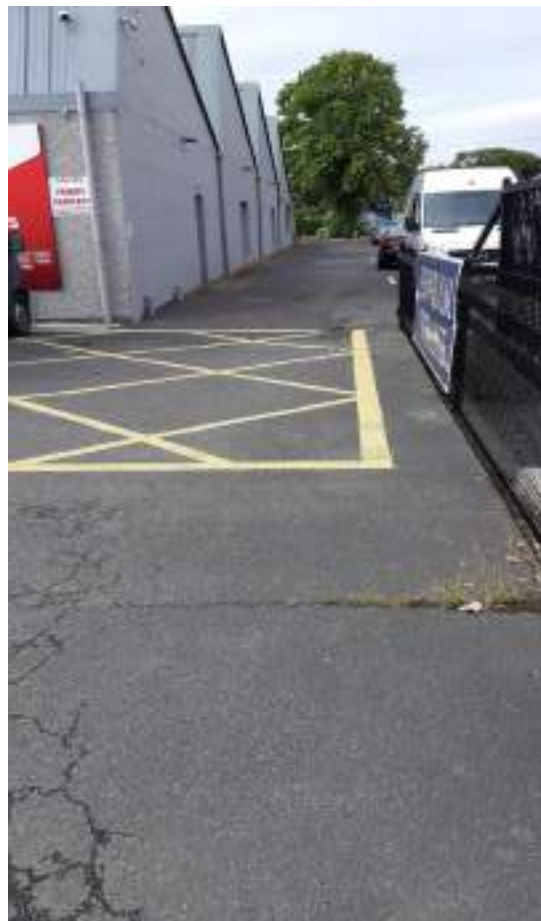
To the north of the Davies showrooms is a second entrance to a car park serving the outlet. Some damage to the tarmac surfacing was observed (Photo 6). A large Woodies premises is to the north of the Davies showroom and the line of the cabling is suspected to run inside a low boundary wall which separates an overflow car park from a grass verge (circa. 3m wide), pathway and the Sallynoggin Road. A bare patch was noted along the verge adjacent to the low wall (Photos 7-8). The tarmac surface of the overflow carpark is circa. 0.3m higher than the ground level of the grass verge. A red mark on the wall is adjacent to the area of grass loss. There was no associated odour or notable staining of the wall itself. The cable crosses the wide entrance roadway leading to Woodies and continues inside the boundary wall of M. Kelly interiors (single storey, warehouse-type building). There are several services along the pavement on this side of the Sallynoggin Road notably eircorn cables, gas, storm drainage and water services which could potentially act as conduits for leak that has occurred.

Photo 6: View southeast along Davies showroom (along presumed line of cabling). Some cracked tarmacadam. Leak point is located close to the large tree at far end.

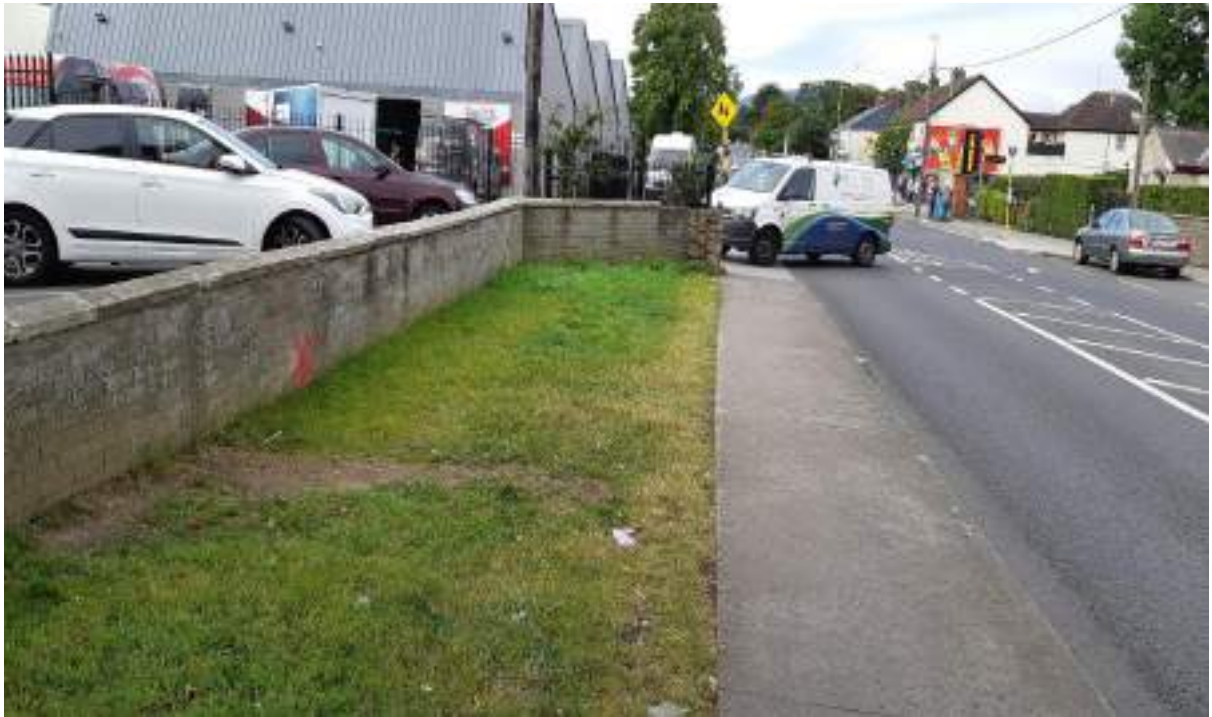
Photo 7: Possible indication of leakage, circa. 75 m northeast of recorded leak point. Grass vegetation on verge damaged close to red mark on wall. Sallynoggin Road dips slightly in direction of known leak point near distinctive tree in background close to southern end of Davies showrooms.

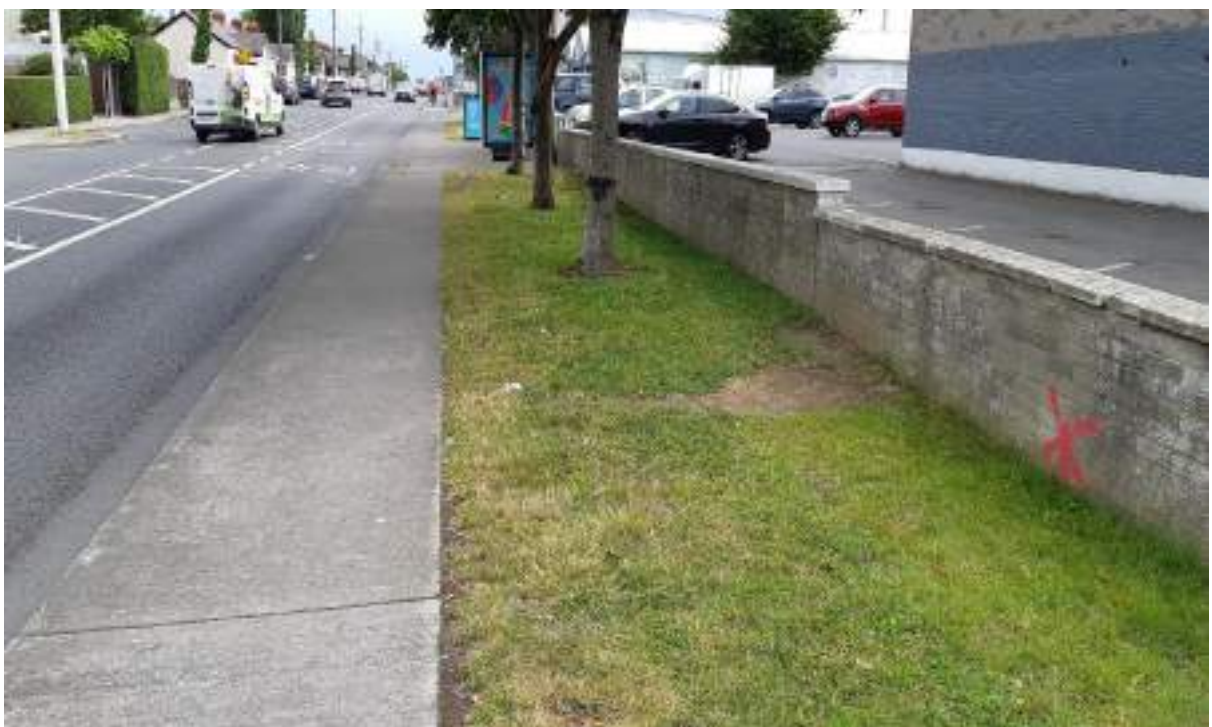
Photo 8: Looking north eastwards along Sallynoggin Road. Further view of possible leak. Cabling understood to run on right hand side of wall which separates overflow car park for Woodies from grass verge.

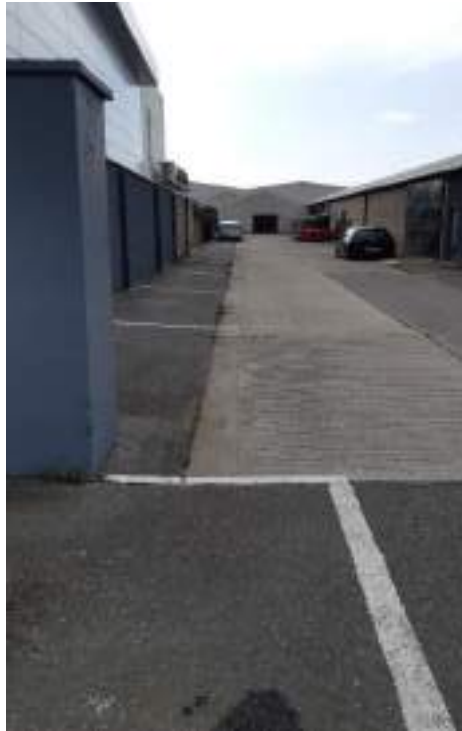
Photo 9: Views along lane way to southeast off Sallynoggin Road which leads to substation (Sallynoggin 38Kv Station) at top of lane on LHS. Lidl is on let and M. Kelly Interiors is on RHS. The 200m marker location from the suspected leak is along this laneway.

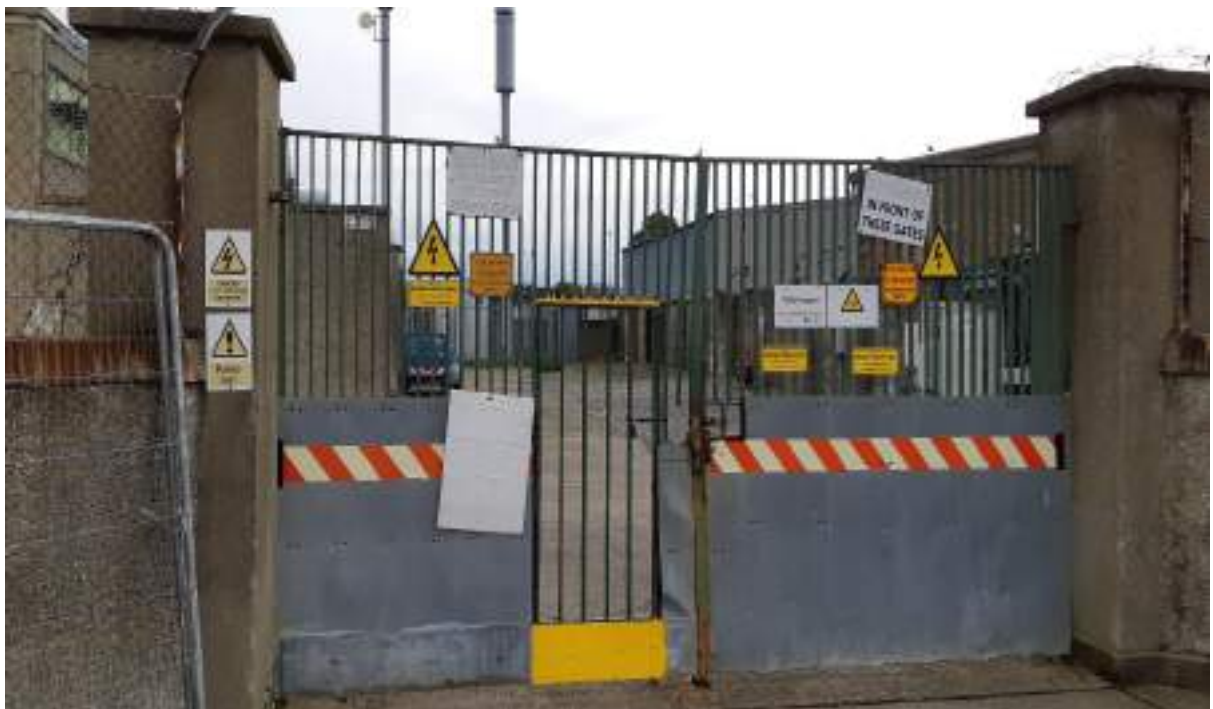
Photo 10: Entrance to substation at end of laneway. Concrete yard with gravel areas. Substation is circa. 200m northeast of recorded leak point

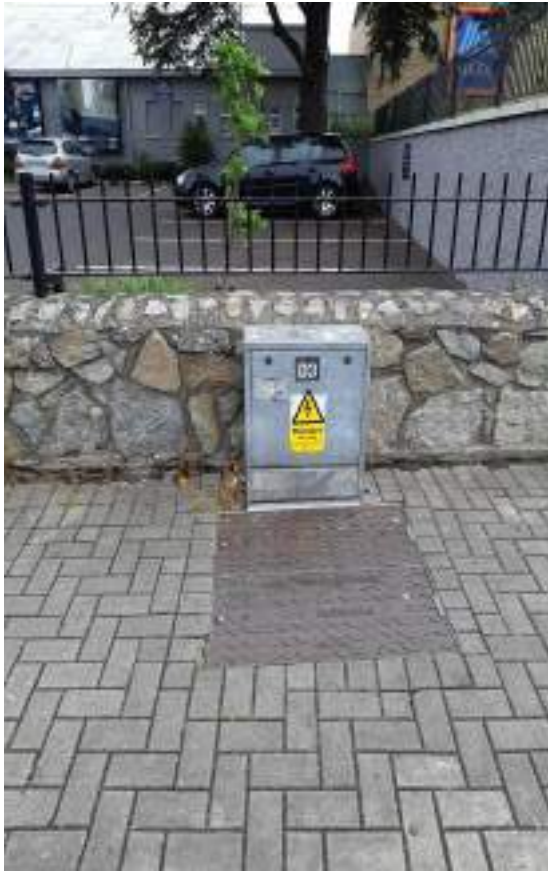
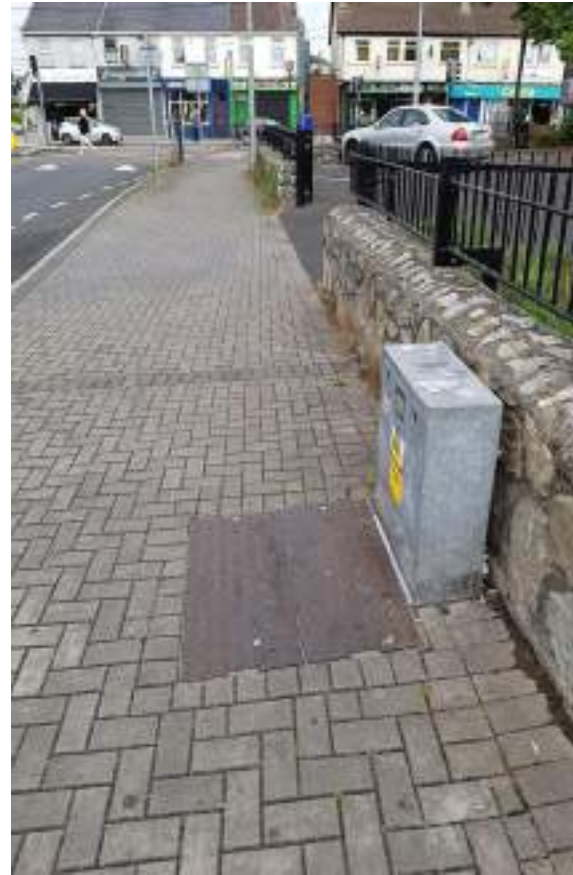
Photos 11 and 12: Cabling below paving along Pearse Street adjacent to southern entrance to Davies car park

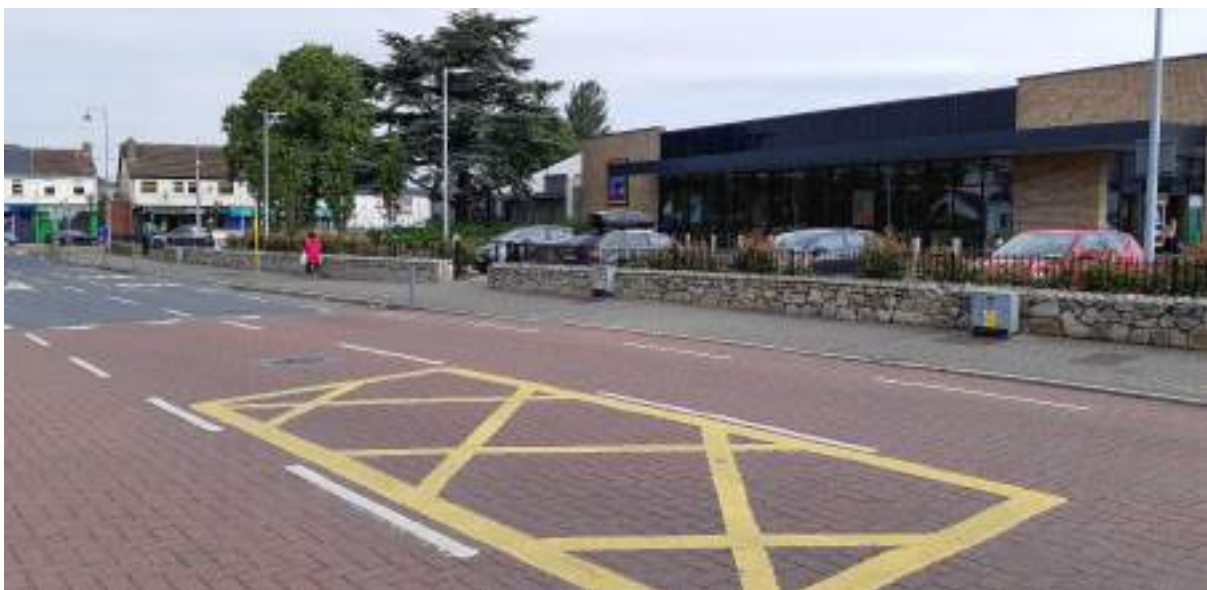
Photo 13: Cabling and ESB boxes along northern pavement of Pearse Street. Junction with Sallynoggin Road is on LHS

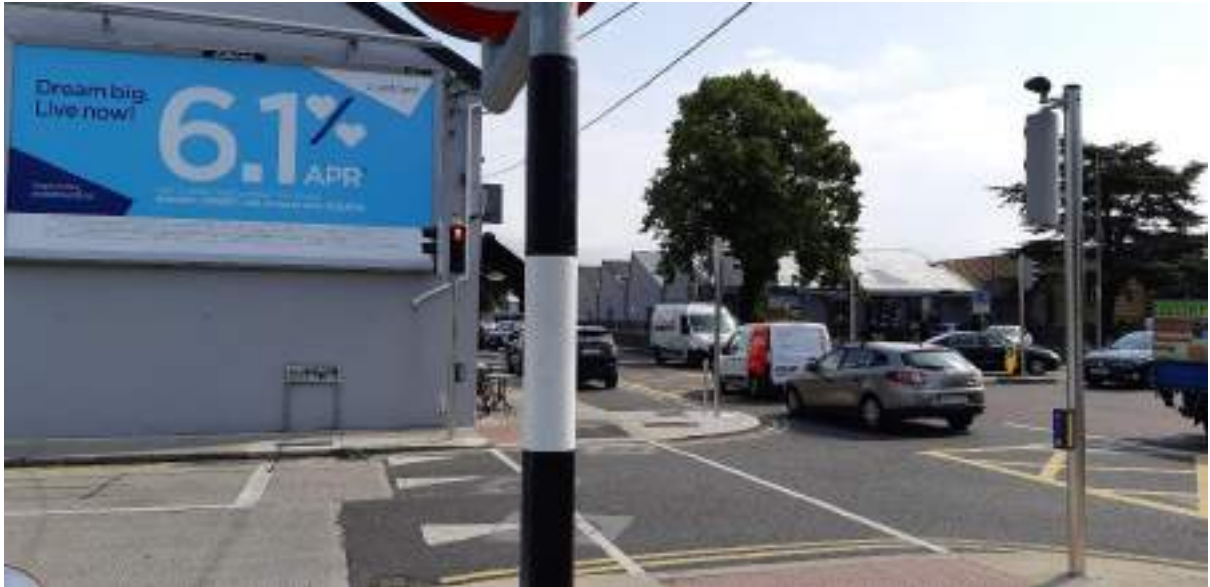
To the south of the leak point in Davies Showroom car parks, the route of the cabling cross to the north side of the Sallynoggin Road, close to the junction with Pearse Street (Photo 14), before entering Wood Park a small communal park associated with the adjacent residential estate (O'Rourke Park). There was no evidence of leakage observed along this section (Photos 15-16). After traversing Wood Park, the cable route veers to the northwest and passes through a narrow alley that links to additional area of the residential estate (Photo 17).

Photo 14: looking across junction at Davies showroom (in distance). Maps indicate cables traverse junction (Sallynoggin Road) diagonally at this location and continue into park

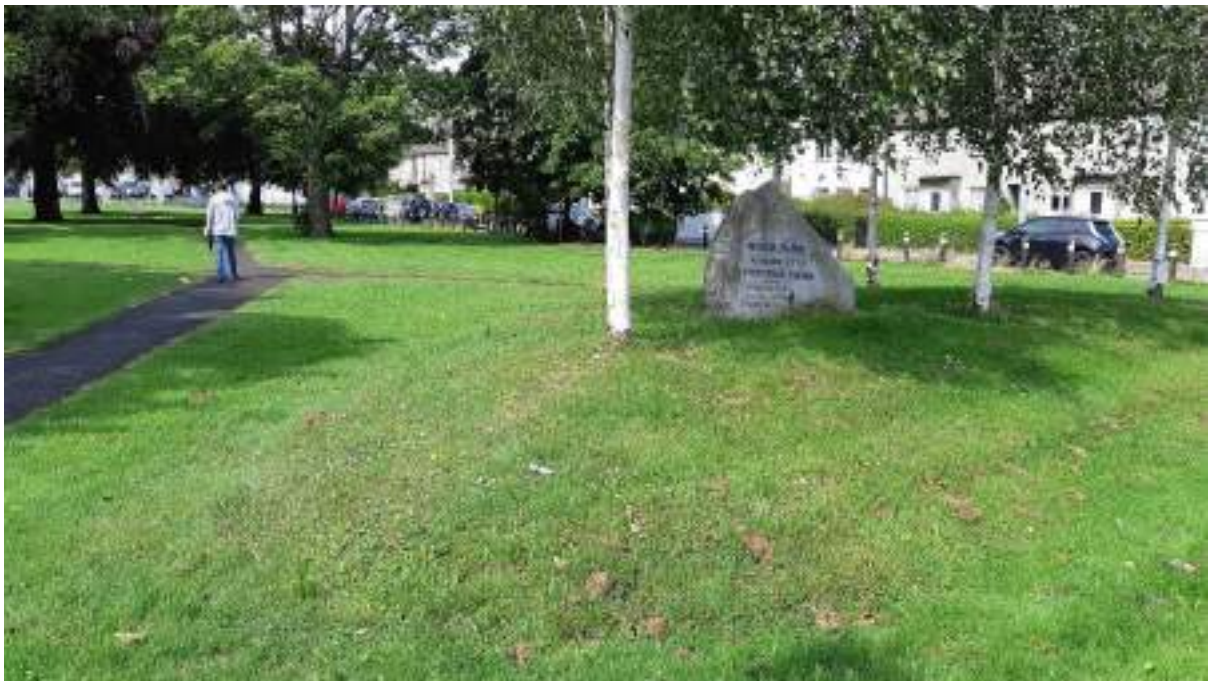
Photo 15: Cables traverse Wood Park in southwest direction to RHS of central path. No evidence on surface of leaks.

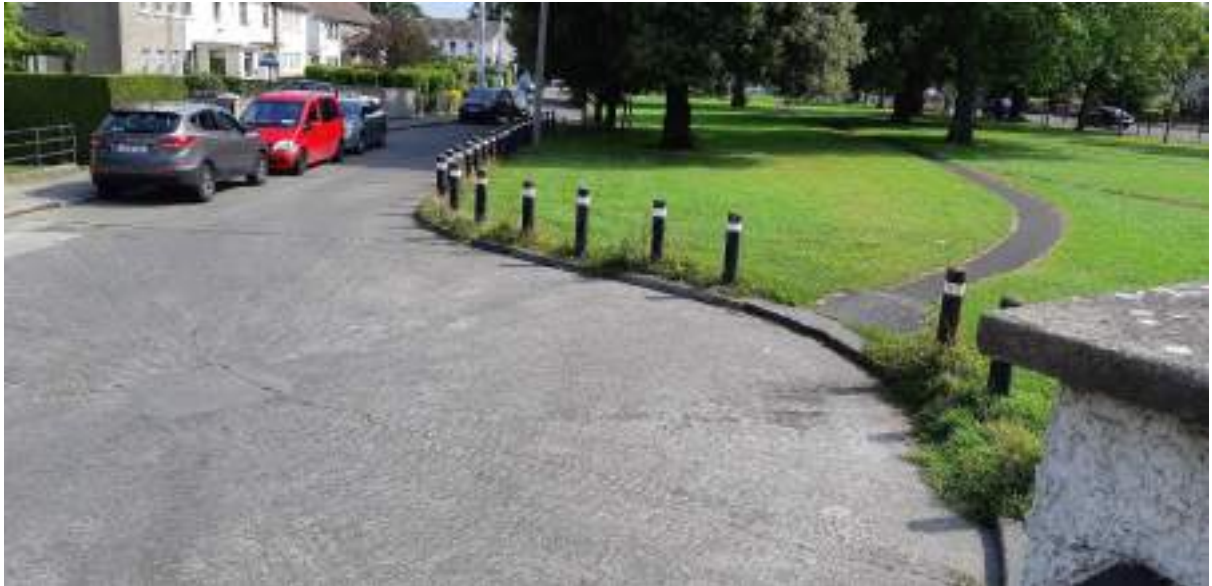
Photo16: At southwest corner of Wood Park, cables cross parking circle at end of O'Rourke Park residential estate. Cables veer to right and travel up narrow laneway which connects to further area of estate

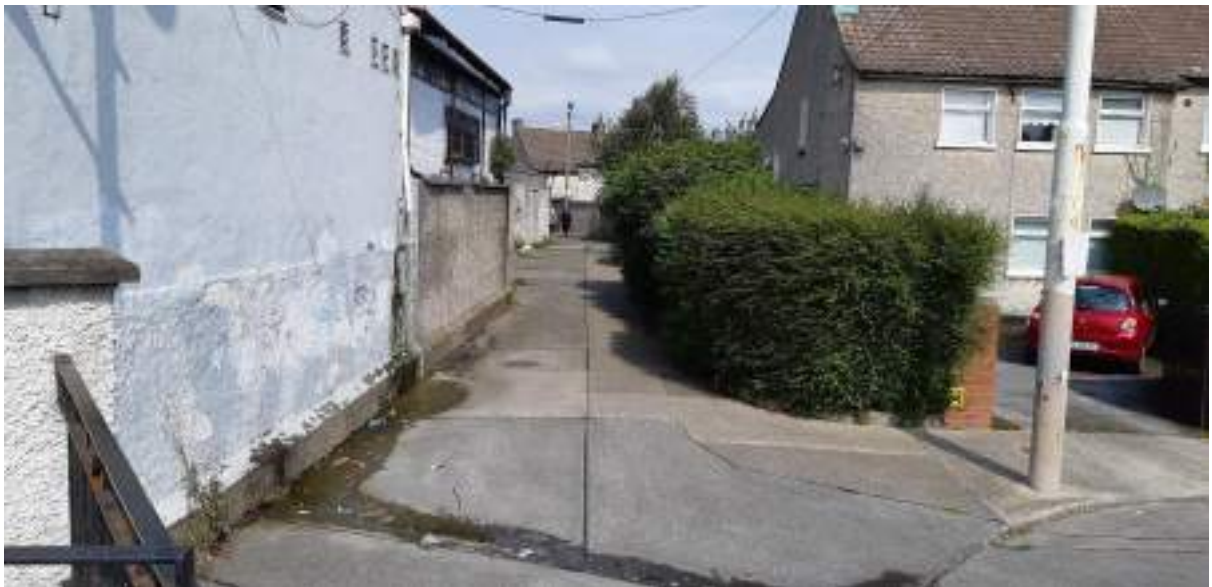
Photo 17: Laneway that connects two areas of O'Rourke Park. Cabling is understood to run along this laneway.
