ESB Engineering and Major Projects

Francis Street – Camden Row (Site ID 33)

Preliminary Environmental Site Assessment

602620 – R01 (04)

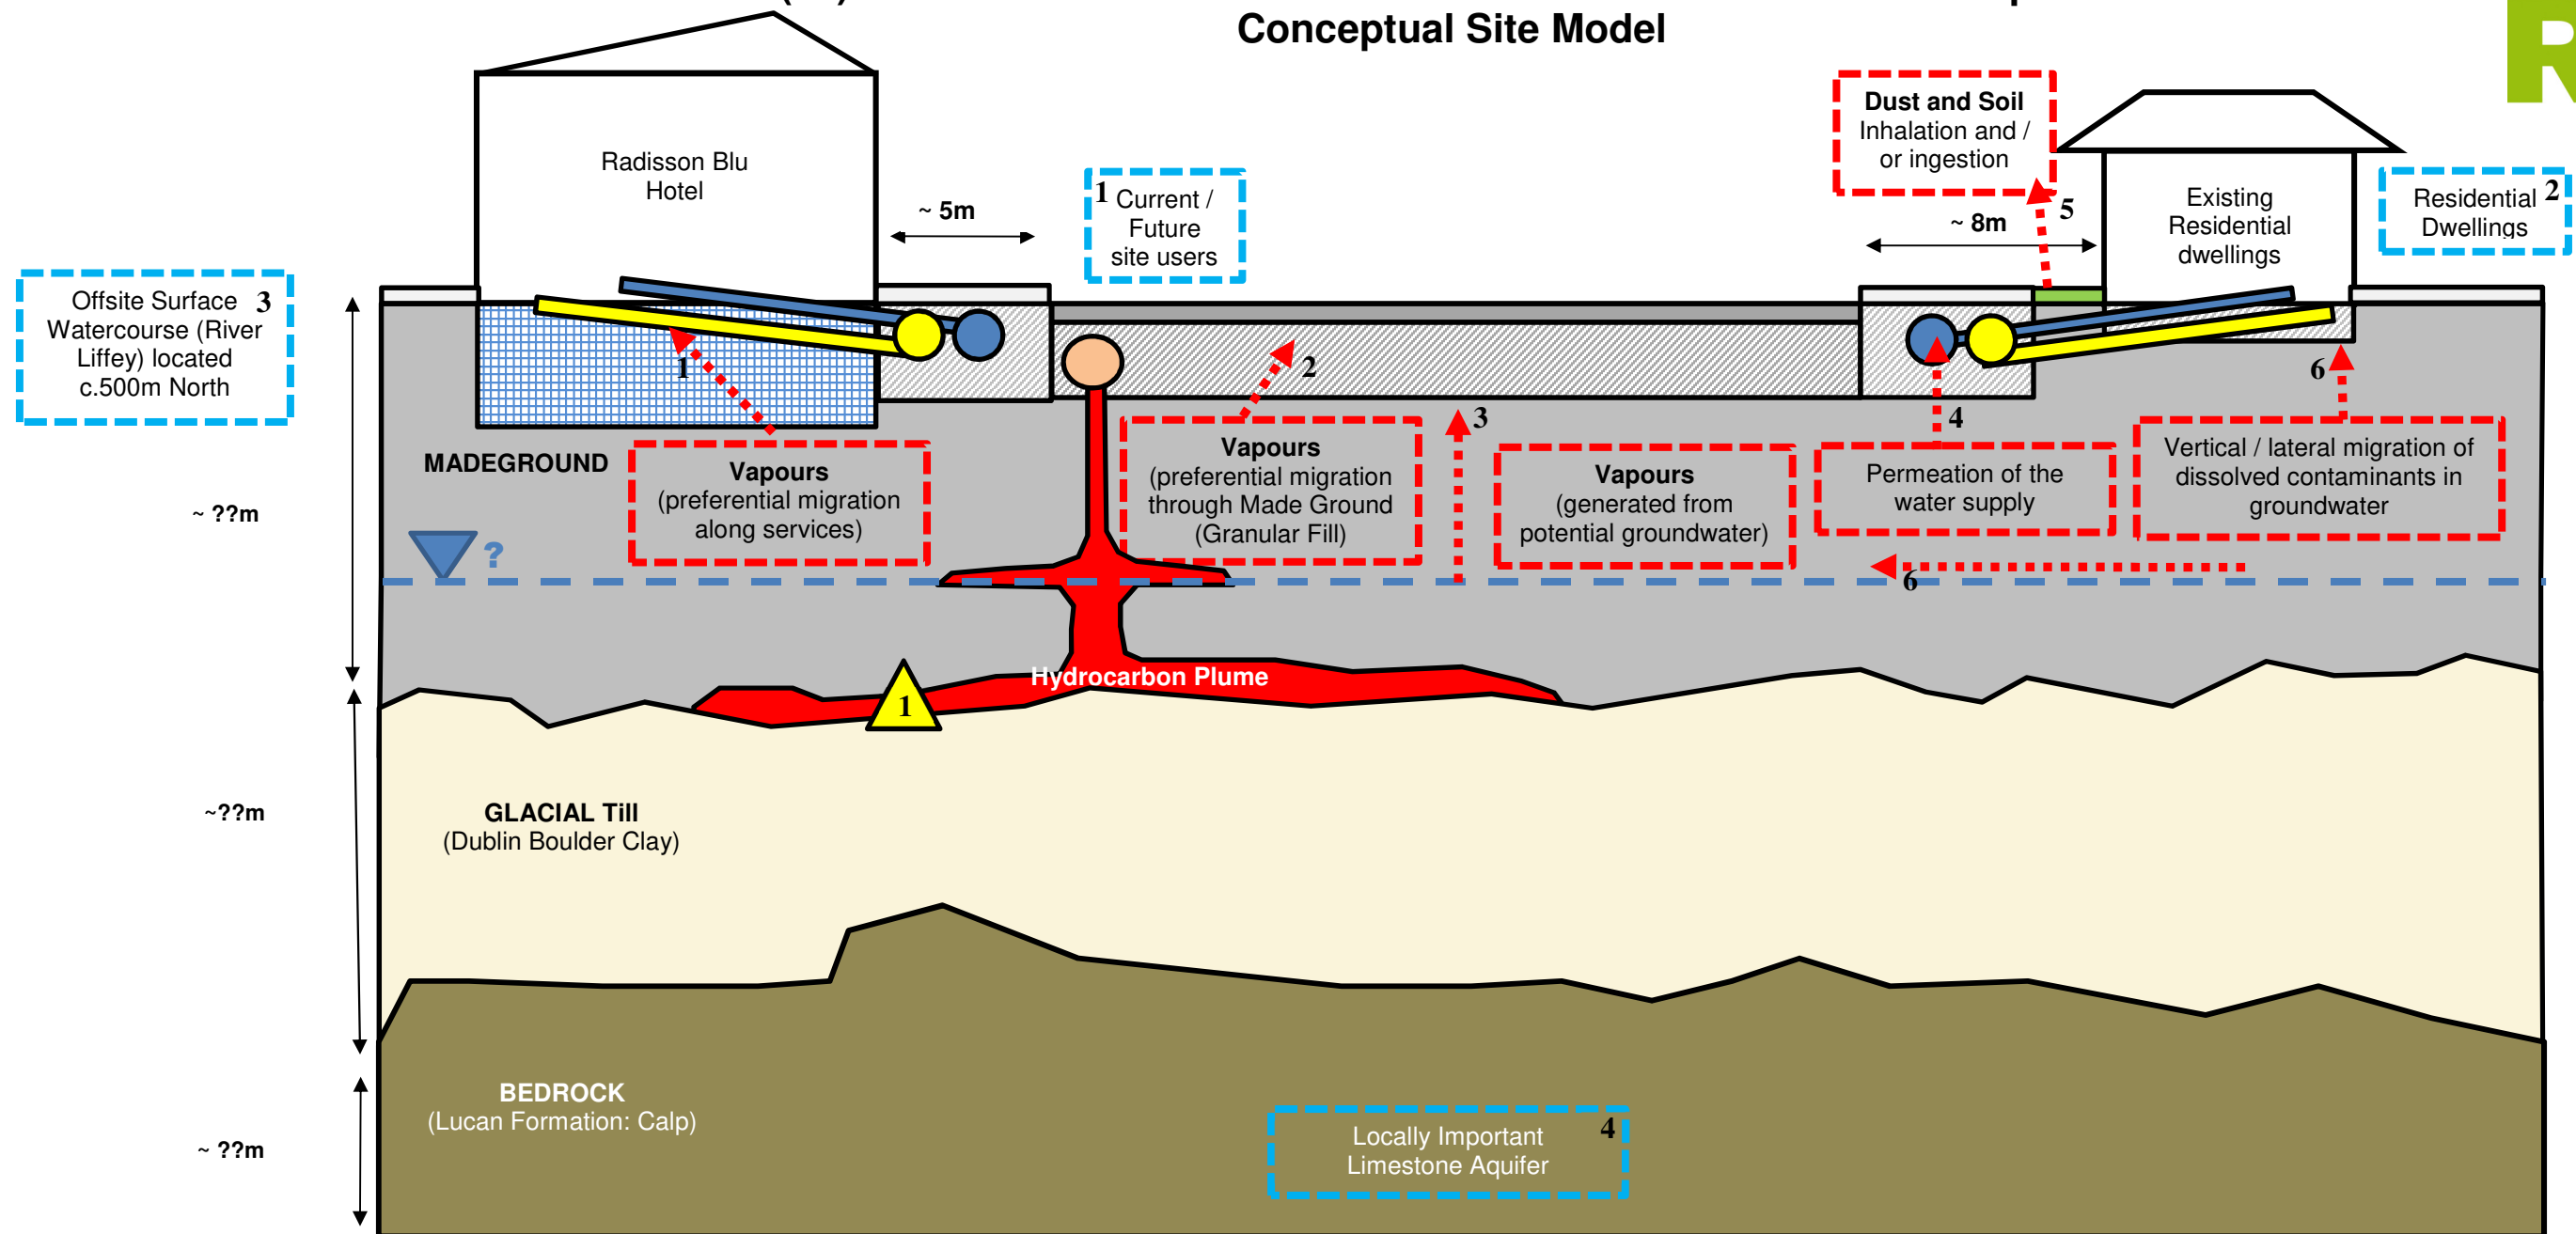
(33) Francis Street – Camden Row Indicative Leak Location - Graphical Conceptual Site Model

The initial CSM has identified potential pollutant linkages with a risk class of **LOW** for all identified pollution linkages.

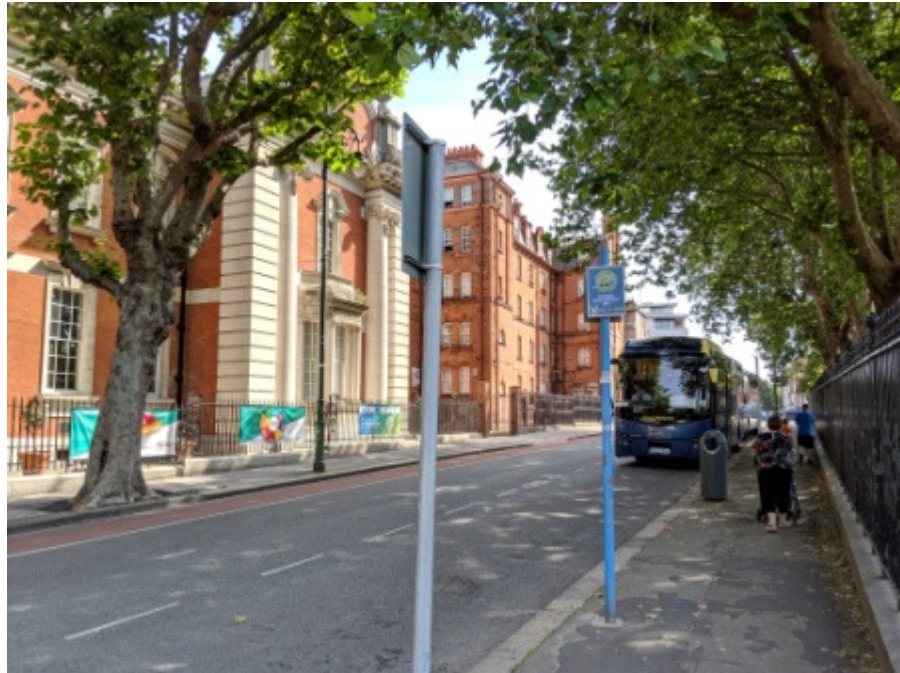
View of the 200m west marker from the indicative leak location. Liberties College is located to the immediate north of the 200m marker and St. Patrick's Cathedral and grounds are located to the immediate south.

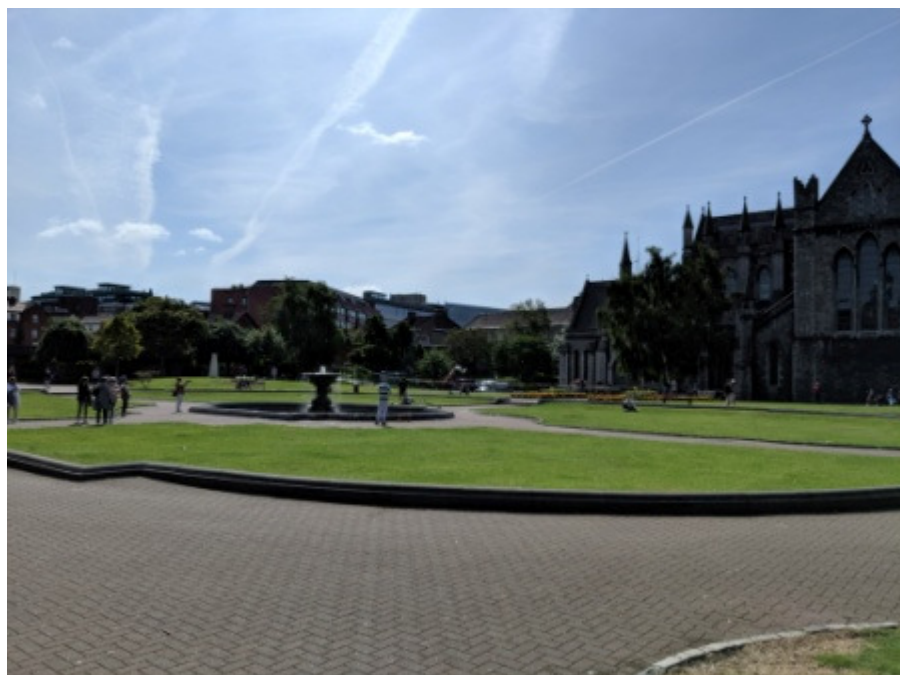
Photo No.
2

View of St. Patrick's Cathedral and grounds located in the vicinity of the 200m west marker from the indicative leak location. The park was busy with pedestrians.

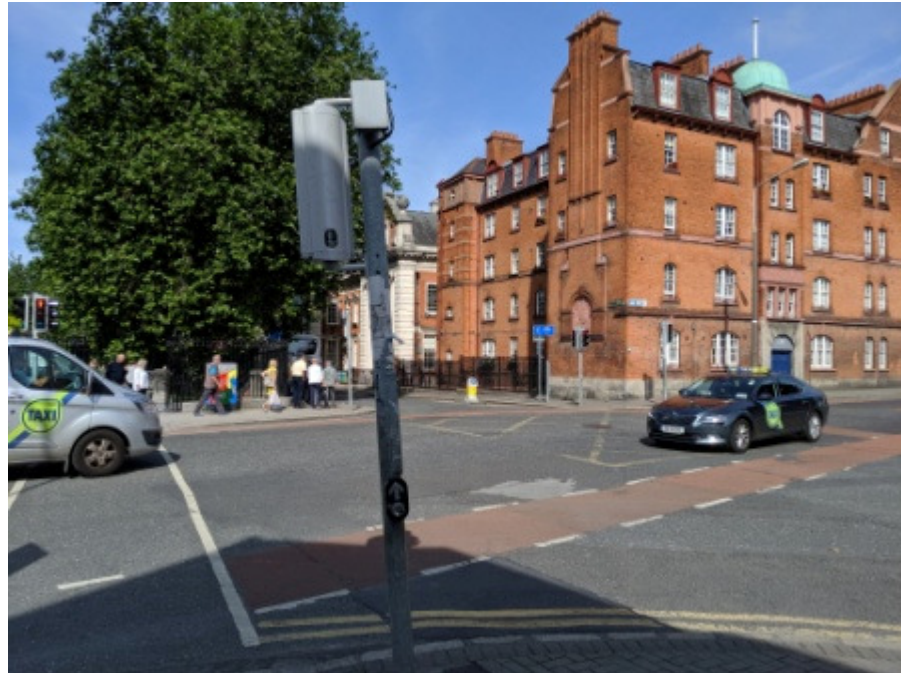
View of the junction at Bride Street (north) and Golden Lane (east), located c.165m west of the indicative leak location. The area is mixed commercial and residential, mainly office spaces with residential apartments above.

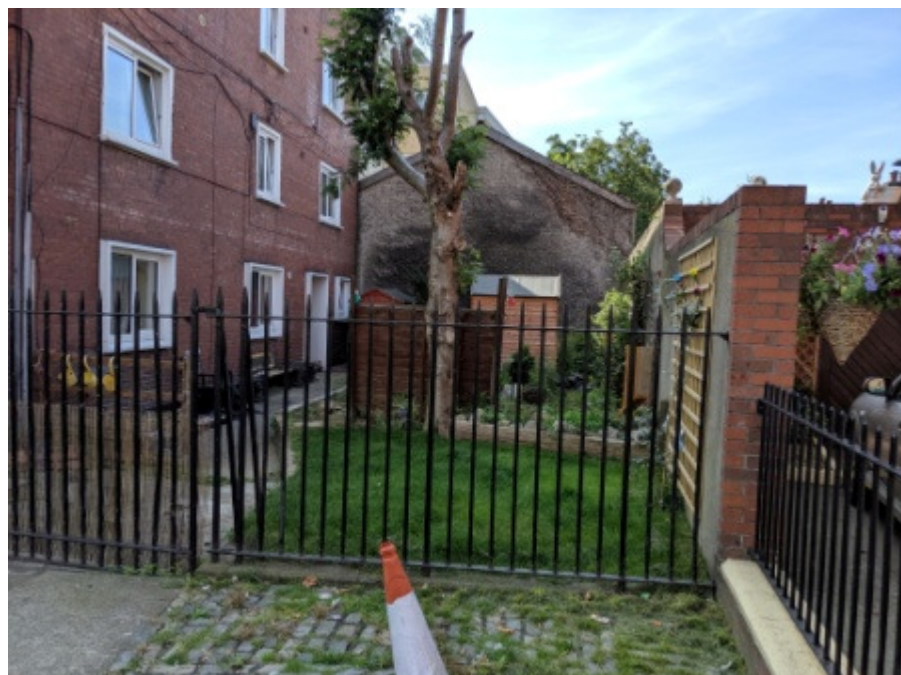
Photo No.
4

Garden relating to residential property of McDonagh House on Golden Lane, located c.75m west of indicative leak location.

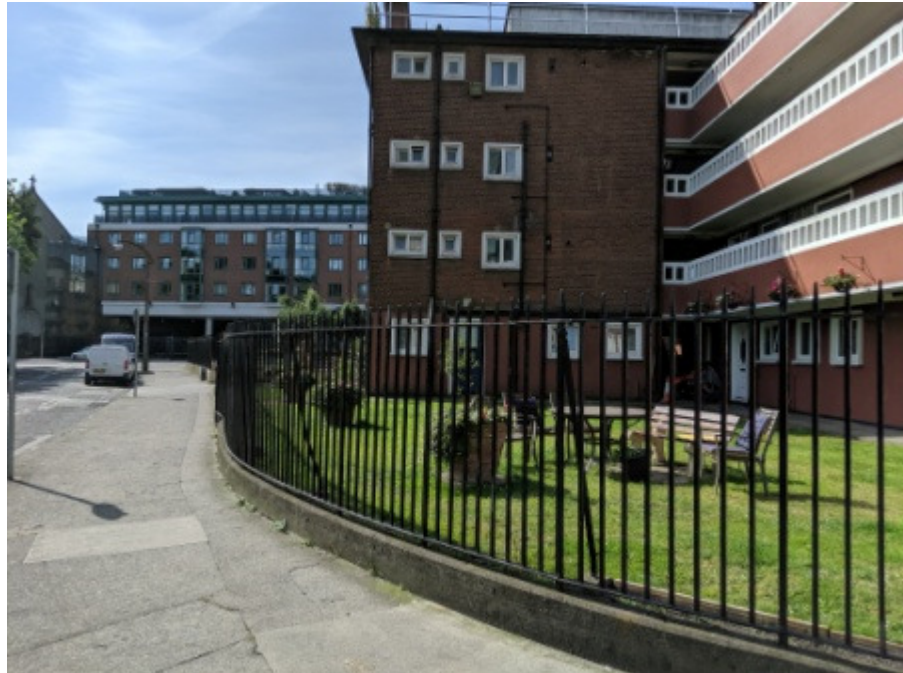
Indicative leak location.
View of McDonagh House Residential apartments.
The apartments have a communal landscaped area.

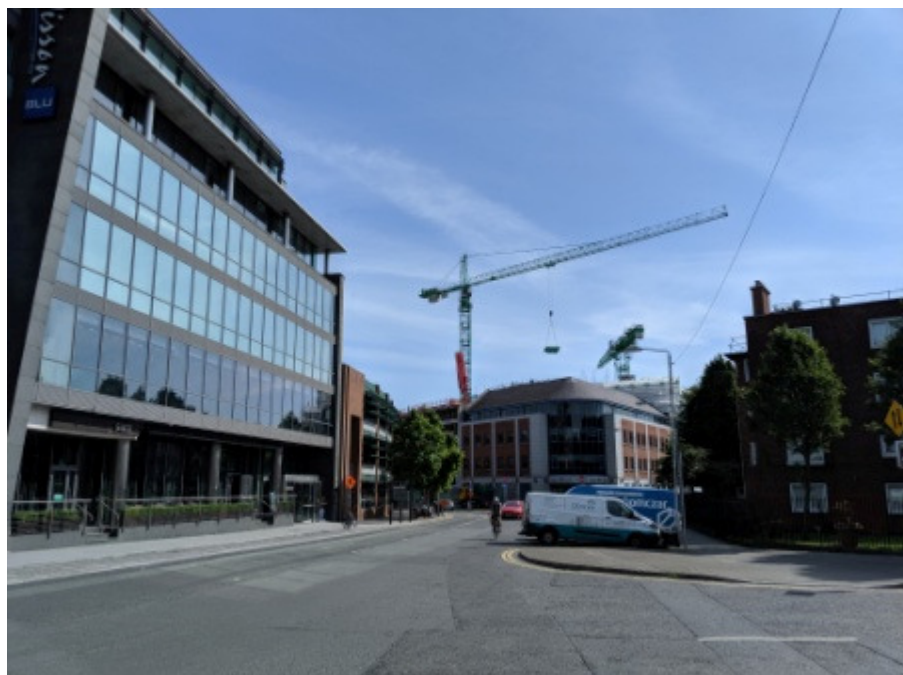
Photo No.
6

Indicative leak location.
View of the junction between Whitefriar Street and Golden Lane. Road is heavily scarred and multiple service manhole covers are present in the vicinity of the leak.
Radisson Blu Hotel is located to the immediate north of the indicative leak location.

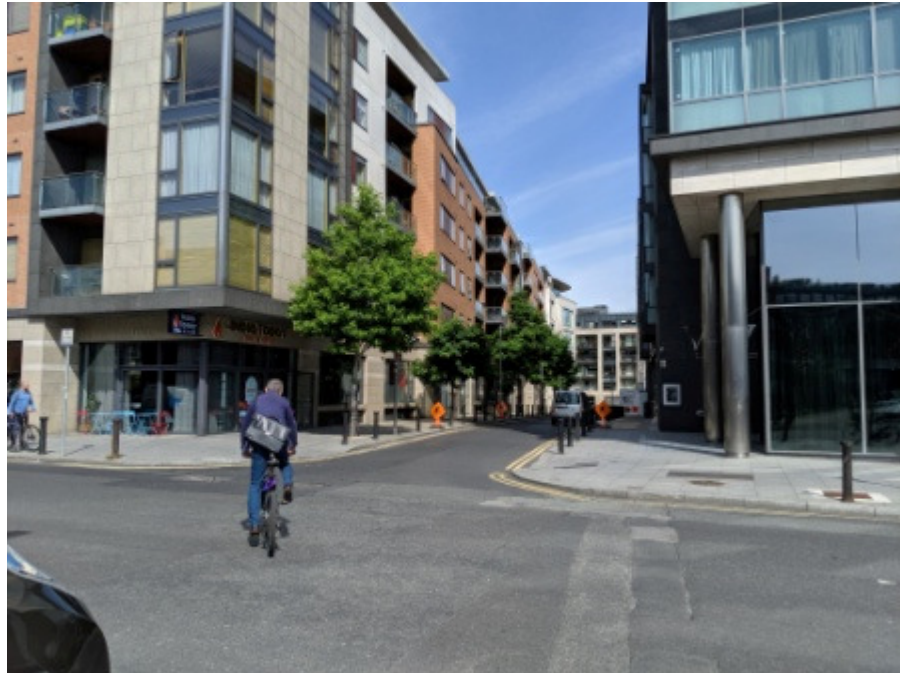
View of the indicative leak location.

Radisson Blu Hotel is located to the immediate north of the indicative leak location. Chancery Lane Apartments are located to the northwest of the leak location which have a communal landscaped area.

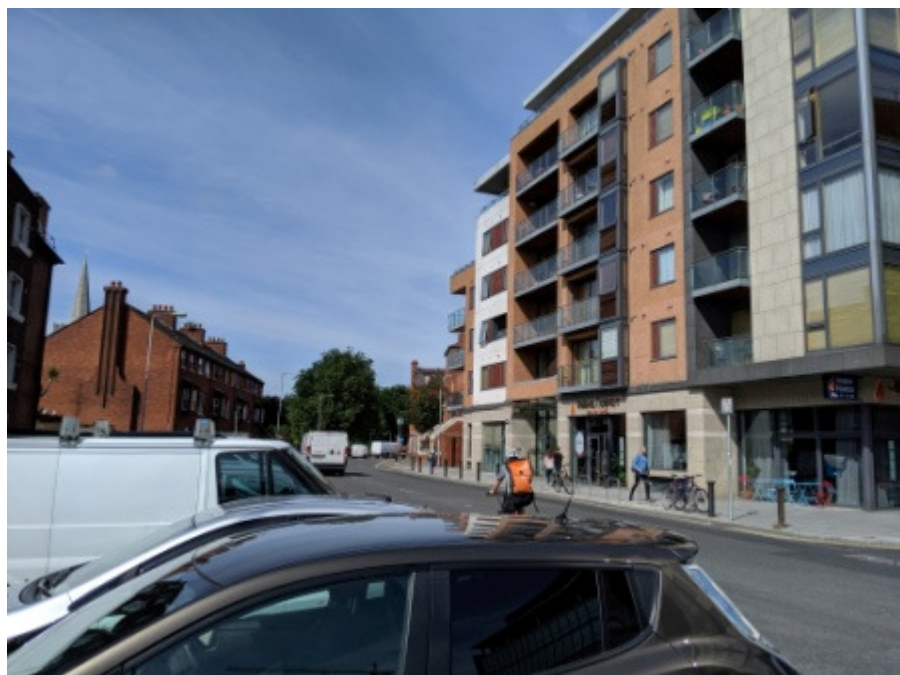
Photo No.
8

View of the indicative leak location. Chancery Lane Apartments are located to the northwest of the leak location which have a communal landscaped area.

McDonagh House residential flats are located to the south of the indicative leak location which also have a communal landscaped area.

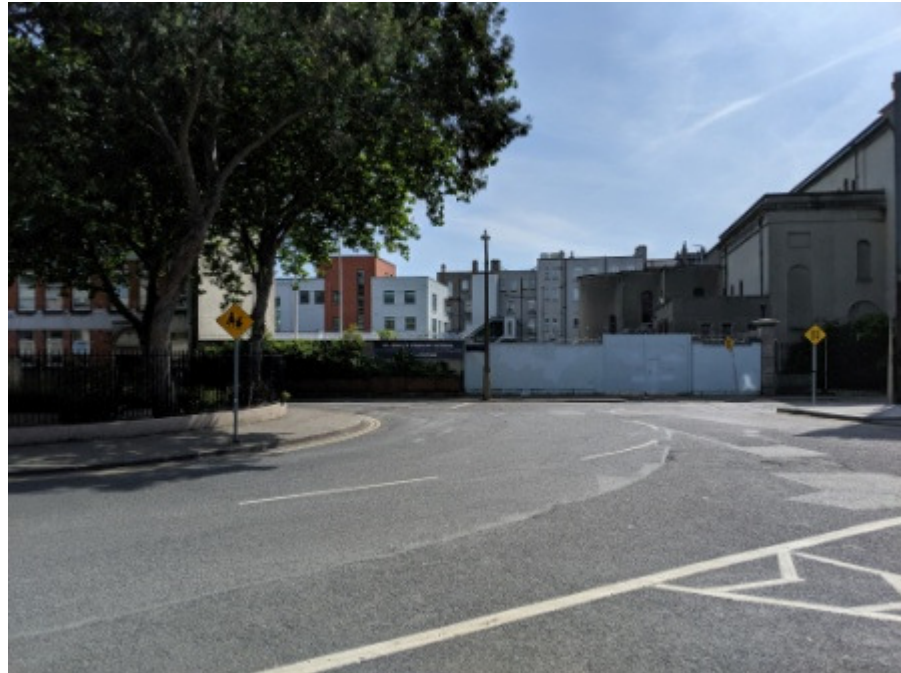
View of side entrance to St. Enda's Primary School. Located c.55m southeast of the indicative leak location.

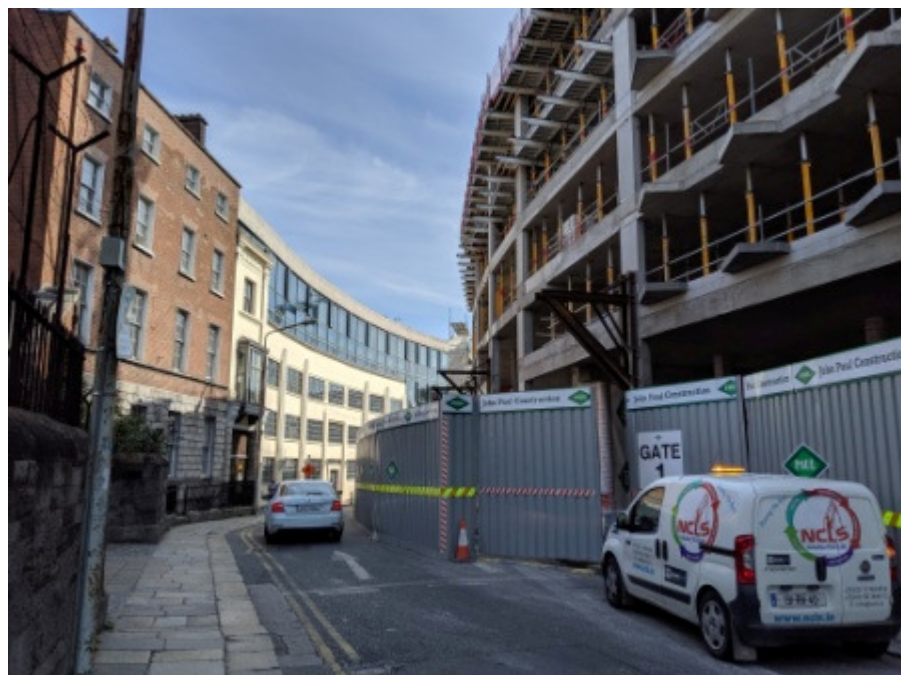
Photo No.
10

View of Stephen Street Upper (c.75m northeast of indicative leak location) which is currently a one-way system with temporary traffic lights due to the ongoing construction. Buildings to the north of Upper Stephen Street and mixed residential / commercial use.

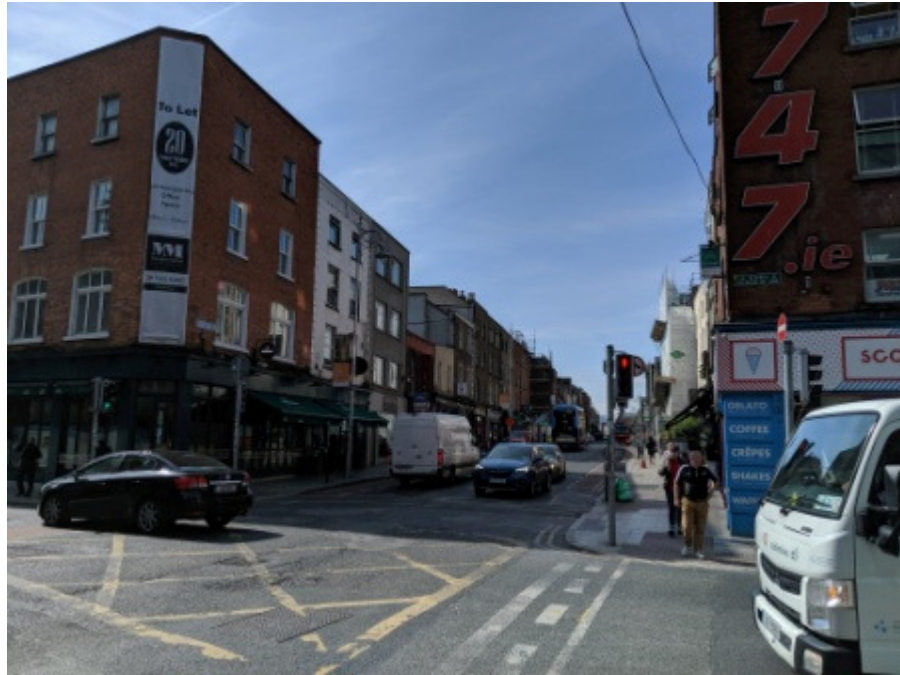
Photo No. 11	Date: Aug 2019
Direction Photo taken: South

200m marker from indicative leak location. View of the junction between Stephen Street upper and Stephen Street lower. The land use is predominantly commercial; dominated by restaurants / cafes with office space above.

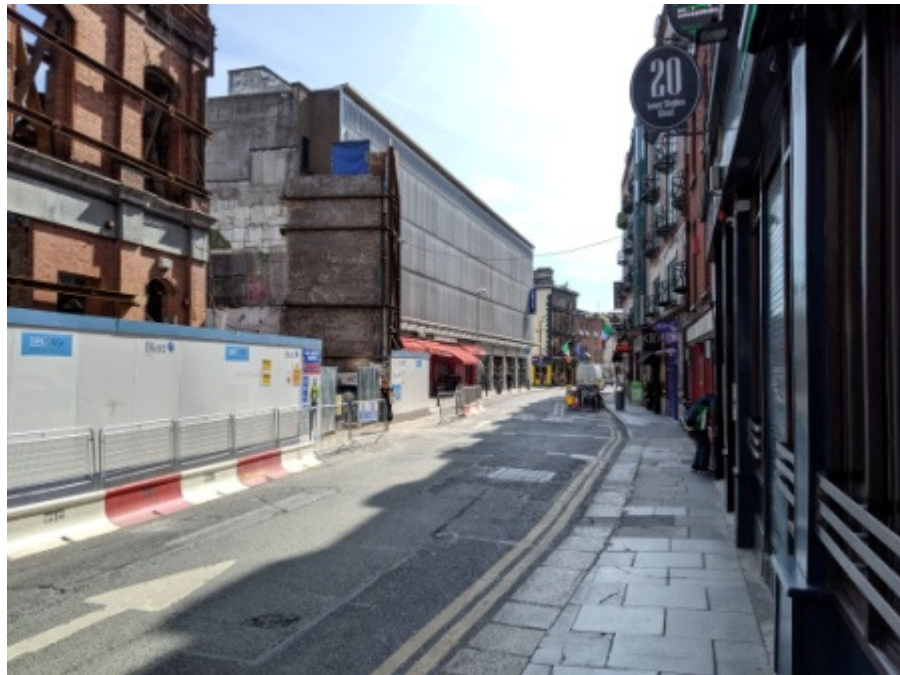
Photo No. 12	Date: Aug 2019
Direction Photo taken: East

200m marker from Indicative Leak location. Construction work ongoing in the area to the east of the 200m marker. Land use is predominantly commercial.
