Preliminary Site Assessment Report for Monaghan Road, Cork City

ESB Site Ref: 38
Marina – Trabeg Two 110kV

Project Title: ESB Networks Historic Fluid Filled Cable Loss
Environmental Assessment

Report Ref: Stage 1 Preliminary Site Assessment Report for Monaghan Road, Cork. ESB Ref: 38 Marina – Trabeg Two 110kV

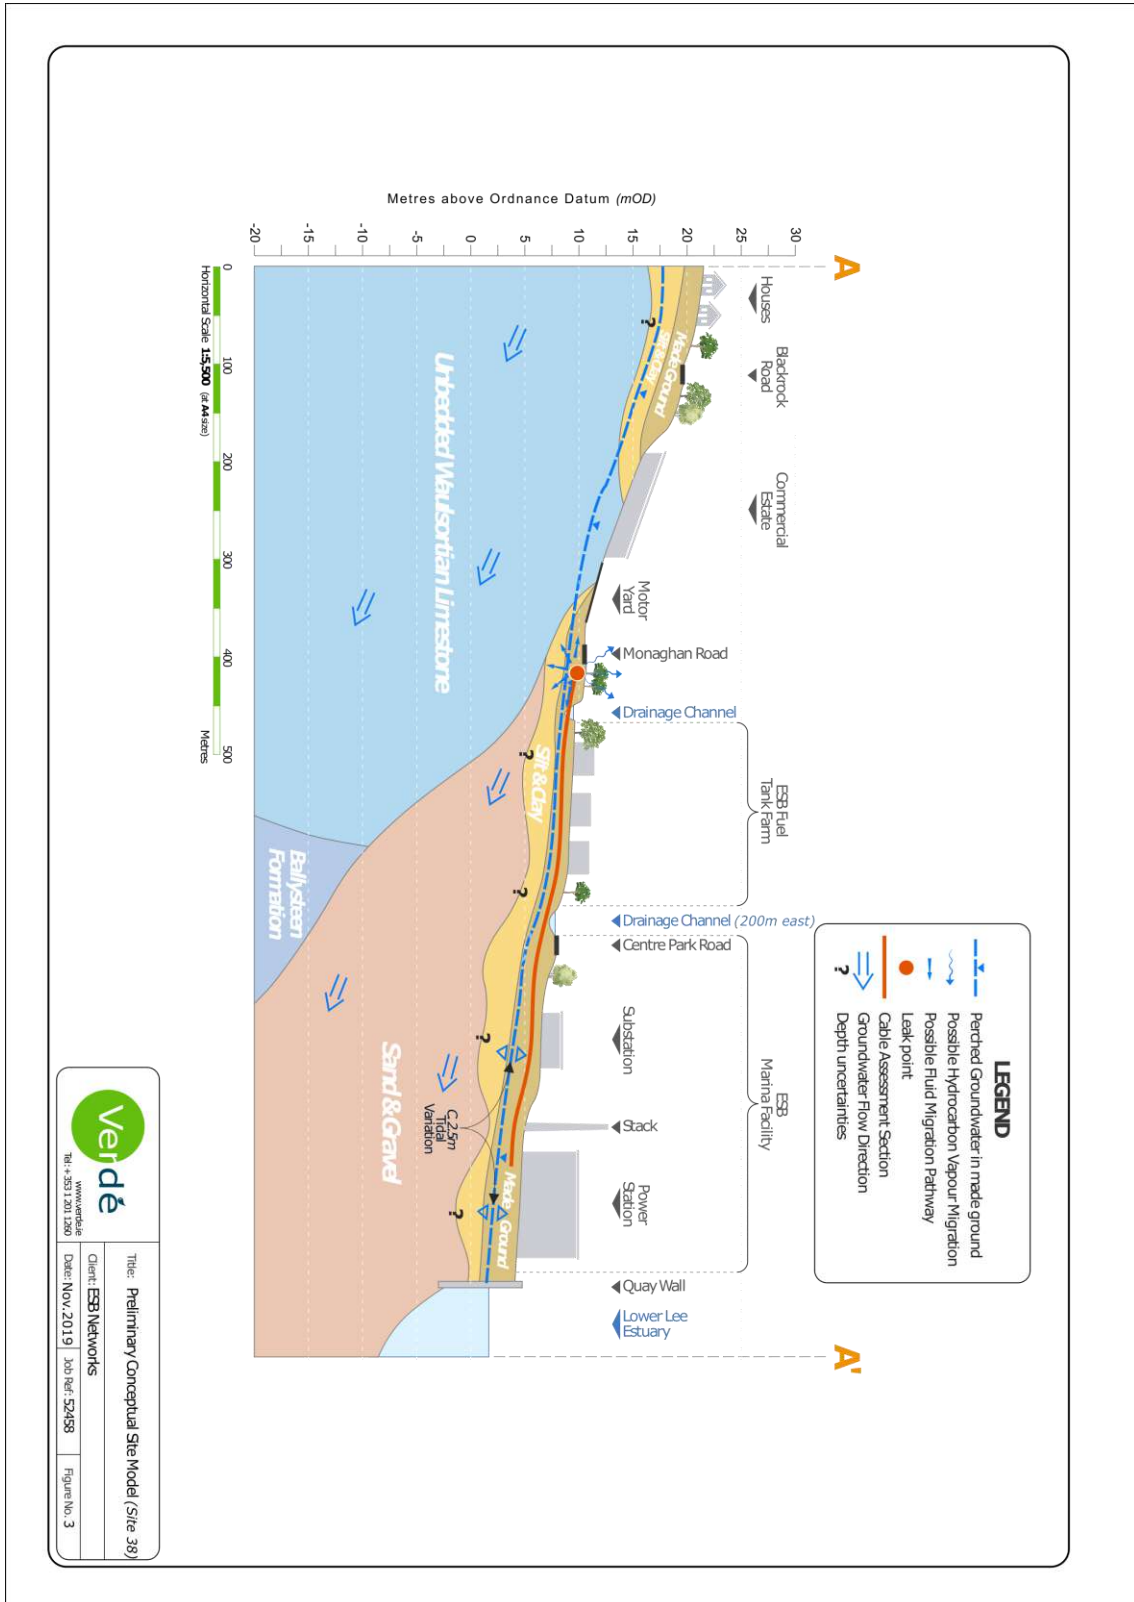
Figure 3 – Conceptual Site Model

- hydrocarbon migration to the Atlantic Pond and Lee Estuary given the existence of a hydrogeological pathway between the leak site and the local drainage channels and the Atlantic Pond downstream.
- hydrocarbon migration downwards to the underlying aquifer given the possible connection to shallow groundwater through shallow rock and gravels in the area indicated by the moderate to high vulnerability.

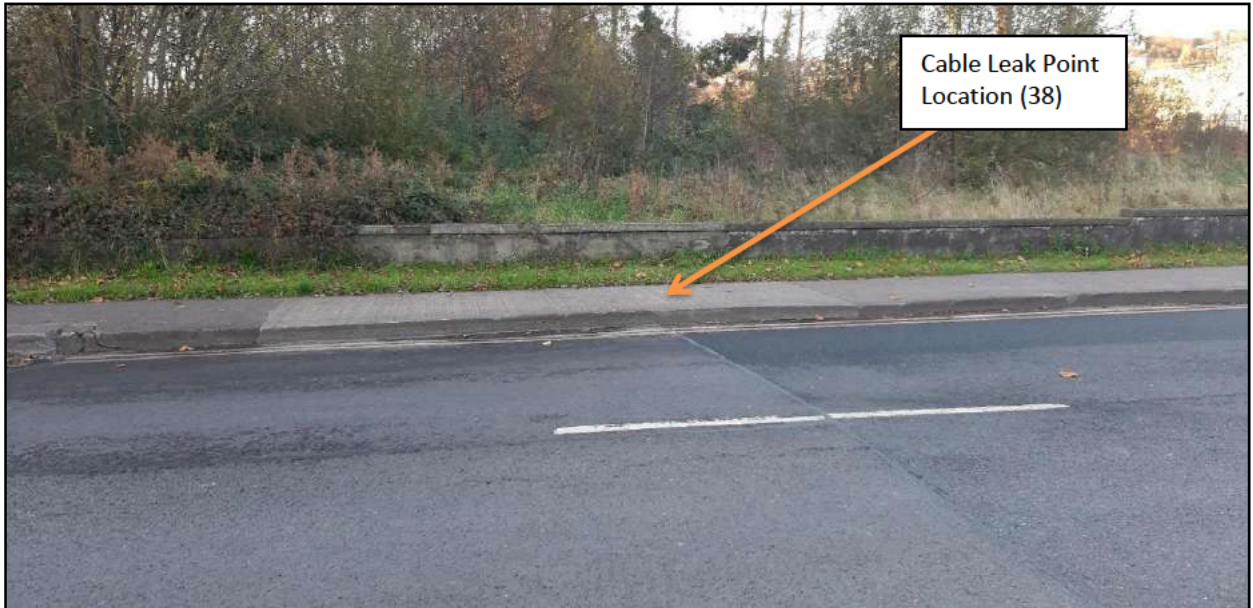
Possible evidence of remediation/investigation works are evident in the form of the replacement of a section of footpath above the known leak point (Appendix C). There is no indication that vegetation in the grass verge has been impacted by the leak (no discoloration or noticeable impact of nearby tree growth).

Photo 1: View north from Monaghan Road looking into section of concrete pathway that is associated with the leak point. Cable progresses north and west from this point. Note green area in background extends for c.50m to north where drainage channel is located.

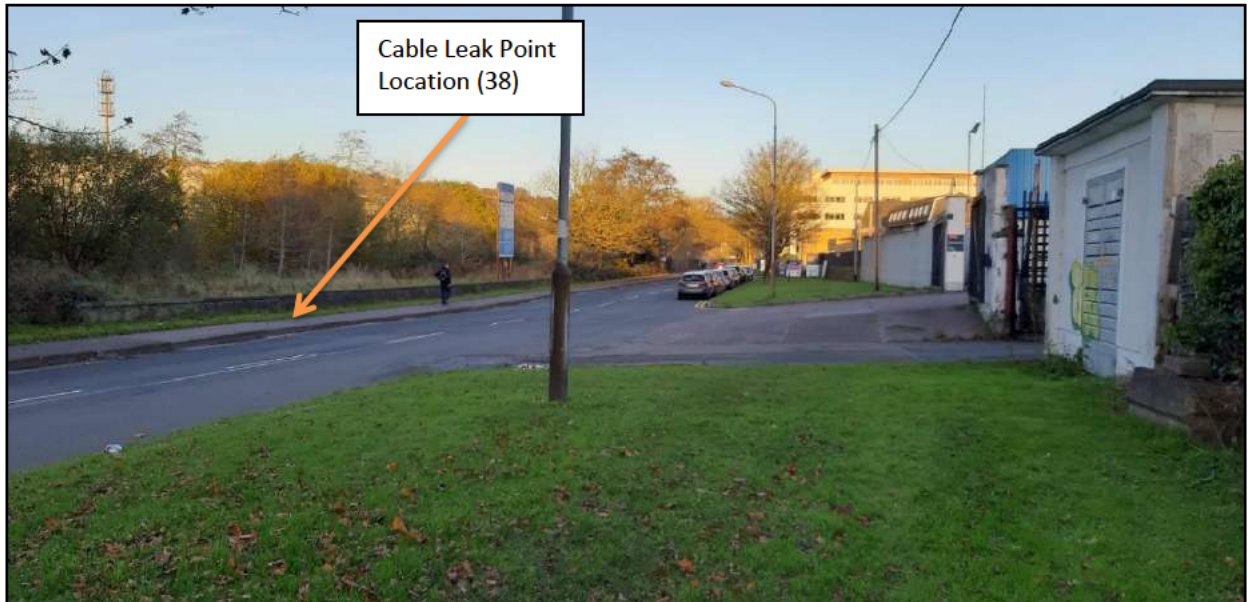
Photo 2: Looking east from entrance to nearby office complex; view of Monaghan Road. Note that cable leak point is located under pathway on left side of image. Also note the ESB substation on the right of the image.

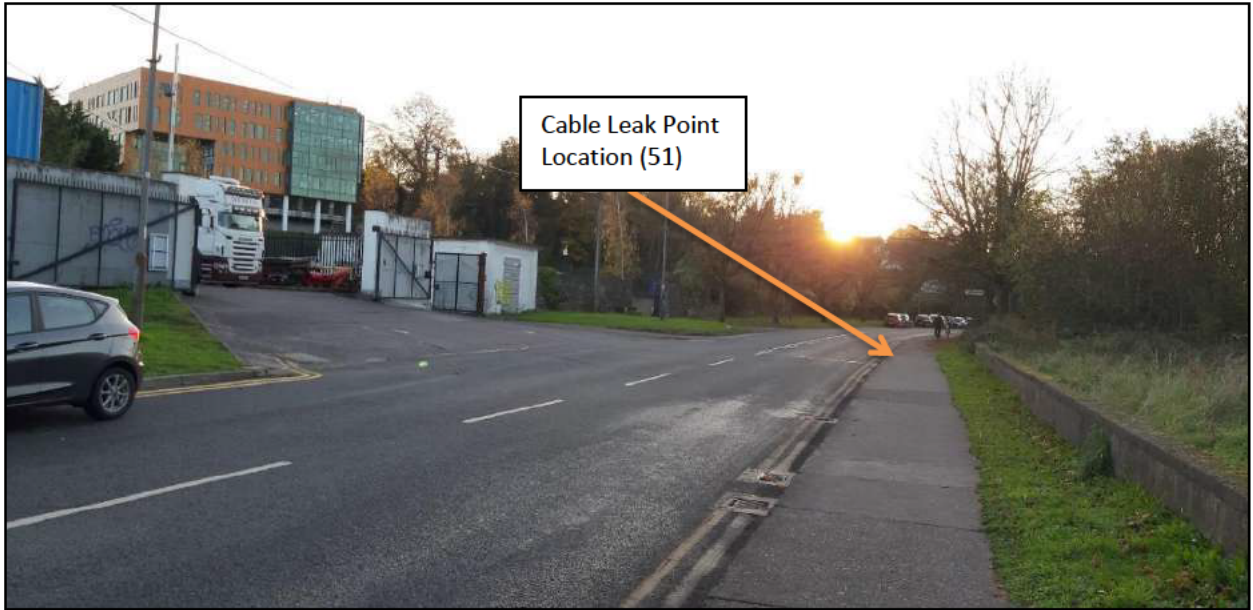
Photo 3: View west looking towards Tellangana House office development and leak point 51 which is located under pathway on right side of image. Note presence of storm drains on curbside.

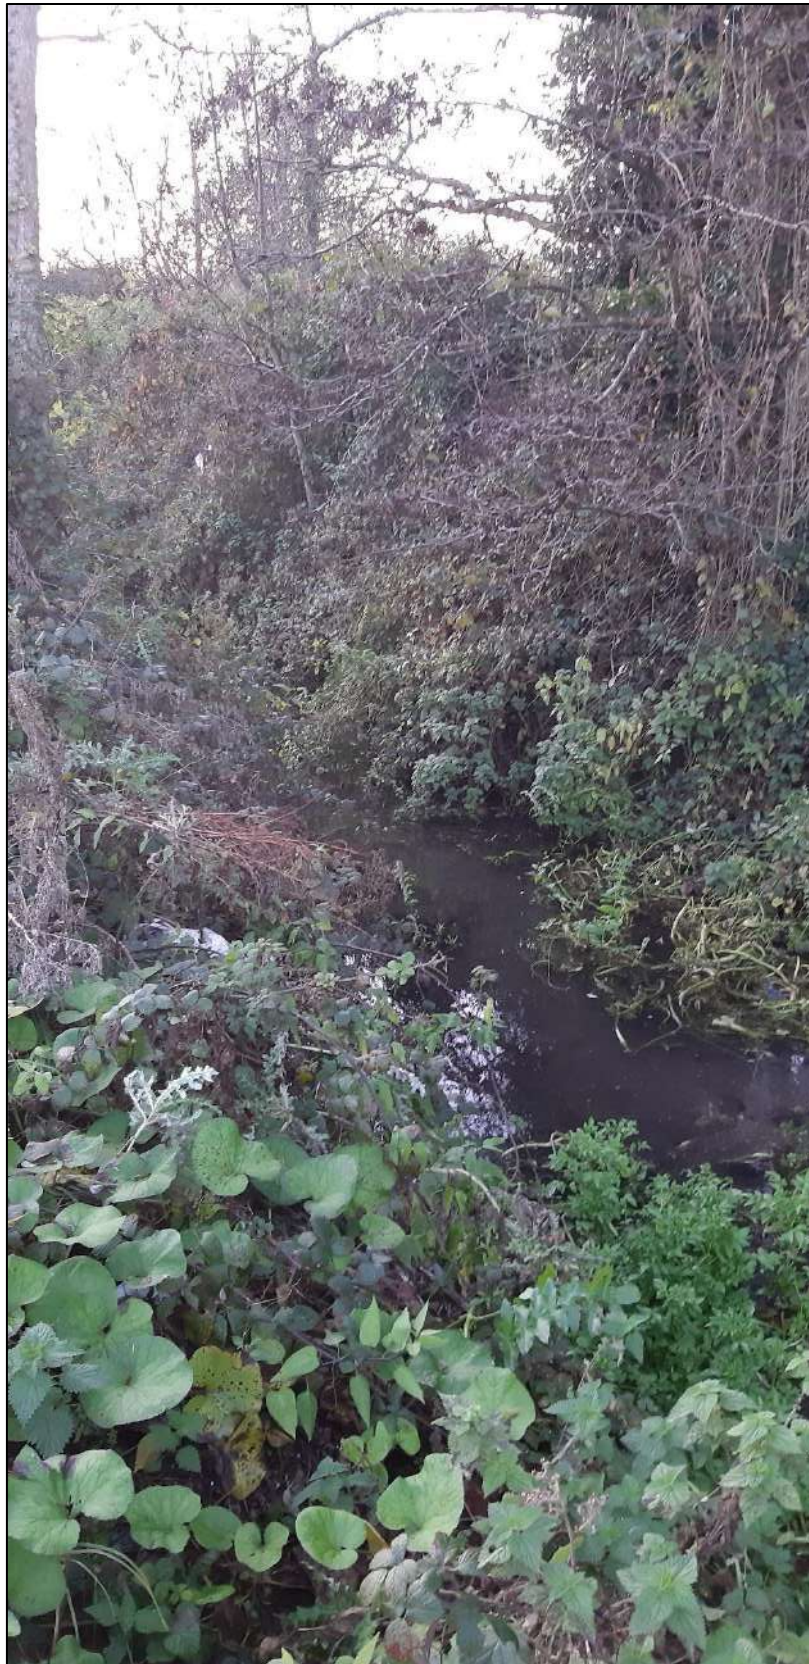
The nearest surface watercourses were observed during a site walkover on 15th of November 2019. The closest drainage channel is located at 45m north of the leak point, which flows towards the Atlantic Pond; which then drains into the Lee Estuary. Several other drainage channels were also observed in the site area. A drainage channel runs along the south side of the Centre Park Road, which appears to serve as an artificial storm water drainage channel that flows to the east towards the Atlantic Pond and the Lee Estuary. These drainage channels were seen, during the walkover, to be very low flow systems with some visible signs of contamination, in the form of a greyish-blue cloudy hue; as seen in Appendix C. Considering the location and low-flow nature of the drainage channel, it is not certain if the discolouration is related in, any manner, to the loss of cable fluids nearby.

Photo 5: Image of drainage channel, looking west, located c.45m north of leak point. Note greyish-blue appearance of water and near-stagnant state of water.

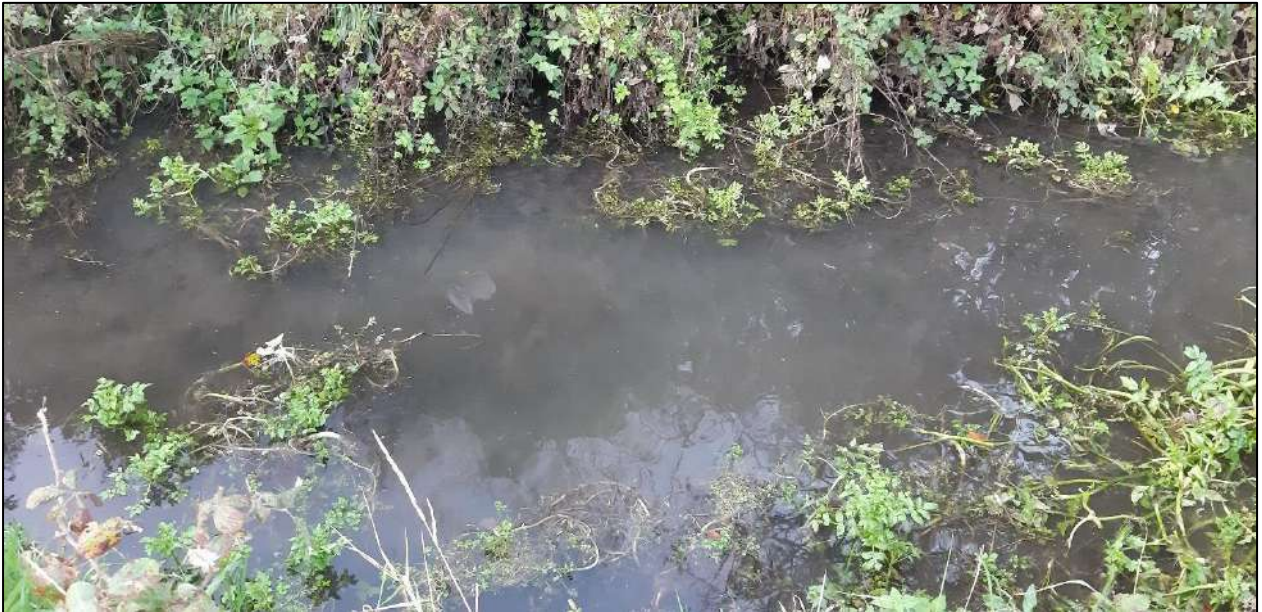
Photo 6: Image of nearest drainage channel, north of leak point, showing the poor water quality and stagnant water observed.

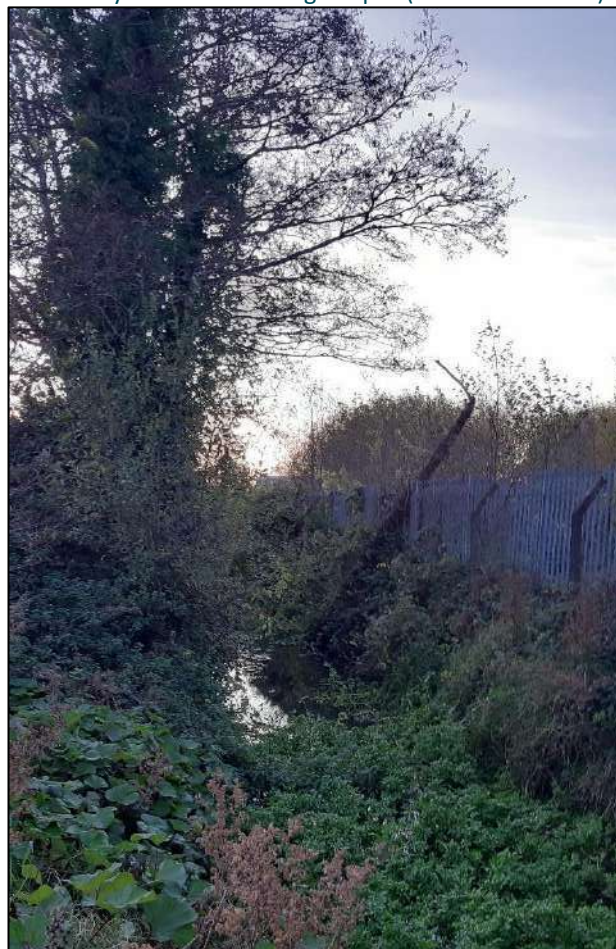
Photo 7: Image of nearest drainage channel north of leak point; looking west. Note the fence marks the rear boundary of the fuel storage depot (decommissioned).

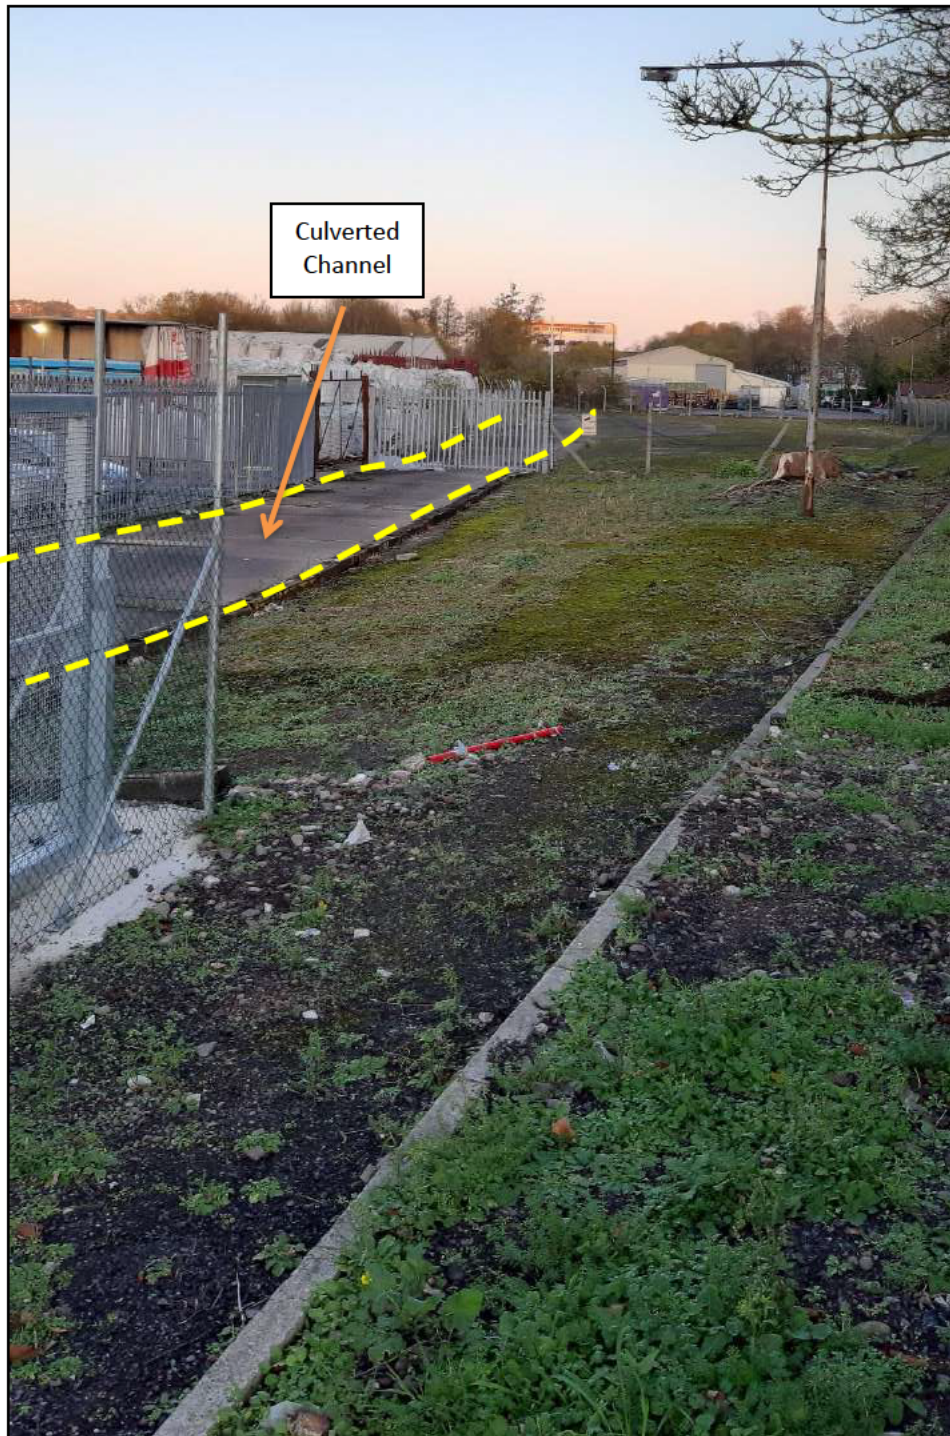
Photo 8: View, looking east, of a commercial property c.280m west of leak point, showing the concrete, culverted route of the drainage channel (flowing east). Note the Greenstar recycling facility in the far background.

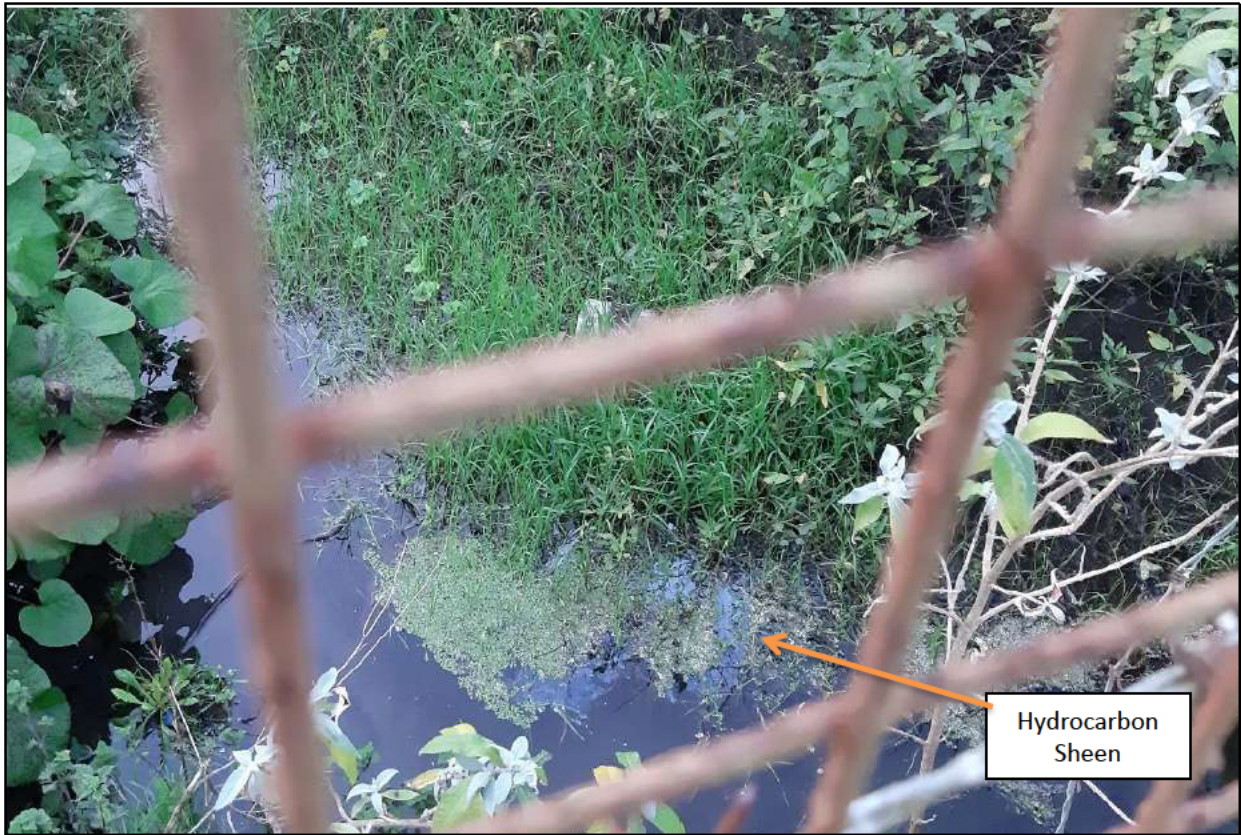
Photo 9: View of drainage channel at location of photo 8 (upstream); looking westward, showing occurrence of apparent hydrocarbon contamination in drainage waters.

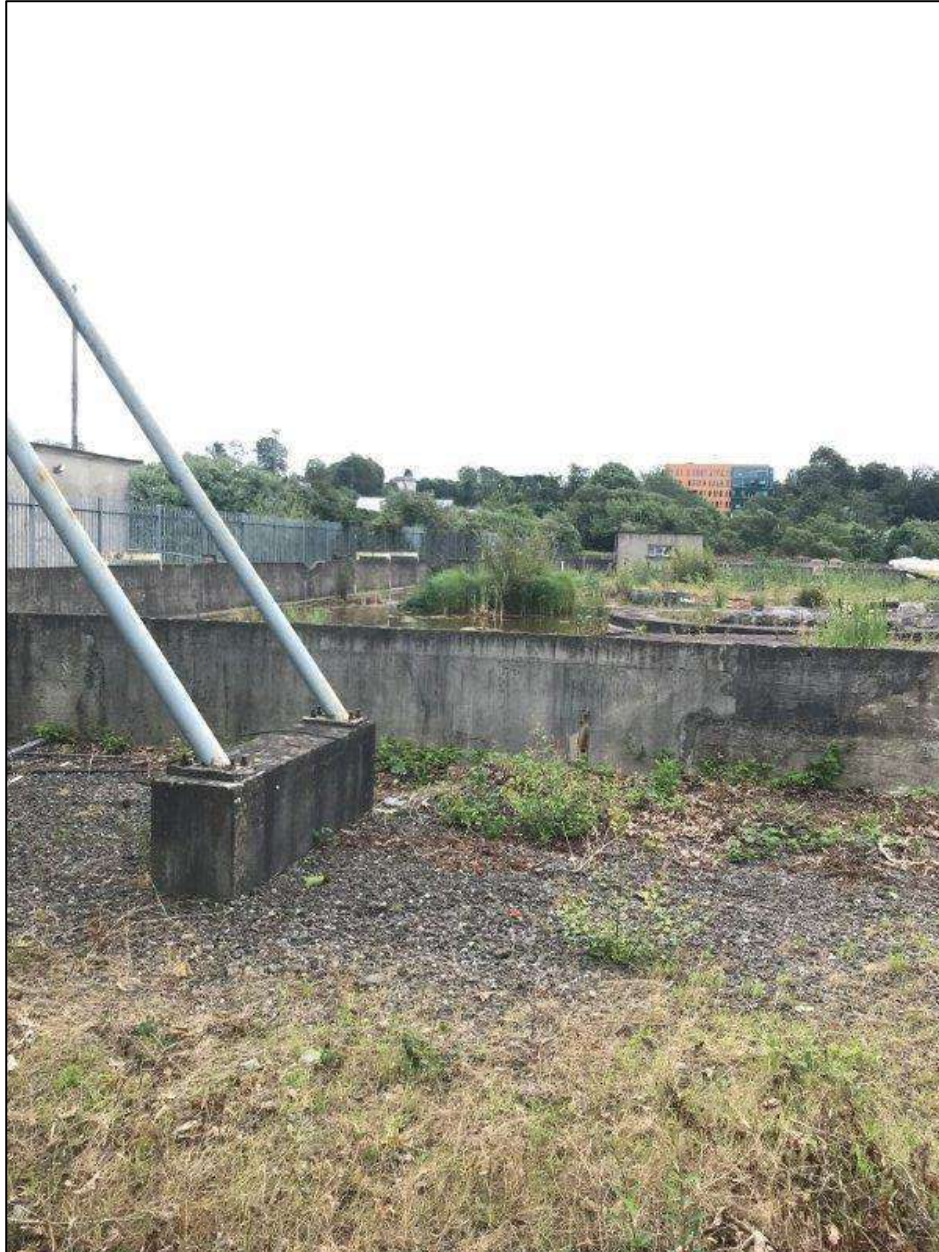
Photo 10: View from north side of decommissioned fuel storage depot on southern side of Centre Park Road. Note that the tree line in the background marks the boundary of the fuel facility and the location of the drainage channel. The 110kV cable runs along the left hand side of this image, towards the leak point.
