# **Preliminary Site Assessment Report for Finglas Road, Dublin 11**

ESB Site Ref: 66  
Finglas – Merville 38kV

**March 2020**

**Project Title:** ESB Networks Historic Fluid Filled Cable Loss  
Environmental Assessment

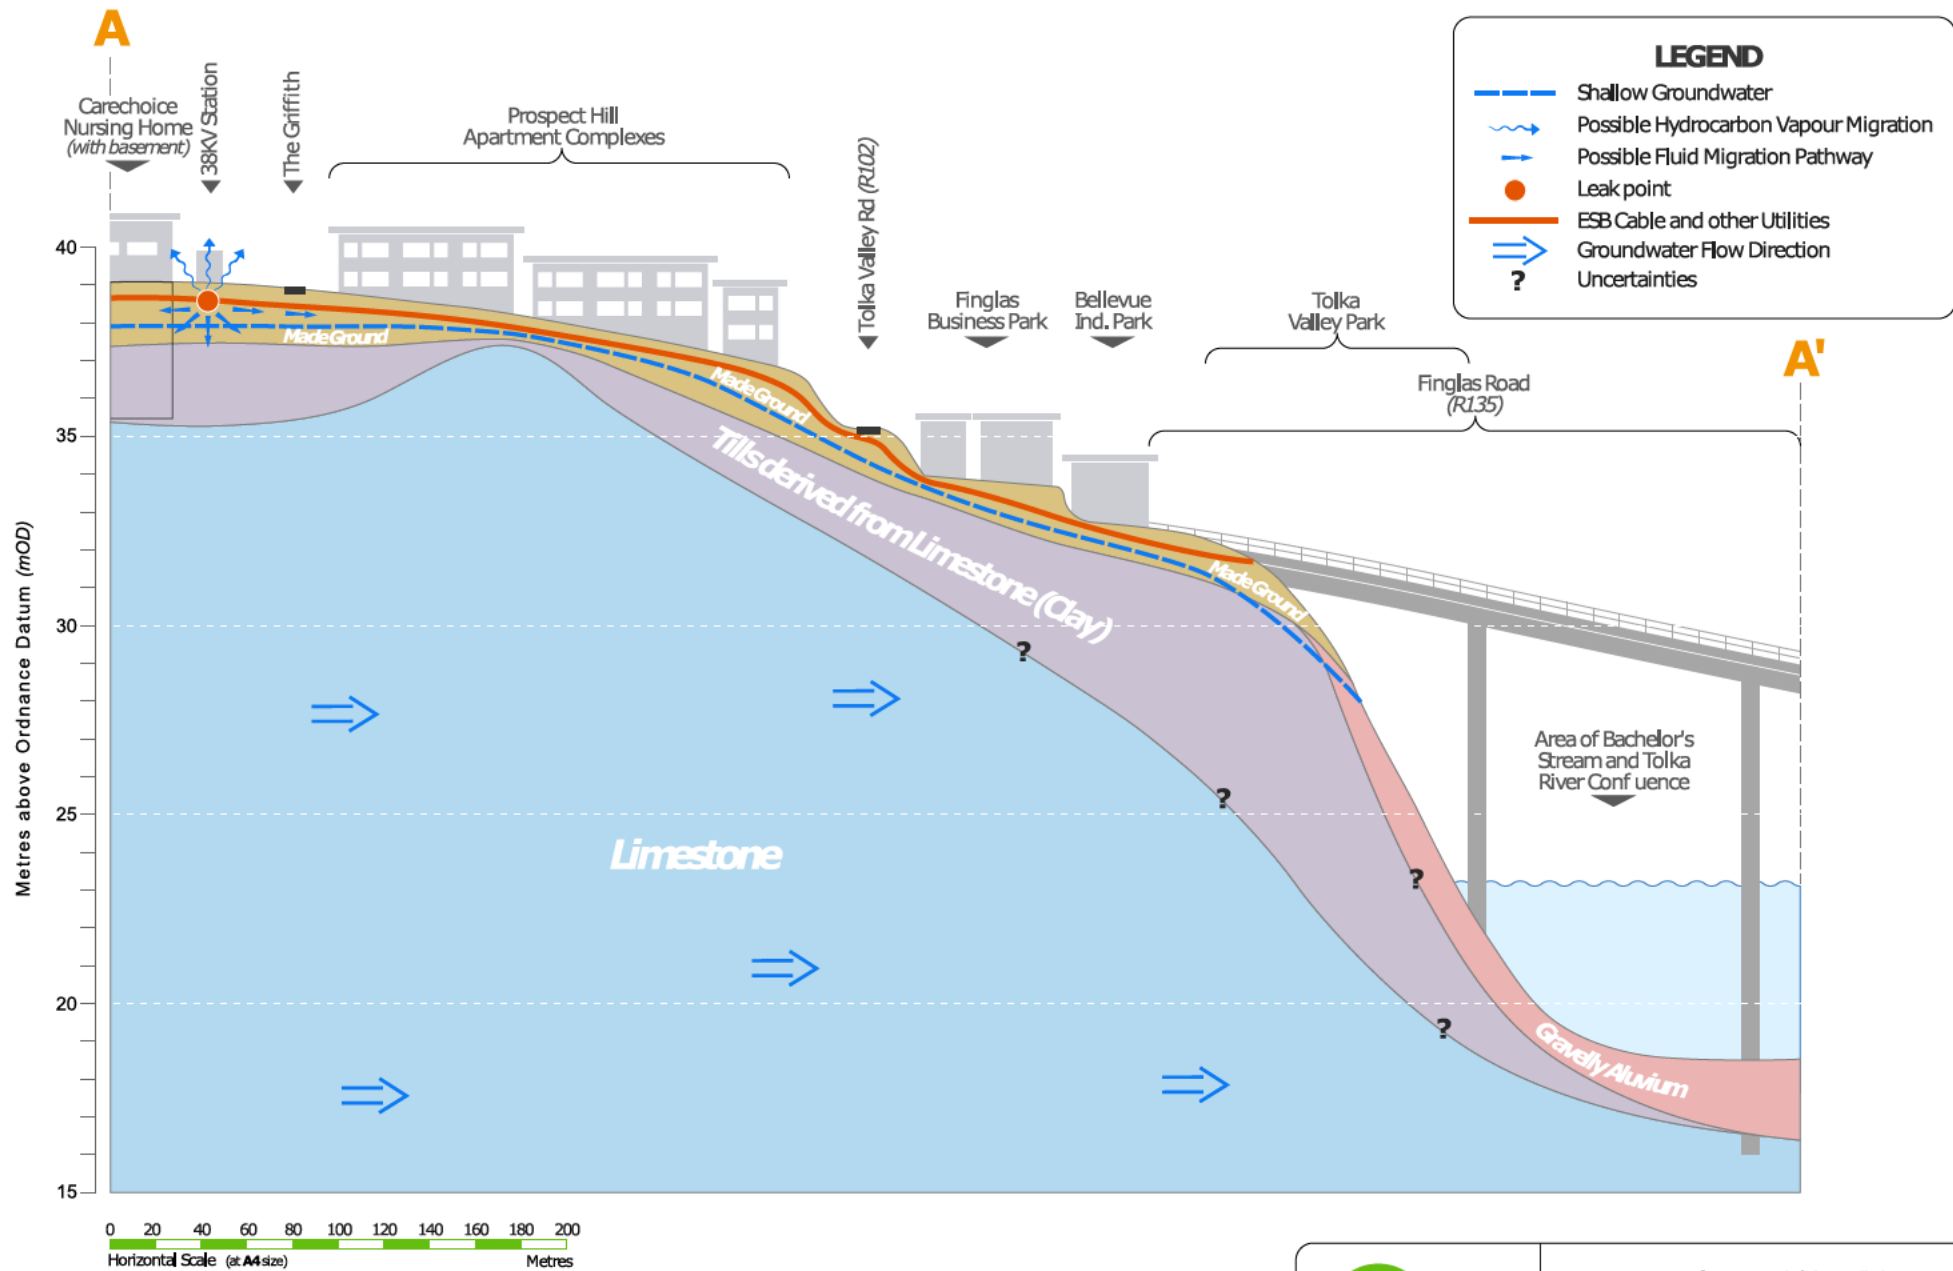
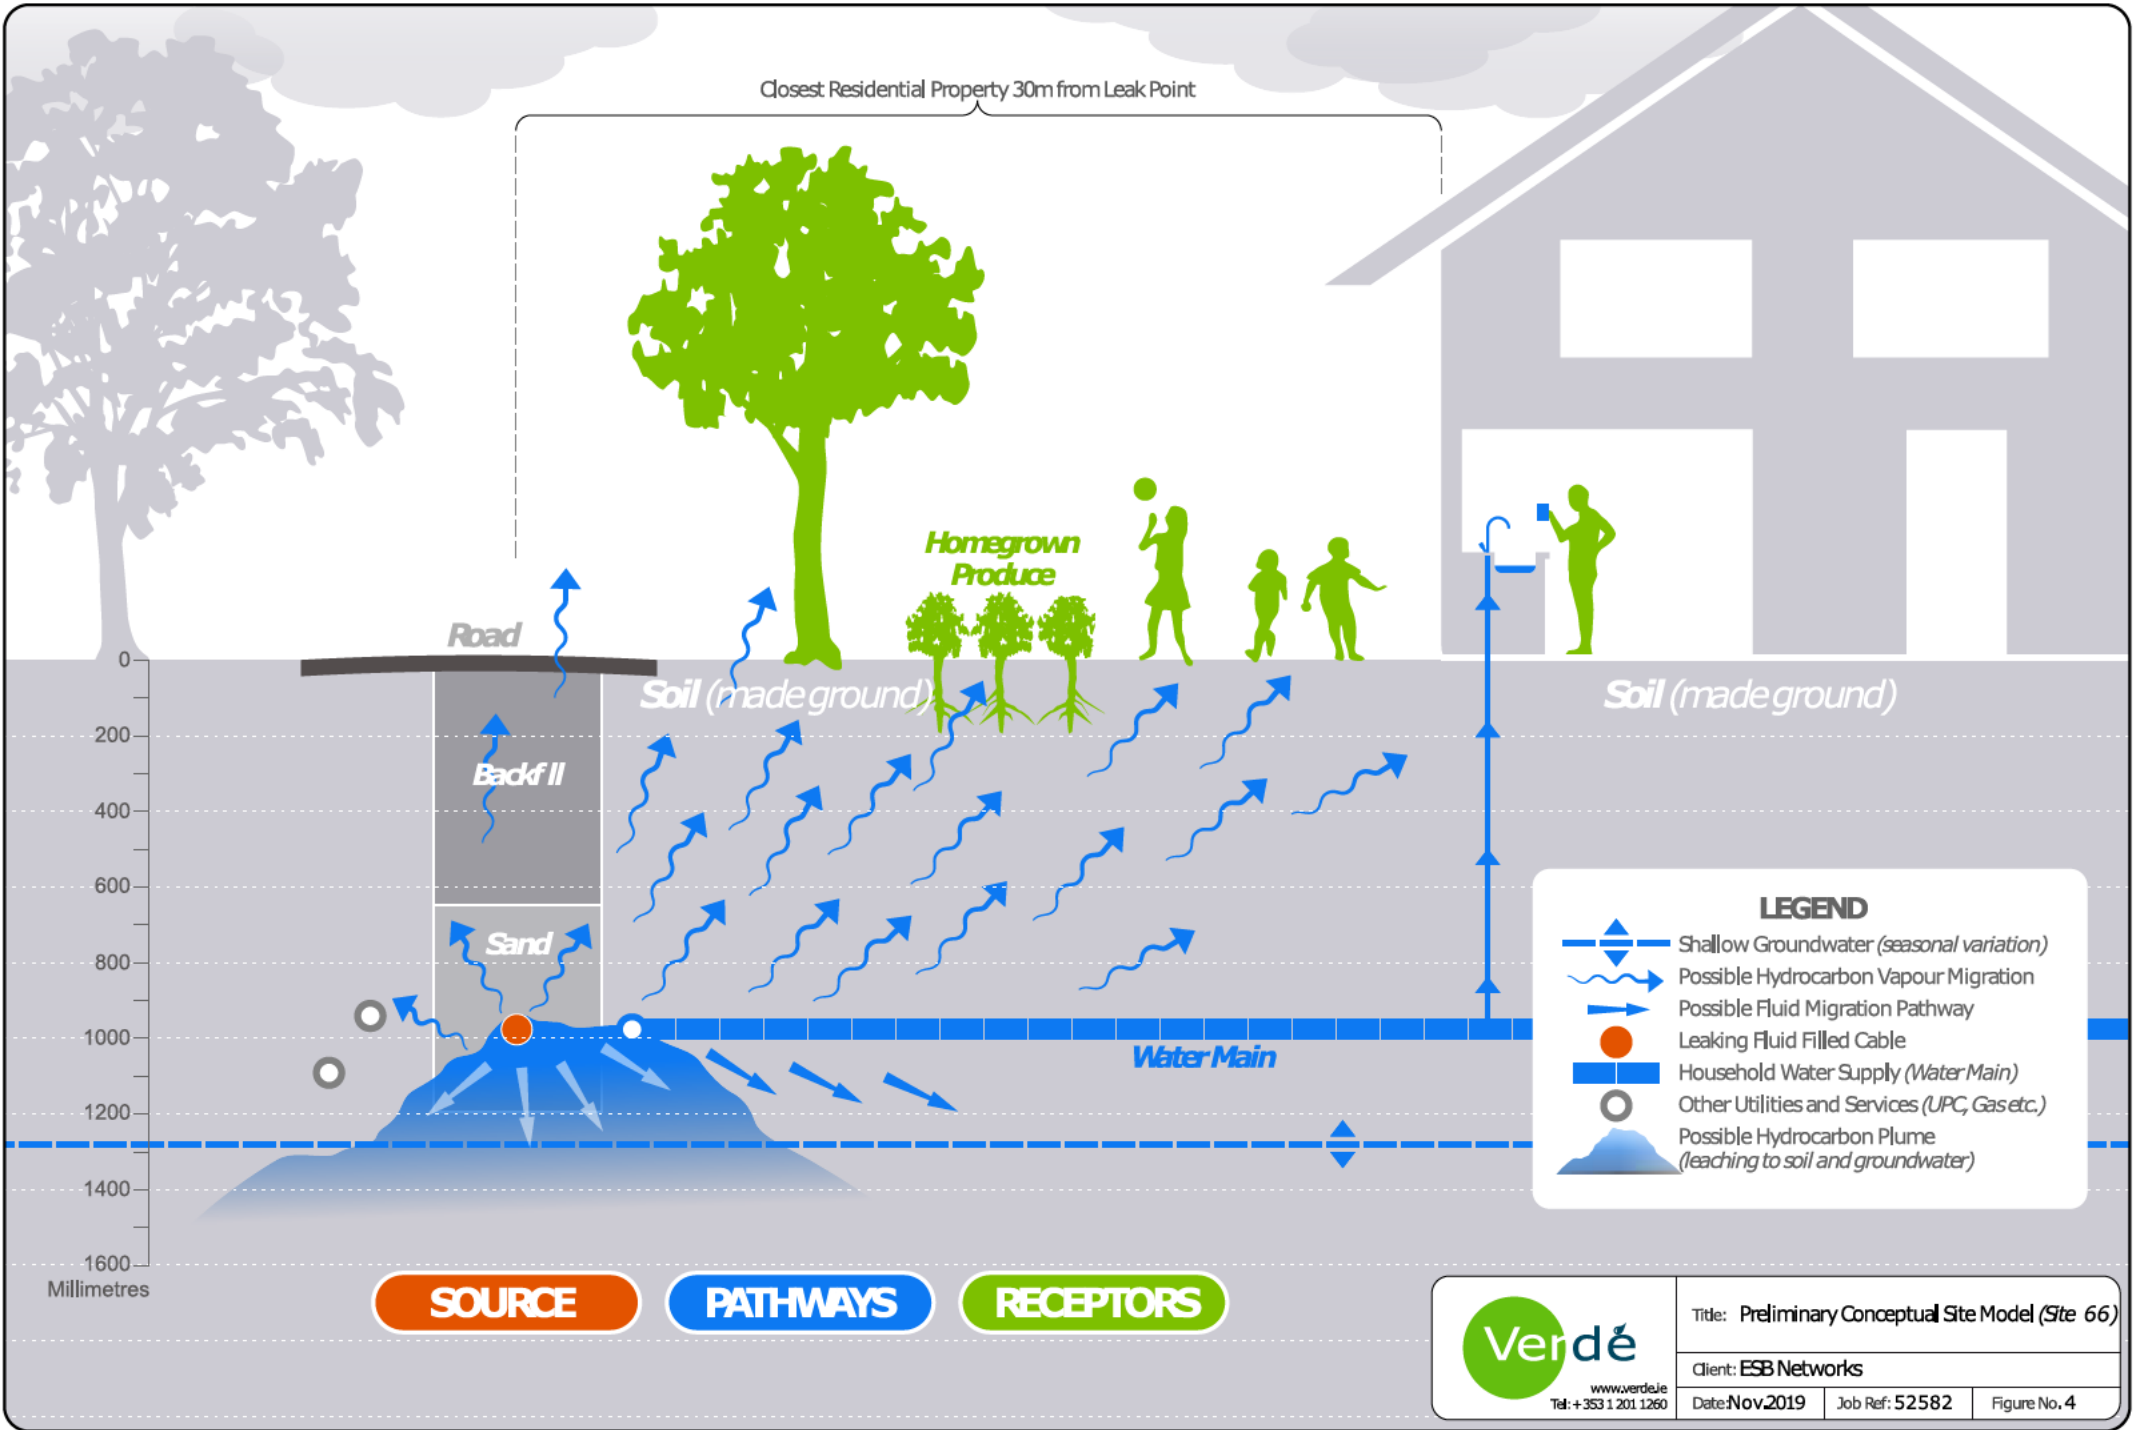
Title: Conceptual Site Model (A-A')(Site 66)  
Client: ESB Networks  
Date: Nov. 2019 Job Ref: 52582 Figure No. 3

The topography of the area as obtained from the GSI database show the leak point is located at approximately 47metres ordnance datum (mOD) with the Tolka River downgradient at approximately 20mOD. The topographic contours are orientated approximately east to west which infers that the groundwater flow direction is likely to be in a southerly/south easterly flow direction, as presented in Figure 2 and within the CSM in Figure 3.

LAB and MO direct downward migration as NAPL until reaches shallow groundwater where forms LNAPL and with a limited dissolved plume based on low solubilities, then lateral migrations towards surface waters	River Tolka and its tributaries, namely Bachelors Stream	Y	Bachelors stream is culverted to the east of the Finglas Road immediately east of the leak site. The River Tolka and Bachelors Stream meet at a confluence approximately 740m to the south east of the site discharging to Dublin Bay approx. 4.9km to the south east.
	LAB and MO migration downwards through glacial till to Limestone bedrock aquifer and then lateral migration	Limestone bedrock aquifer / Groundwater Users	Y	There are two recorded groundwater abstraction wells located within a 1km radius of the leak however these wells are located up gradient of the leak point. The surrounding properties are serviced by mains water. Downward contaminant migration into the limestone could be possible due to shallow rock in the area.

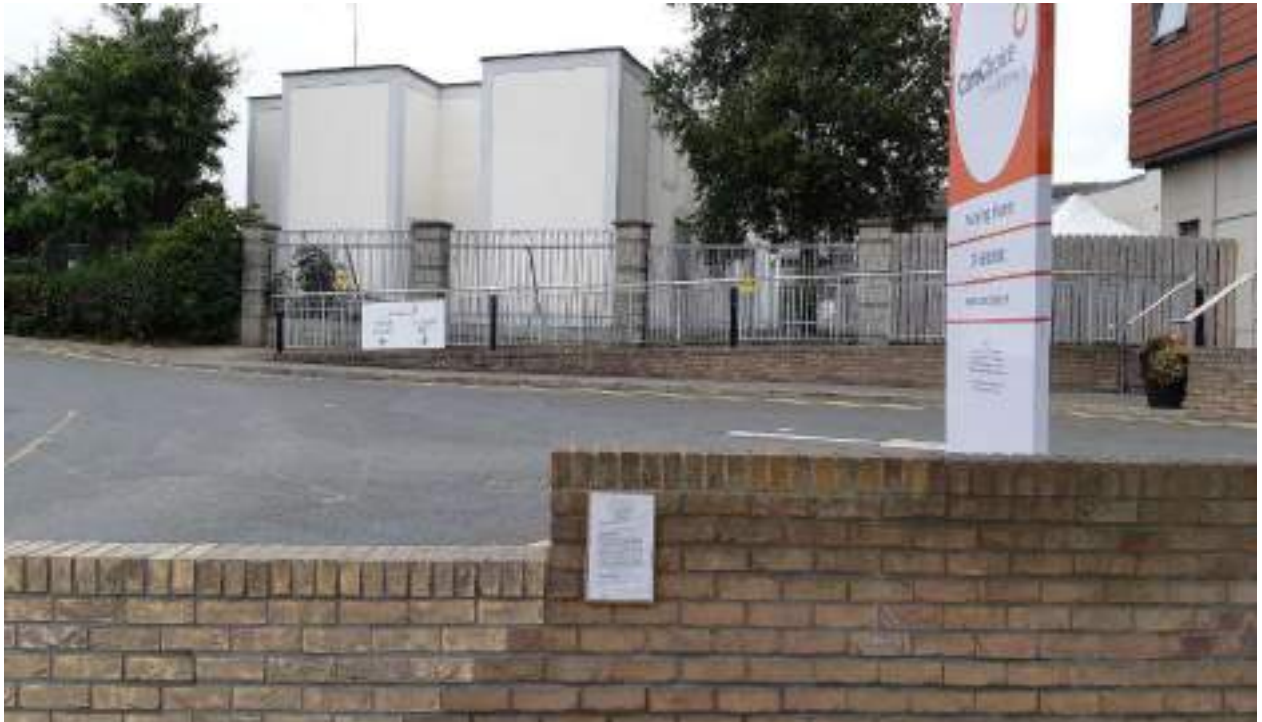
Photo 1: View of sub-station from position on verge of R135 close to access to nursing home. Planning notice on wall is for extension to nursing home.

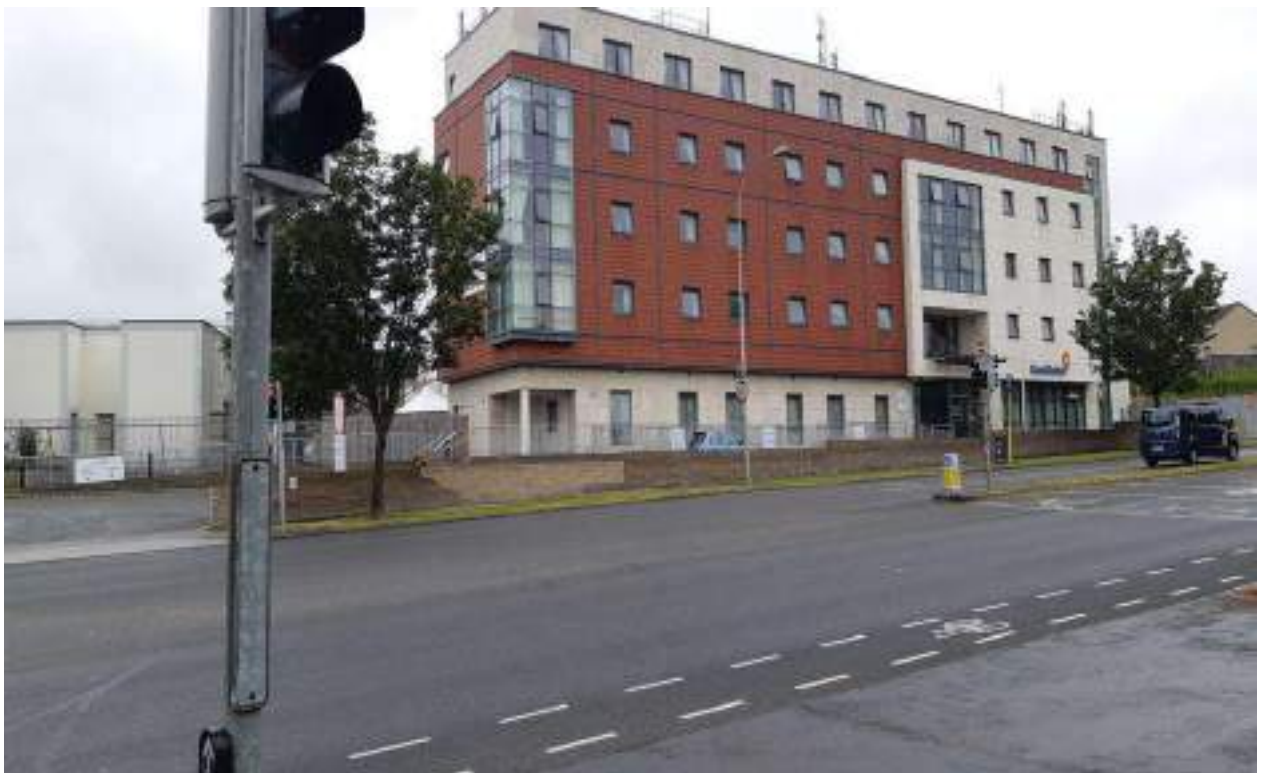
Photo 2: Location of sub-station in relation to nursing home and access to R135

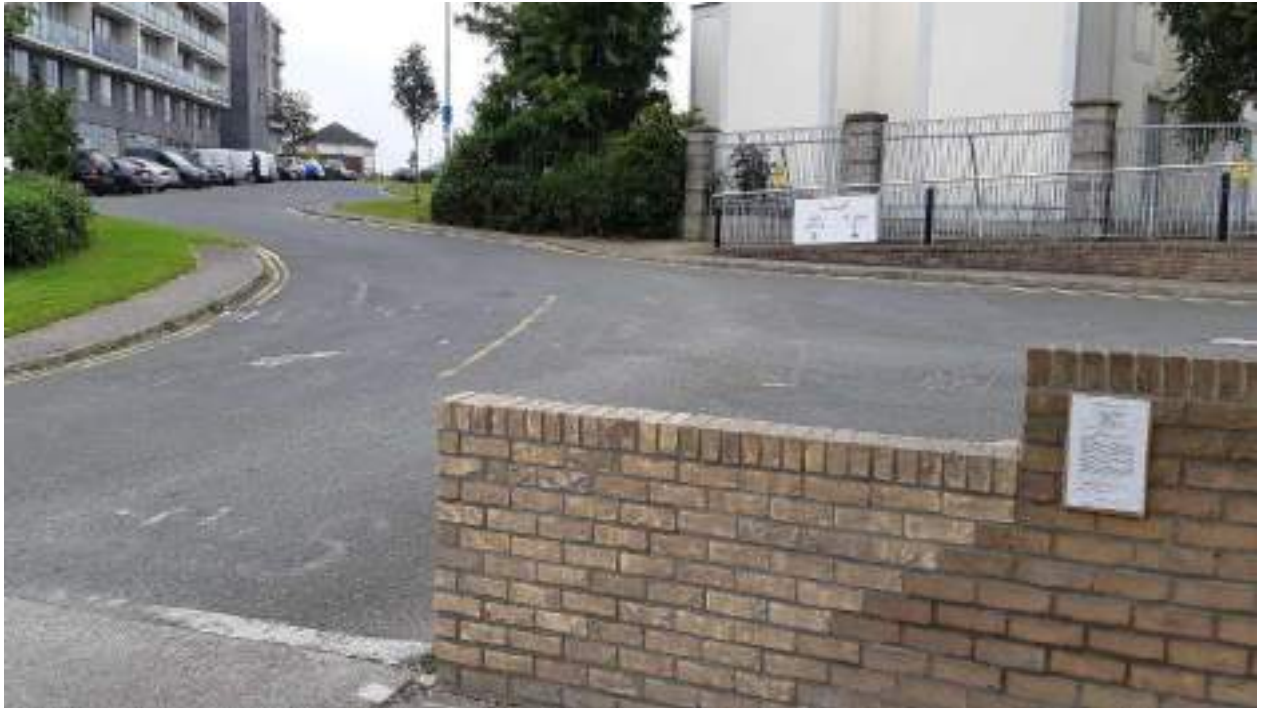
Photo 3: Substation is located approx. 25-30m from Finglas Road (R135). Note apartments to LHS (south) and access slope. Replacement area of wall stands out.

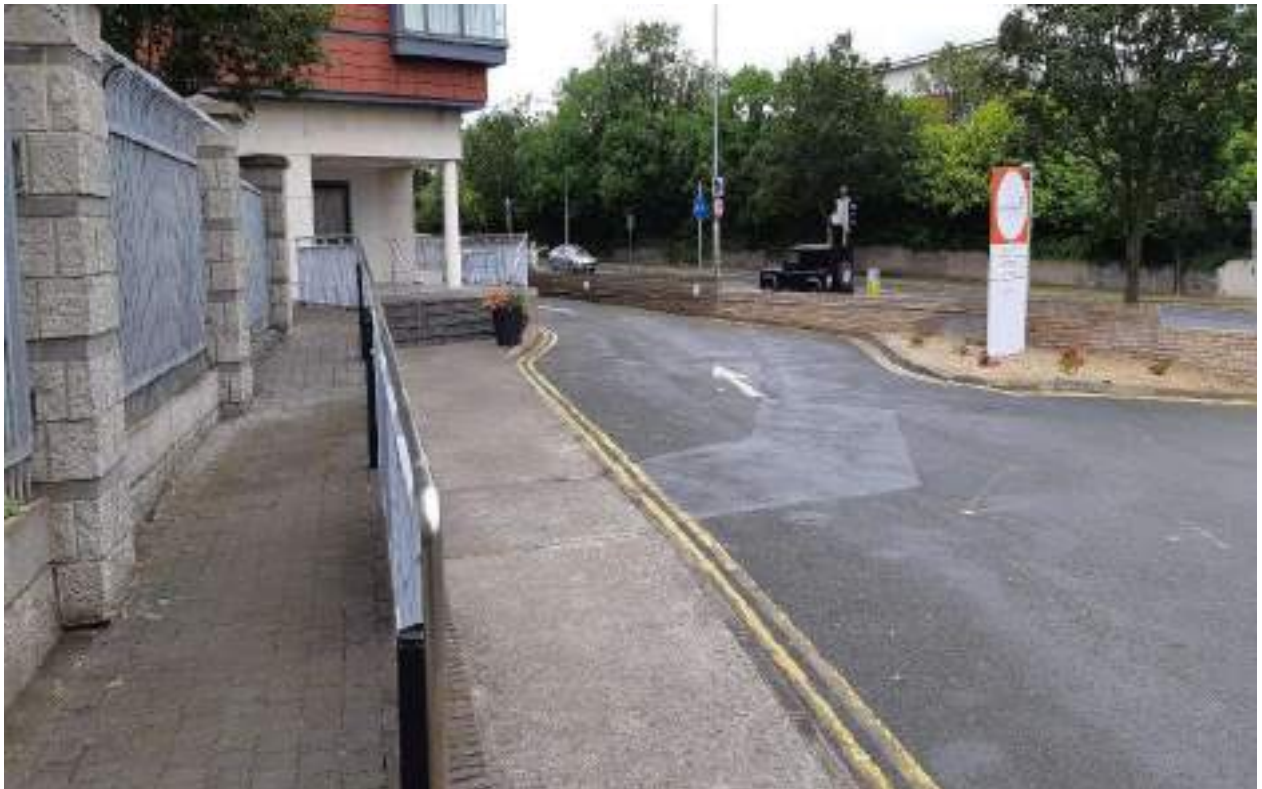
Extensive trench works were completed from the substation to the edge of the north bound R135 carriageway (Photo 4). The perimeter of the care centre is formed by a low brick wall which separates the set-down area for the facility from pavement, cycle lane and grass verge and R135 northbound carriageway. There is a noticeable change in coloration of the brickwork which relates to rebuilding works following the leak investigation (Photos 1 and 5). There is no indication that vegetation in the grass verge has been impacted by the leak (no discoloration or noticeable impact of nearby tree growth).

Photo 4: Outline of trench leading from ESB substation across set-down route for nursing home

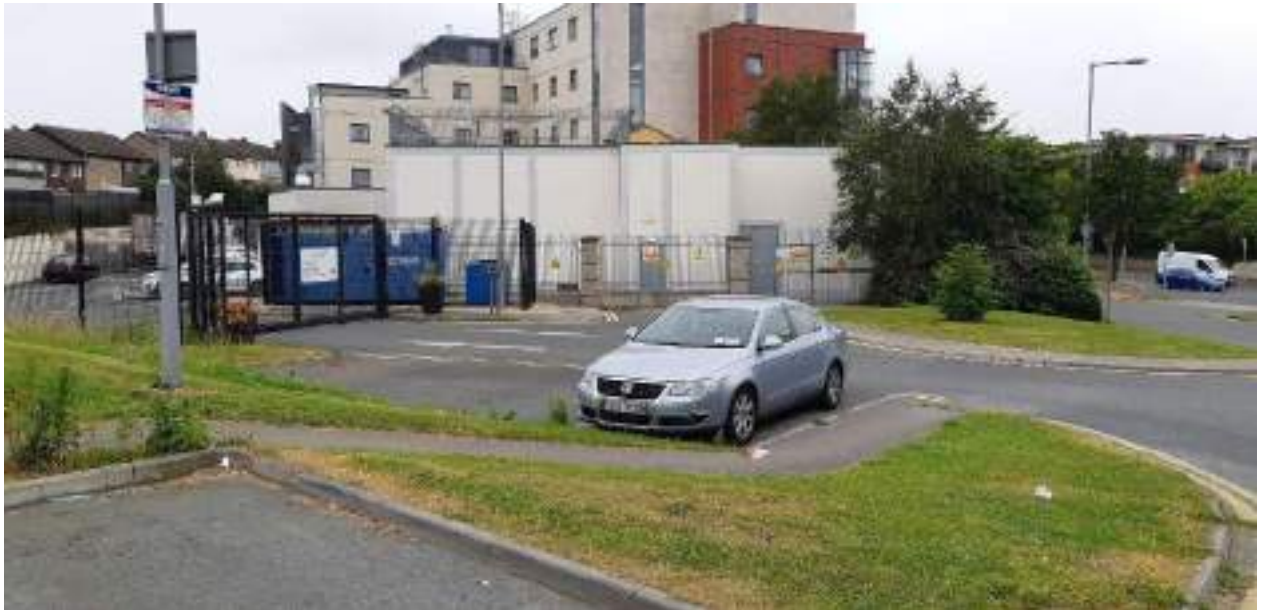
Photo 5: View of Substation from south. Note outside generator (blue) and traffic on R135 at lower elevation.

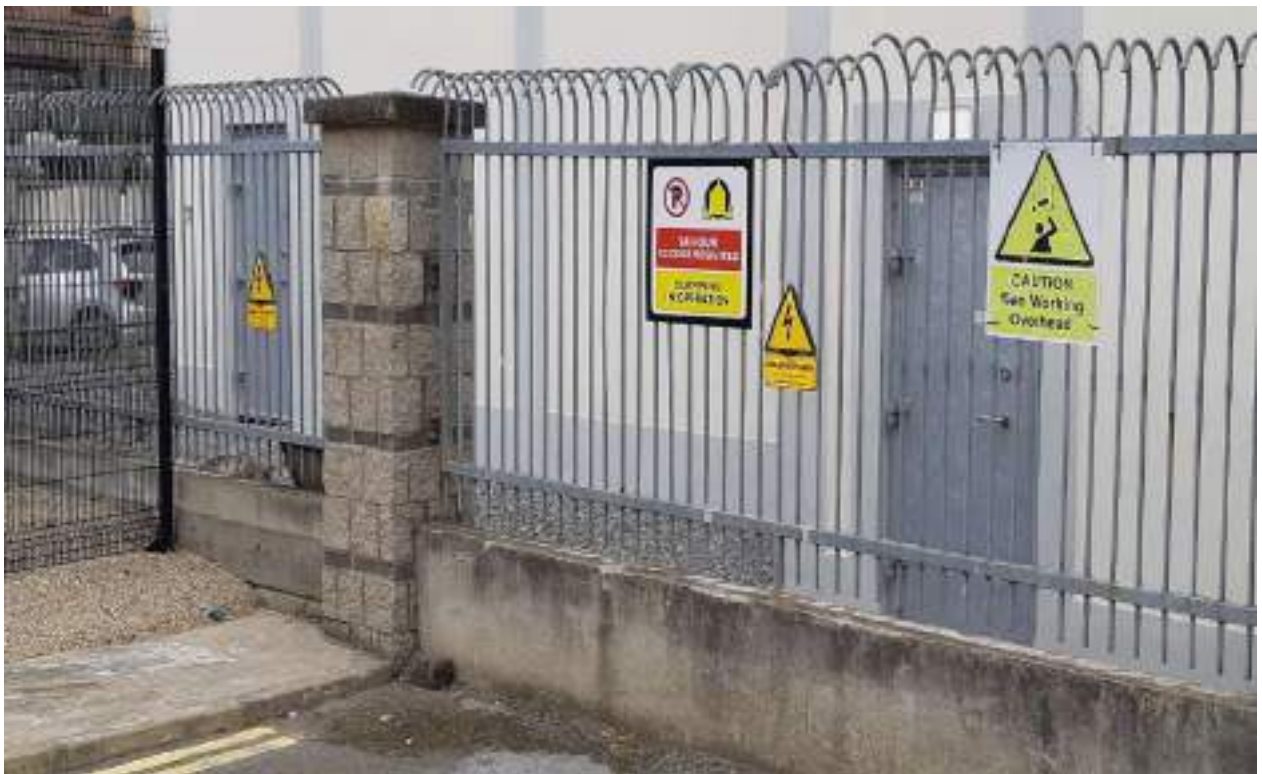
Photo 6: Secured compound. Note gravel substrate which appeared clean and free from contamination.

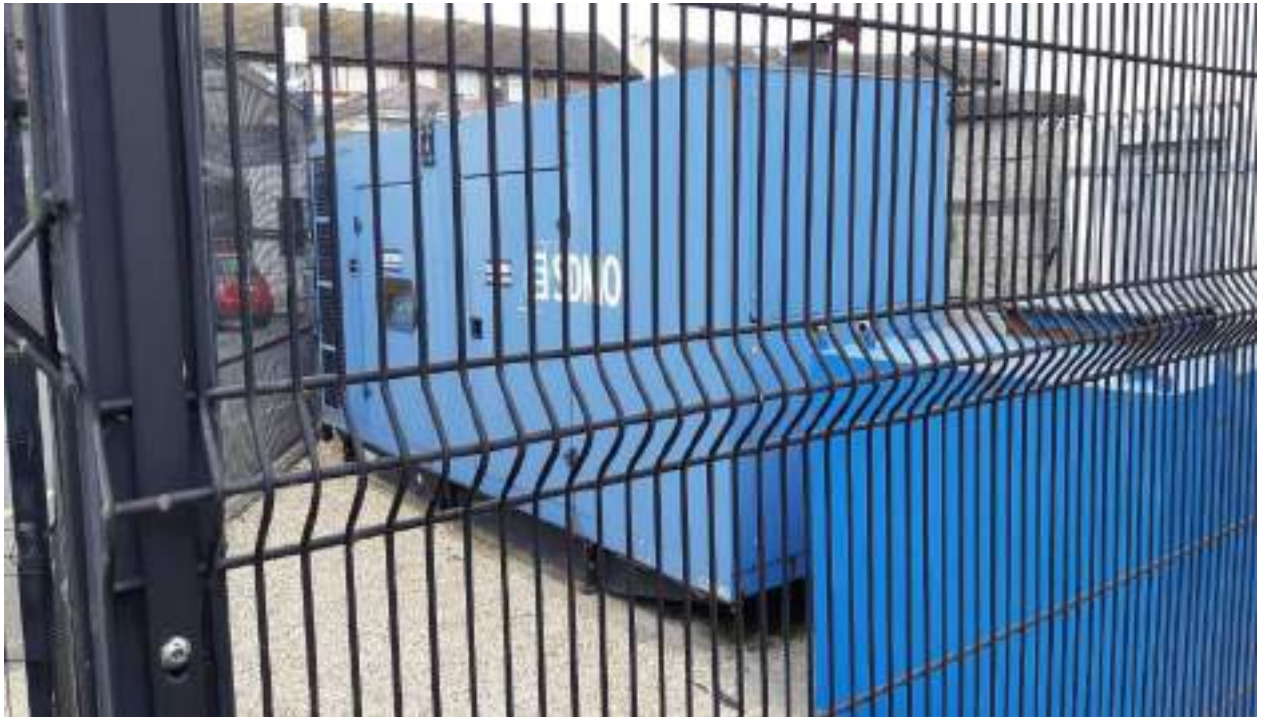
Approximately 200m north of the known leak area, the western verge of the road (northbound carriageway of R135) and pavement contain several buried services and green service box. A recently installed services manhole is located (see Photos 7 and 8).

Photo 7: Generator and fuel supply located in substation compound

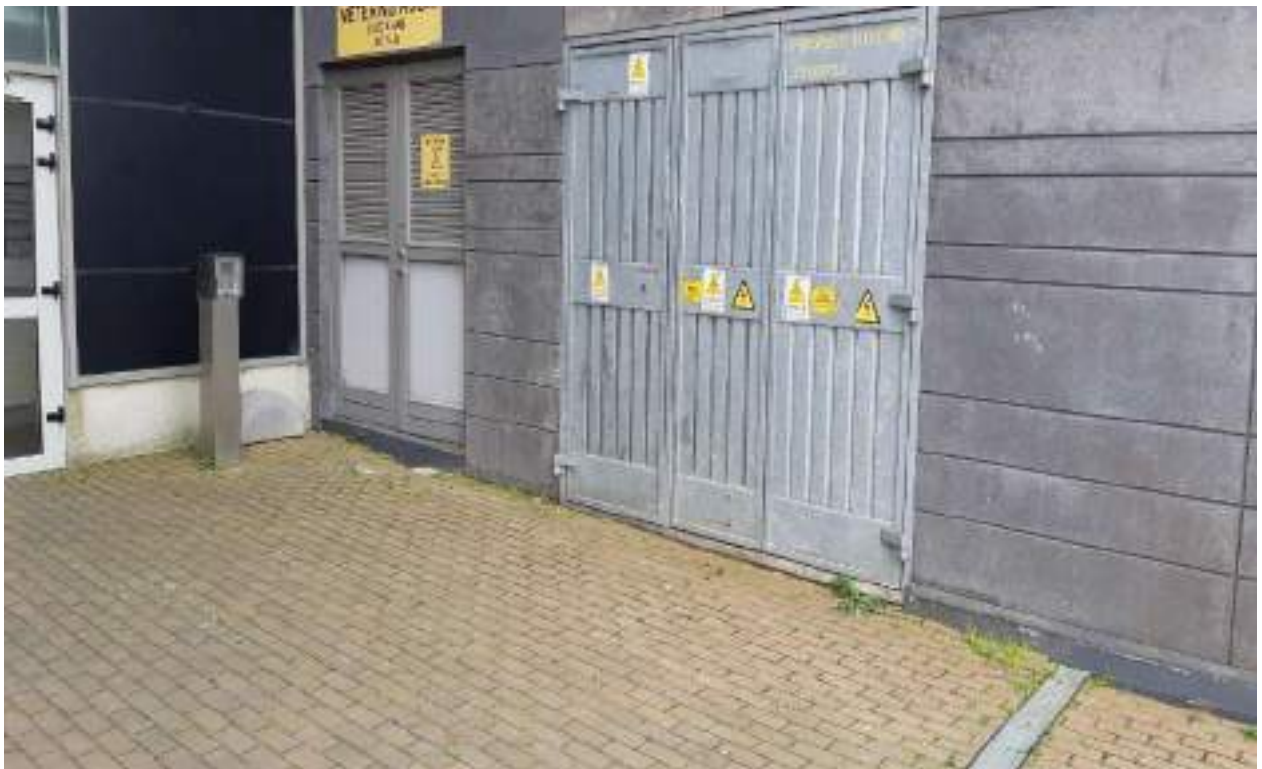
Photo 8: Substation associated with Prospect Hill apartment block. Apartments located approximately 40m to the south. Construction works were on-going on these units and on residential units further south along the Griffith Road which leads to Tolka Valley Road.

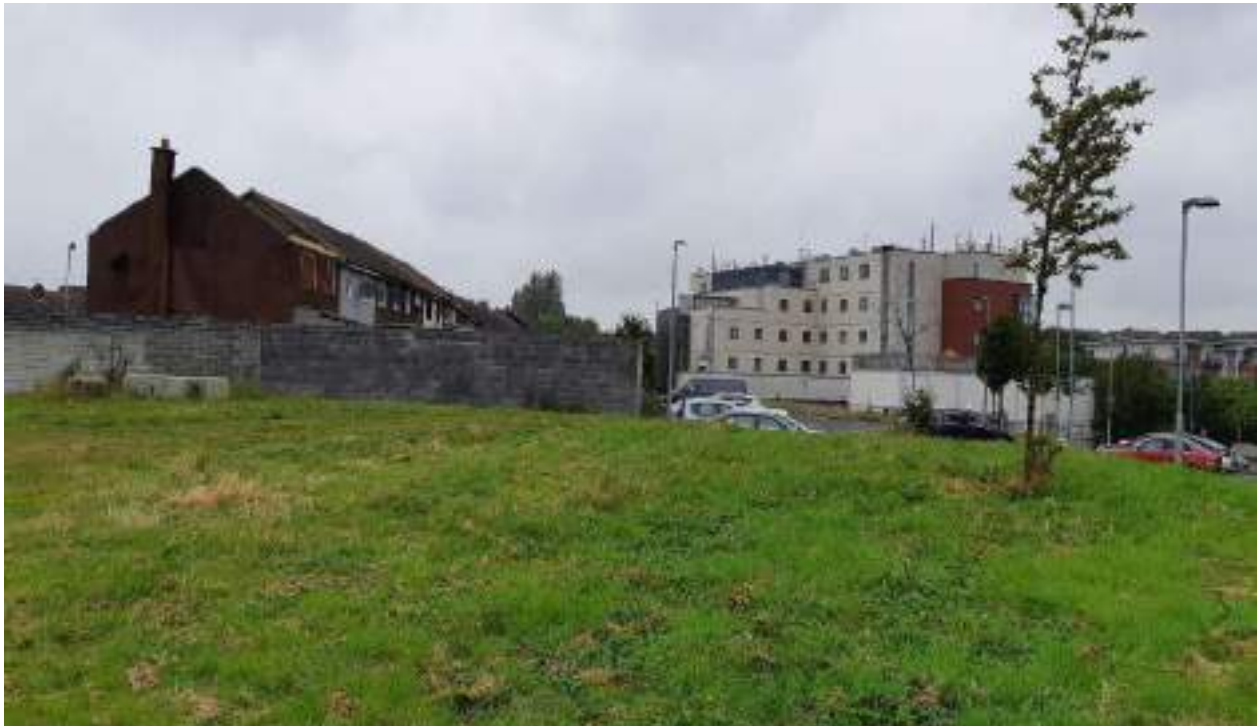
Photo 9: Row of houses (Fairglen) to west of substation. Closest property is approx. 25m to the west though back gardens are elevated compared to ground level at substation.

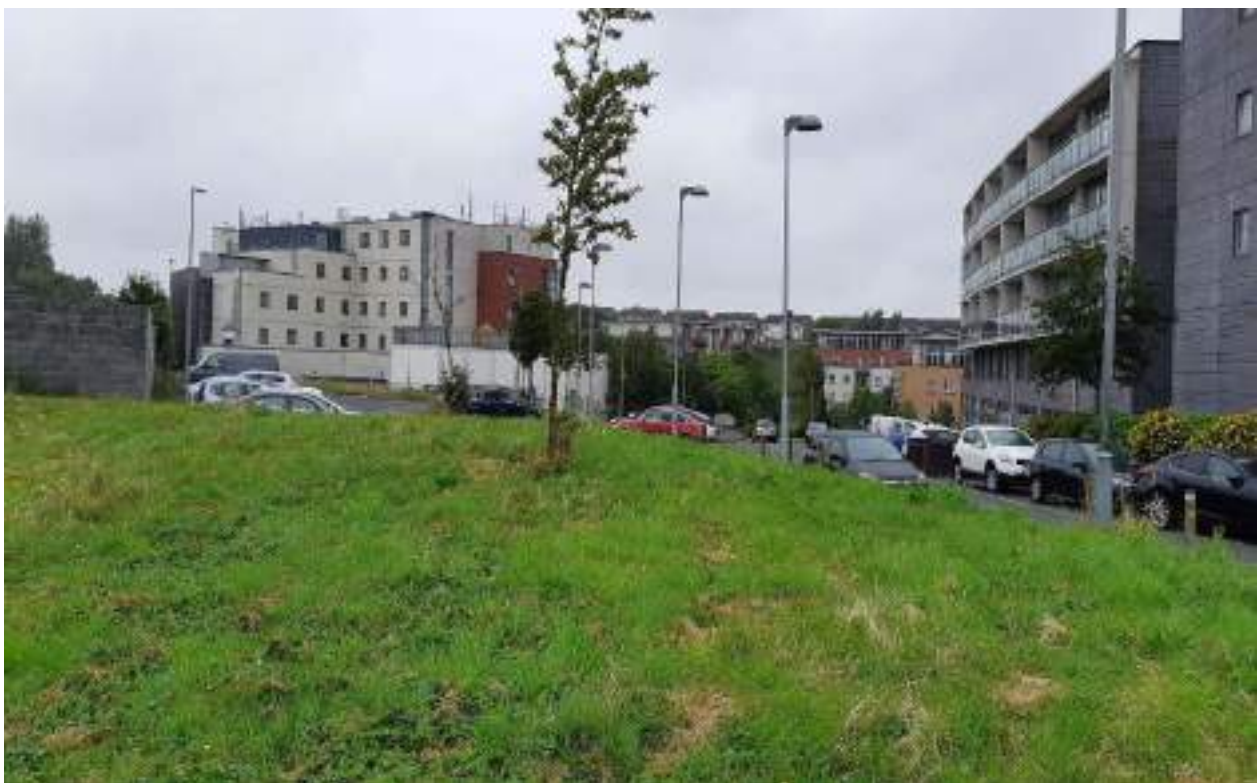
Photo 10: Apartment complex to the south (shown here on RHS apartments are approx. 40m south of substation)

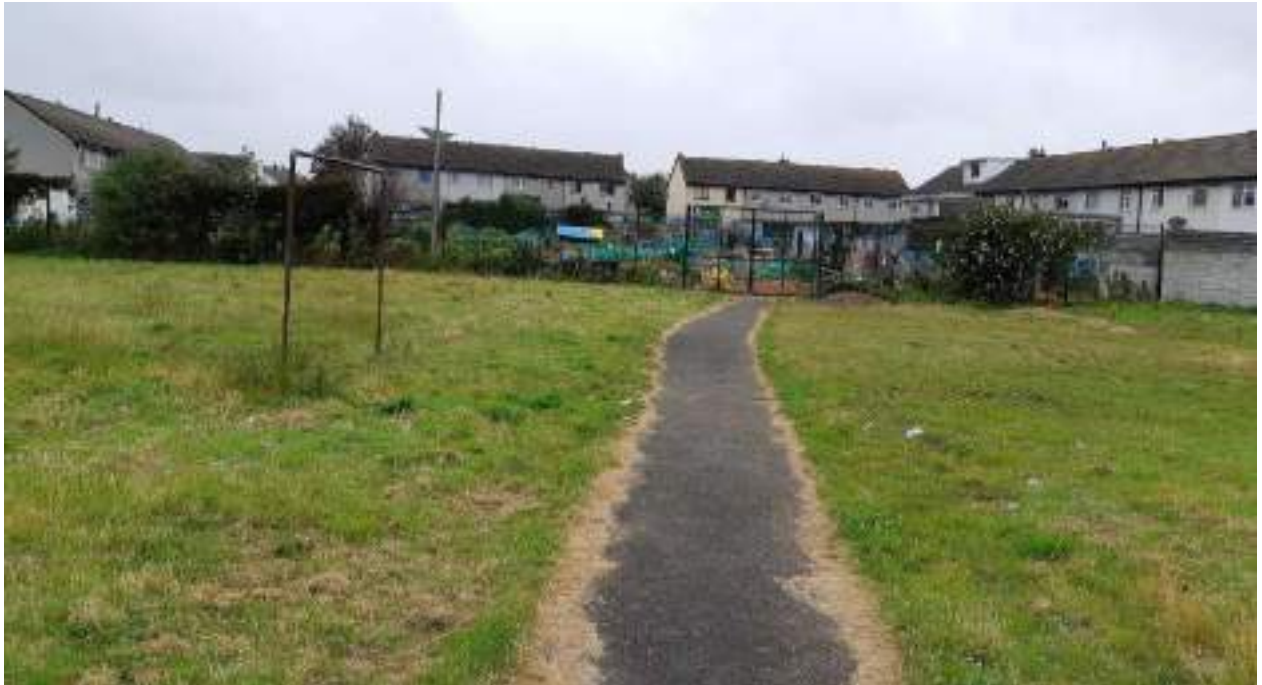
Photo 11: Fairlawn, Prospect Hill Community Garden. The garden is located approximately 80m to the southwest of the substation but is elevated.

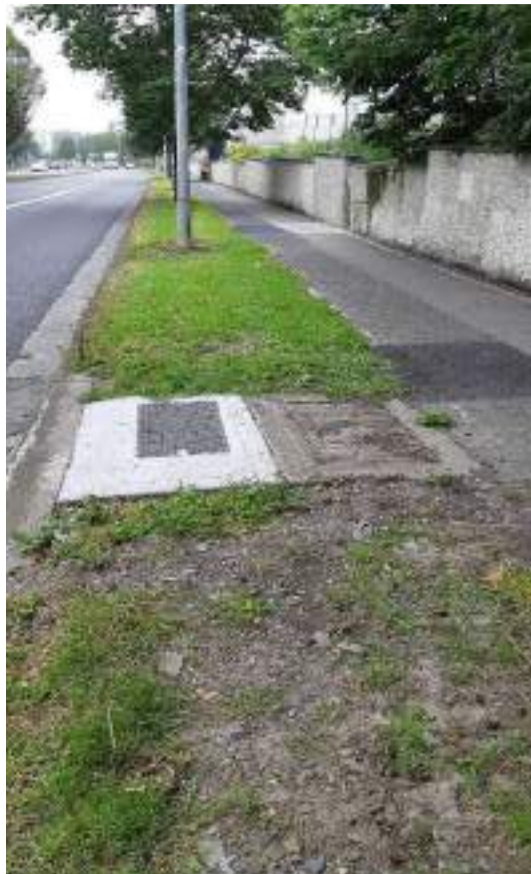
Photo 12: Area close to 200m marker along western margin of the R135. View below is looking south back towards source of leak. There is general slope in this direction (i.e. in direction of Tolka River Valley)
