Preliminary Site Assessment

Site 68 Francis Street - Inchicore 110 kV (August -
November 1993)

Electricity Supply Board

Project number: PR-427640_ACM_RP_ENV_063_1

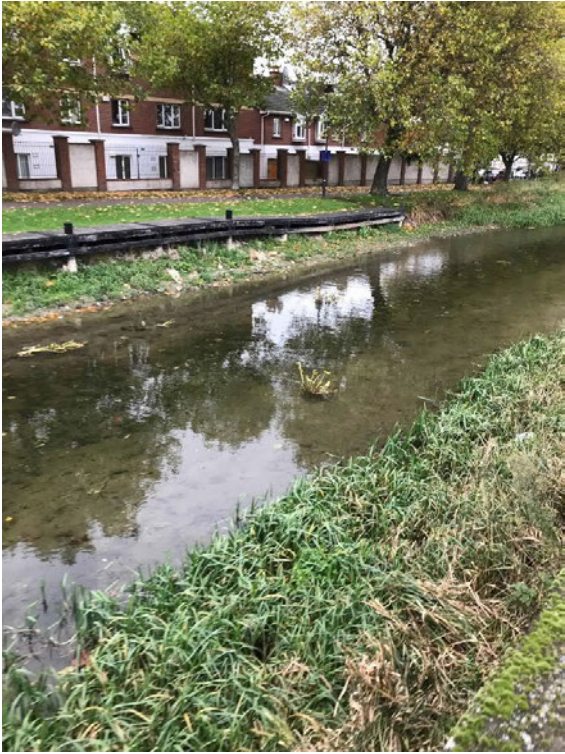
Photo No. 2	Date: 01/11/19

Direction Photo Taken: Northeast		
Description: Photo shows the stretch of Grand Canal in front of leak location.

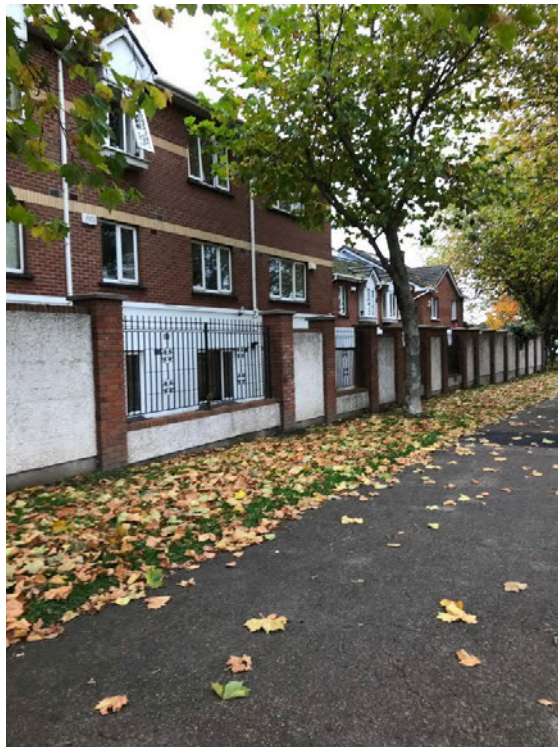
Facility Name:
ESB Cable Assessment**Site Location:**
Site 68 – Davitt Road**Project No.**
427640**Photo No.**
3**Date:**
01/11/19**Direction Photo Taken:**

Residential houses lying beyond the north bank of Grand Canal, in front of the leak location.

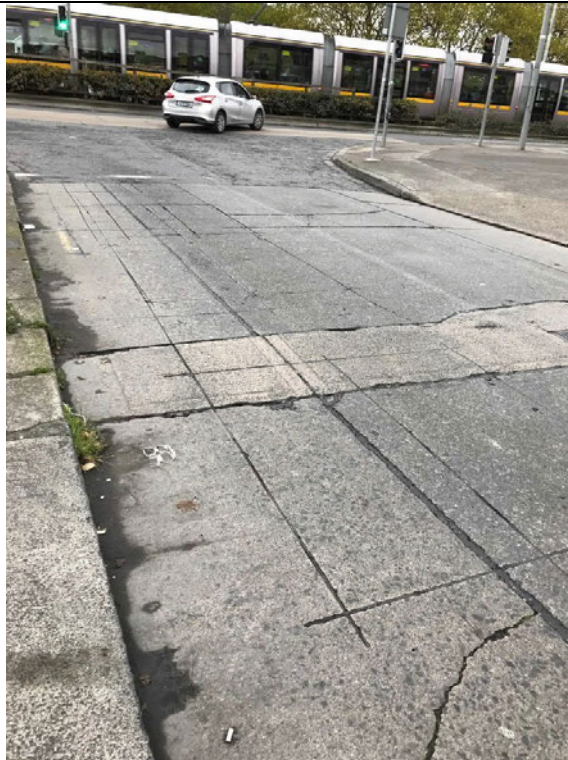
Facility Name:
ESB Cable Assessment**Site Location:**
Site 68 – Davitt Road**Project No.**
427640**Photo No.**
4**Date:**
01/11/19**Direction Photo Taken:**

North facing view showing the intersection between Belbulbin Rd and Davitt Rd.

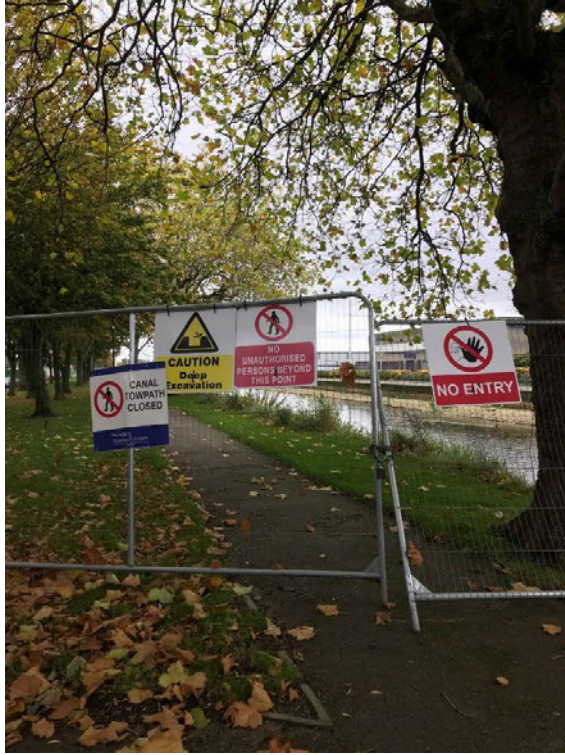
Photo No. 5	Date: 01/11/19
Direction Photo Taken: South	
Description: Presence of construction work along the pedestrian walkway beyond the north bank of Grand Canal. Pedestrian walkway was closed during the site visit.
