Preliminary Site Assessment Report for Junction of Howth Road and Clontarf Road, Dublin 3

ESB Site Ref: 11
Clontarf – East Wall Road 38 kV

September 2019

Project Title: ESB Networks Historic Fluid Filled Cable Loss
Environmental Assessment

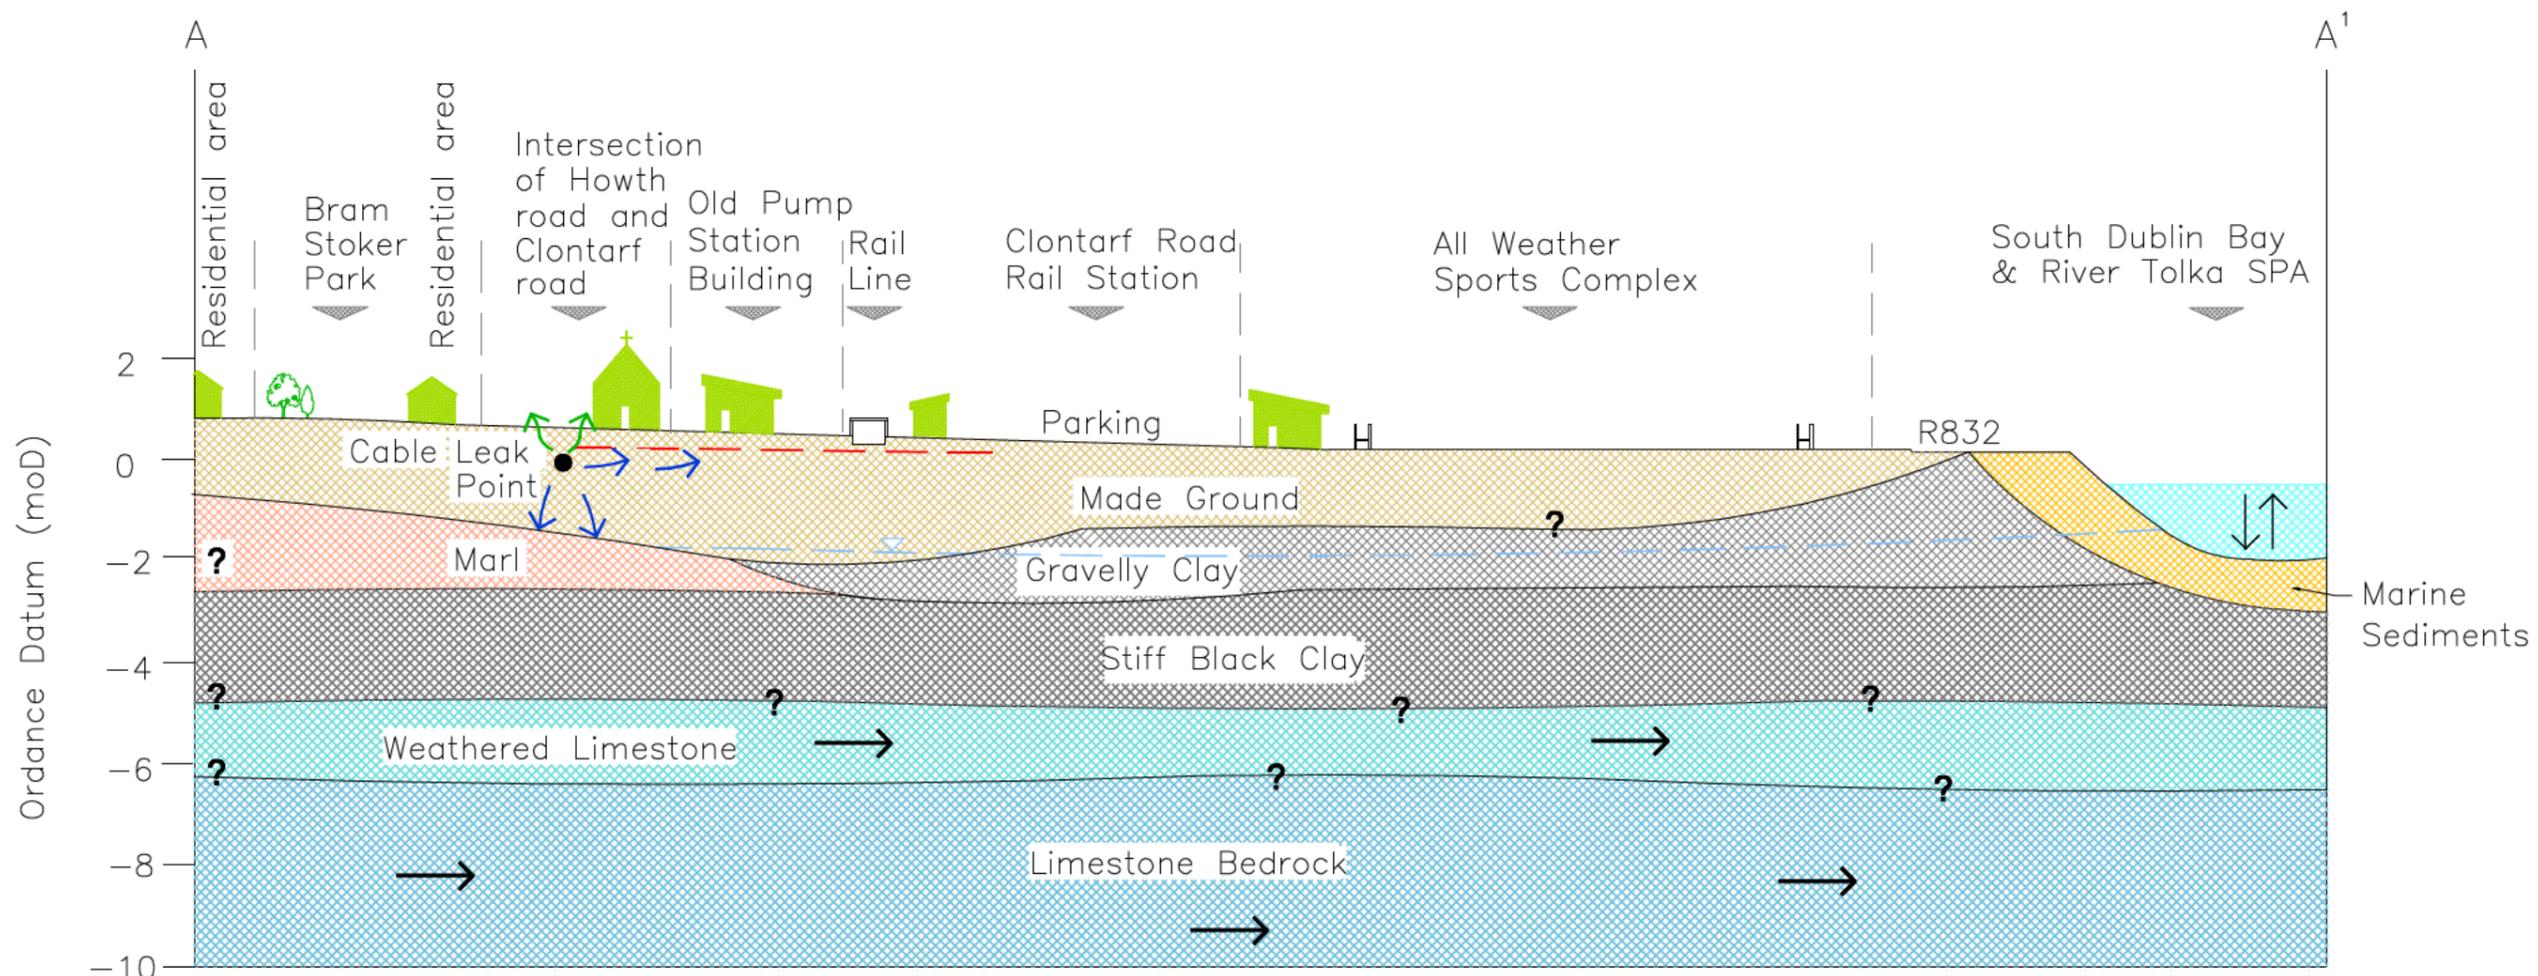
<small>www.verde.ie Tel: +353 1 201 1260</small>	Title: PRELIMINARY CONCEPTUAL SITE MODEL
	Client: ESB NETWORKS
	Date: JULY 2019 Job Ref: 52458 Figure: 3

Based on the known cable leak point, contaminant of potential concern (COPC) fate and transport and hydrogeological desk study information the CSM has the following initial key findings for human health and environmental risks;

- direct dermal/inhalation and ingestion contact to residents or other building users;
- dermal/inhalation and ingestion pathways to construction workers which can be managed by appropriate use of PPE and H&S procedures;
- ingestion of contaminated water by water users in the area following its permeation through plastic water pipes.
- leaching to shallow groundwater given the contaminant properties of low mobility and high sorption to soil, with shallow groundwater unlikely to be a viable groundwater resource in the residential urban setting.
- migration of shallow contaminated groundwater to Dublin Bay SPA & pNHA given the contaminant properties of low mobility and high sorption with a distance of 460m from the leak point and not a significant oil loss volume.
- hydrocarbon vapours in preferential pathways such as services ducts to residents or other building users.

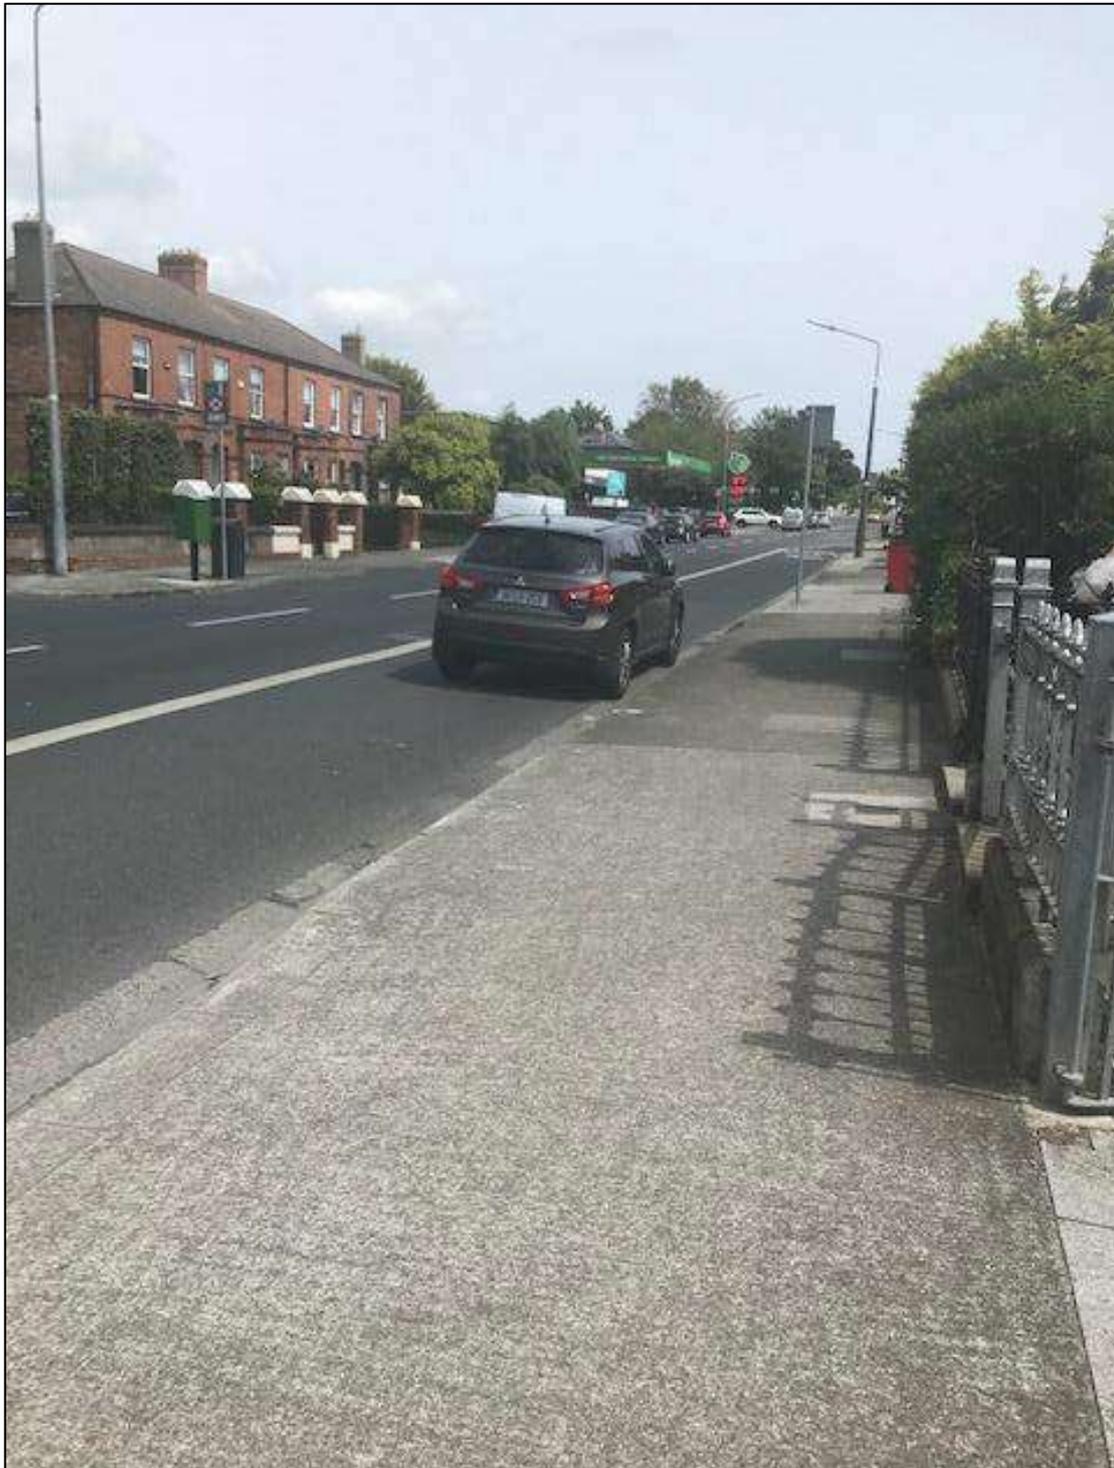
The ESB cable runs along the southern side of Howth Road, as presented in Photograph 1 in Appendix C. There are several buried services under the concrete footpath between Howth Road and residential properties, as presented in Photograph 2. There is an Apple Green service station located approximately 100m further east from the 200m eastern marker on Howth Road and therefore 300m upgradient from the leak point.

Photo 1: At 200m north-east of Leak Point - View to north-east along Howth Road.
Applegreen service station in background.

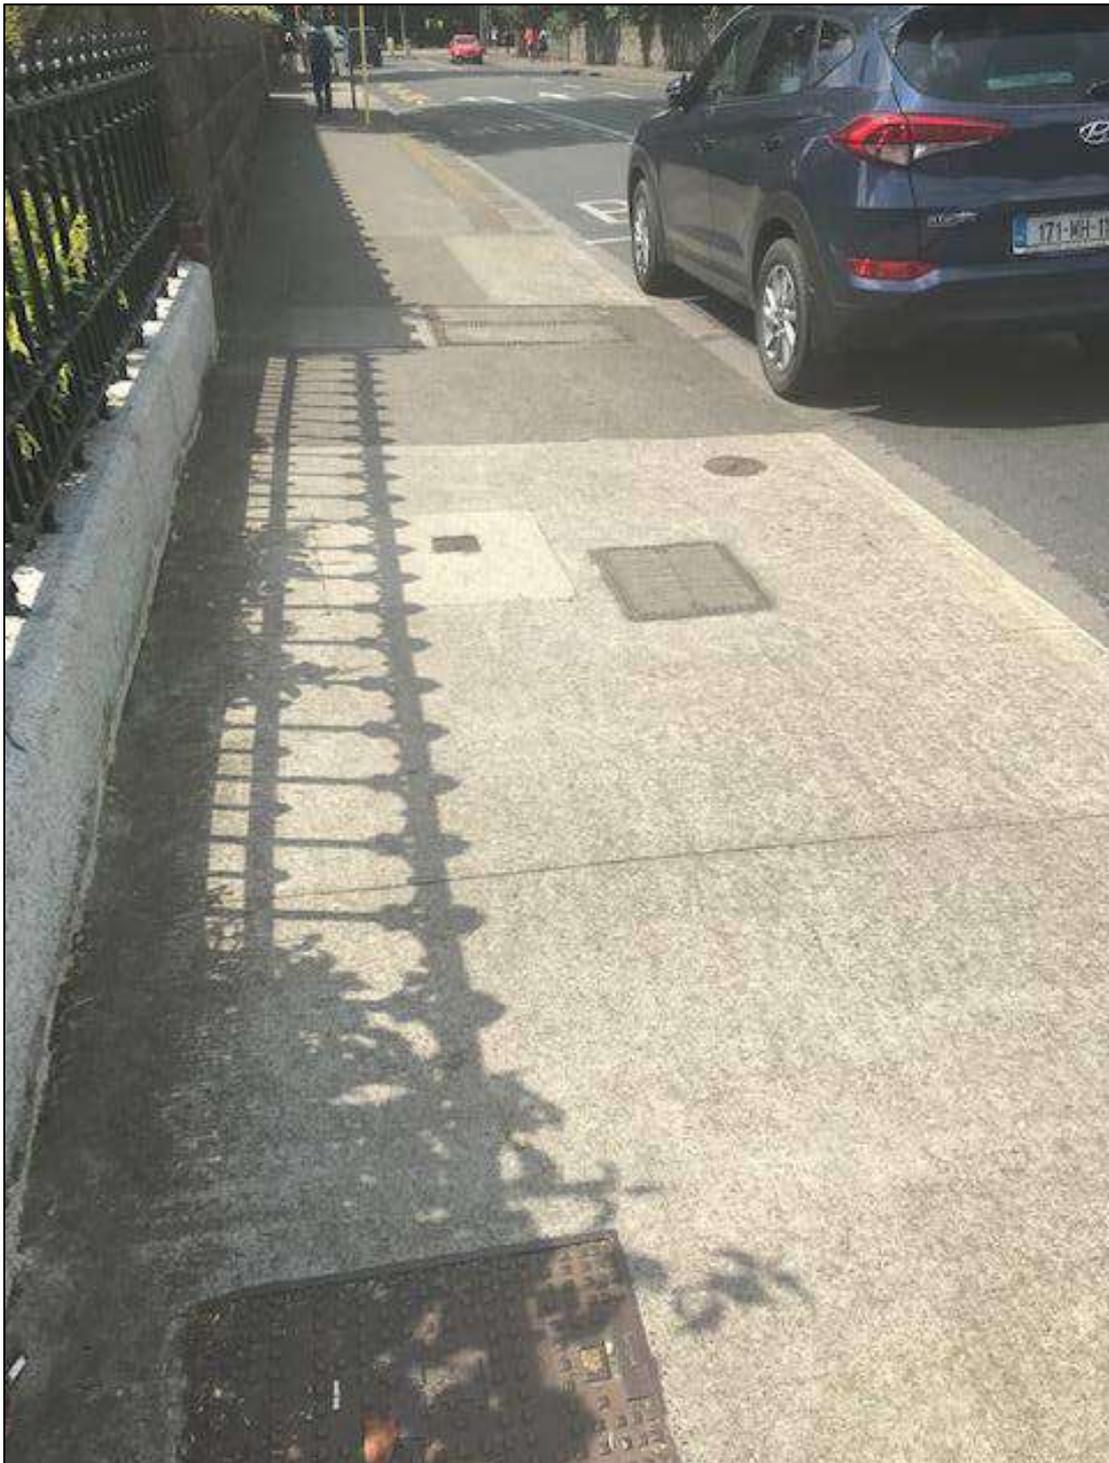
Photo 2: Abundant services on concrete footpath adjacent to cable route on Howth Road.
View to south west along Howth Road

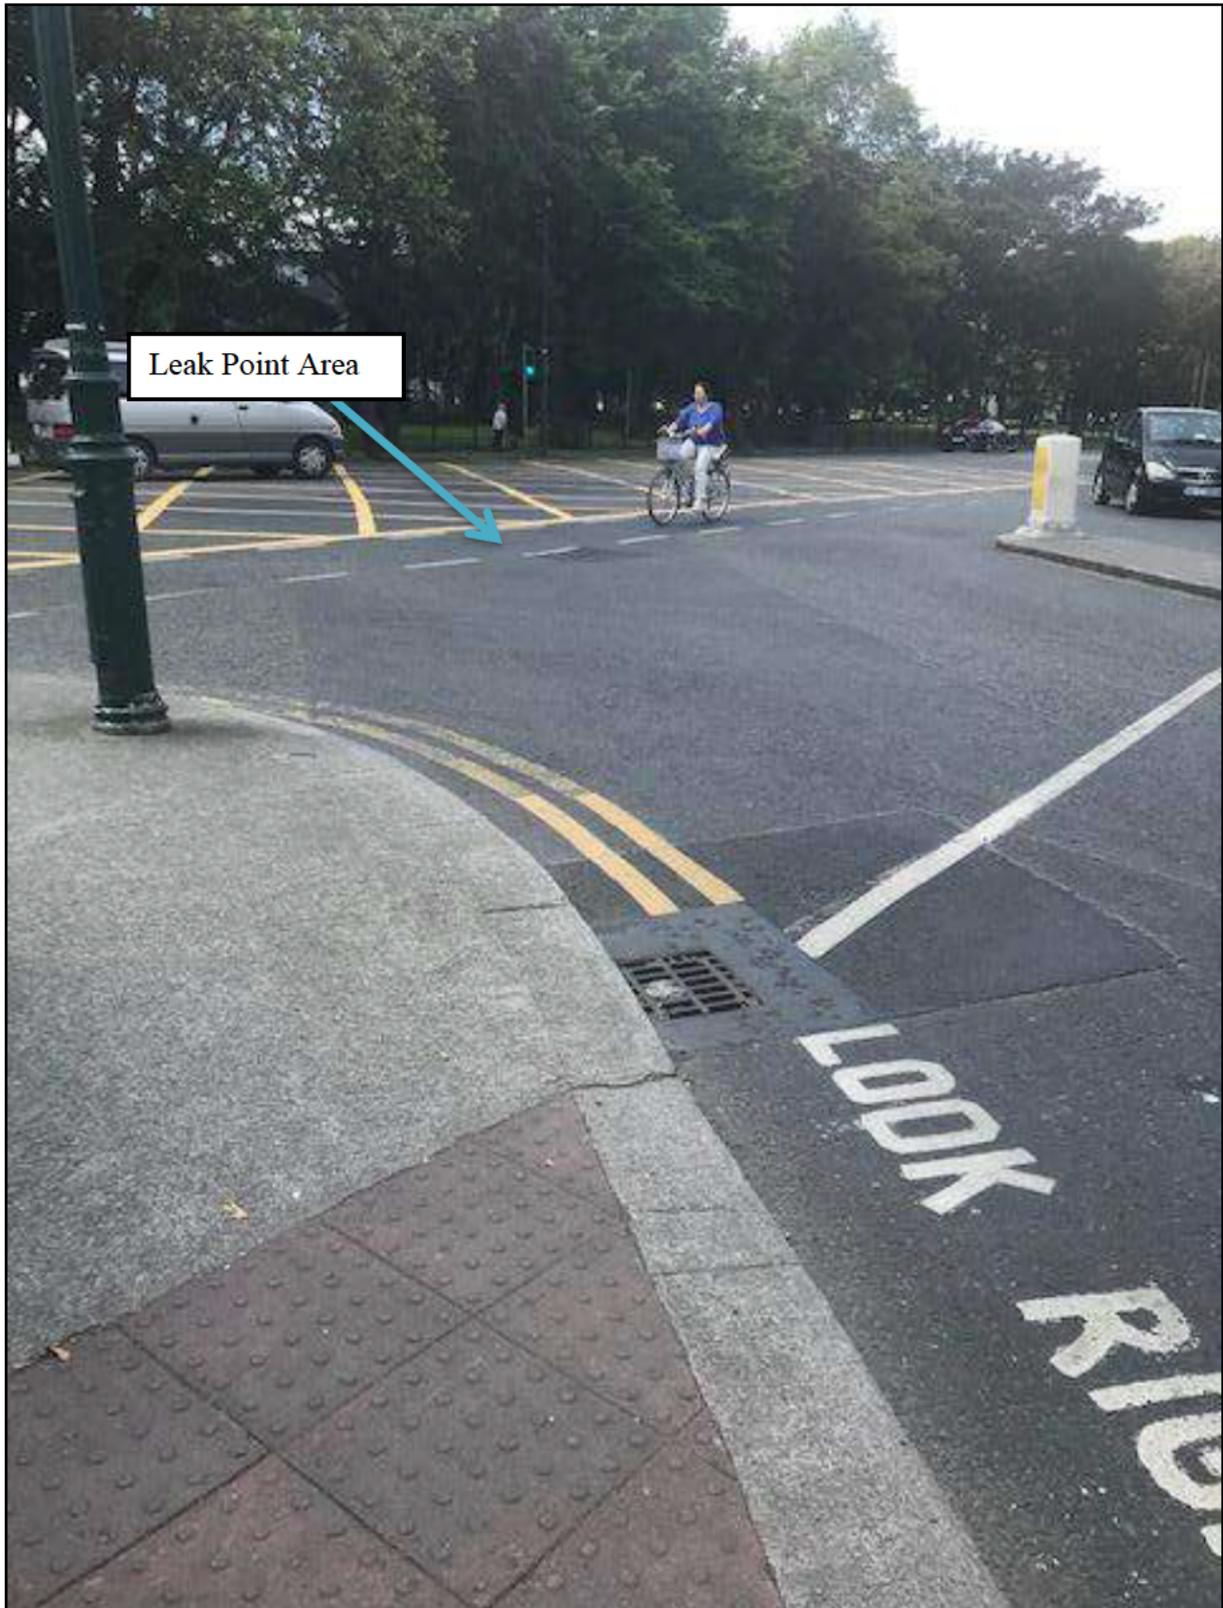
The location of the cable leak point is located in the middle of the road junction as presented in Photograph 4 & 5 in Appendix C. There is no physical evidence of hydrocarbon contamination on the surface in terms of oil odours/staining or impact to vegetation with healthy looking trees and hedges. Immediately to the south of the leak point on Clontarf road is a grassed area, cycle lane and footpath.

Photo 3: Leak point location in roadway in area of newer tarmac

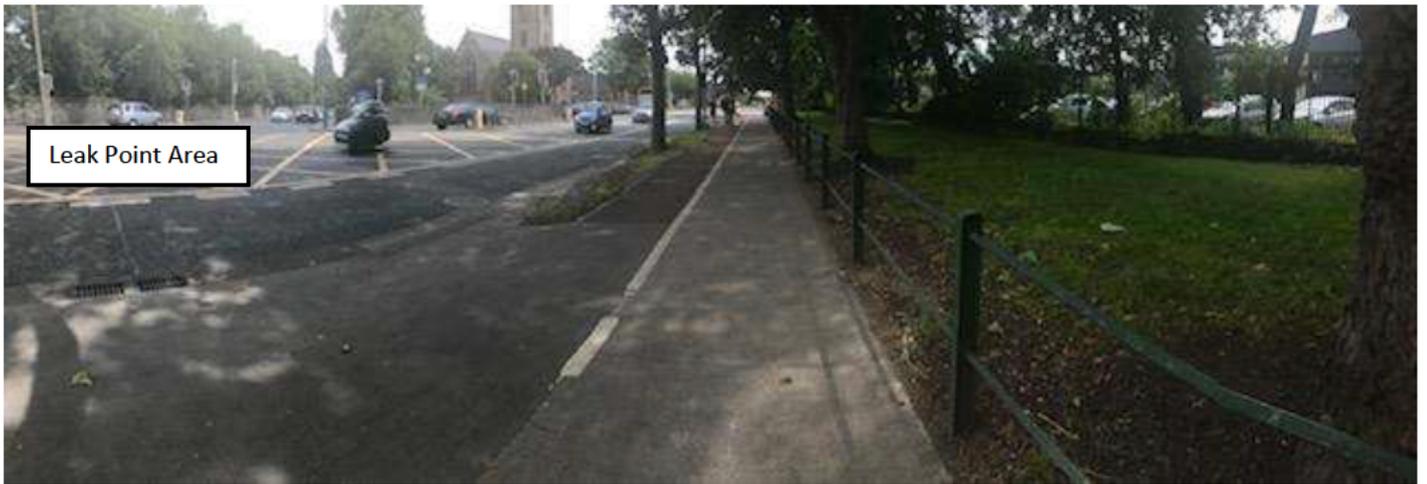
Photo 4: Grassed areas located immediately to the south of the leak point on Clontarf Road

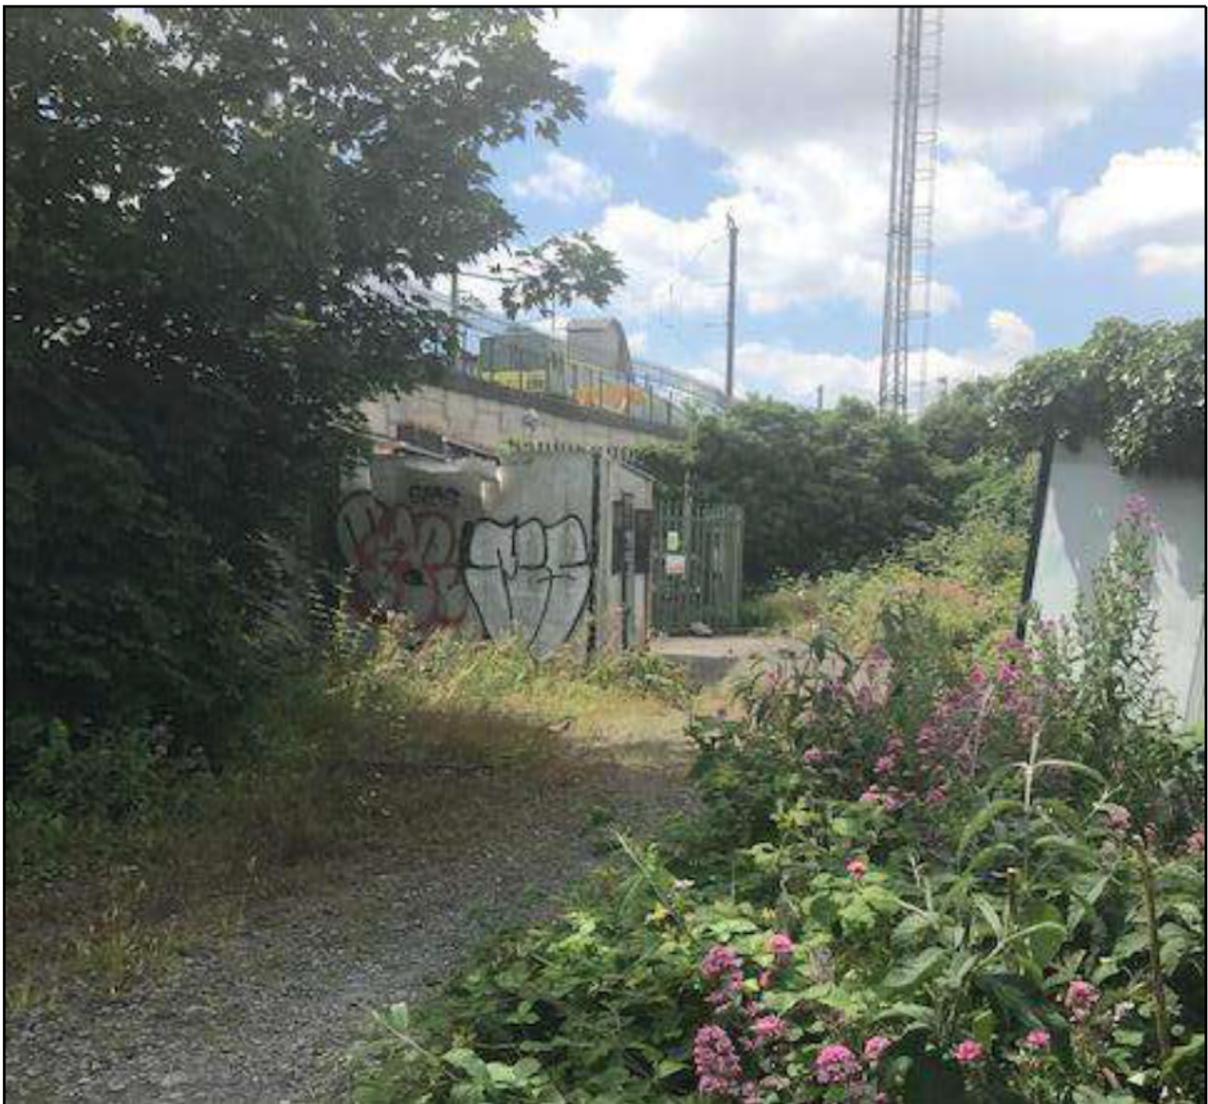
Photo 5: Yard near Clontarf Pumping Station with Gas Network Utilities

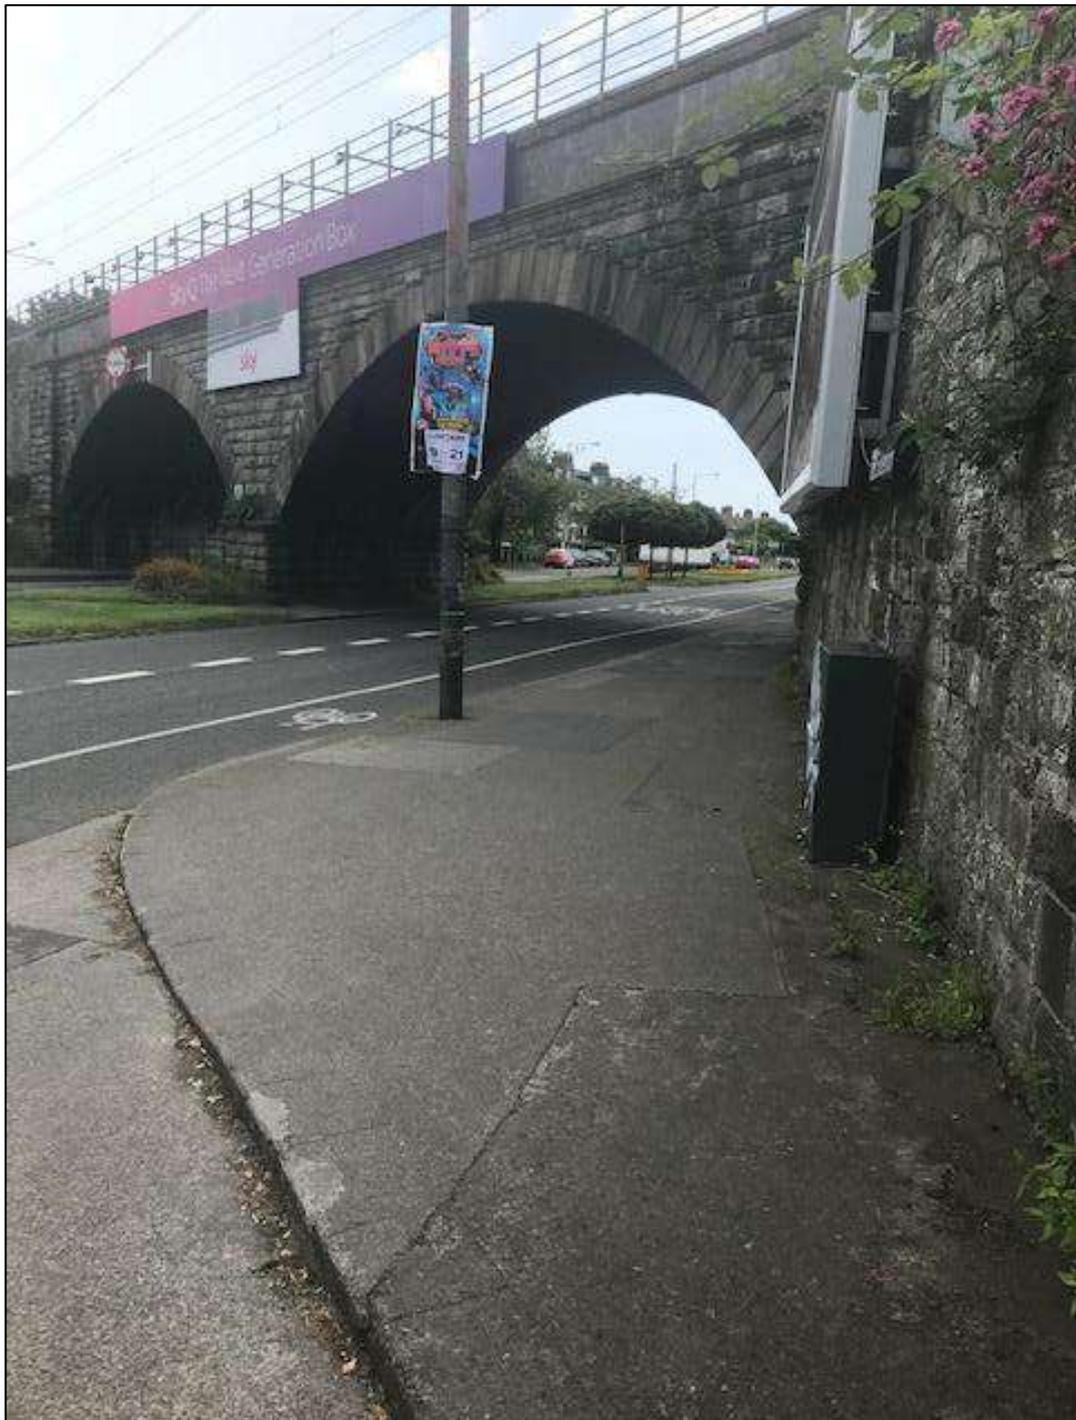
The known presence of permeable made ground around the power cable together with the presence of other underground services along the roadway indicates there is a high potential for preferential lateral migration from the leak point along the underground services routes.

Photo 6: Abundant services on concrete footpath adjacent to Clontarf Road – Approx. 140m east of leak point
