# Preliminary Site Assessment Report for Finglas Road, Dublin 11

ESB Site Ref: 15  
Finglas – Merville 38kV

March 2020

**Project Title:** ESB Networks Historic Fluid Filled Cable Loss  
Environmental Assessment

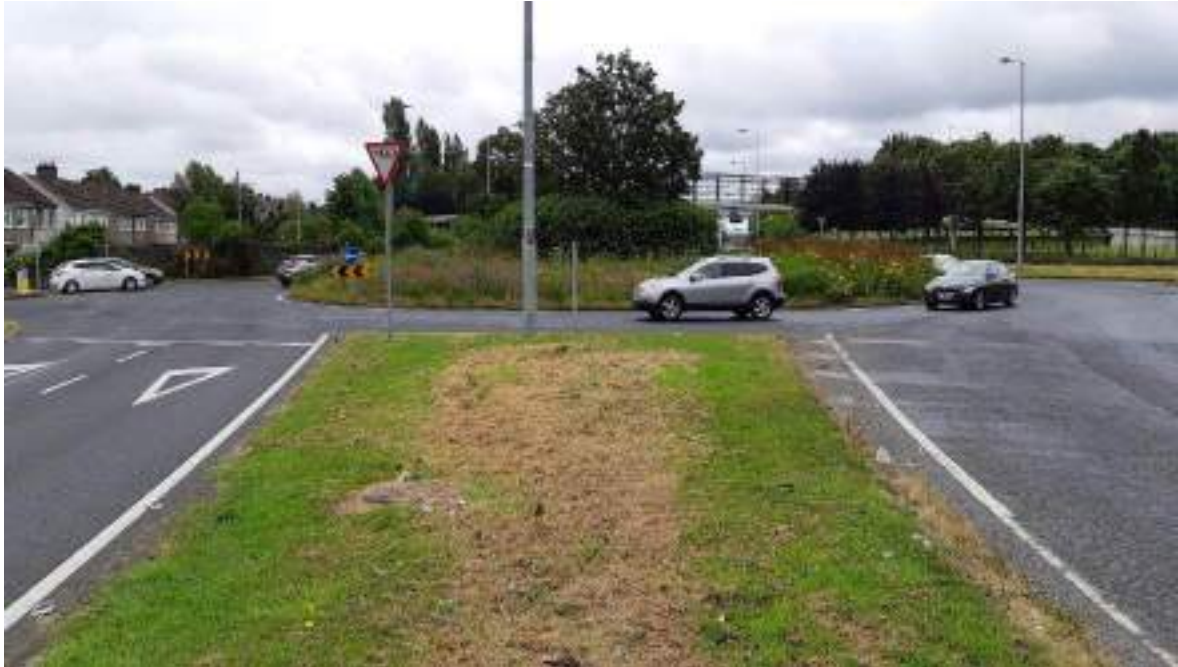
Photo 1: View of roundabout looking south along R135. Location of roundabout is approximately 920m from M50 (Junction 5). Indicative location of leak is beneath road adjacent to RHS of northern margin of central reservation.

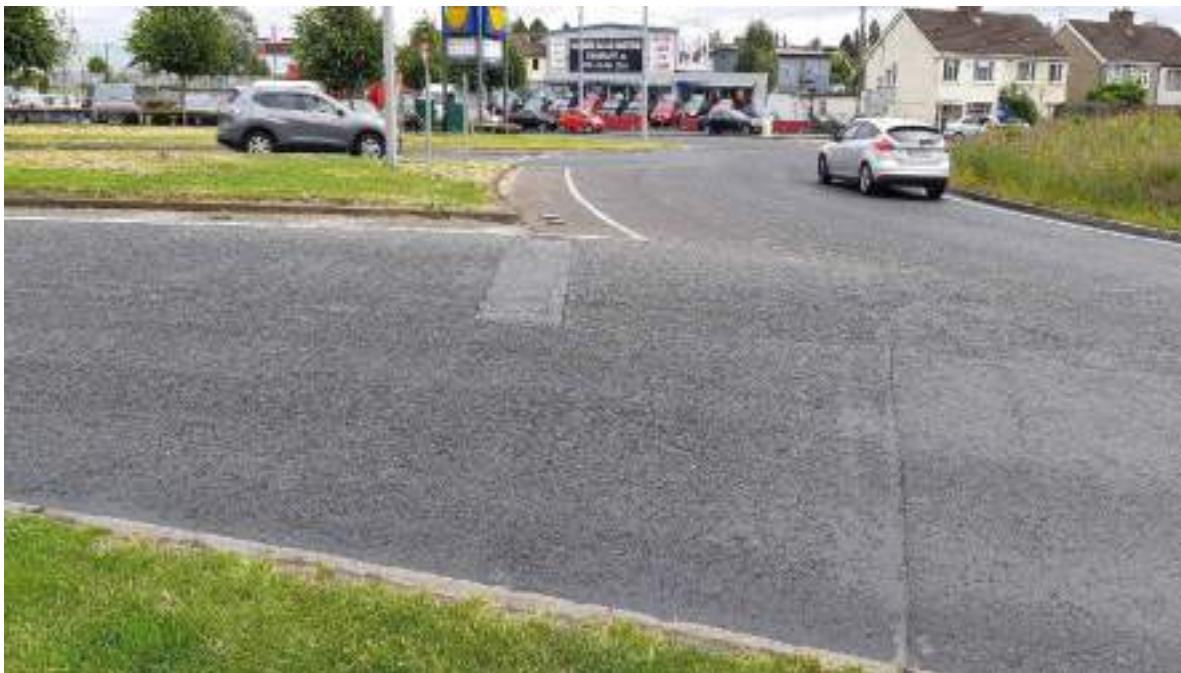
There is evidence of a narrow trench having been cut into the road at the leak point. Some dead grass occurs at the southern tip of the central reservation (close to indicated leak position) though it is unclear whether this is due to contamination or other causes. Apart from the repaired trench shown in Photo 2, there were no other indications that a leak had occurred. The central reservation is approx. 10m wide at the point just north of the roundabout at the leak location. A green margin is located to the west of the northern carriageway (approx. 10m away from reservation). A low wall with steel railings separates the green margin/verge from a green and wooded area that is associated with the residential estate to the west (Casement Road). The width of the grass verge is circa. 4m as it approaches the roundabout. Just inside the wall of the estate (in the green area beneath perimeter trees), there are further services boxes up against the wall including a small grey box labelled "Danger – Keep Away". There are four adjacent manhole covers (rectangular) with the following warning imprinted on the covers "Danger – Electrical Cable". These are indicated in Photographs 5 and 6.

Photo 2: View of trench repair works completed on road at suspected location of leak.

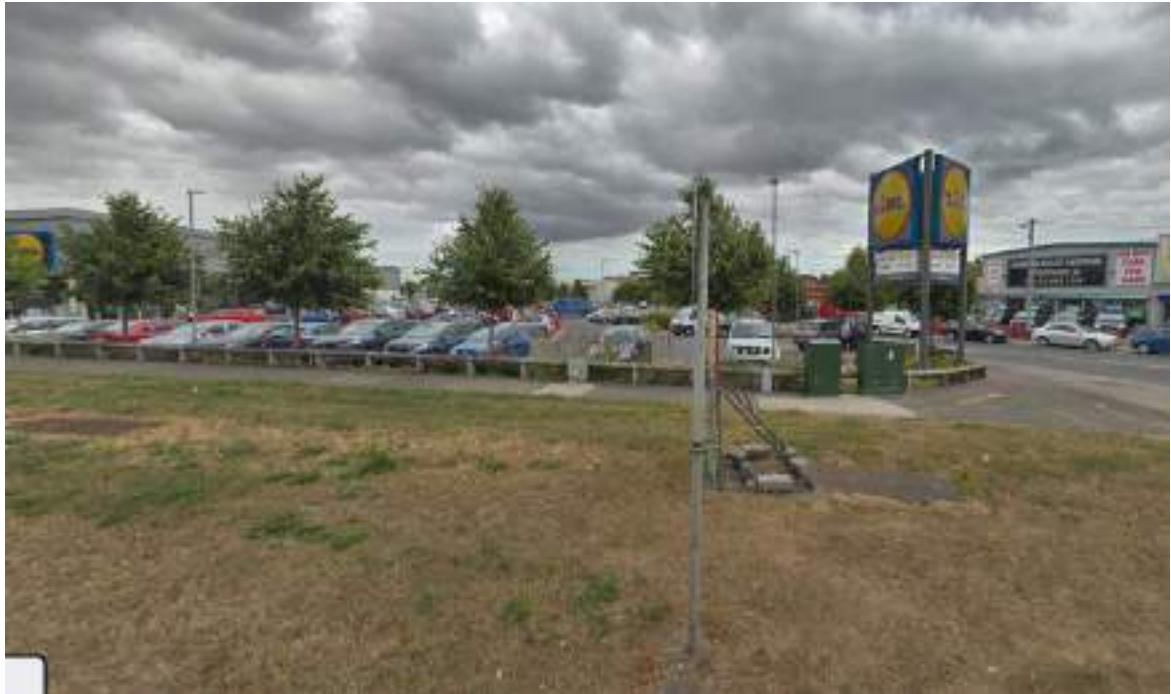
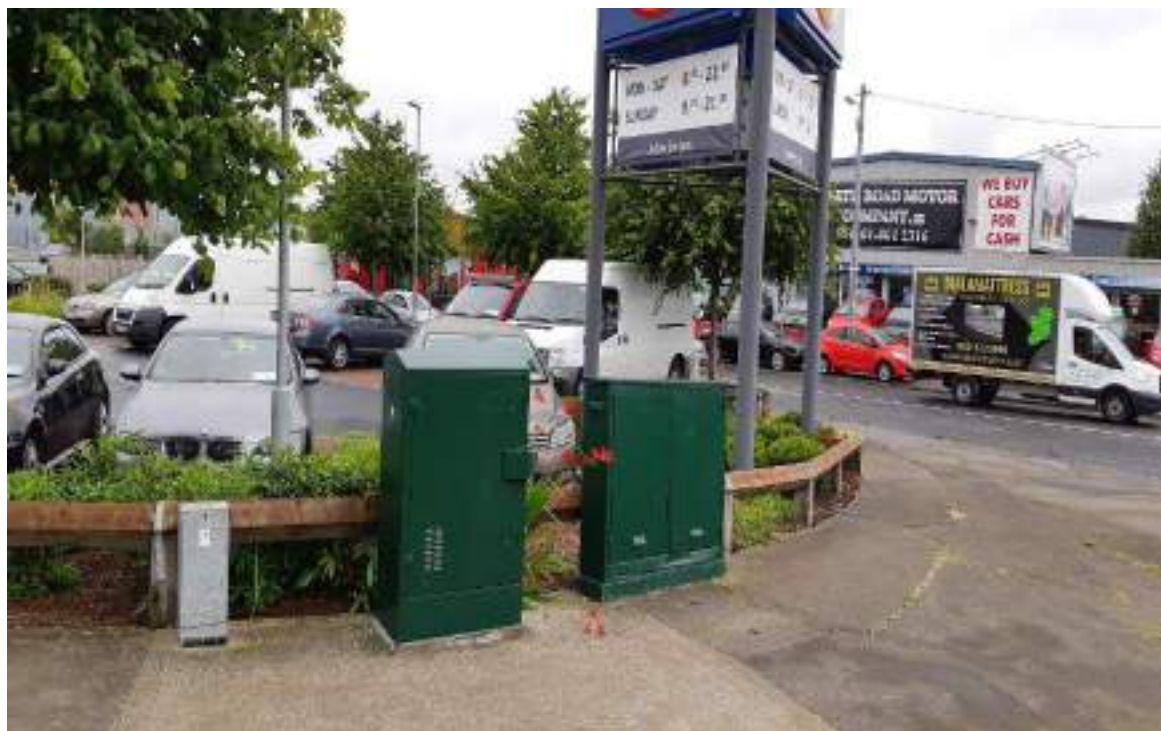
The ground immediately adjacent to the leak point is flat though there is a regional slope in elevation to the south along the R135 (towards Tolka River Valley). The road surrounding the roundabout appears slightly elevated and a downward slope in ground levels was noted to the R104 and to the access road to residential estates to the west. A large Lidl store is located immediately to the northeast of the roundabout (at corner of R135 and R104) and there are several service boxes and manholes located adjacent to the low perimeter wall. These include a small grey box labelled "Live Electricity" and a larger green box (230 V AC). These features are indicated on Photographs 3 and 4.

Photo 3 and 4: Kiosks and service manholes adjacent to boundary with Lidl car park at junction of R104 exit of roundabout (western exit)

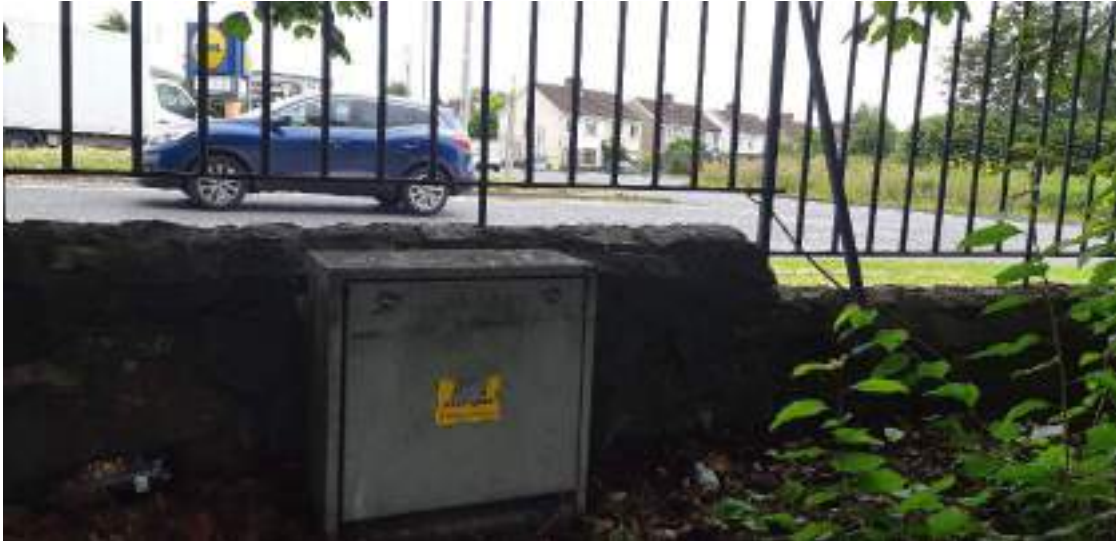
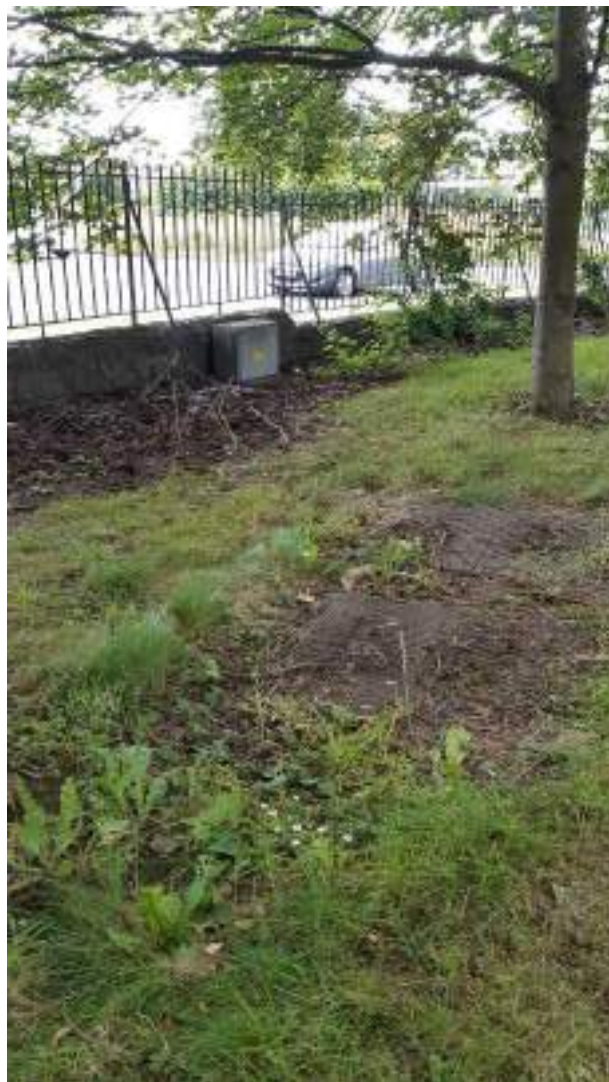
Photo 5 and 6: Grey ESB box labelled “Danger – Keep Away” and access to cabling in ground at location within green associated with Casement Road residential estate. Ground covers are imprinted with warning “Danger – electrical cables”. Roundabout in background. Leak location is circa. 10m to east of this location.

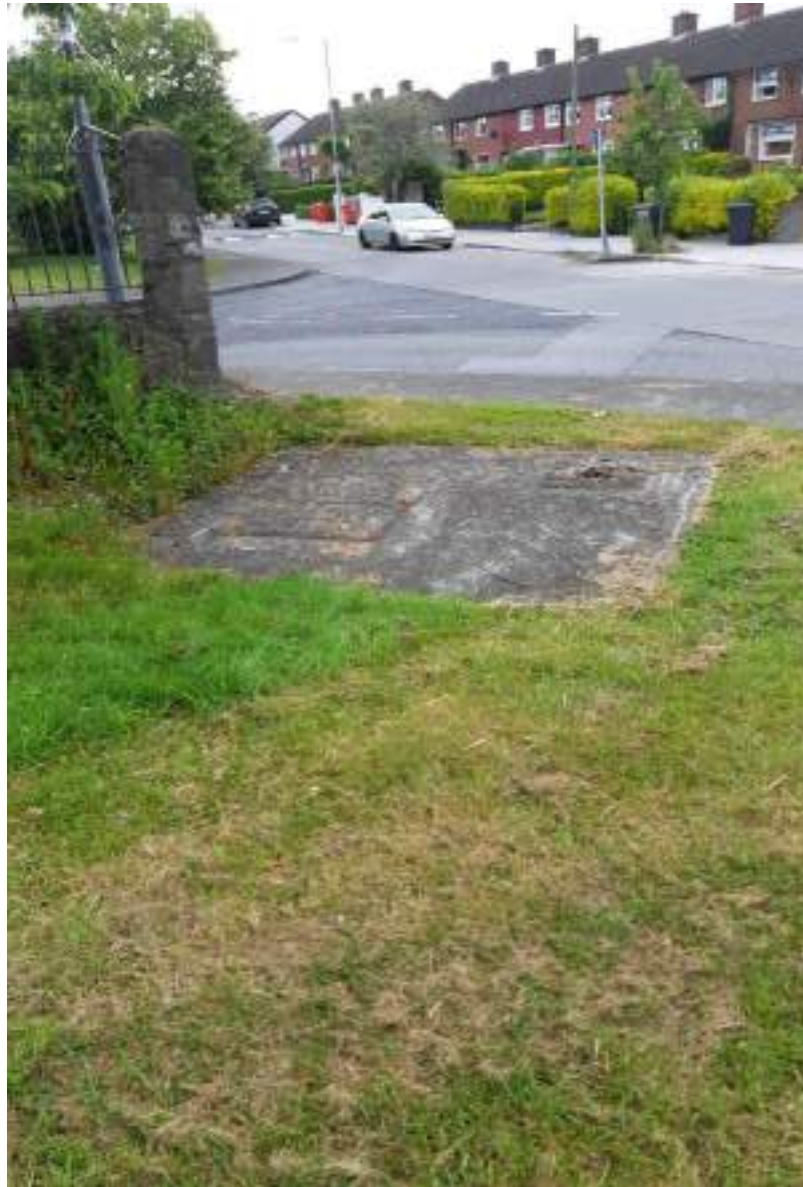
Bachelors Stream, a tributary of the Tolka River, rises at a location just west of the roundabout. The stream is now culverted (underground) at this location. During the walkover, a concrete chamber was observed just north of junction of the access from the roundabout to Casement Road. This is a presumed access point to the stream. The stream crosses to the east of the R135 just south of the roundabout and continues in a southerly direction on a course that runs along the area between the R135 and the North Road (behind back gardens along the North Road). During the site walkover, the

Photo 7: Chamber suspected to be associated with the culverted Bachelors Stream. The chamber is located at the junction of Casement Road with roundabout access (just east of roundabout, approximately 60m west of identified leak point. Source of river is known to be adjacent to roundabout.

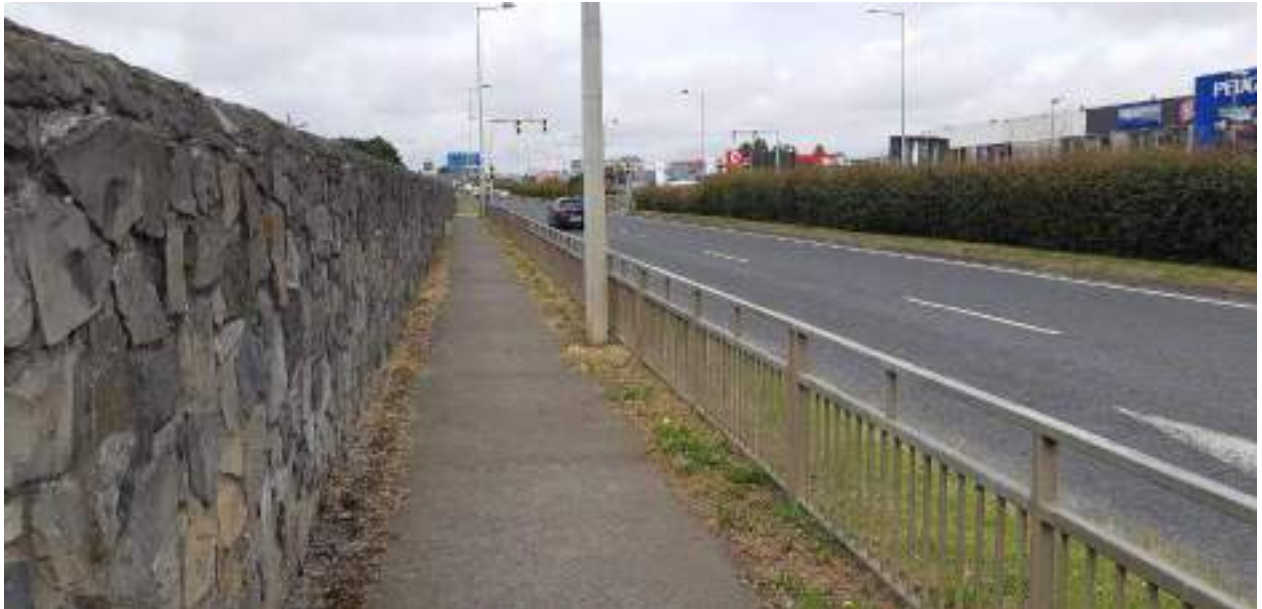
Photo 8: View to north along R135 with signs for M50 in background. Cable route is along pavement on LHS of northbound carriageway.

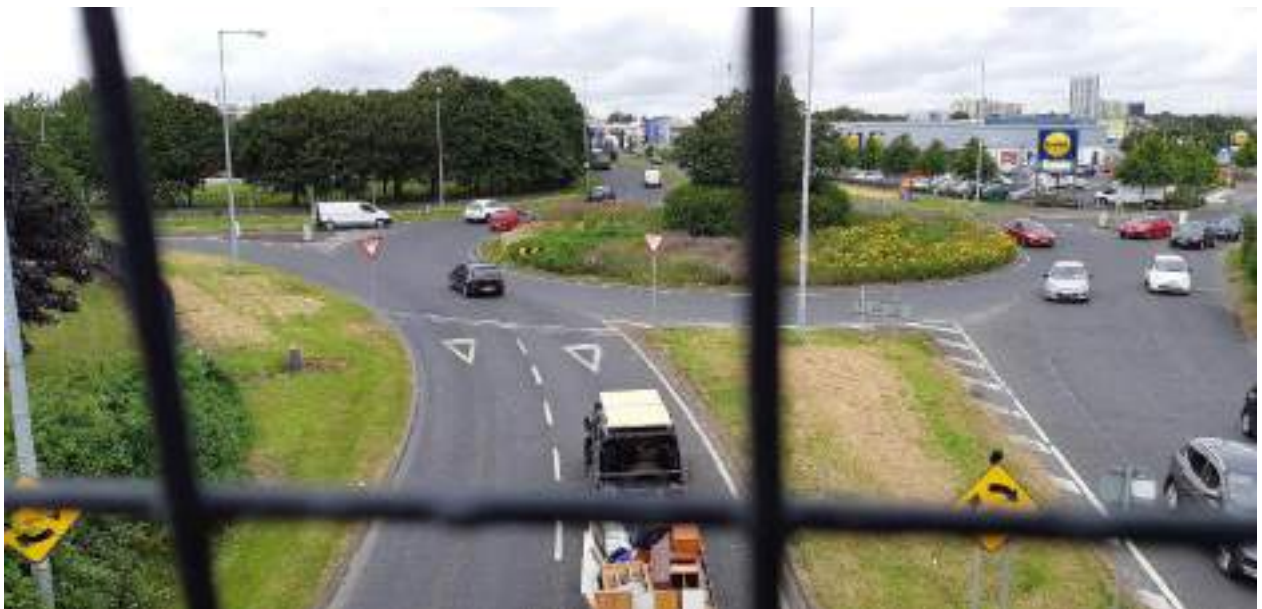
Photo 9: View to north of roundabout from pedestrian overpass. Likely joint section of leak crosses from left to right side of R135 above, just on far side of roundabout. It skirts far side of roundabout and veers down North Road (not in shot but to RHS above).

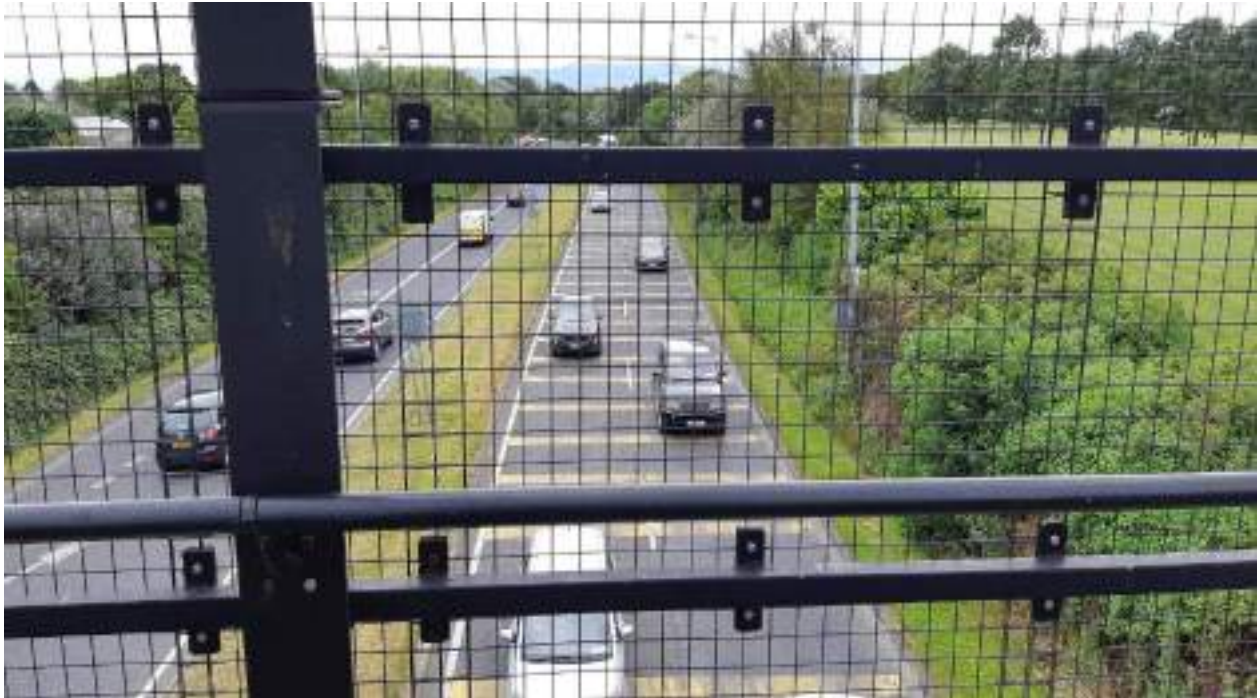
Photo 10: Looking south from pedestrian overpass of R135, just south of roundabout. HV Underground Cable (38 kV - 220 kV) is routed through Mellows Park which bounds the western side of R135. Ground elevation in park is noticeably higher. Bachelors Stream is to the east of the R135 and flowing in a southerly direction from roundabout. Stream could not be accessed. Known that most of along stream route is culverted.

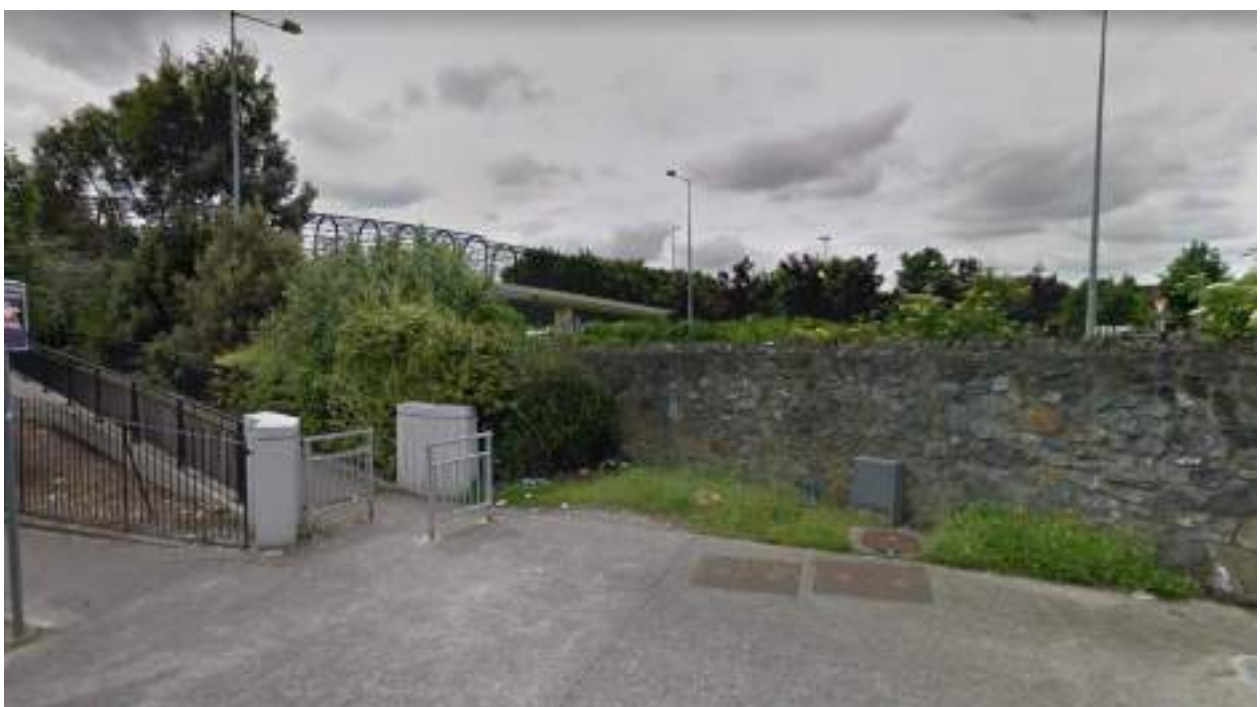
Photo 11: North Road at base of pedestrian overpass. This is location where suspected leak section has crossed R135 and is routed along North Road. No indication of leaking was observed at the surface along this section. Bachelor Stream is downgradient of the cable along a section of North Road where the cable is located within the pavement and the stream is located behind the back gardens of houses along North Road. The stream was not observed during walkover (either culverted or no access possible).
