Preliminary Site Assessment Report for Finglas Road, Dublin 11

ESB Site Ref: 22
Finglas – Merville 38kV

March 2020

Project Title: ESB Networks Historic Fluid Filled Cable Loss
Environmental Assessment

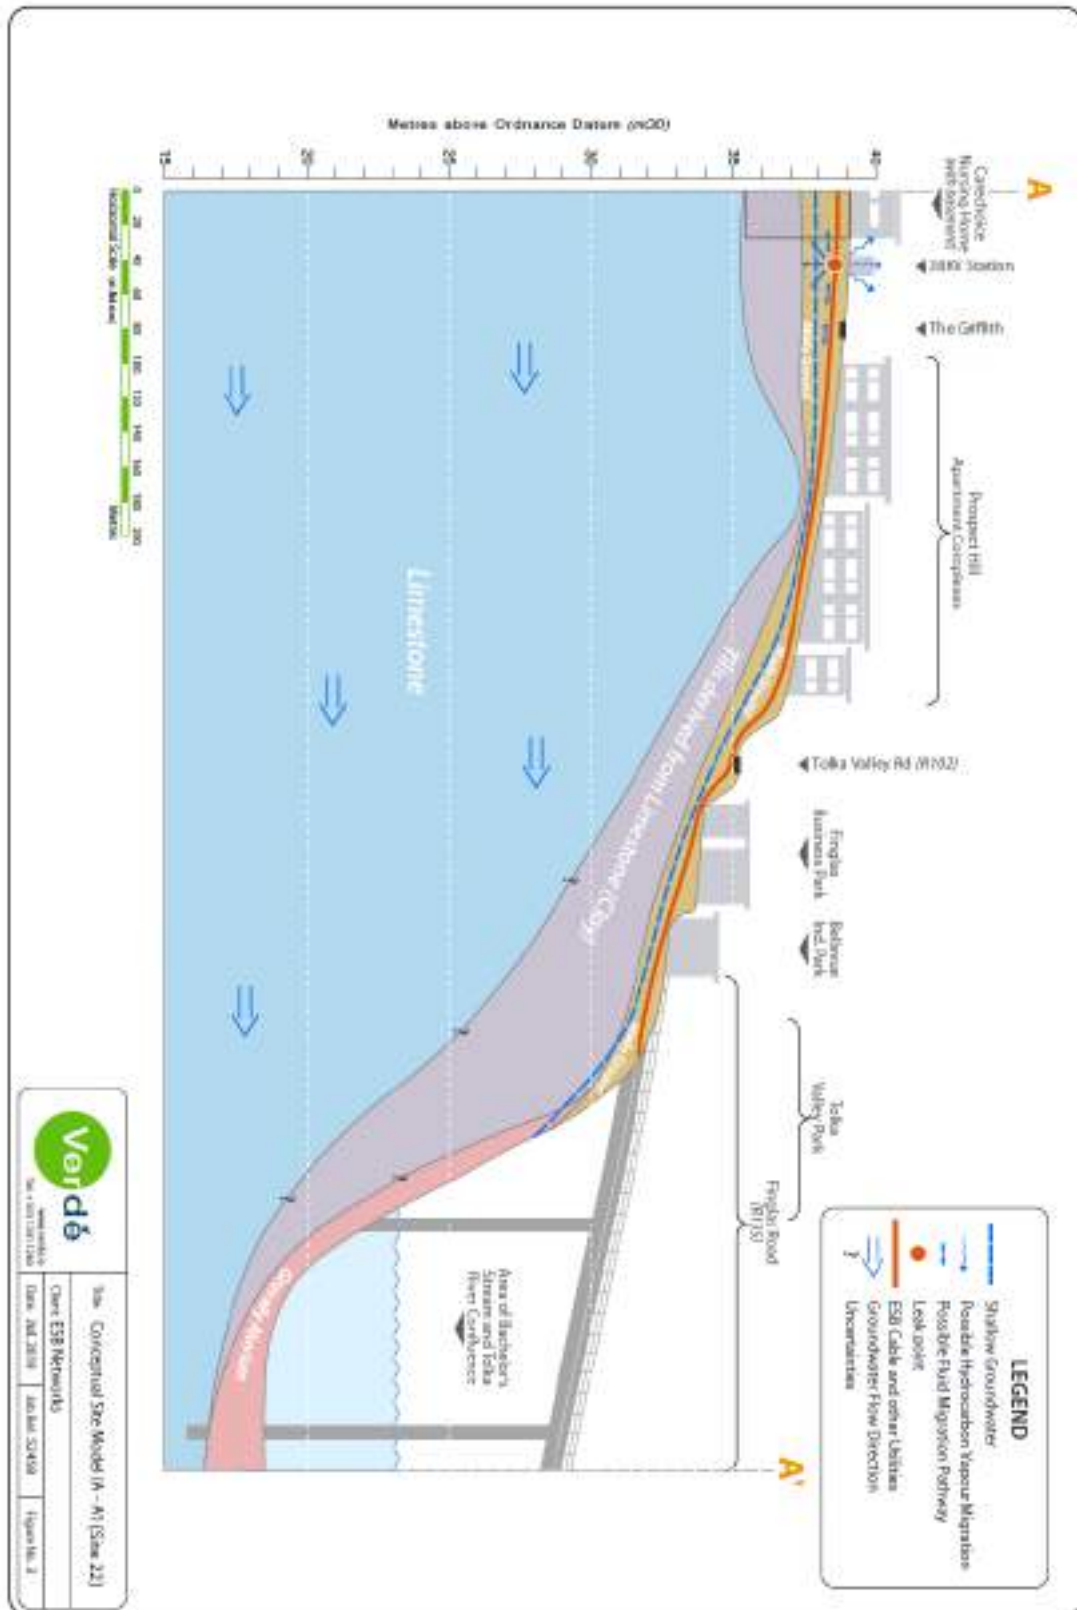
Figure 3 – Conceptual Site Model

- hydrocarbon migration to the adjacent watercourse given the short distance to Bachelors Stream.
- hydrocarbon migration to the underlying aquifer given the possible connection to shallow groundwater through shallow rock in the area indicated by the High vulnerability.

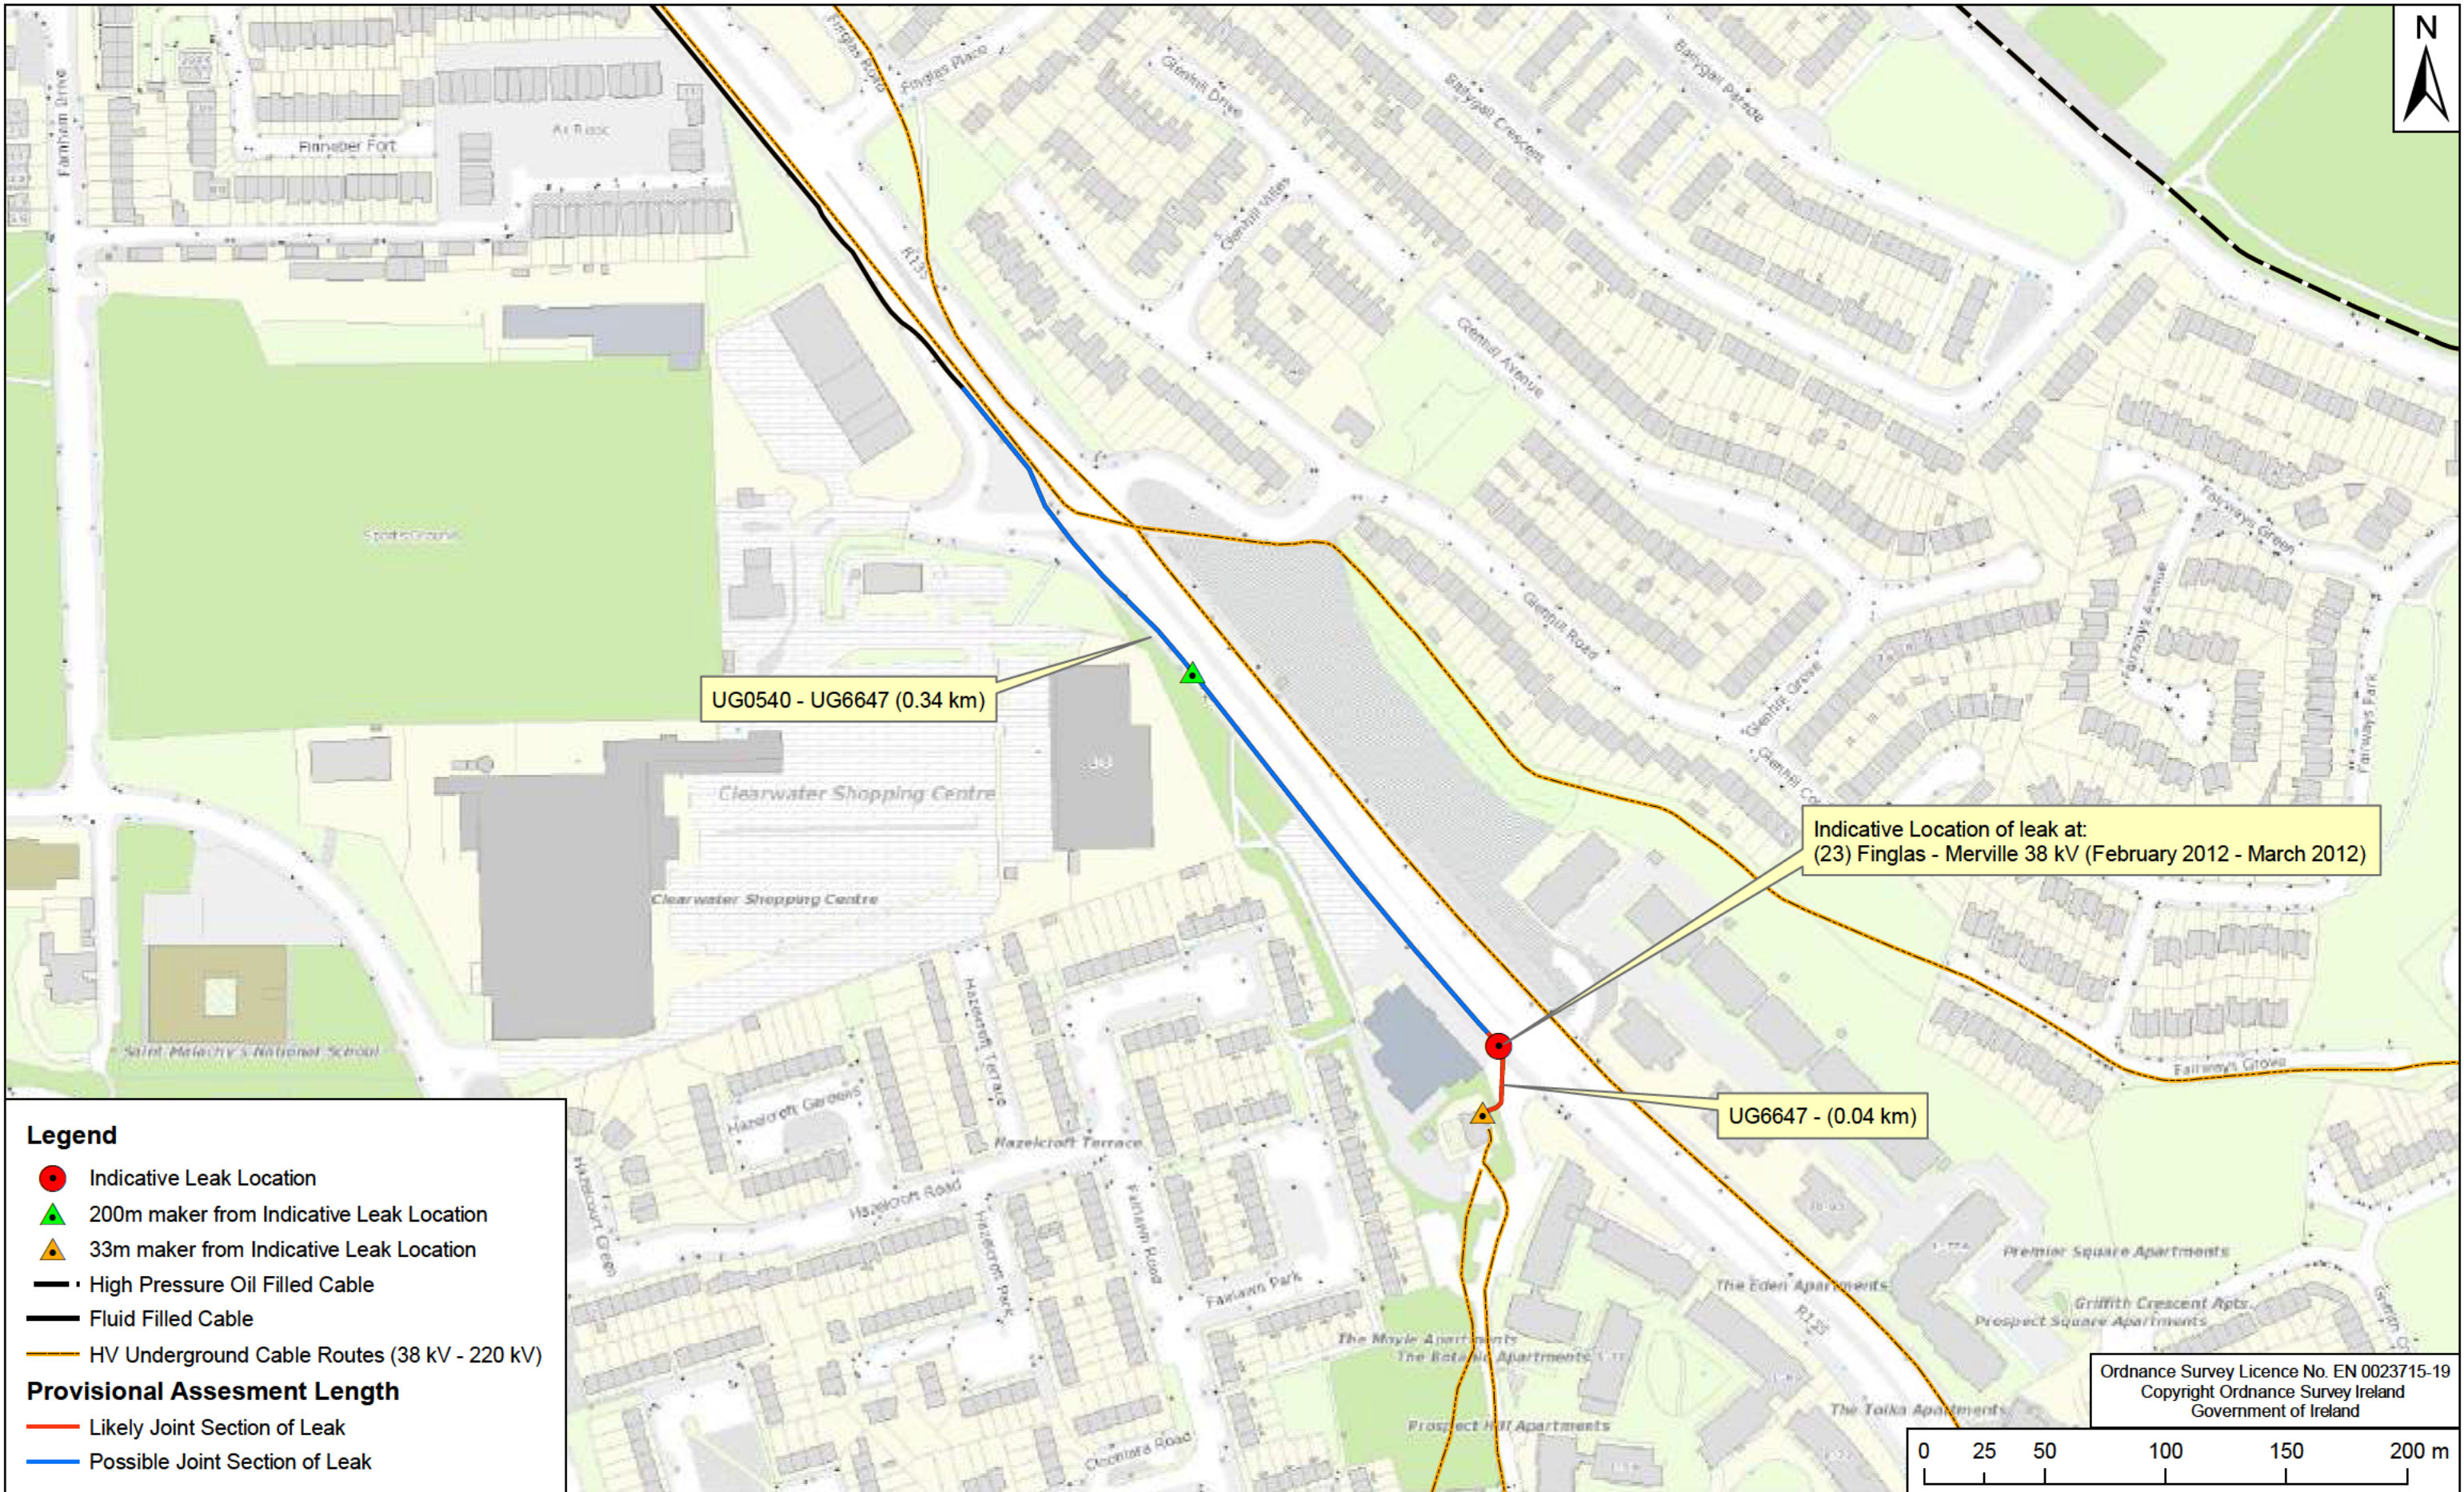
ESB SITE LAYOUT PLAN WITH INDICATIVE CABLE FLUID LEAKAGE LOCATION

Indicative Location of leak at:
(23) Finglas - Merville 38 kV (February 2012 - March 2012)

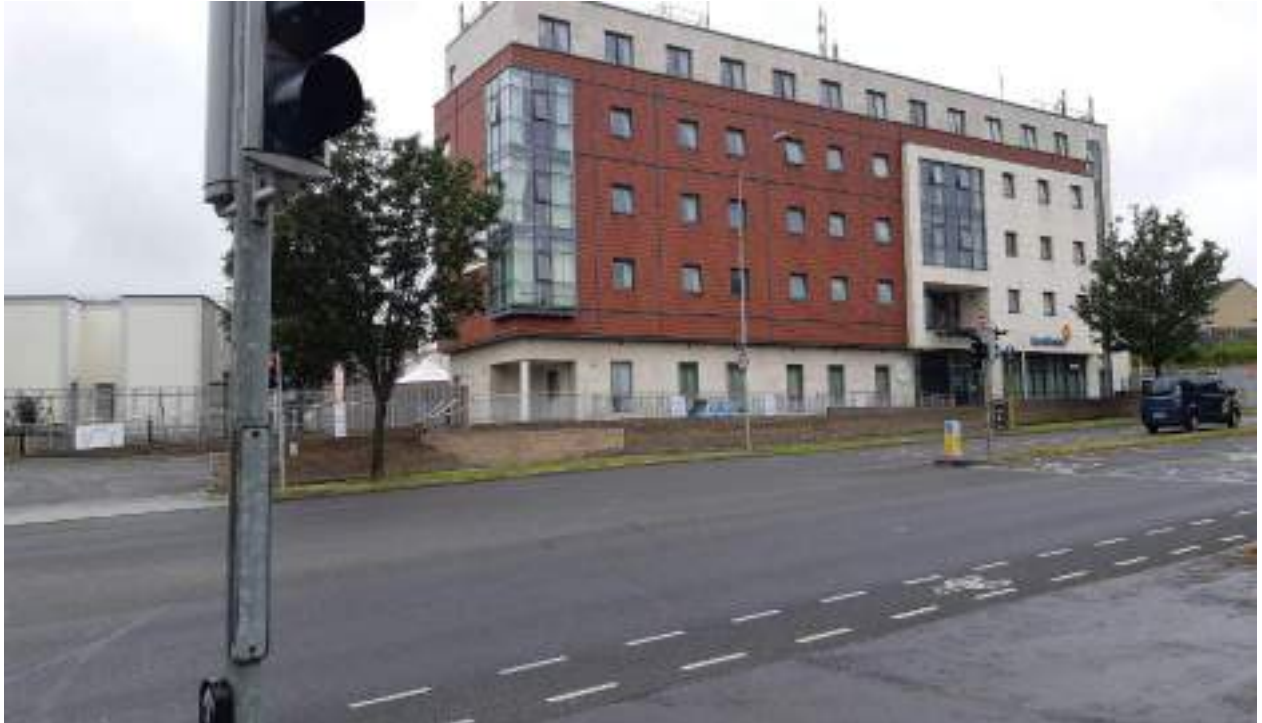
Photo 1: View of former hotel (now CareChoice nursing home). Note entrance on LHS with white colored ESB substation in background. New bricks of re-built section of perimeter wall are conspicuous

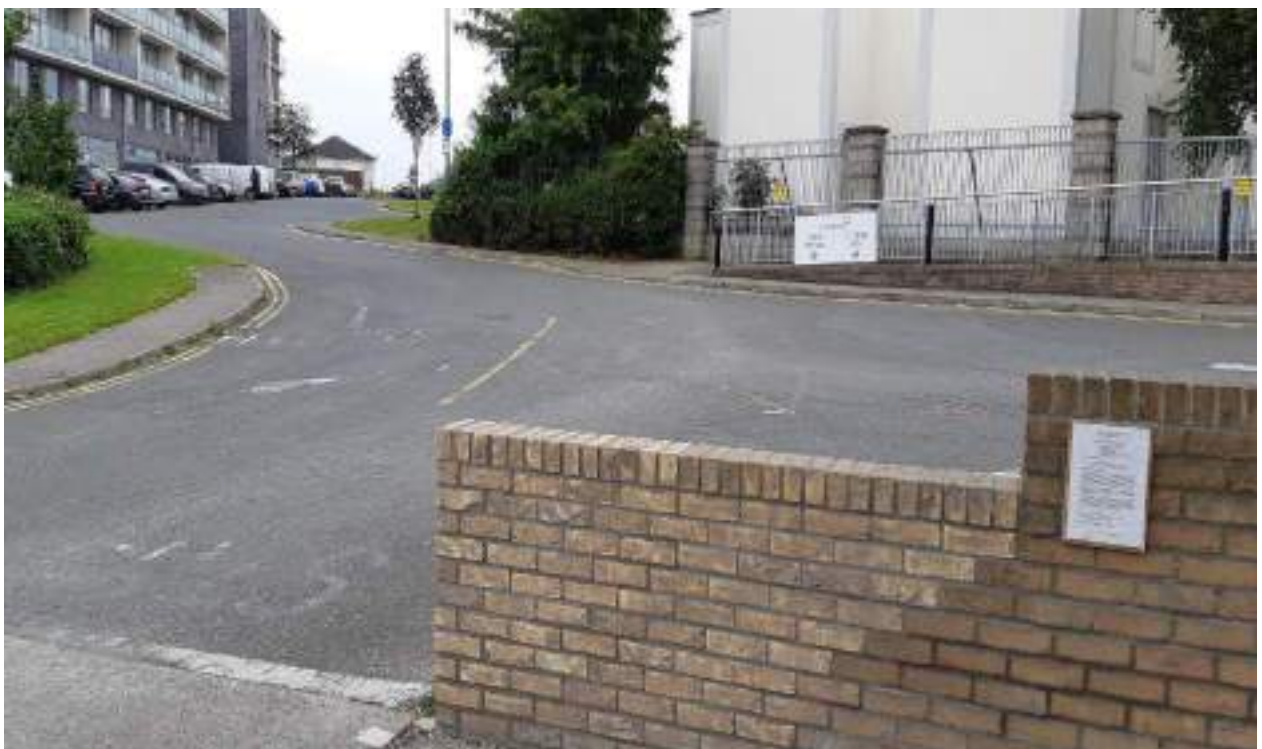
Photo 2: Close up of access and slope at entrance. Planning application notice in place and note substation.

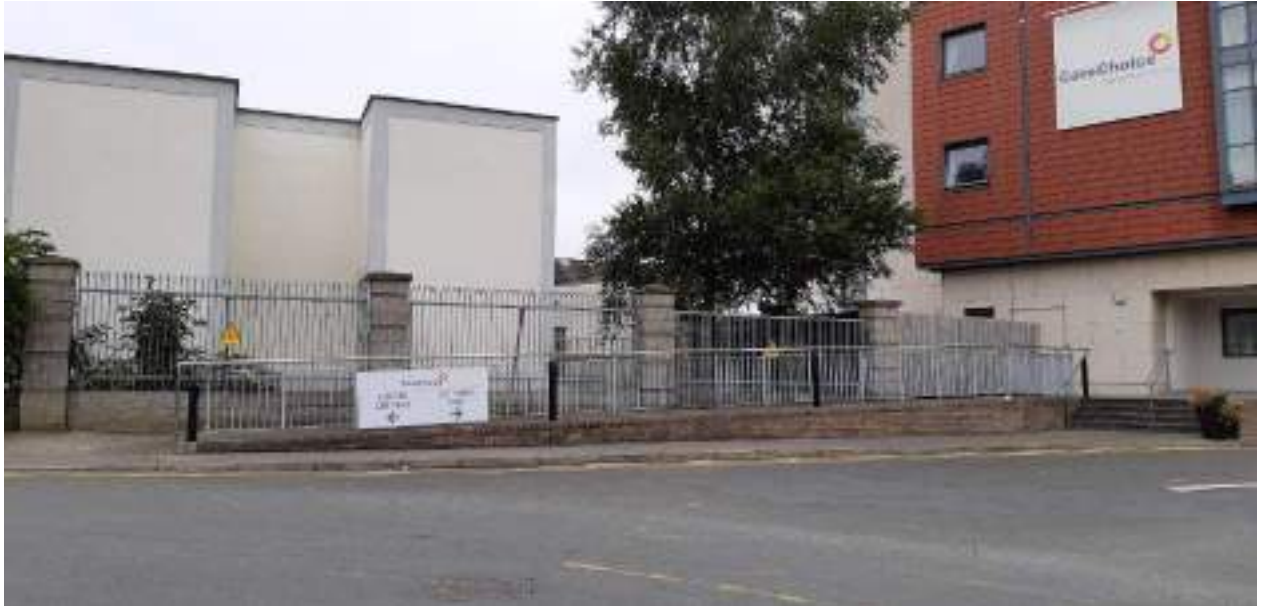
Photo 3: Substation is located approx. 30m from known 2012 leak position and at significantly higher elevation.

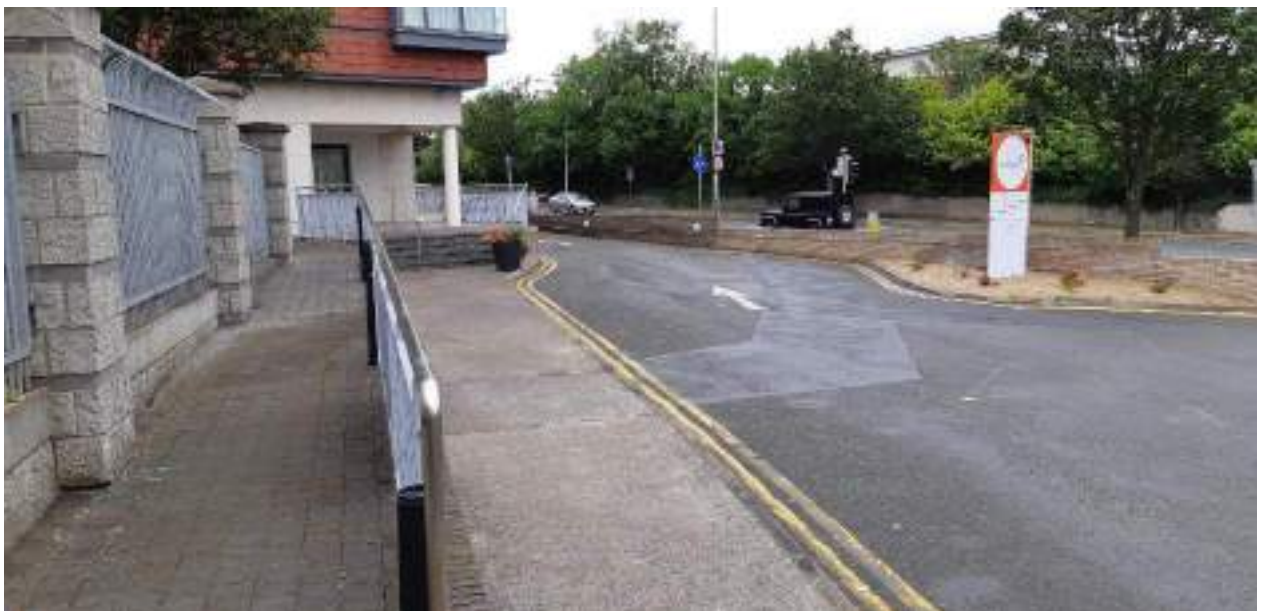
Photo 4: Outline of trench leading from ESB substation to position of leak.

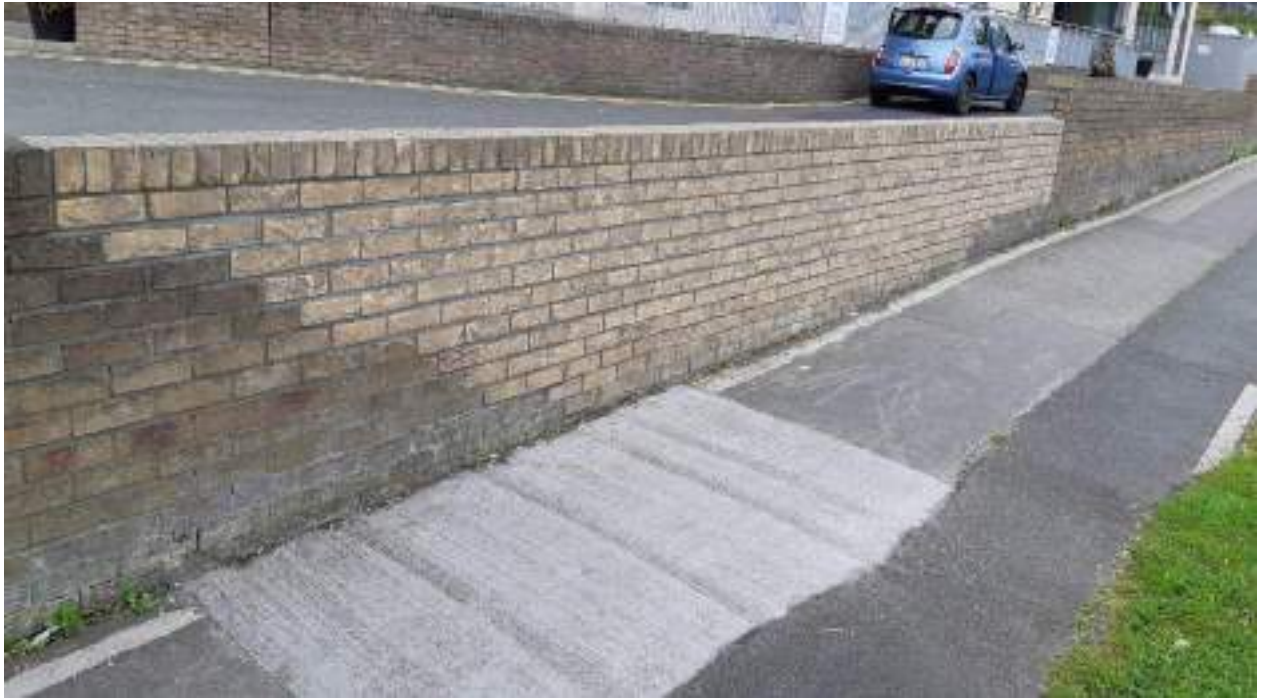
Evidence of remediation works are evident in the form of the replacement of a section of perimeter brick wall close to the entrance to the care centre and the refurbishment of ground surface along the pavement just outside the perimeter wall. Extensive trench works were also completed from the substation to the edge of the north bound R135 carriageway (see Photo 4). The perimeter of the care centre is formed by a low brick wall which separates the set-down area for the facility from pavement, cycle lane and grass verge and R135 northbound carriageway. There is a noticeable change in coloration of the brickwork which relates to rebuilding works following the leak investigation (Photos 1 and 5). There is no indication that vegetation in the grass verge has been impacted by the leak (no discoloration or noticeable impact of nearby tree growth).

Photo 5: Section of re-built wall and area of new concrete marking works that are understood to have been completed subsequent to discovery of leak in February 2012

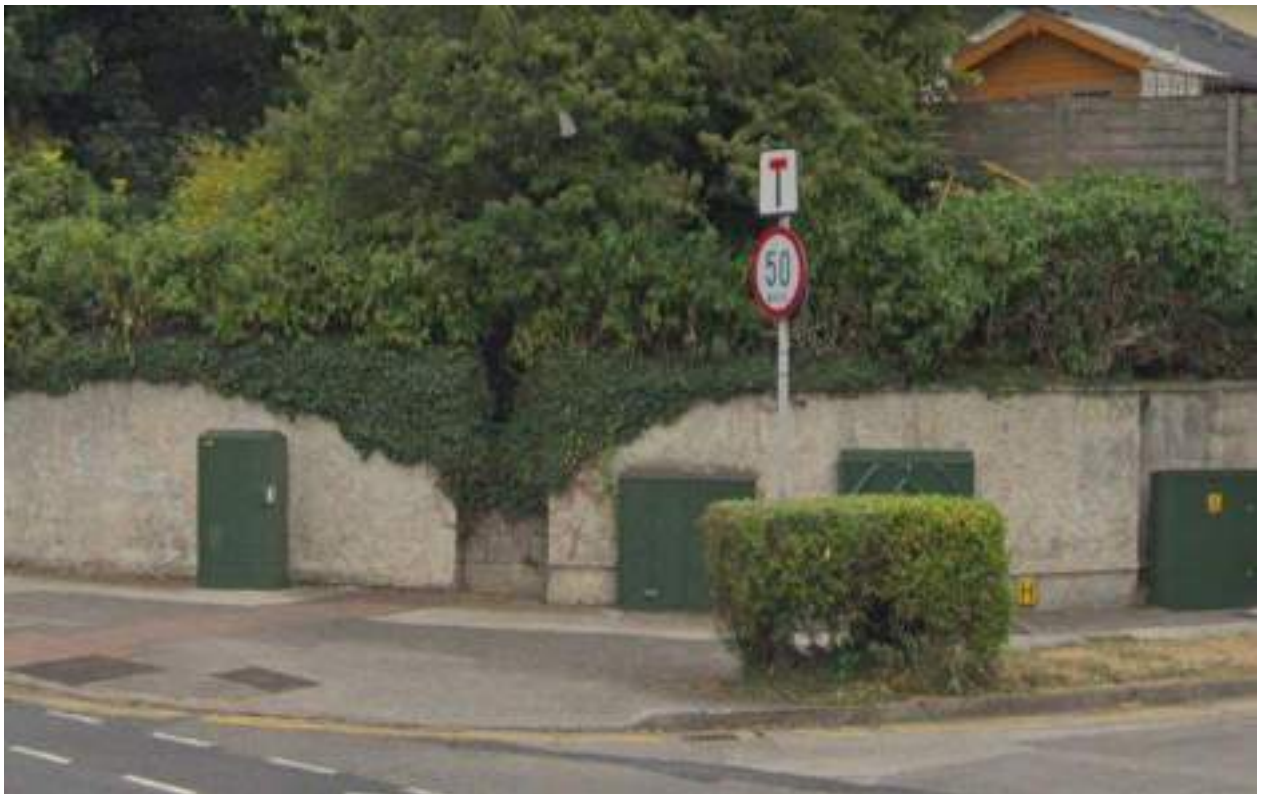
Photo 6: Kiosks on corner of Glenview Road and R135

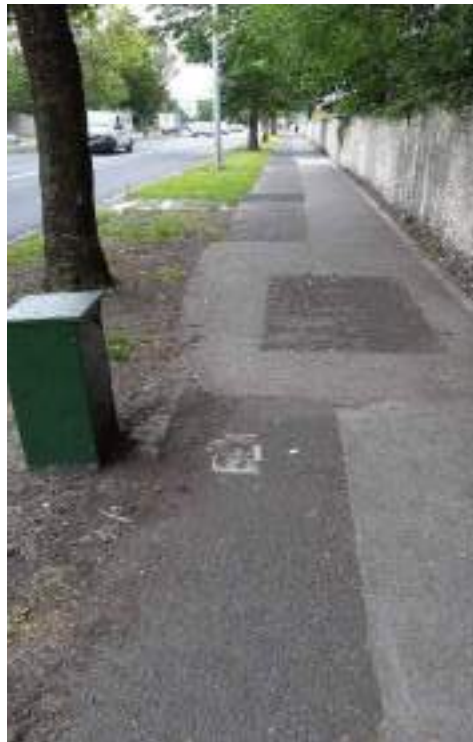
Approximately 200m north of the known leak area, the western verge of the road (northbound carriageway of R135) and pavement contain several buried services and green service box. A recently installed services manhole was observed at the location also (see Photos 7 and 8).

Photo 7: Position approx. 210 m north of leak site.

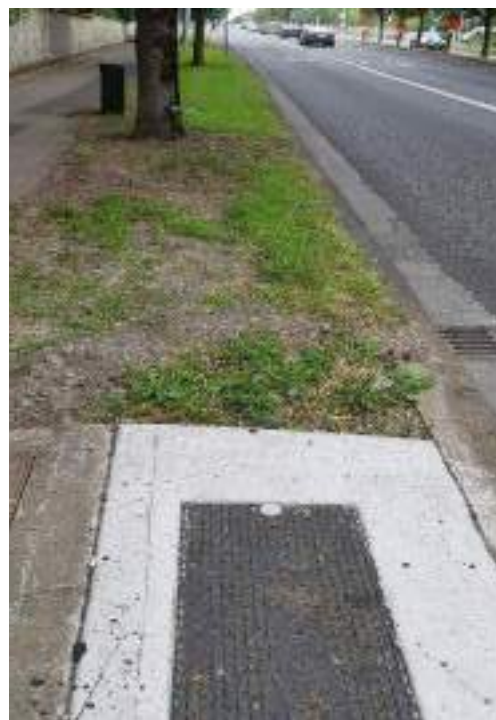
Photo 8: Position 200m north of leak site along western boundary of R135

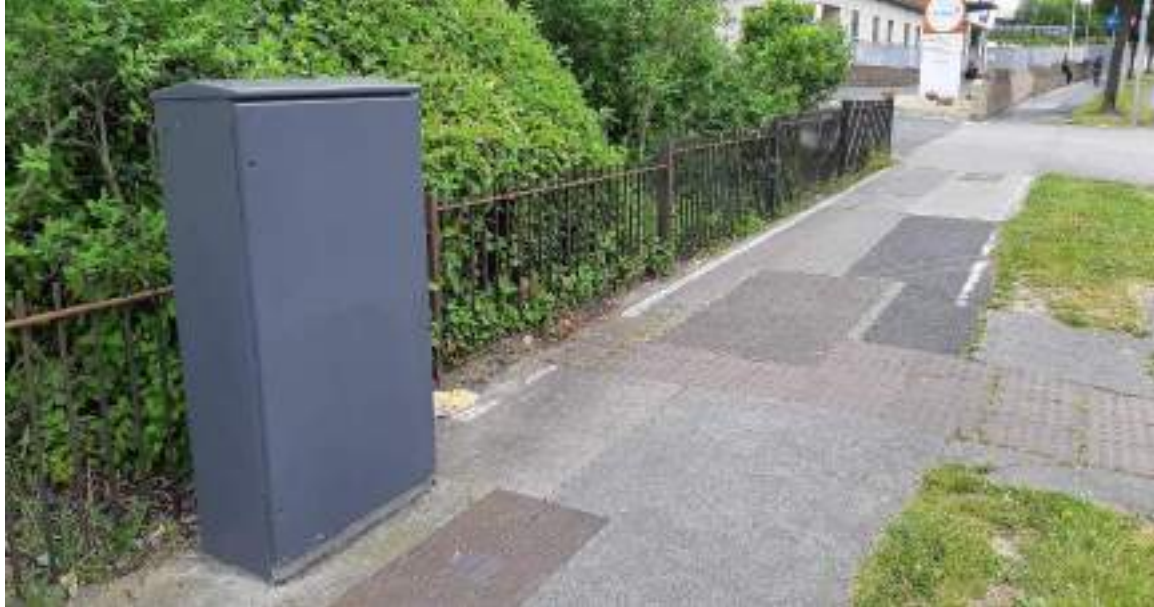
Photo 9: Area just south of the know leak site. See entrance to nursing home on LHS followed by repaired wall. Area of gravel around sign inside perimeter.
