Preliminary Site Assessment Report for Marina Commercial Park, Centre Park Road, Cork

ESB Site Ref: 27
Marina – Trabeg Two 110kV

Project Title: ESB Networks Historic Fluid Filled Cable Loss
Environmental Assessment

Report Ref: Stage 1 Preliminary Site Assessment Report for Marina Commercial Park, Centre Park Road, Cork. ESB Ref: 27 Marina - Trabeg Two 110kV

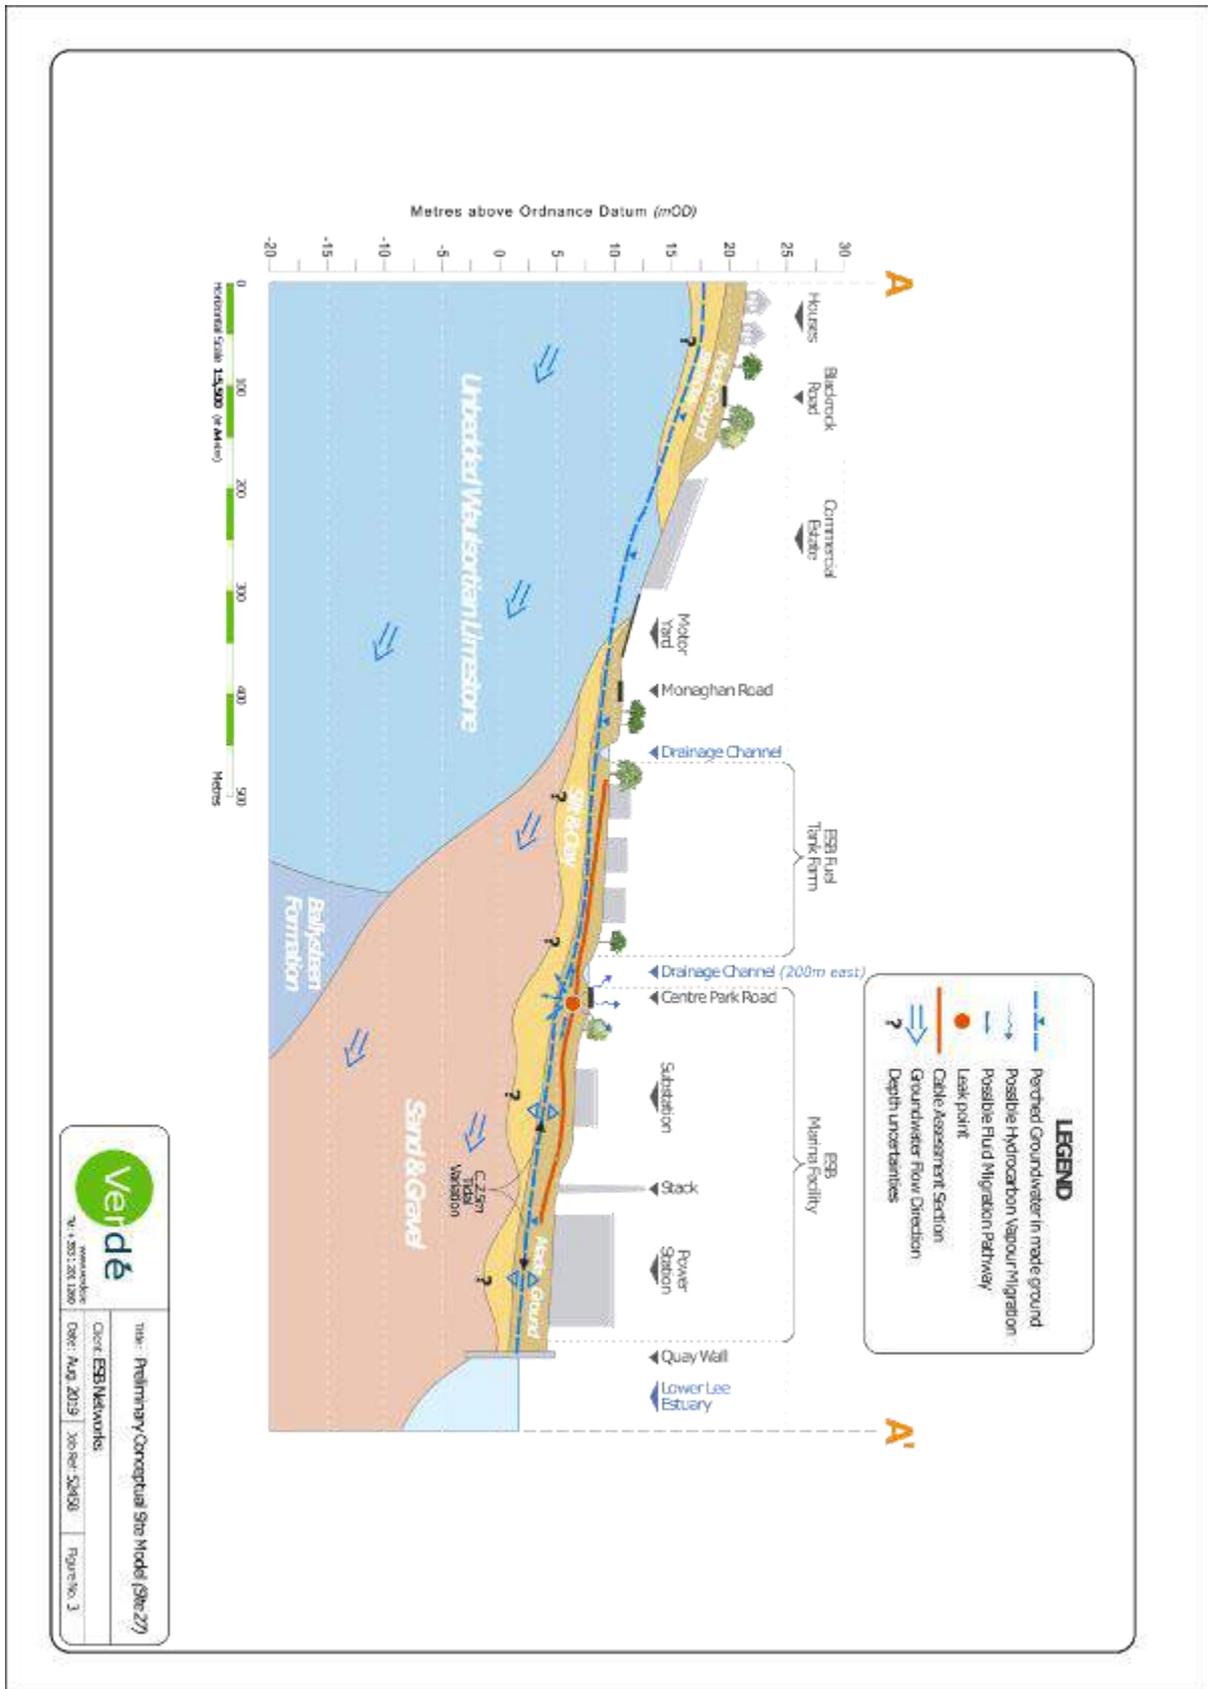
Figure 3 – Conceptual Site Model

Based on the known cable leak point, chemical of potential concern (COPC) fate and transport and hydrogeological desk study information the CSM has the following initial key findings for human health and environmental risks;

- ingestion contact with suspected contamination in the soil and groundwater through permeation of contamination through plastic water pipes or through low-pressure infiltration of possible soil contamination into water pipes via nearby breaks or leaks;

hydrocarbon migration to the Atlantic Pond and Lee Estuary given the existence of a potential hydrogeological pathway between the leak site and the local drainage channels and the Atlantic Pond downstream.

It should be noted that the report contained within Appendix G states that the majority of the leaked fluid was recovered at the time of the leak and, as such, the risks associated with the leak have been assessed with this consideration.

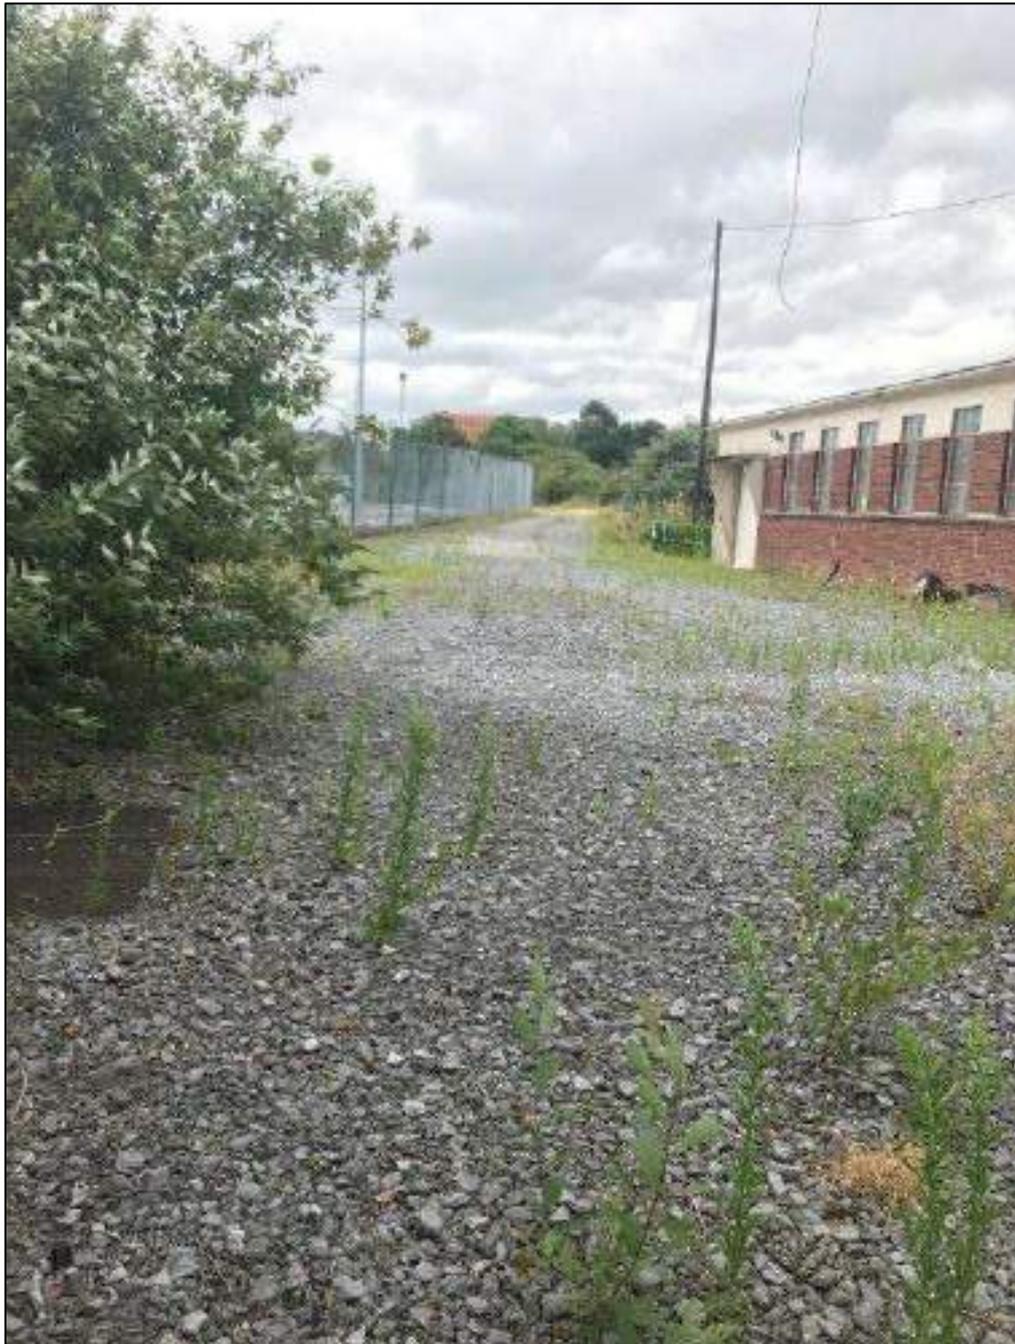
Photo 1: View south from Centre Park Road into ESB property.
Cable route is along the left of the gravel roadway near the chain link fence.

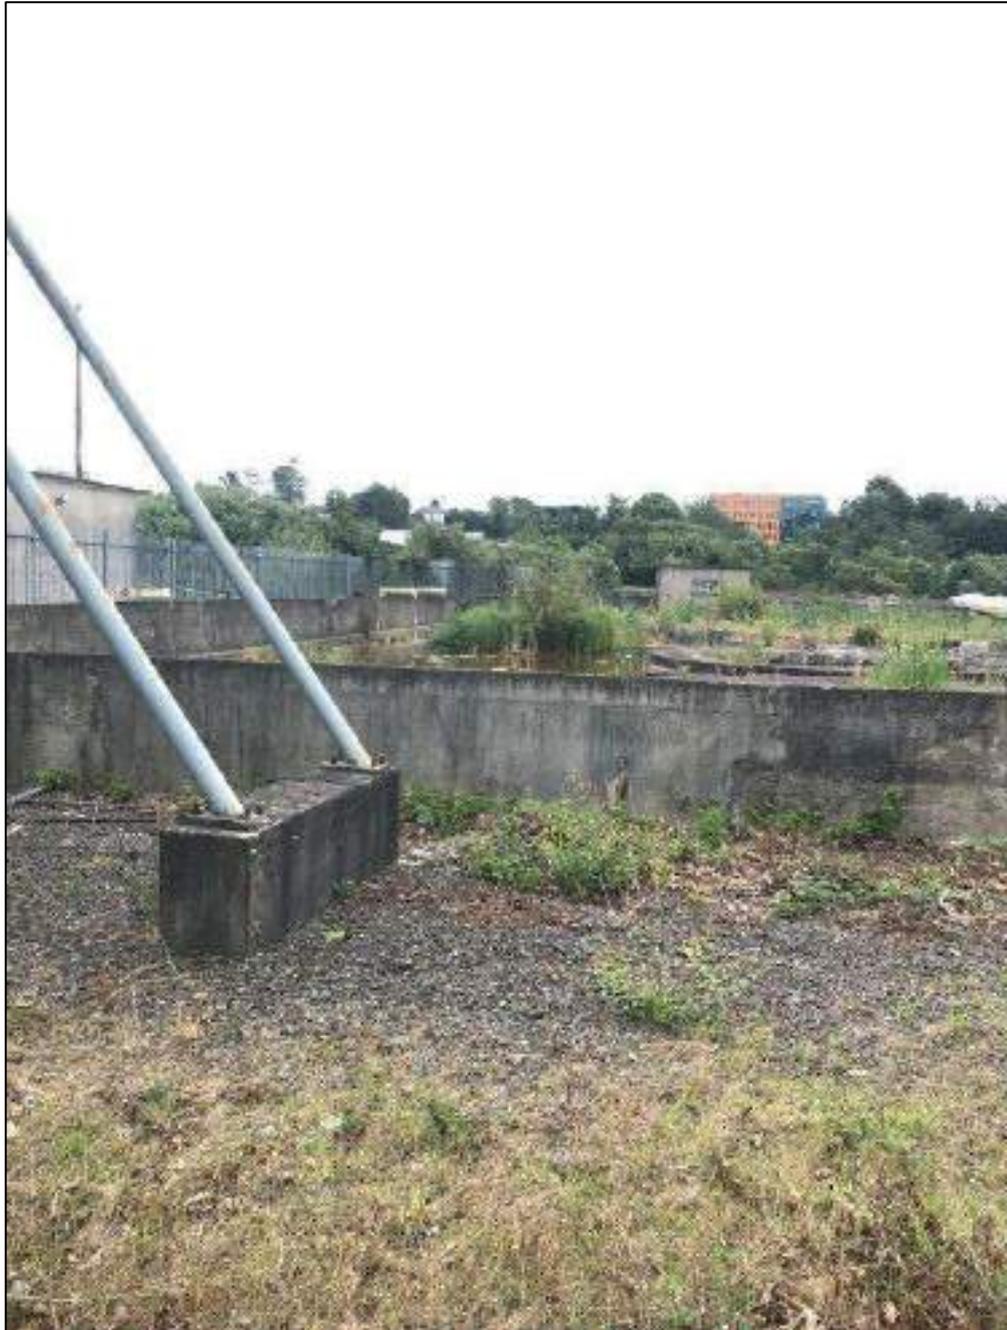
Photo 2: Area west of cable route south of Centre Park Road
Concrete bunds in area of former fuel tanks and pipelines

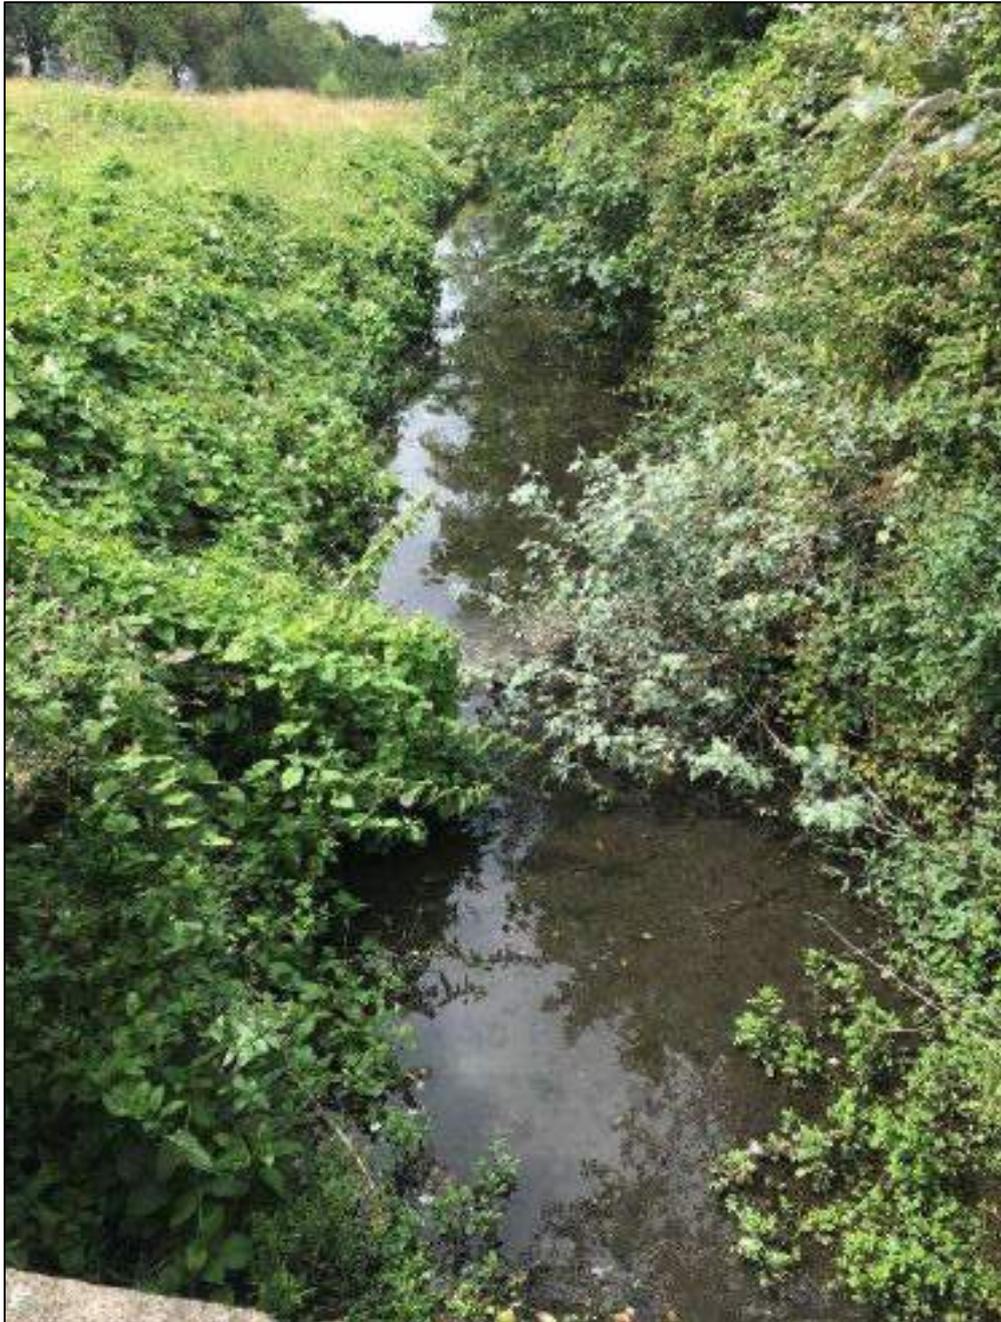
Photo 3: Watercourse that drains along the southern boundary of the ESB property and cable route.
Clear, low flowing water that drains in a north easterly flow direction

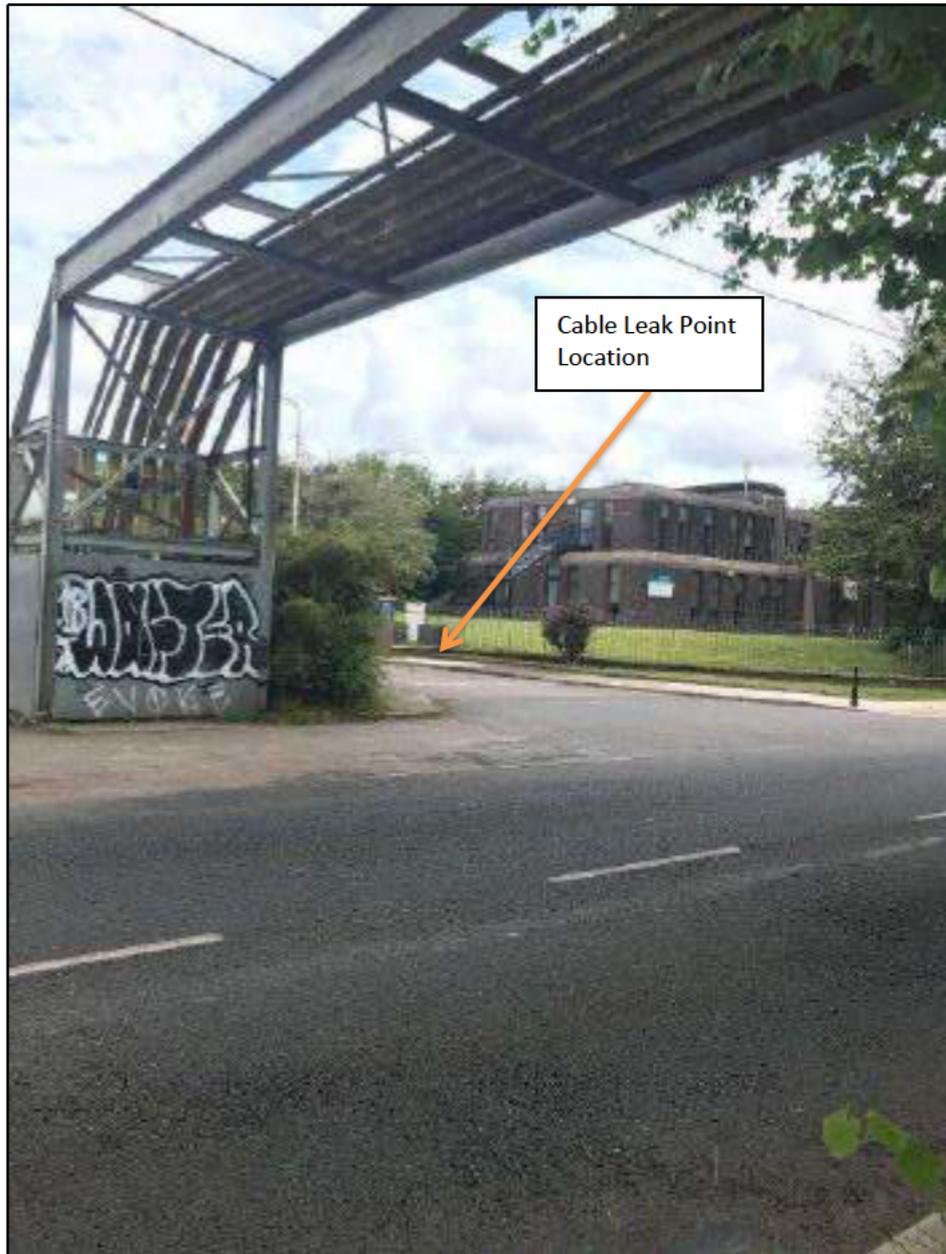
There is no physical evidence of hydrocarbon contamination on the surface in terms of oil odours/staining or impact to vegetation with healthy looking trees and hedges.

Photo 4: View of Cable Leak Point north of Centre Park Road.

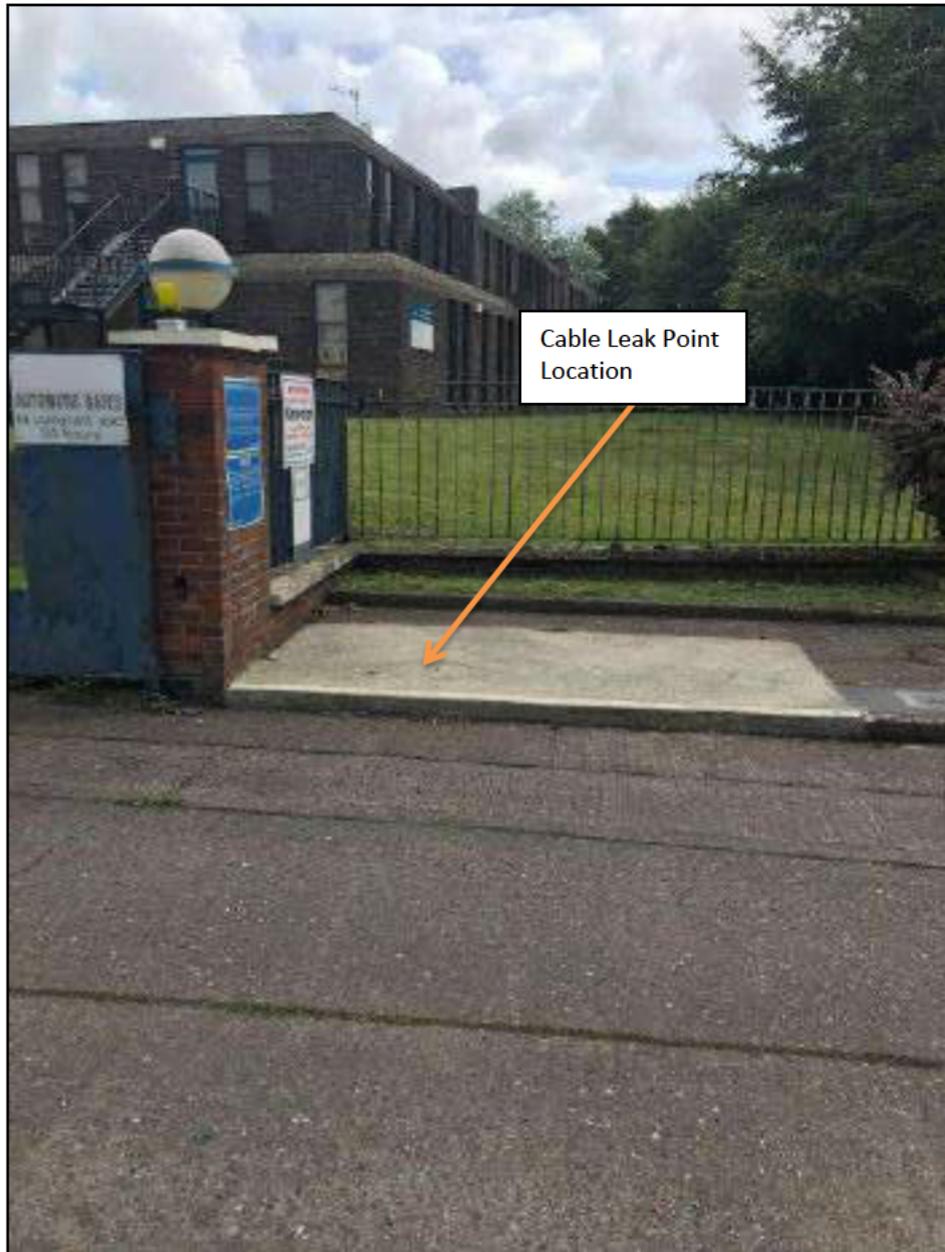
Photo 5: Location of Cable Leak Point on area of fresher footpath concrete. OPW offices in background.

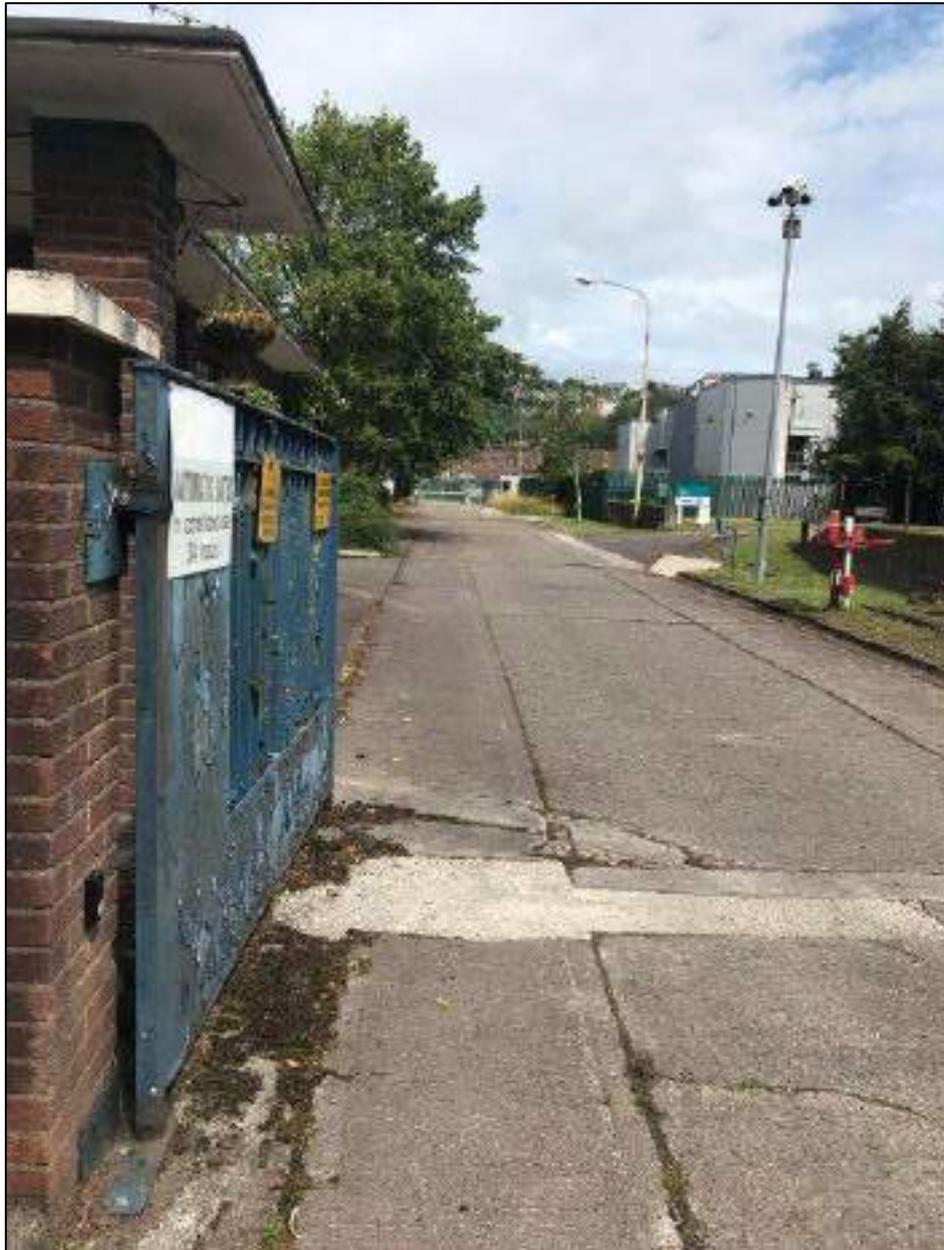
Photo 6: View north from Centre Park Road into ESB property.
Cable route is along the concrete roadway north to the ESB Building in the foreground.

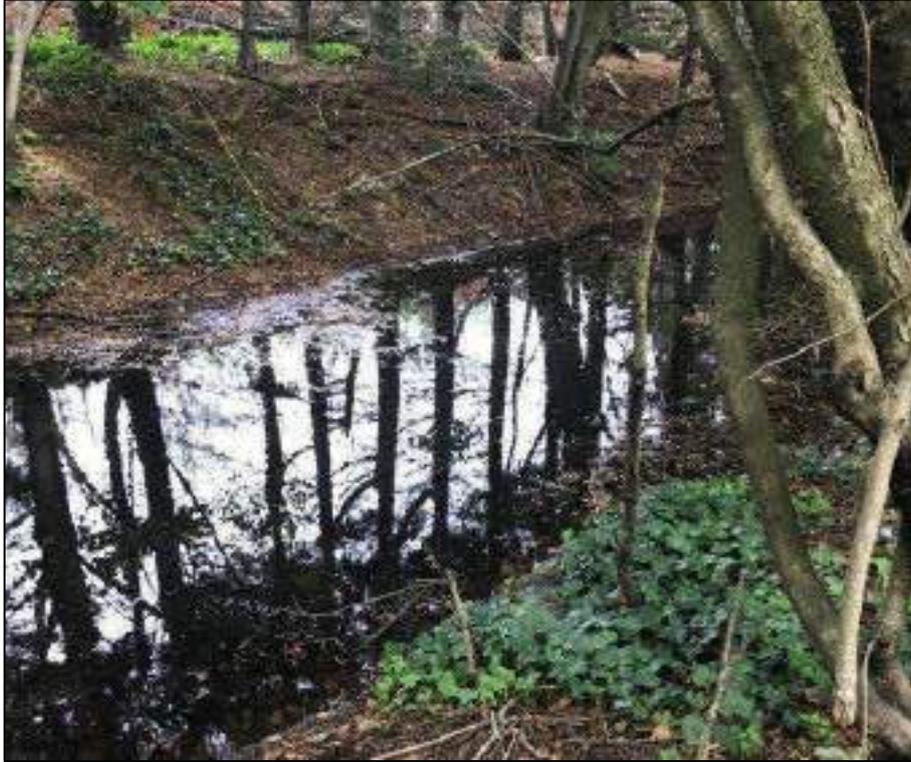
Photo 7: Watercourse approximately 150m east of leak point, north of centre park road (clear water, low flow).

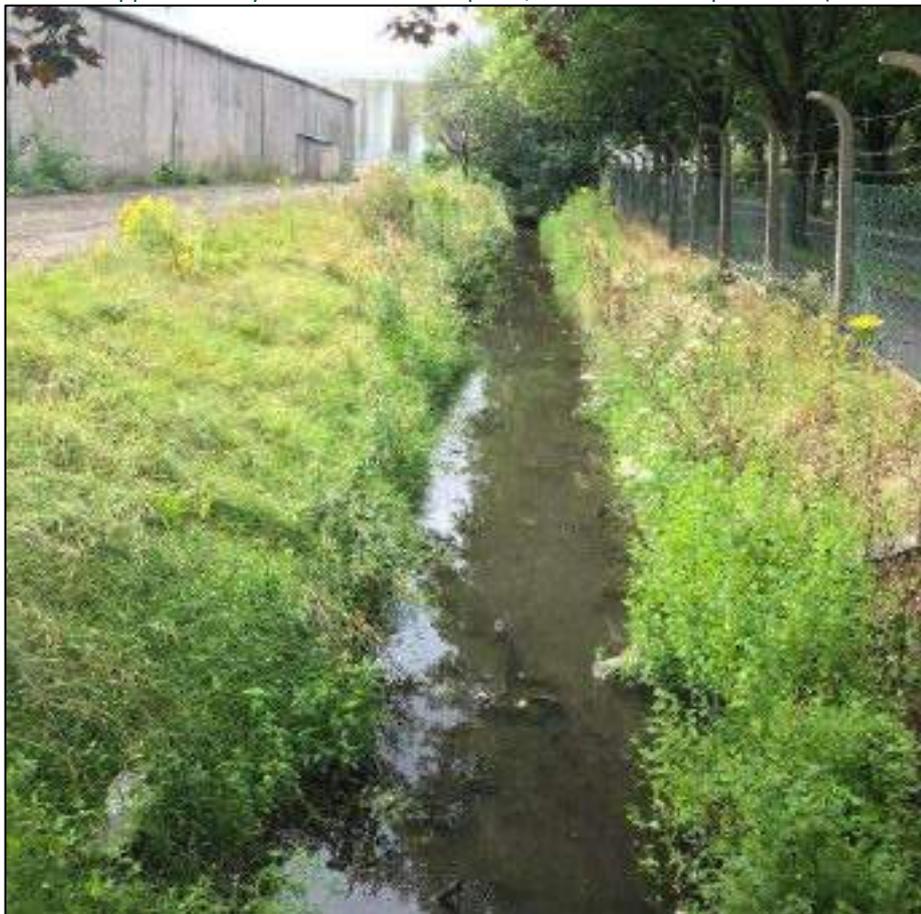
Photo 8: Watercourse approximately 150m east of leak point, south of centre park road (clear water, low flow).
