# **Preliminary Site Assessment**

Site 30 Francis Street - Inchicore 110 kV (July 2010)

**Electricity Supply Board**

Project number: PR-427640\_ACM\_RP\_ENV\_043\_2

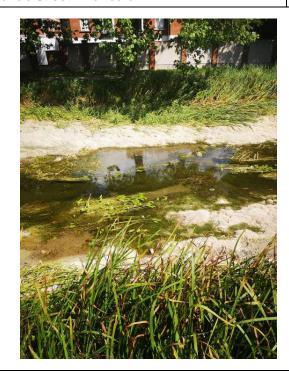
The Grand Canal located directly north of the APEC and running east and west along the cable route.
Residential Housing is located on the northern side of the Canal.

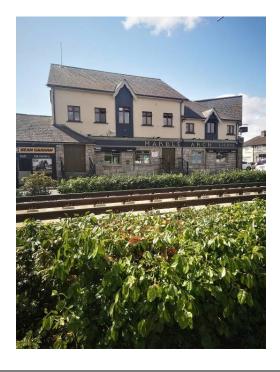
Red Line Luas tracks and the Marble Arch Pub located on the southern side of the APEC along the Davitt Road.

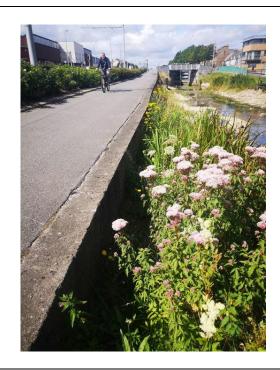
Tow path looking west from the APEC. The Grand Canal runs along the APEC and the ESB cables are beneath the tow path.

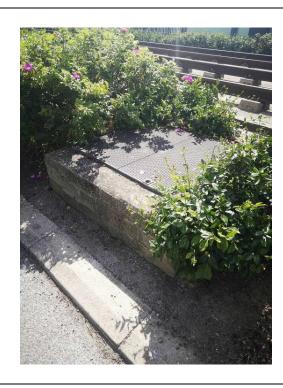
Services located immediately south of the APEC and along Luas track.

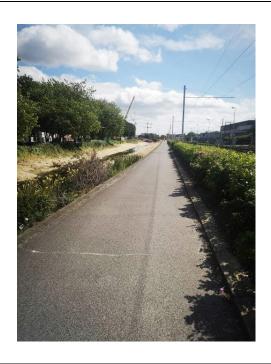
Tow path looking east from the APEC. The Grand Canal on the left runs along the APEC and the ESB cables are beneath the tow path.

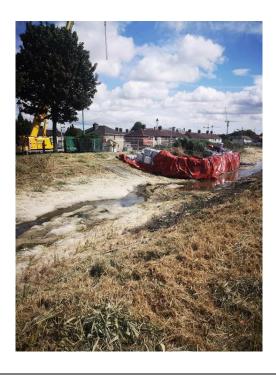
No evidence of impact from the cable fluid release was noted during the site walkover. Construction works were observed directly on the banks of the canal during the site walkover and the water levels in the canal were reduced.

Construction works at the eastern boundary of the site. Showing reduced water levels in the canal, presumed to be associated with construction works.

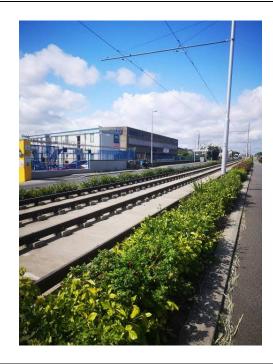
Light industrial units to north of Cable Route.

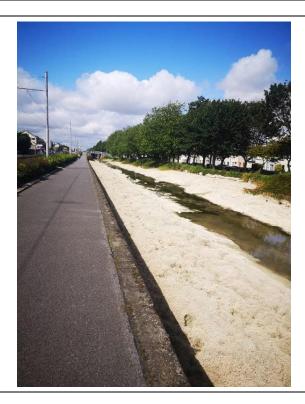
Description:
View west along the
Grand Canal from the
eastern boundary of the
site along the cable route.

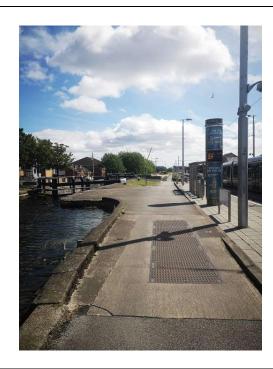
Description
West of the APEC
along the cable route,
the second Lock along
the Grand Canal, with
the tow pass and the
Goldenbridge Luas
Stop

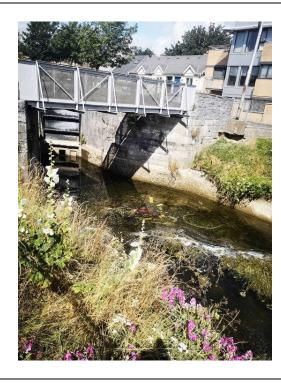
Second lock to the west of the APEC.

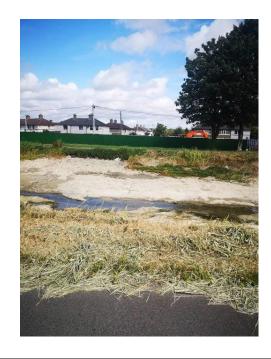
**Description**Residential housing north of the site.

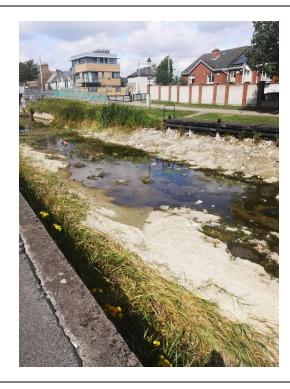
Grand Canal at western boundary of the site showing general litter.

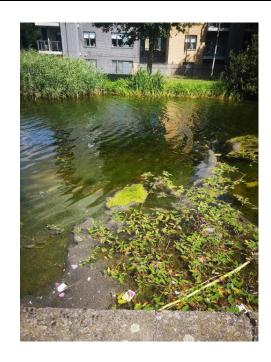
**Description**Vegetation and litter
within the Grand Canal
along the site
boundary.

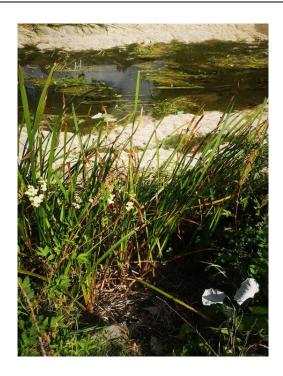
**Description:**Vegetation along the Grand Canal bank adjacent to the APEC.
