# Preliminary Site Assessment Report for Griffith Avenue, Dublin 9

ESB Site Ref: 5  
Ballymun - Fairview 38kV

March 2020

**Report Ref:** Stage 1 Preliminary Site Assessment Report for Griffith Avenue, Dublin 9. ESB Ref: 5 Ballymun - Fairview 38kV

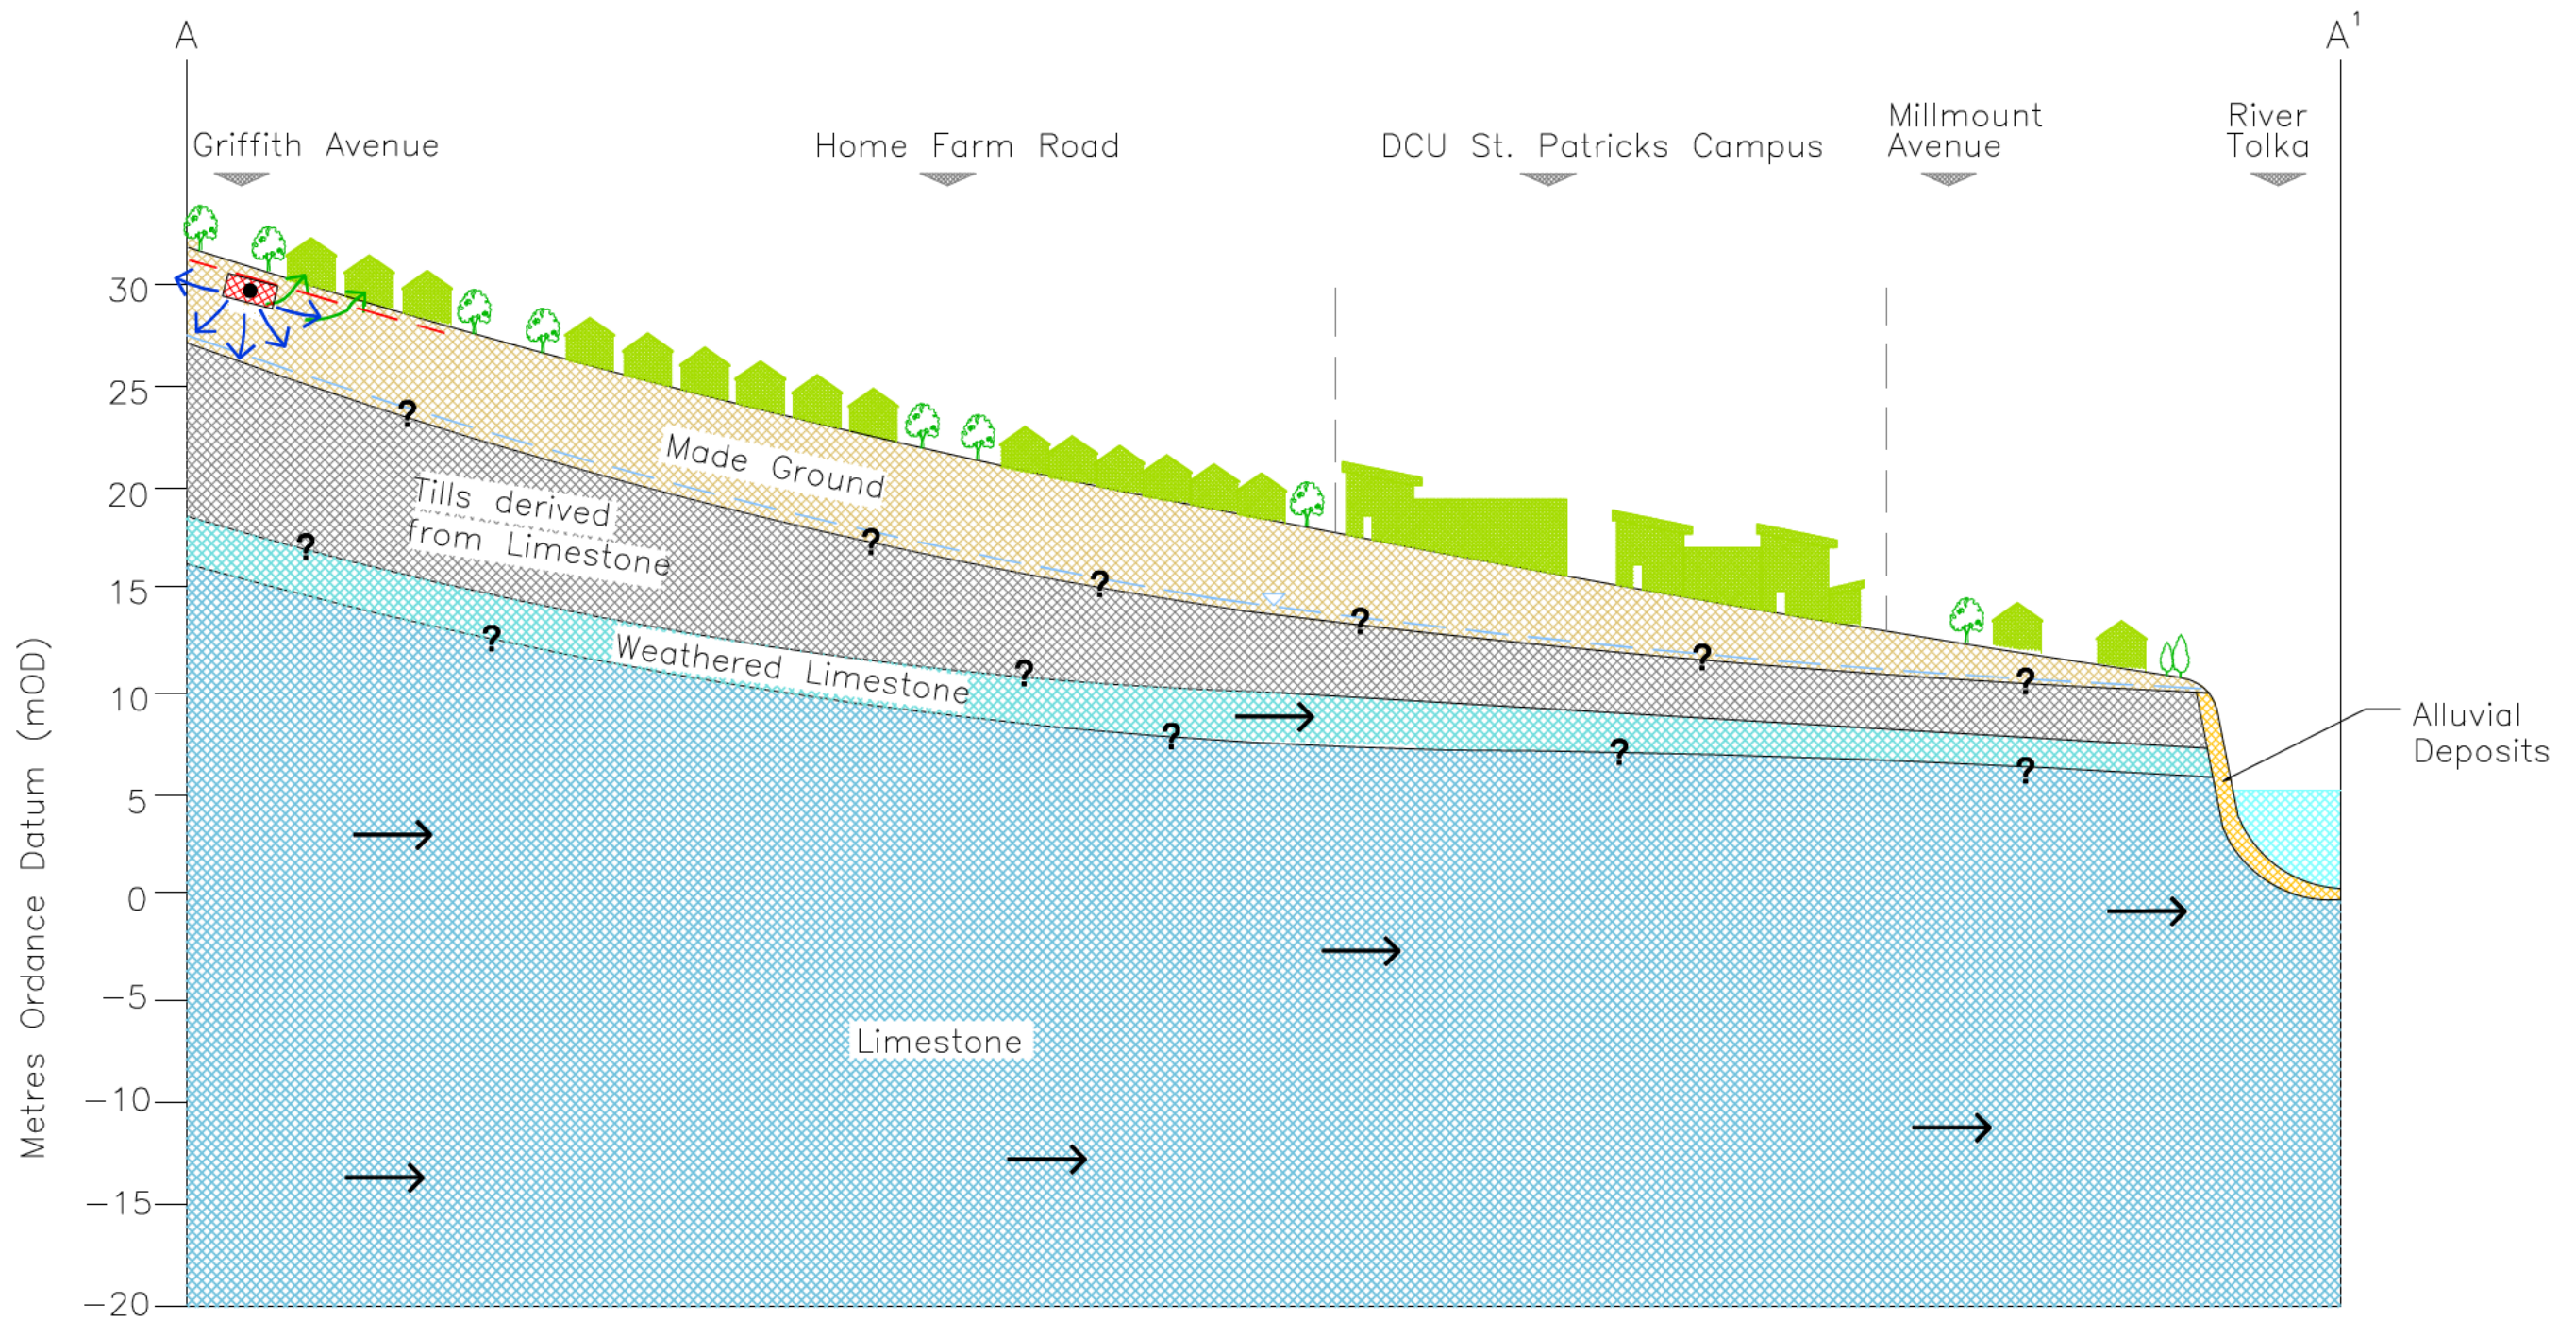
Figure 3 – Conceptual Site Model

Based on the known cable leak point, contaminant of potential concern (COPC) fate and transport and hydrogeological desk study information the CSM has the following initial key findings for human health and environmental risks;

- hydrocarbon vapours in preferential pathways such as service ducts to residents and other nearby building users.

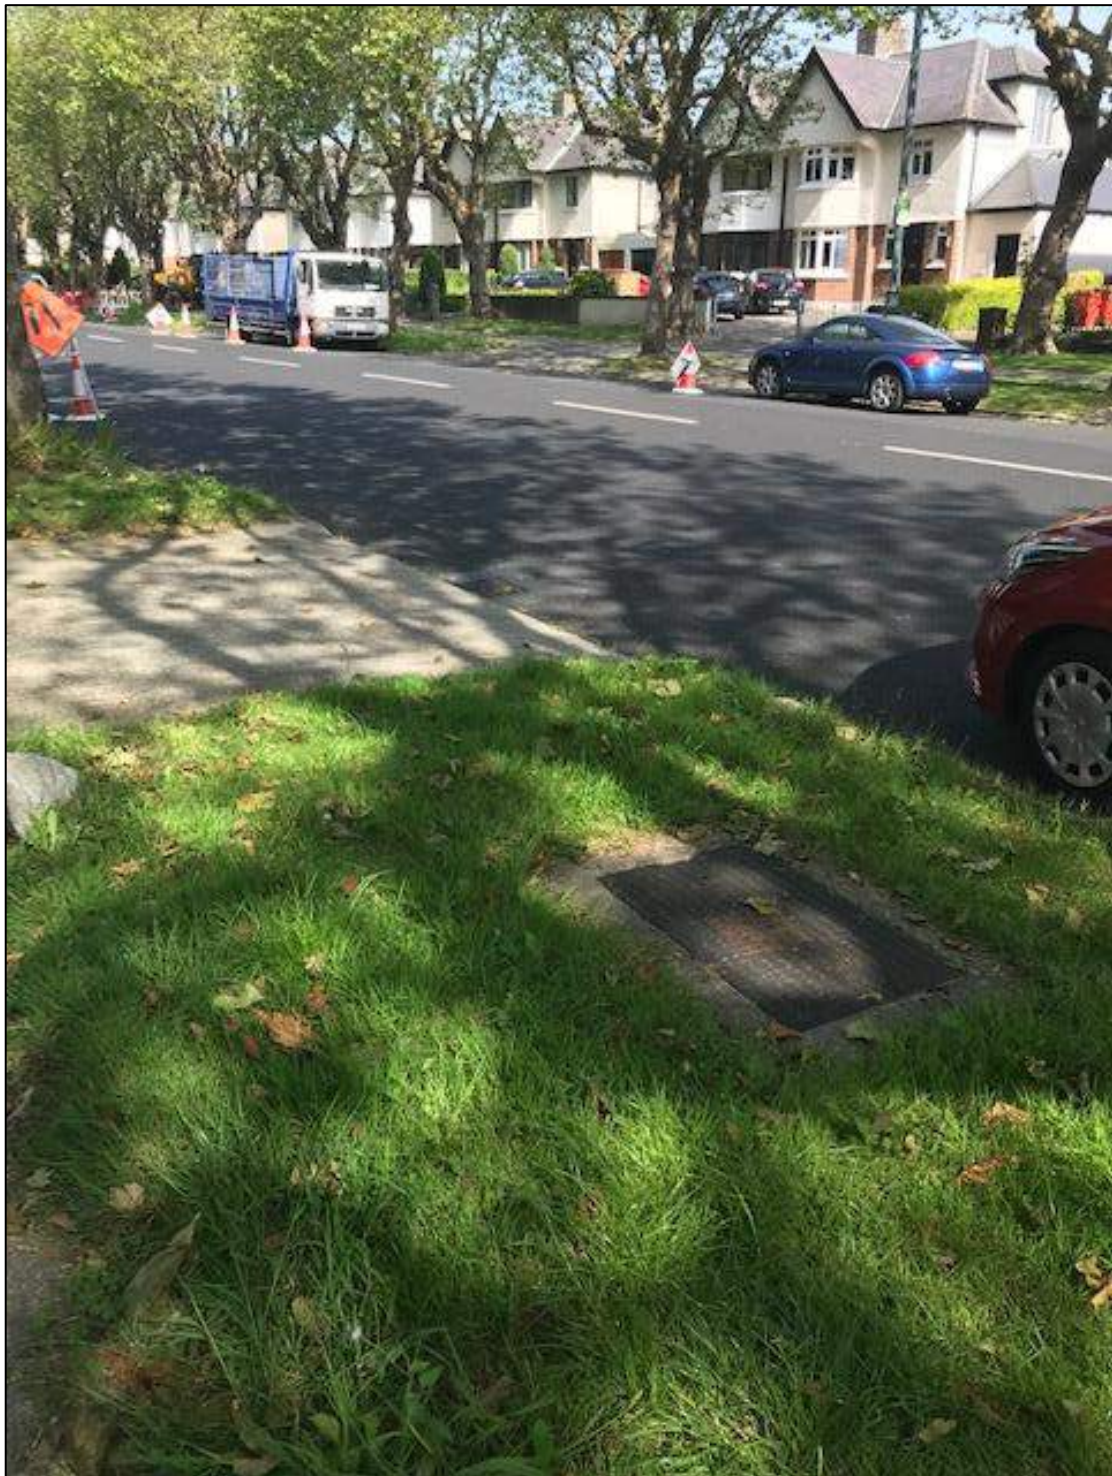
Photo 1: Approx 180m east of Leak Point - View to west. UPC services on grass verge

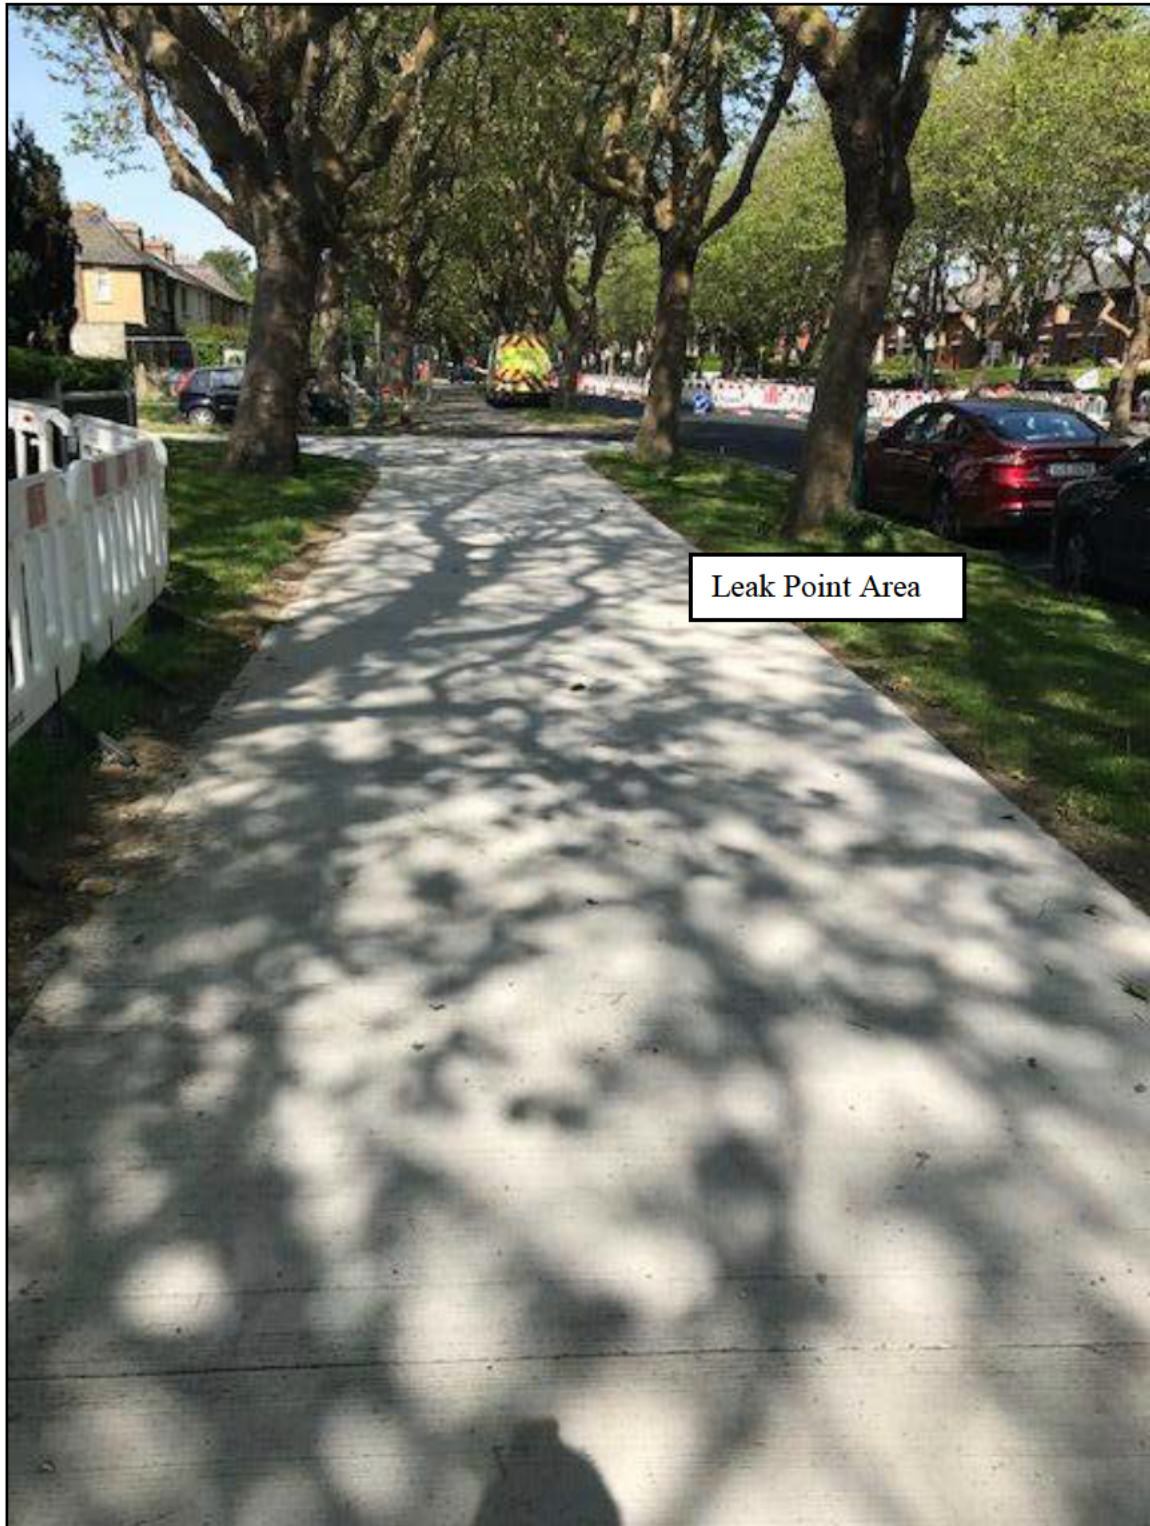
The cable leak point area and downgradient area are shown in Photograph 2 & 3 respectively in Appendix C. There is no physical evidence of hydrocarbon contamination on the surface in terms of oil odours/staining or impact to vegetation with healthy looking trees and hedges.

Photo 2: Leak point location in area next to new concrete footpath – abundant services in area

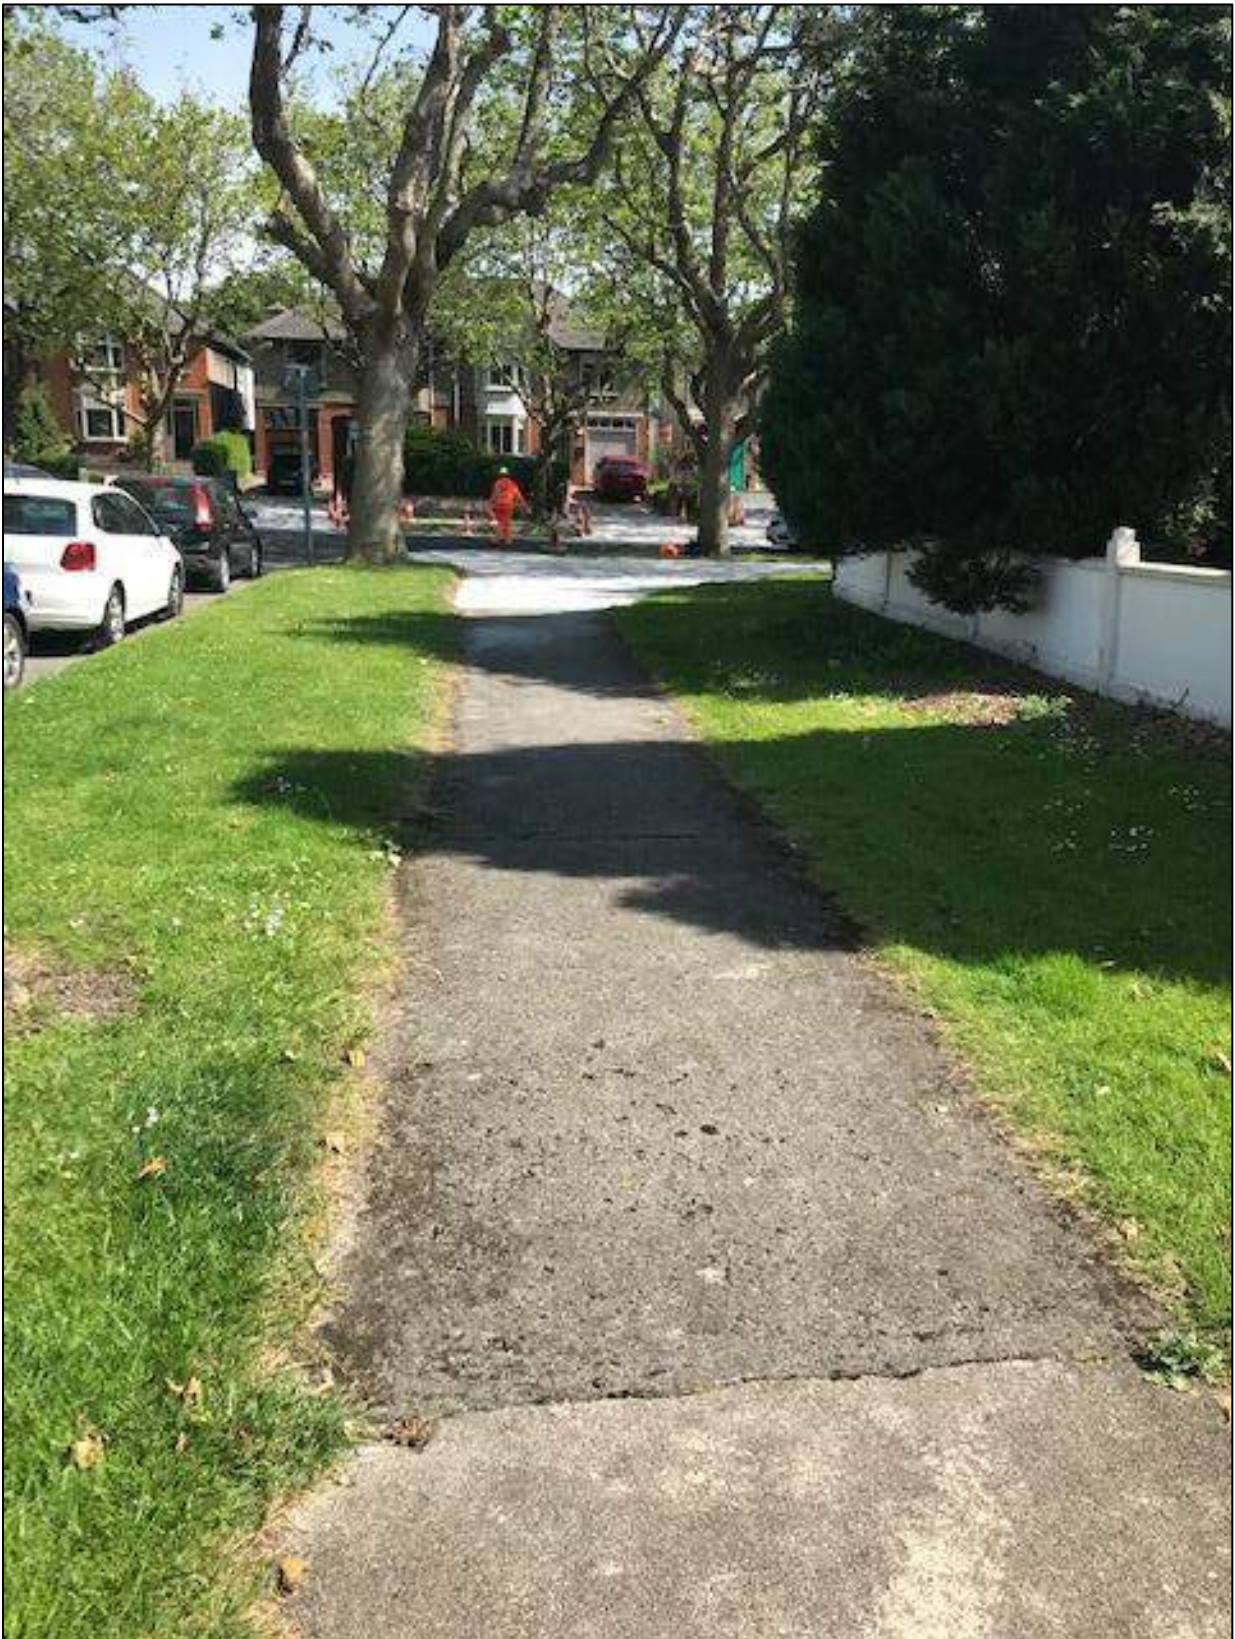
Photo 3: Area downgradient of leak point

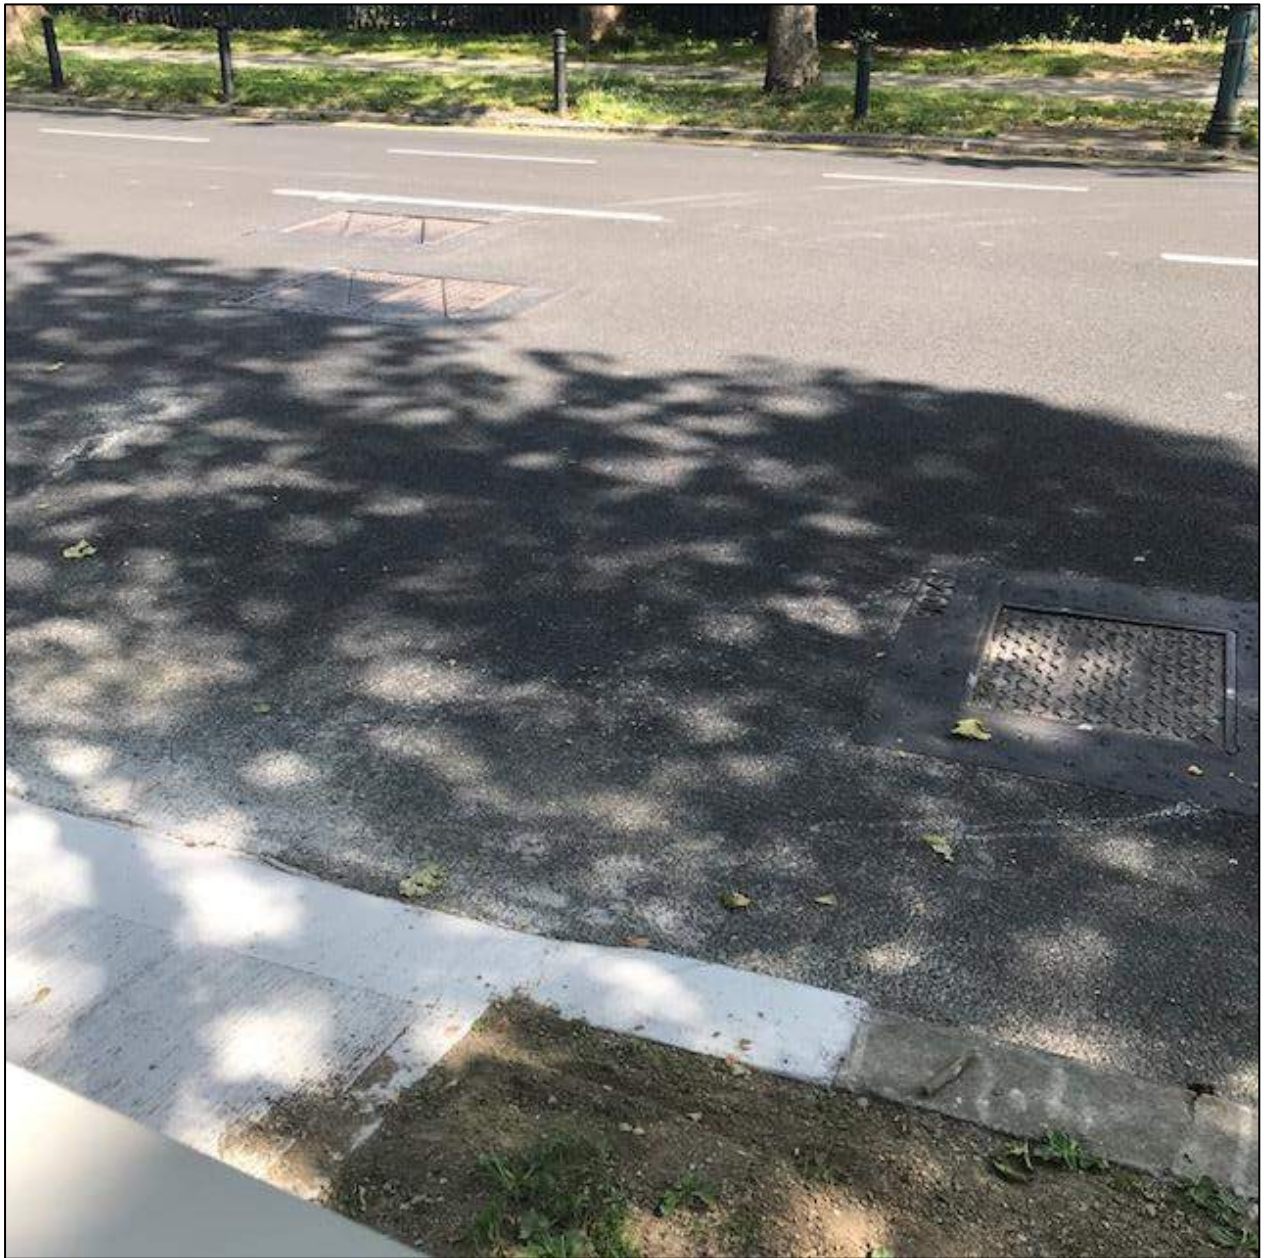
Photo 4: Approx 80m east of leak point. Abundant services on roadway next to ESB cable.  
Layby area available on the roadway verge for car parking.

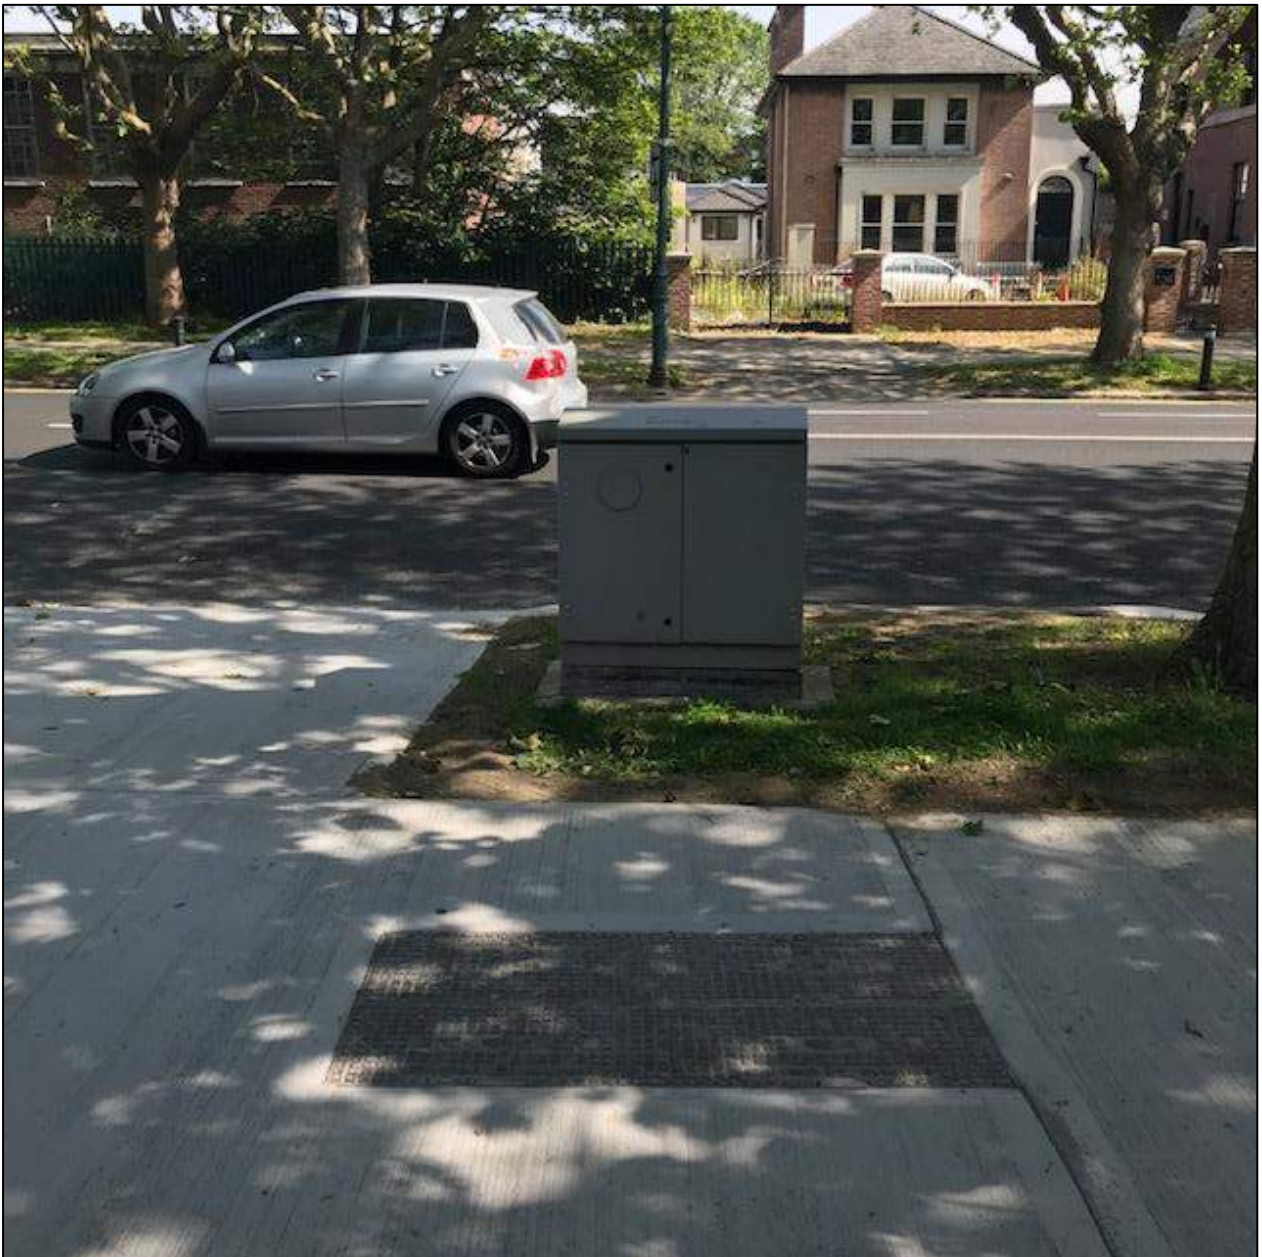
There is a grass verge adjacent to the roadway and ESB cable route, inside which is a concrete footpath which was being replaced at the time of the site walkover. There was evidence of abundant site services in the roadway, the grass verge and concrete footpaths with manhole covers and kiosks. Services in the area included sewers, road gully drains, water mains, telecom, UPC and ESB. There are several different service kiosks near the roadway consisting of ESB, traffic and others which are unknown, such as in Photograph 5 in Appendix C.

Photo 5: Approx 90m east of leak point. Kiosk location adjacent to ESB cable.

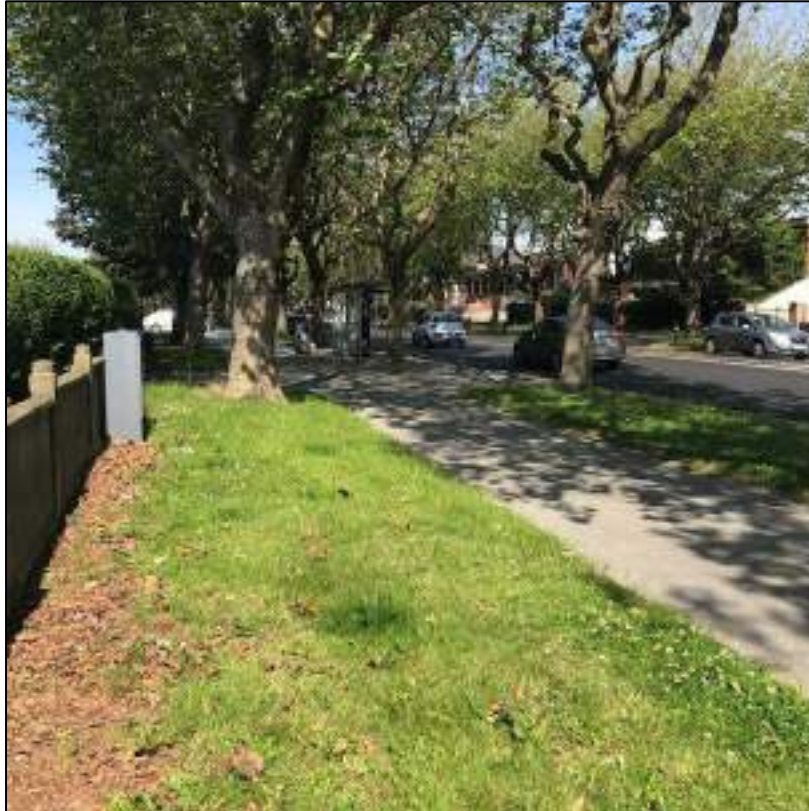
Photo 6: ESB Kiosk approx. 135m east of leak point.

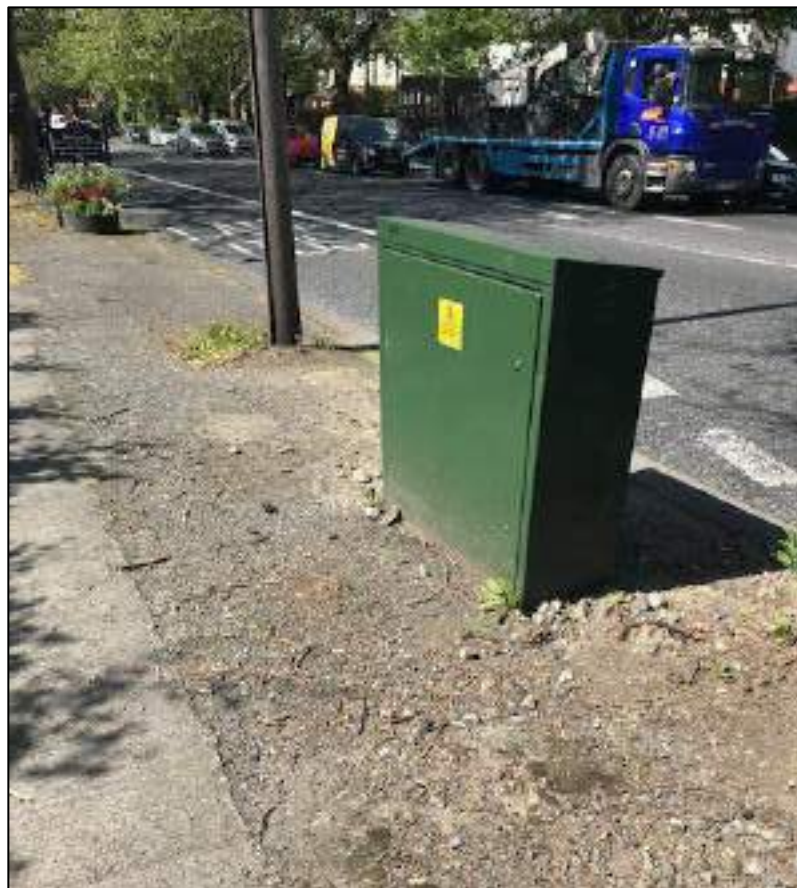
Photo 7: Green Kiosk approx. 180m east of leak point located on Drumcondra Road Upper near southern branch of ESB Cable
