# Preliminary Site Assessment Report for Monaghan Road, Cork City

ESB Site Ref: 51  
Marina – Trabeg Two 110kV

March 2020

**Report Ref:** Stage 1 Preliminary Site Assessment Report for Monaghan Road, Cork. ESB Ref: 51 Marina – Trabeg Two 110kV

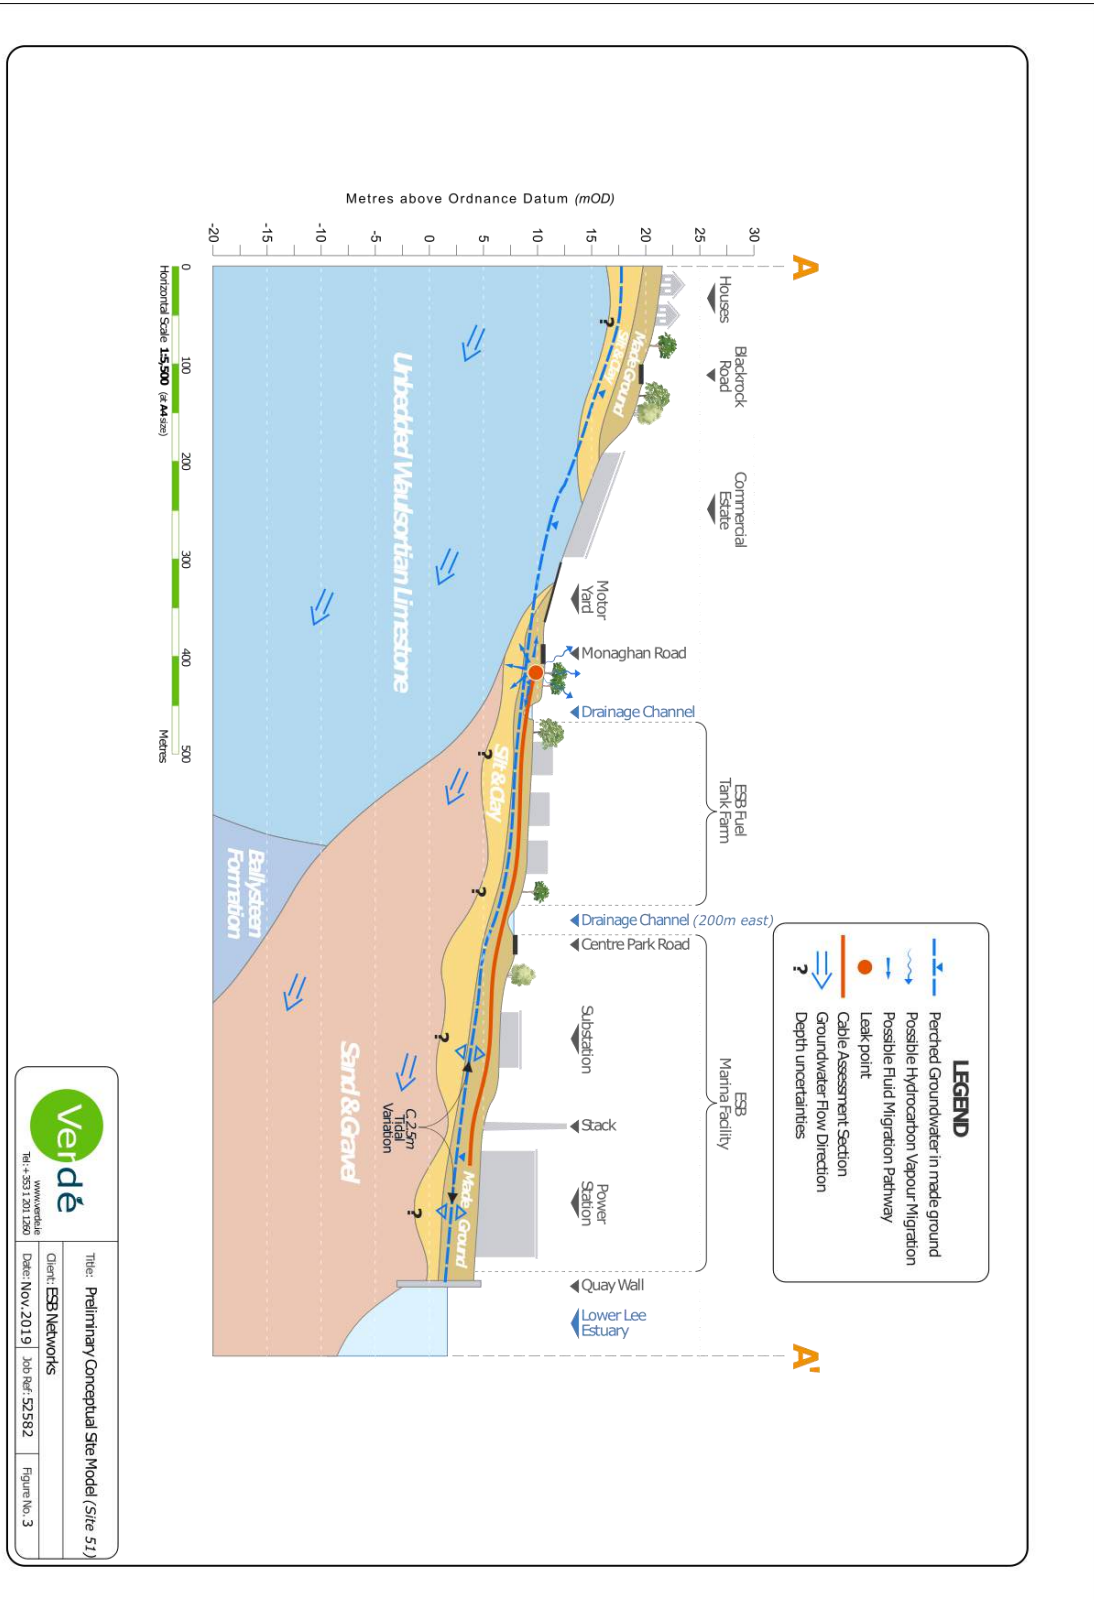
Figure 3 – Conceptual Site Model

Based on the known cable leak point, COPC fate and transport and hydrogeological desk study information the CSM has the following initial key findings for human health and environmental risks;

- direct dermal/inhalation and ingestion contact to residents or other building users;
- dermal/inhalation and ingestion pathways to construction workers, which can be managed by appropriate use of PPE and H&S procedures;
- ingestion contact with suspected contamination in the soil and groundwater through permeation of contamination through plastic water pipes or through low-pressure infiltration of possible soil contamination into water pipes via nearby breaks or leaks;
- hydrocarbon/COPC vapours in preferential pathways such as services ducts to nearby building users;

- Leaching to shallow groundwater given the contaminant properties of low mobility and high sorption to soil, with shallow groundwater unlikely to be a viable groundwater resource in the commercial urban and tidally influenced setting.
- COPC migration to the Atlantic Pond and Lee Estuary given the existence of a hydrogeological pathway between the leak site and the local drainage channels and the Atlantic Pond downstream.

COPC migration downwards to the underlying aquifer given the possible connection to shallow groundwater through shallow rock and gravels in the area indicated by the moderate to high vulnerability.

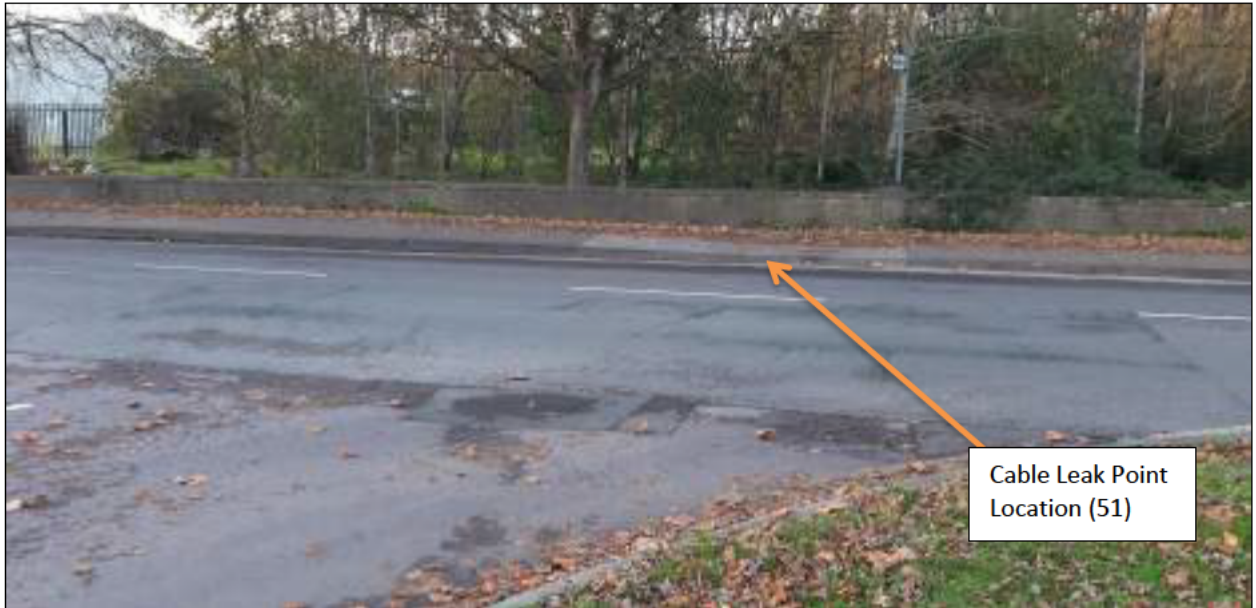
Photo 1: View north from Monaghan Road looking into section of concrete pathway that is associated with the leak point 51. Cable progresses north and west from this point. Note green area in background extends for c.50m to north where drainage channel is located.

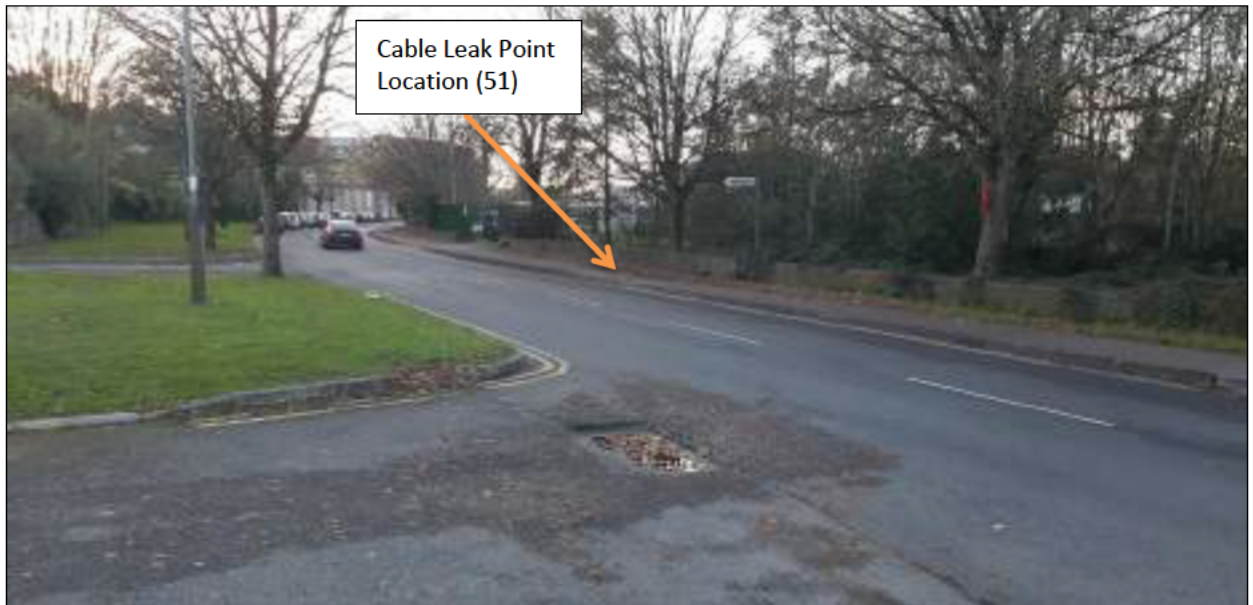
Photo 2: Looking west from entrance to nearby office complex; view of Monaghan Road. Note that cable leak point is located under pathway.

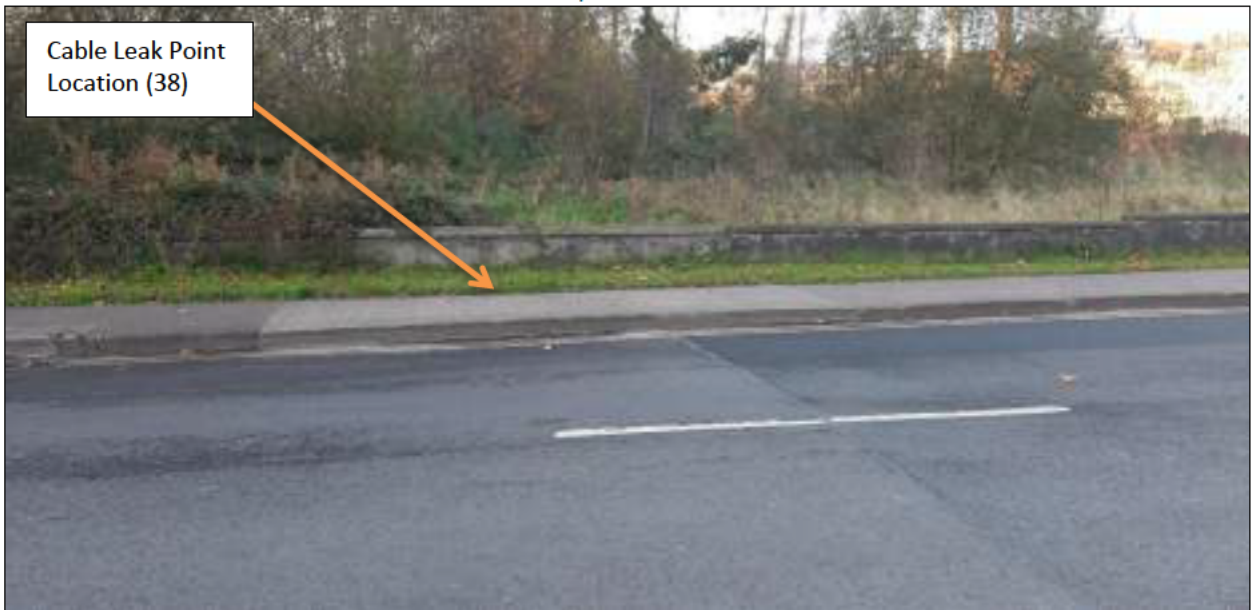
Photo 3: View north from Monaghan Road looking into section of concrete pathway that is associated with the leak point 38.

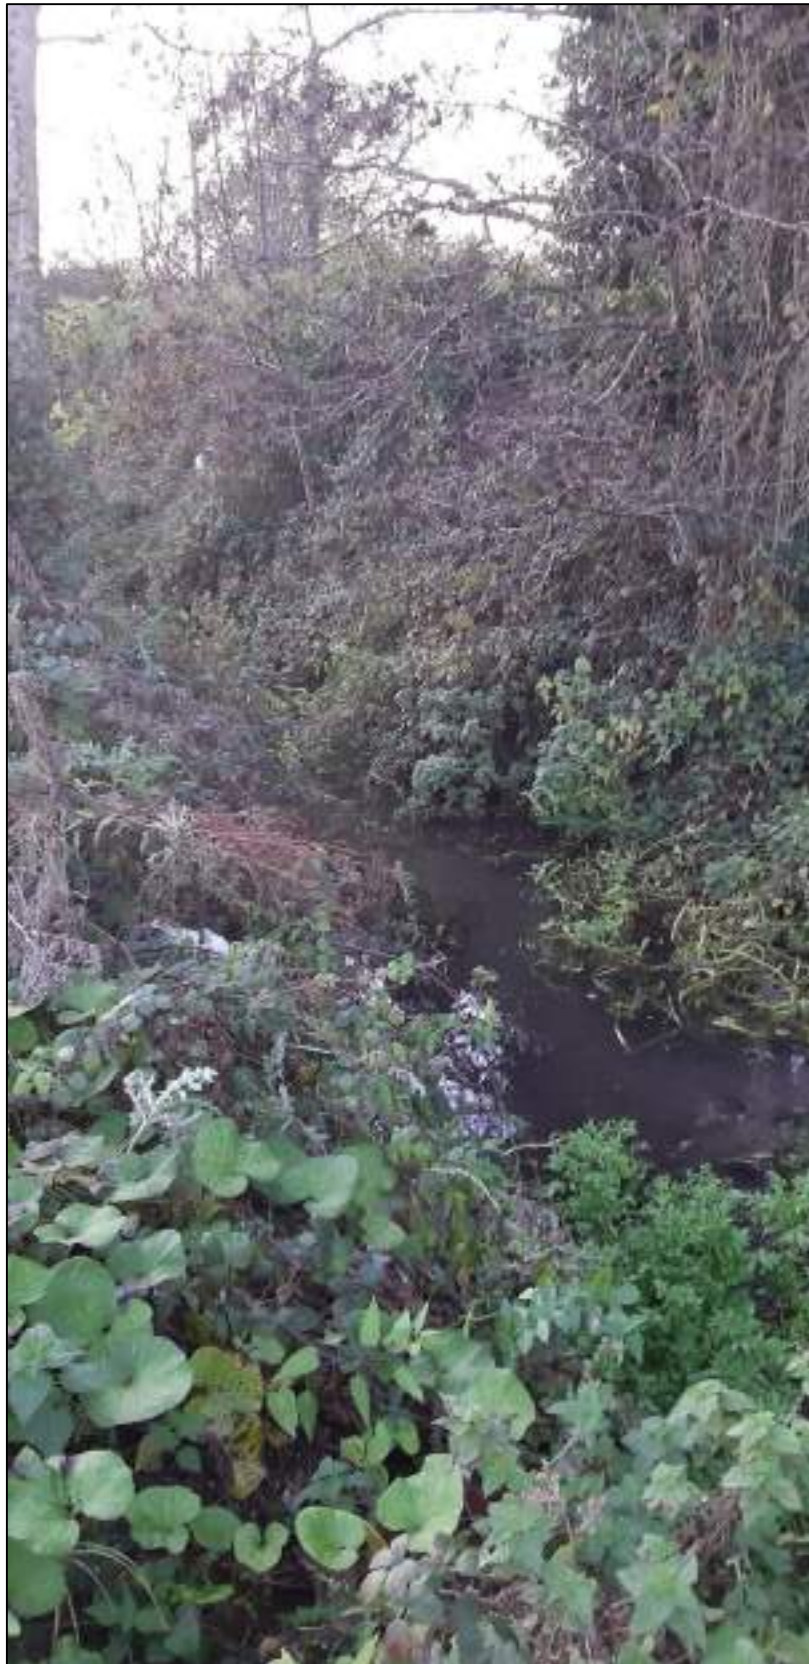
Photo 5: Image of drainage channel, looking west, located c.45m north of leak point. Note greyish-blue appearance of water and near-stagnant state of water.

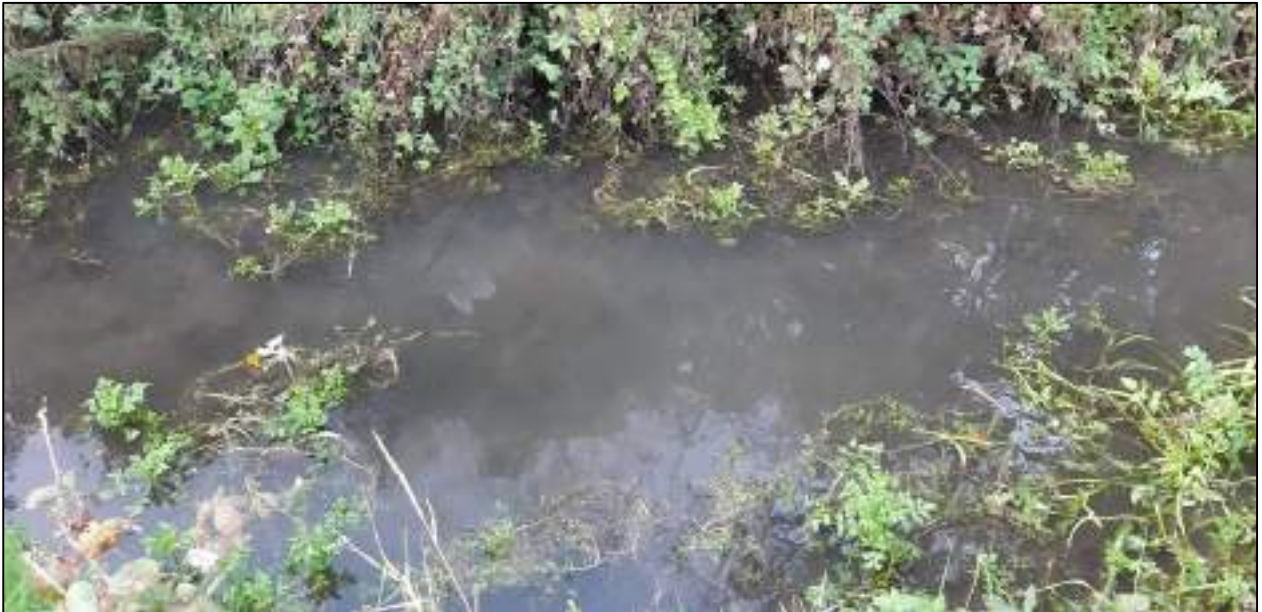
Photo 6: Image of nearest drainage channel, north of leak point, showing the poor water quality and stagnant water observed.

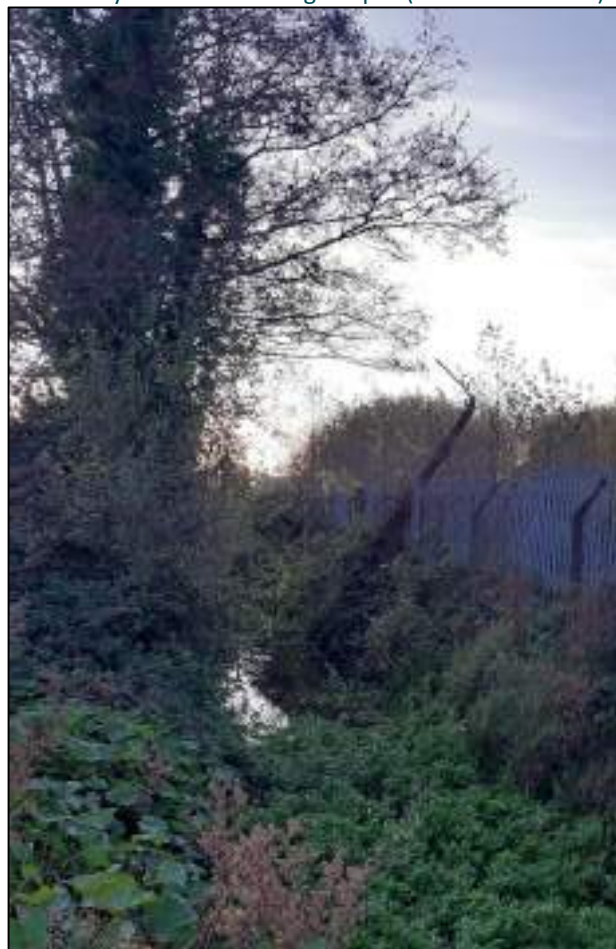
Photo 7: Image of nearest drainage channel north of leak point; looking west. Note the fence marks the rear boundary of the fuel storage depot (decommissioned).

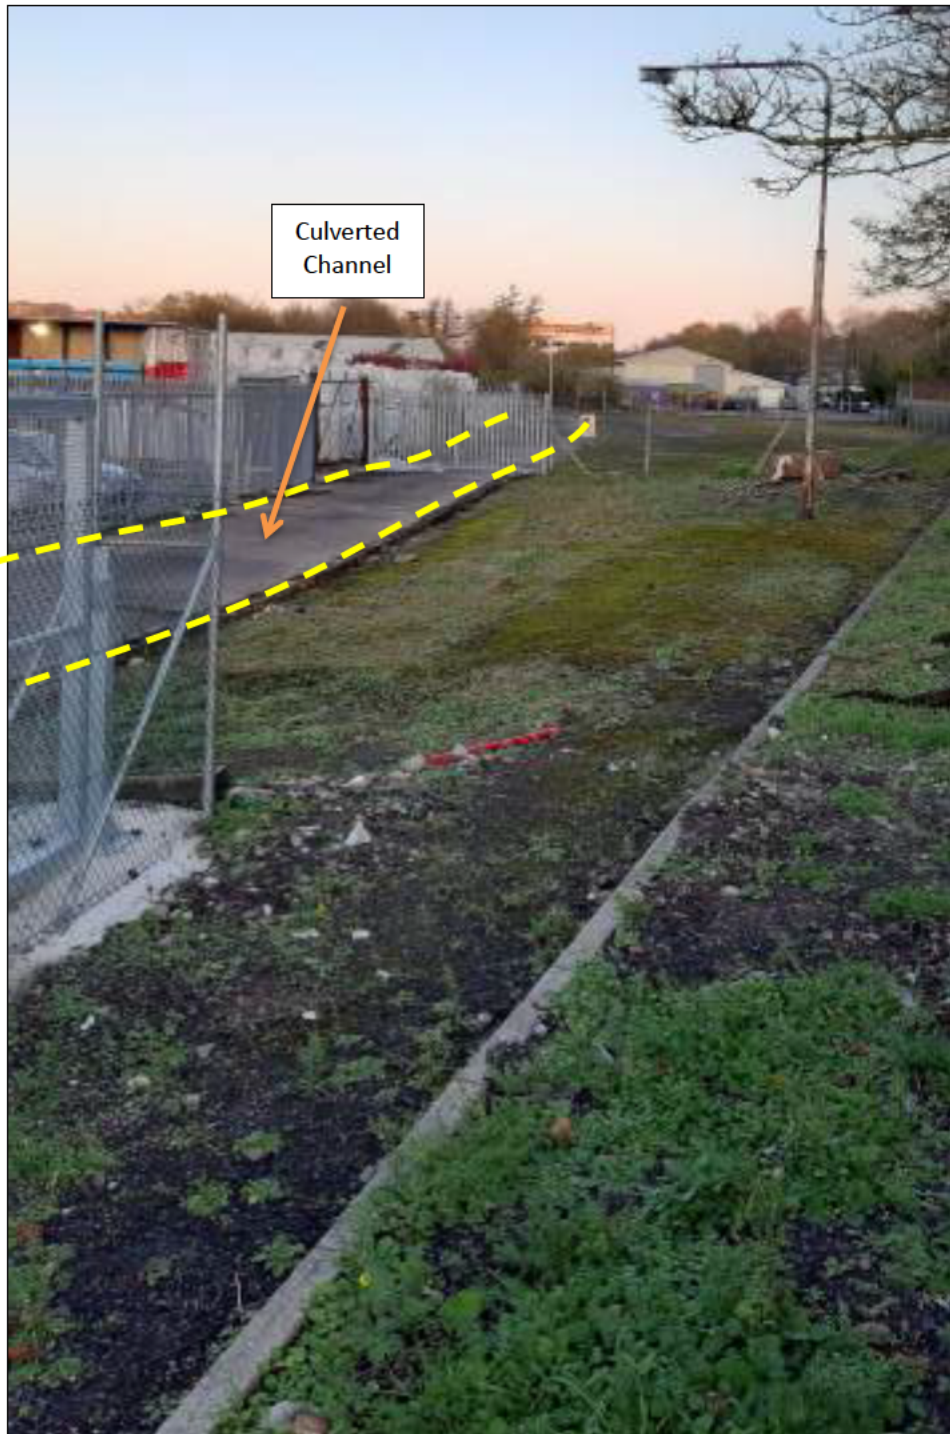
Photo 8: View, looking east, of a commercial property c.280m west of leak point, showing the concrete, culverted route of the drainage channel (flowing east). Note the Greenstar recycling facility in the far background.

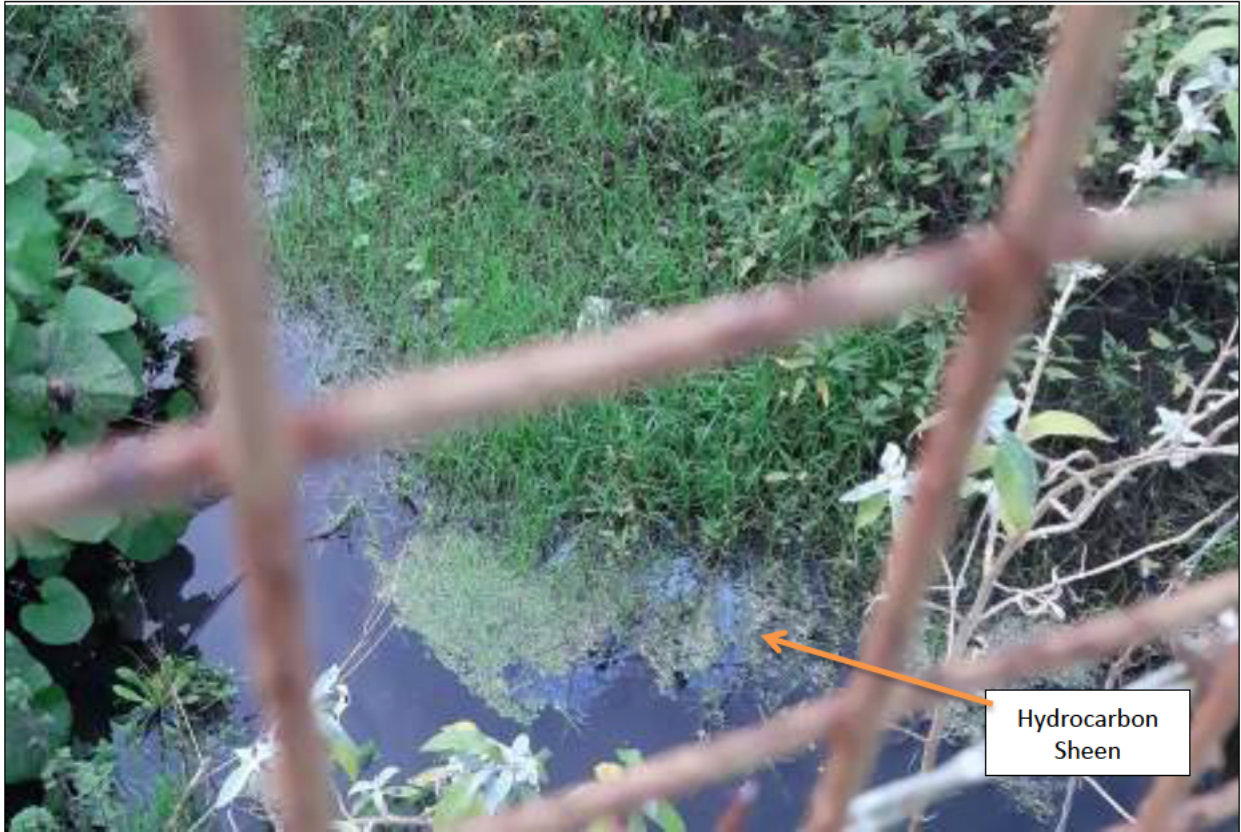
Photo 9: View of drainage channel at location of photo 8 (upstream); looking westward, showing occurrence of apparent hydrocarbon contamination in drainage waters. This contamination is not thought the related to the cable leak (as it is located upstream) and is likely related to surface water run-off from the adjacent Monaghan Road.

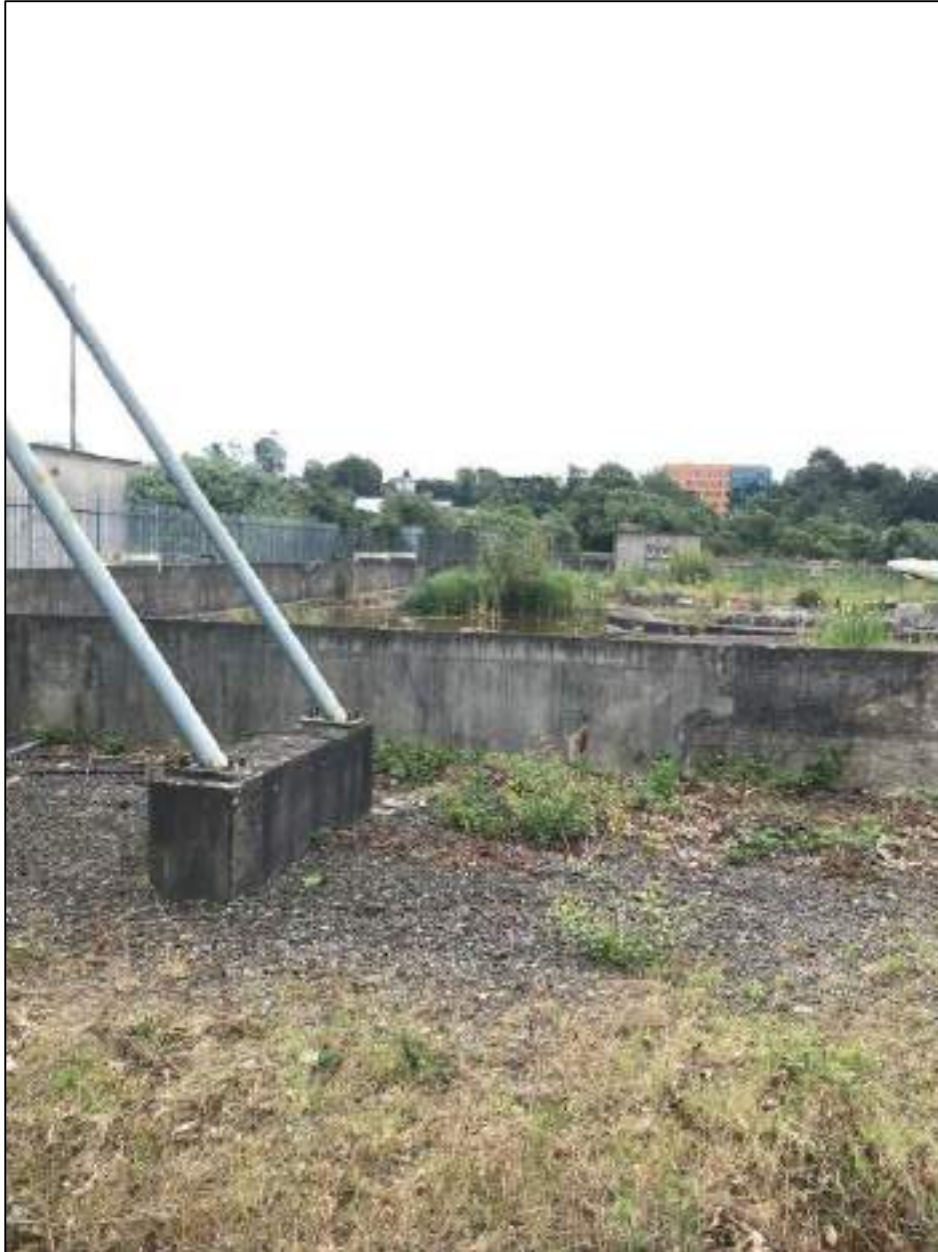
Photo 10: View from north side of decommissioned fuel storage depot on southern side of Centre Park Road. Note that the tree line in the background marks the boundary of the fuel facility and the location of the drainage channel. The 110kV cable runs along the left hand side of this image, towards the leak point.
