Preliminary Site Assessment Report for Fairhill – Wolfe Tone Street Cork City

ESB Site Ref: 56
Fairhill – Kilbarry 38 kV

April 2020

Project Title: ESB Networks Historic Fluid Filled Cable Loss
Environmental Assessment

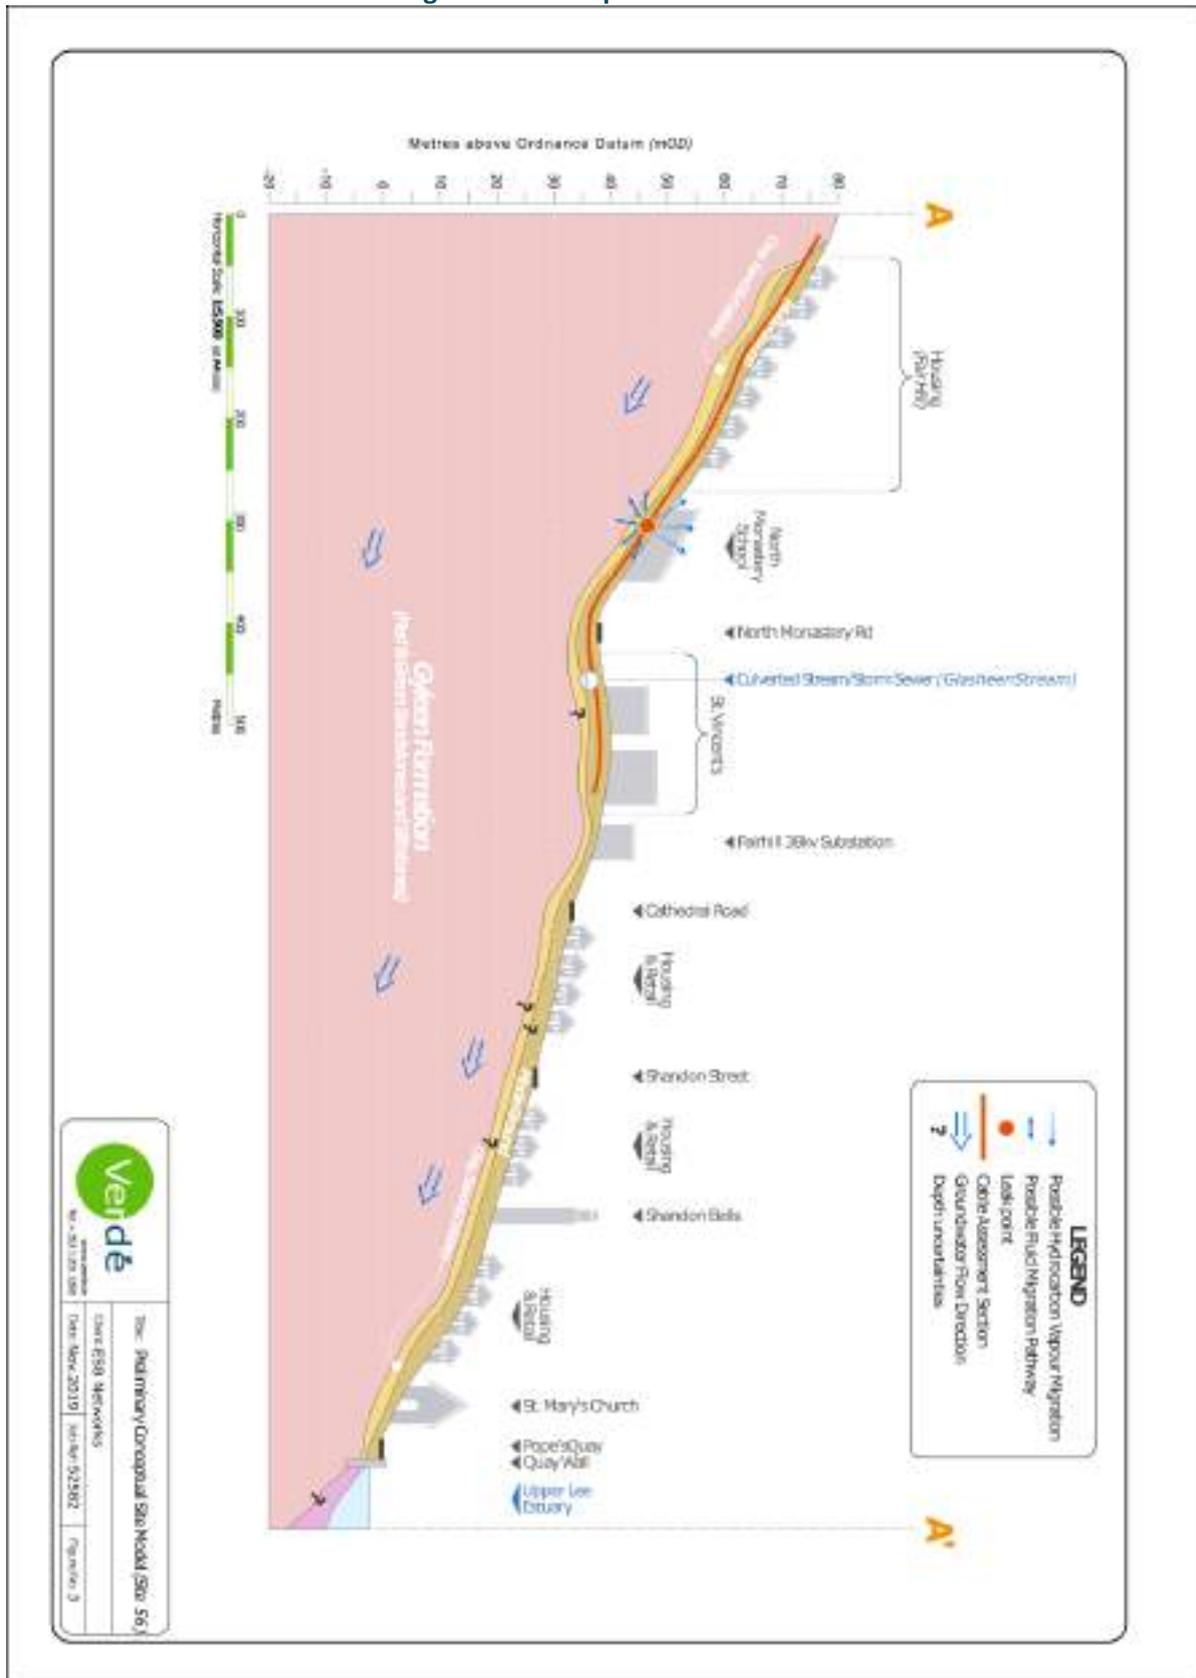
Figure 3 – Conceptual Site Model

Based on the known cable leak point, contaminants of potential concern (COPC) fate and transport and hydrogeological desk study information the CSM has the following initial key findings for human health and environmental risks;

- direct dermal/inhalation and ingestion contact to residents or other building users;
- dermal/inhalation and ingestion pathways to construction workers which can be managed by appropriate use of PPE and H&S procedures;
- ingestion contact with suspected contamination in the soil and groundwater through permeation of contamination through plastic water pipes or through low-pressure infiltration of possible soil contamination into water pipes via nearby breaks or leaks;

- leaching to shallow groundwater given the contaminant properties of low mobility and high sorption to soil, with rare shallow groundwater unlikely to be a viable groundwater resource in the residential urban setting.
- hydrocarbon migration to the adjacent watercourse/sewerage network and the downstream River Bride/Kiln and the Upper Lee Estuary given the downhill position of the culverted Glasheen Stream/storm sewer which poses a potential pollutant linkage between the leak site and downgradient surface water receptors.
- hydrocarbon vapours in preferential pathways such as services ducts to residents or other building users;

- hydrocarbon migration to the underlying aquifer given the possible connection to shallow groundwater or directly to bedrock through shallow rock in the area indicated by the high to extreme vulnerability.

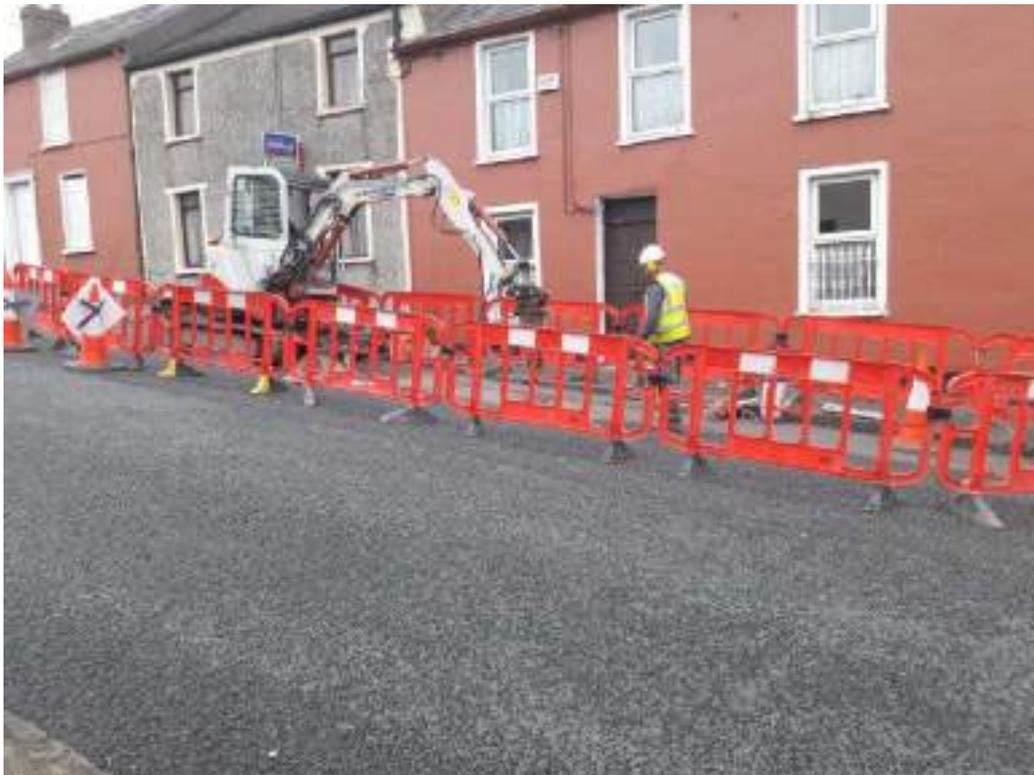
The leak point was located on the eastern side of the road as presented in Photograph 1 in Appendix C. On initial site walkover in May 2019, there was no physical evidence of hydrocarbon contamination on the surface in terms of oil odours/staining or impact to vegetation with healthy looking trees and hedges.

Photo 1 Cable route and location of known leak point (ESB Ref: 56) located on eastern side of Fair Hill.

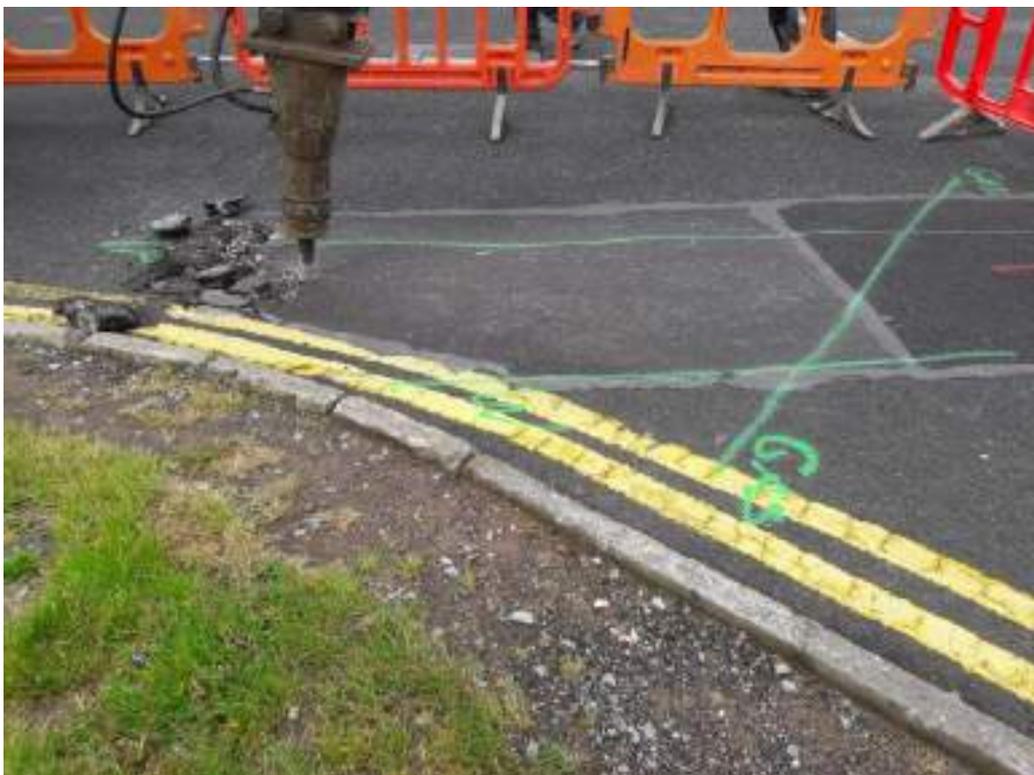
Photo 2 Location of gas and utility lines marked on road in preparation of trial pit works.

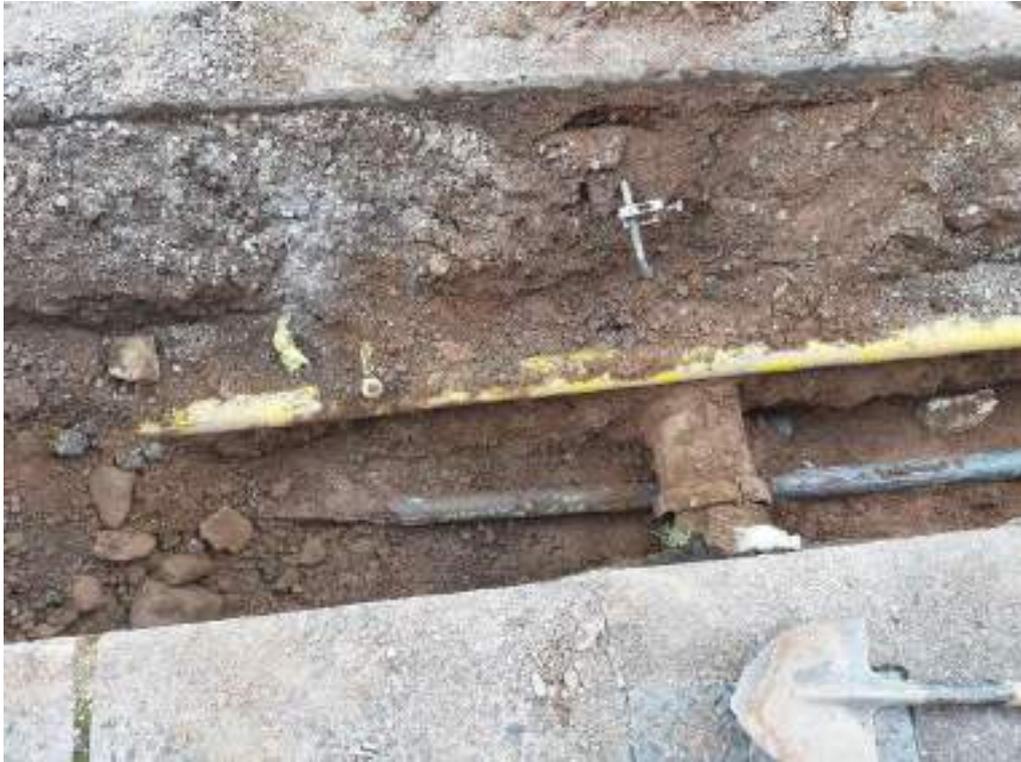
Photo 3 Occurrence of underground services during excavations. Gas, sewerage and communication ducts visible in image.

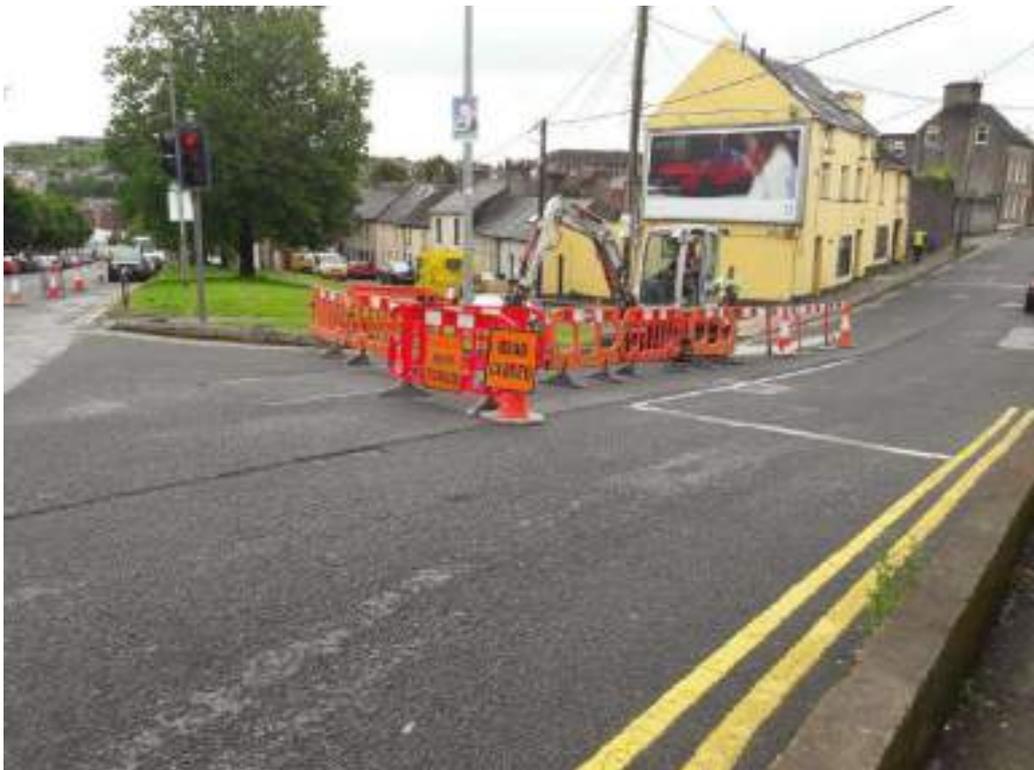
Photo 4 Location of known leak point on eastern side of Wolfe Tone Street. Trial pit works in progress.

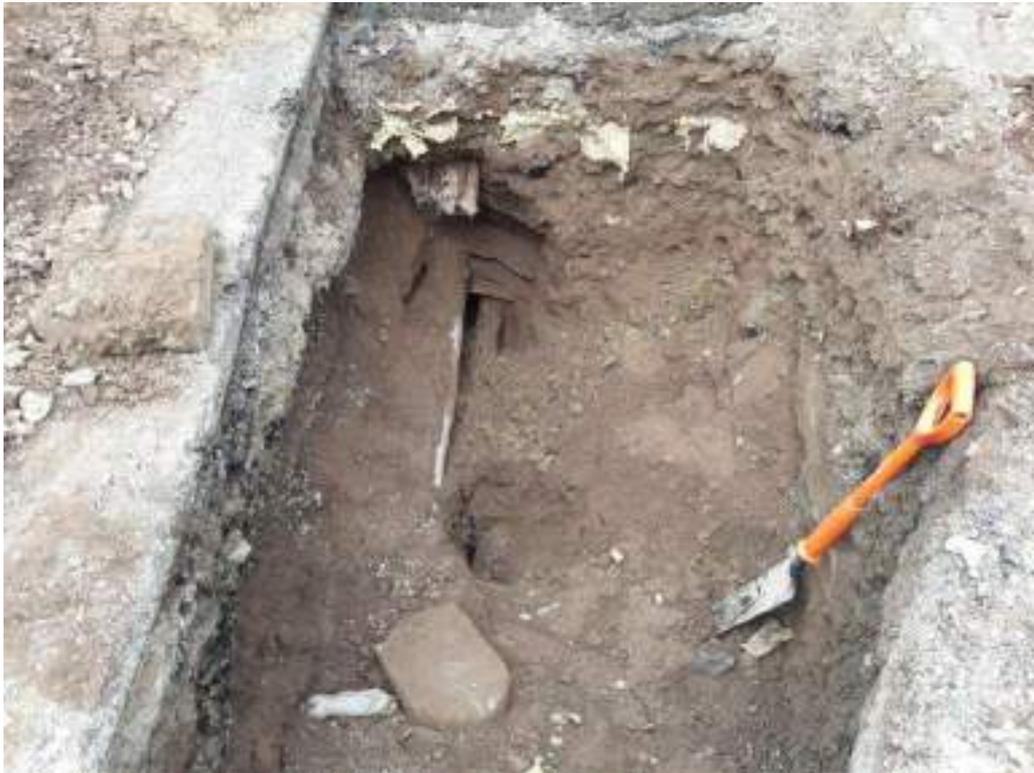
Photo 5 Trial pit and inspection hole works being completed at the location of the nearby known leak point (ESB Ref: 2)

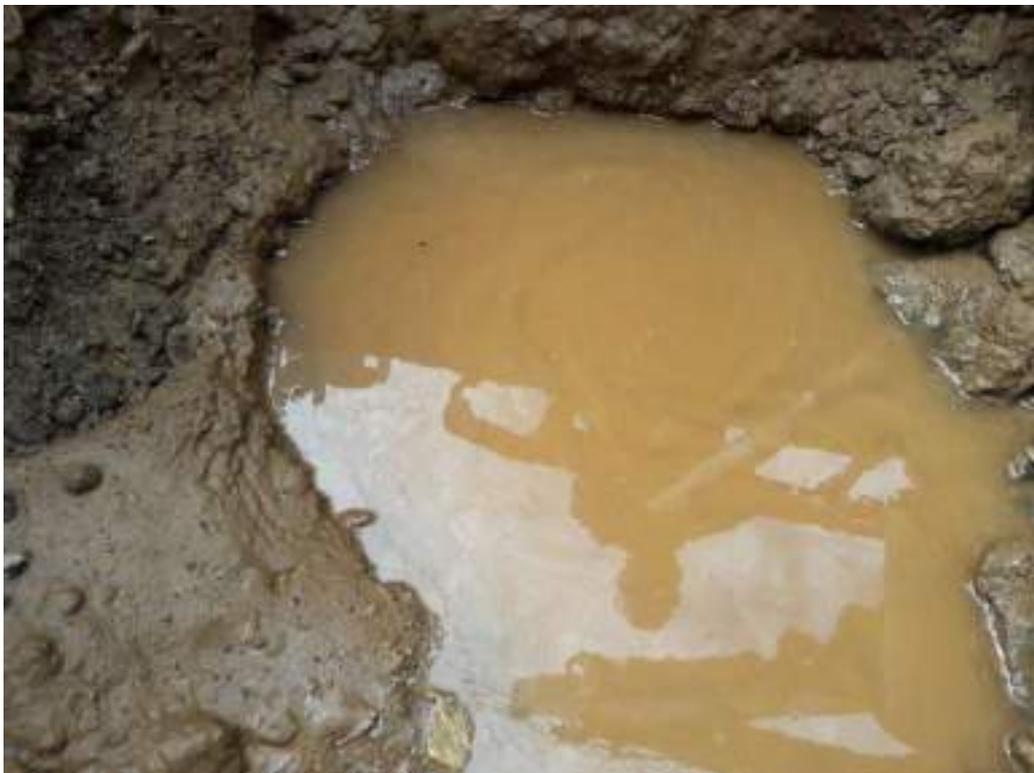
Photo 6. Image showing the ingress of water into trial pit excavation during initial site investigation activities in June 2019. Note the visible hydrocarbon sheen thought to be associated with residual cable fluid in soils.
