# Preliminary Site Assessment Report for Griffith Avenue, Dublin 9

ESB Site Ref: 6  
Ballymun - Fairview 38kV

March 2020

**Report Ref:** Stage 1 Preliminary Site Assessment Report for Griffith Avenue, Dublin 9. ESB Ref: 6 Ballymun - Fairview 38kV

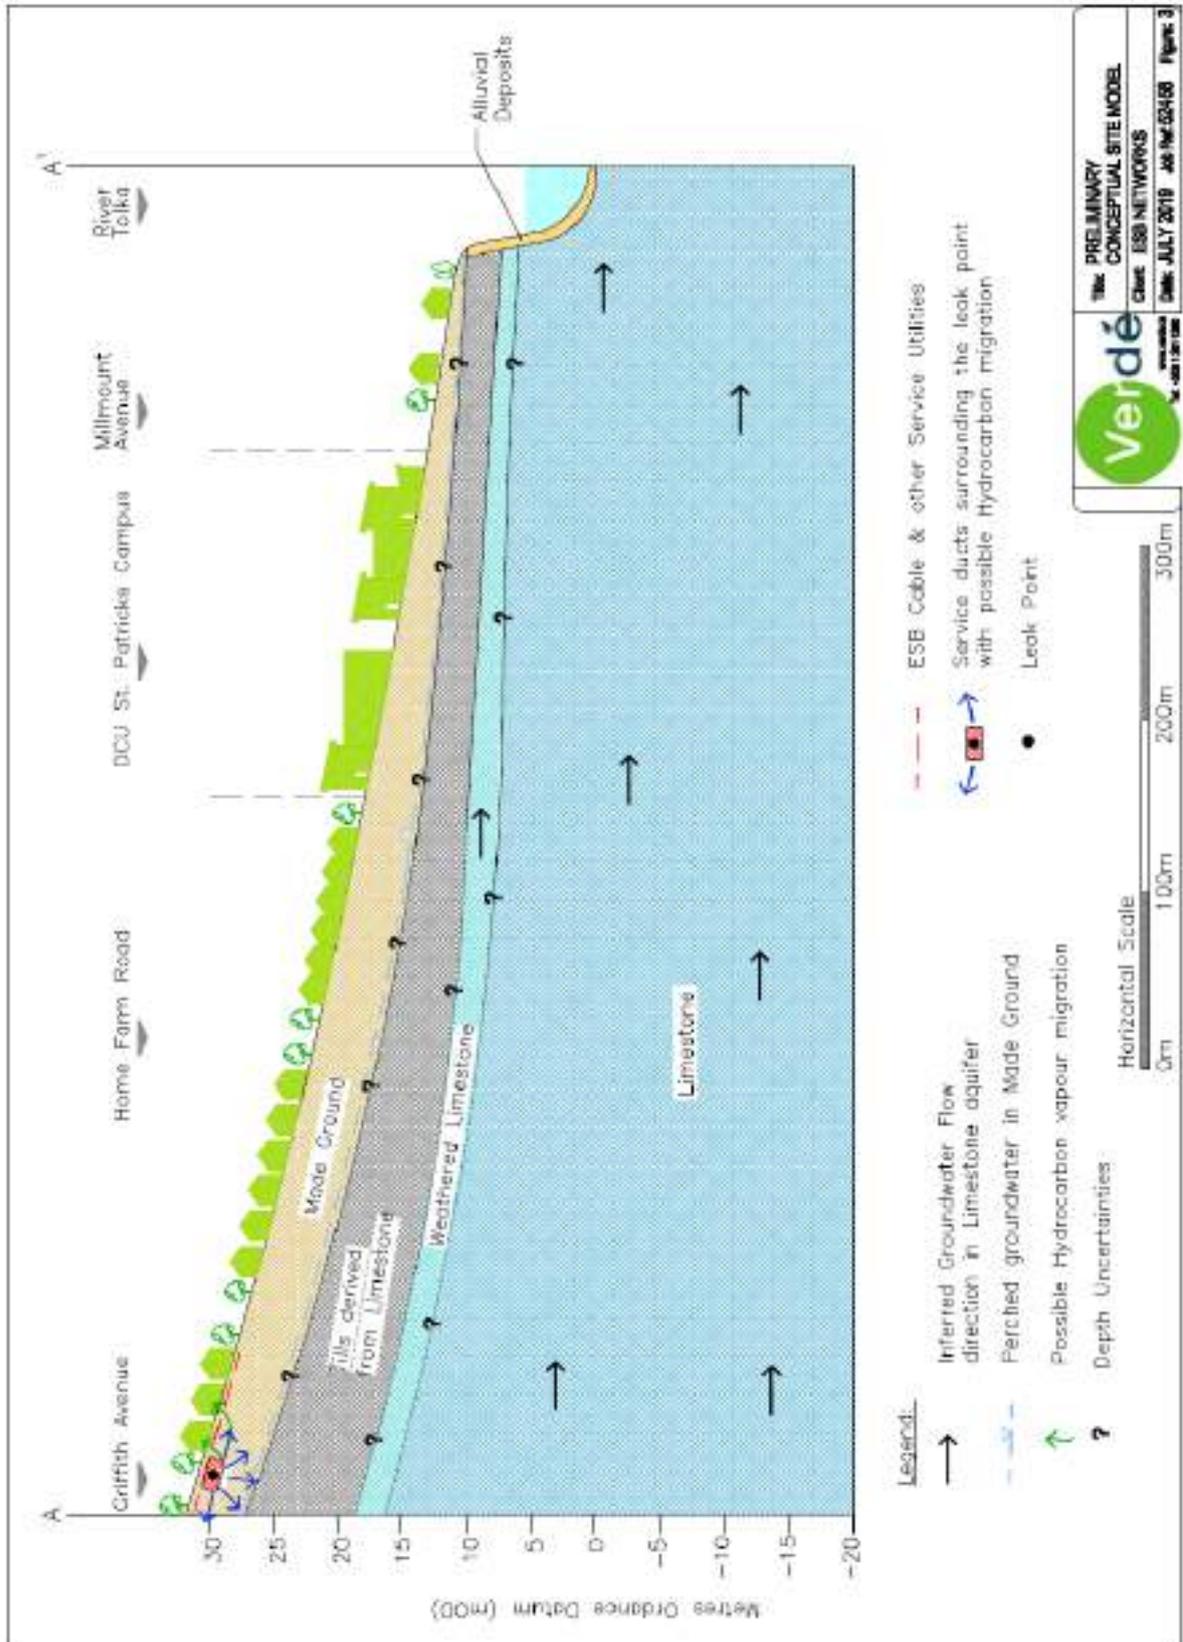
Figure 3 – Conceptual Site Model

- hydrocarbon vapours in preferential pathways such as services ducts to residents or other building users.

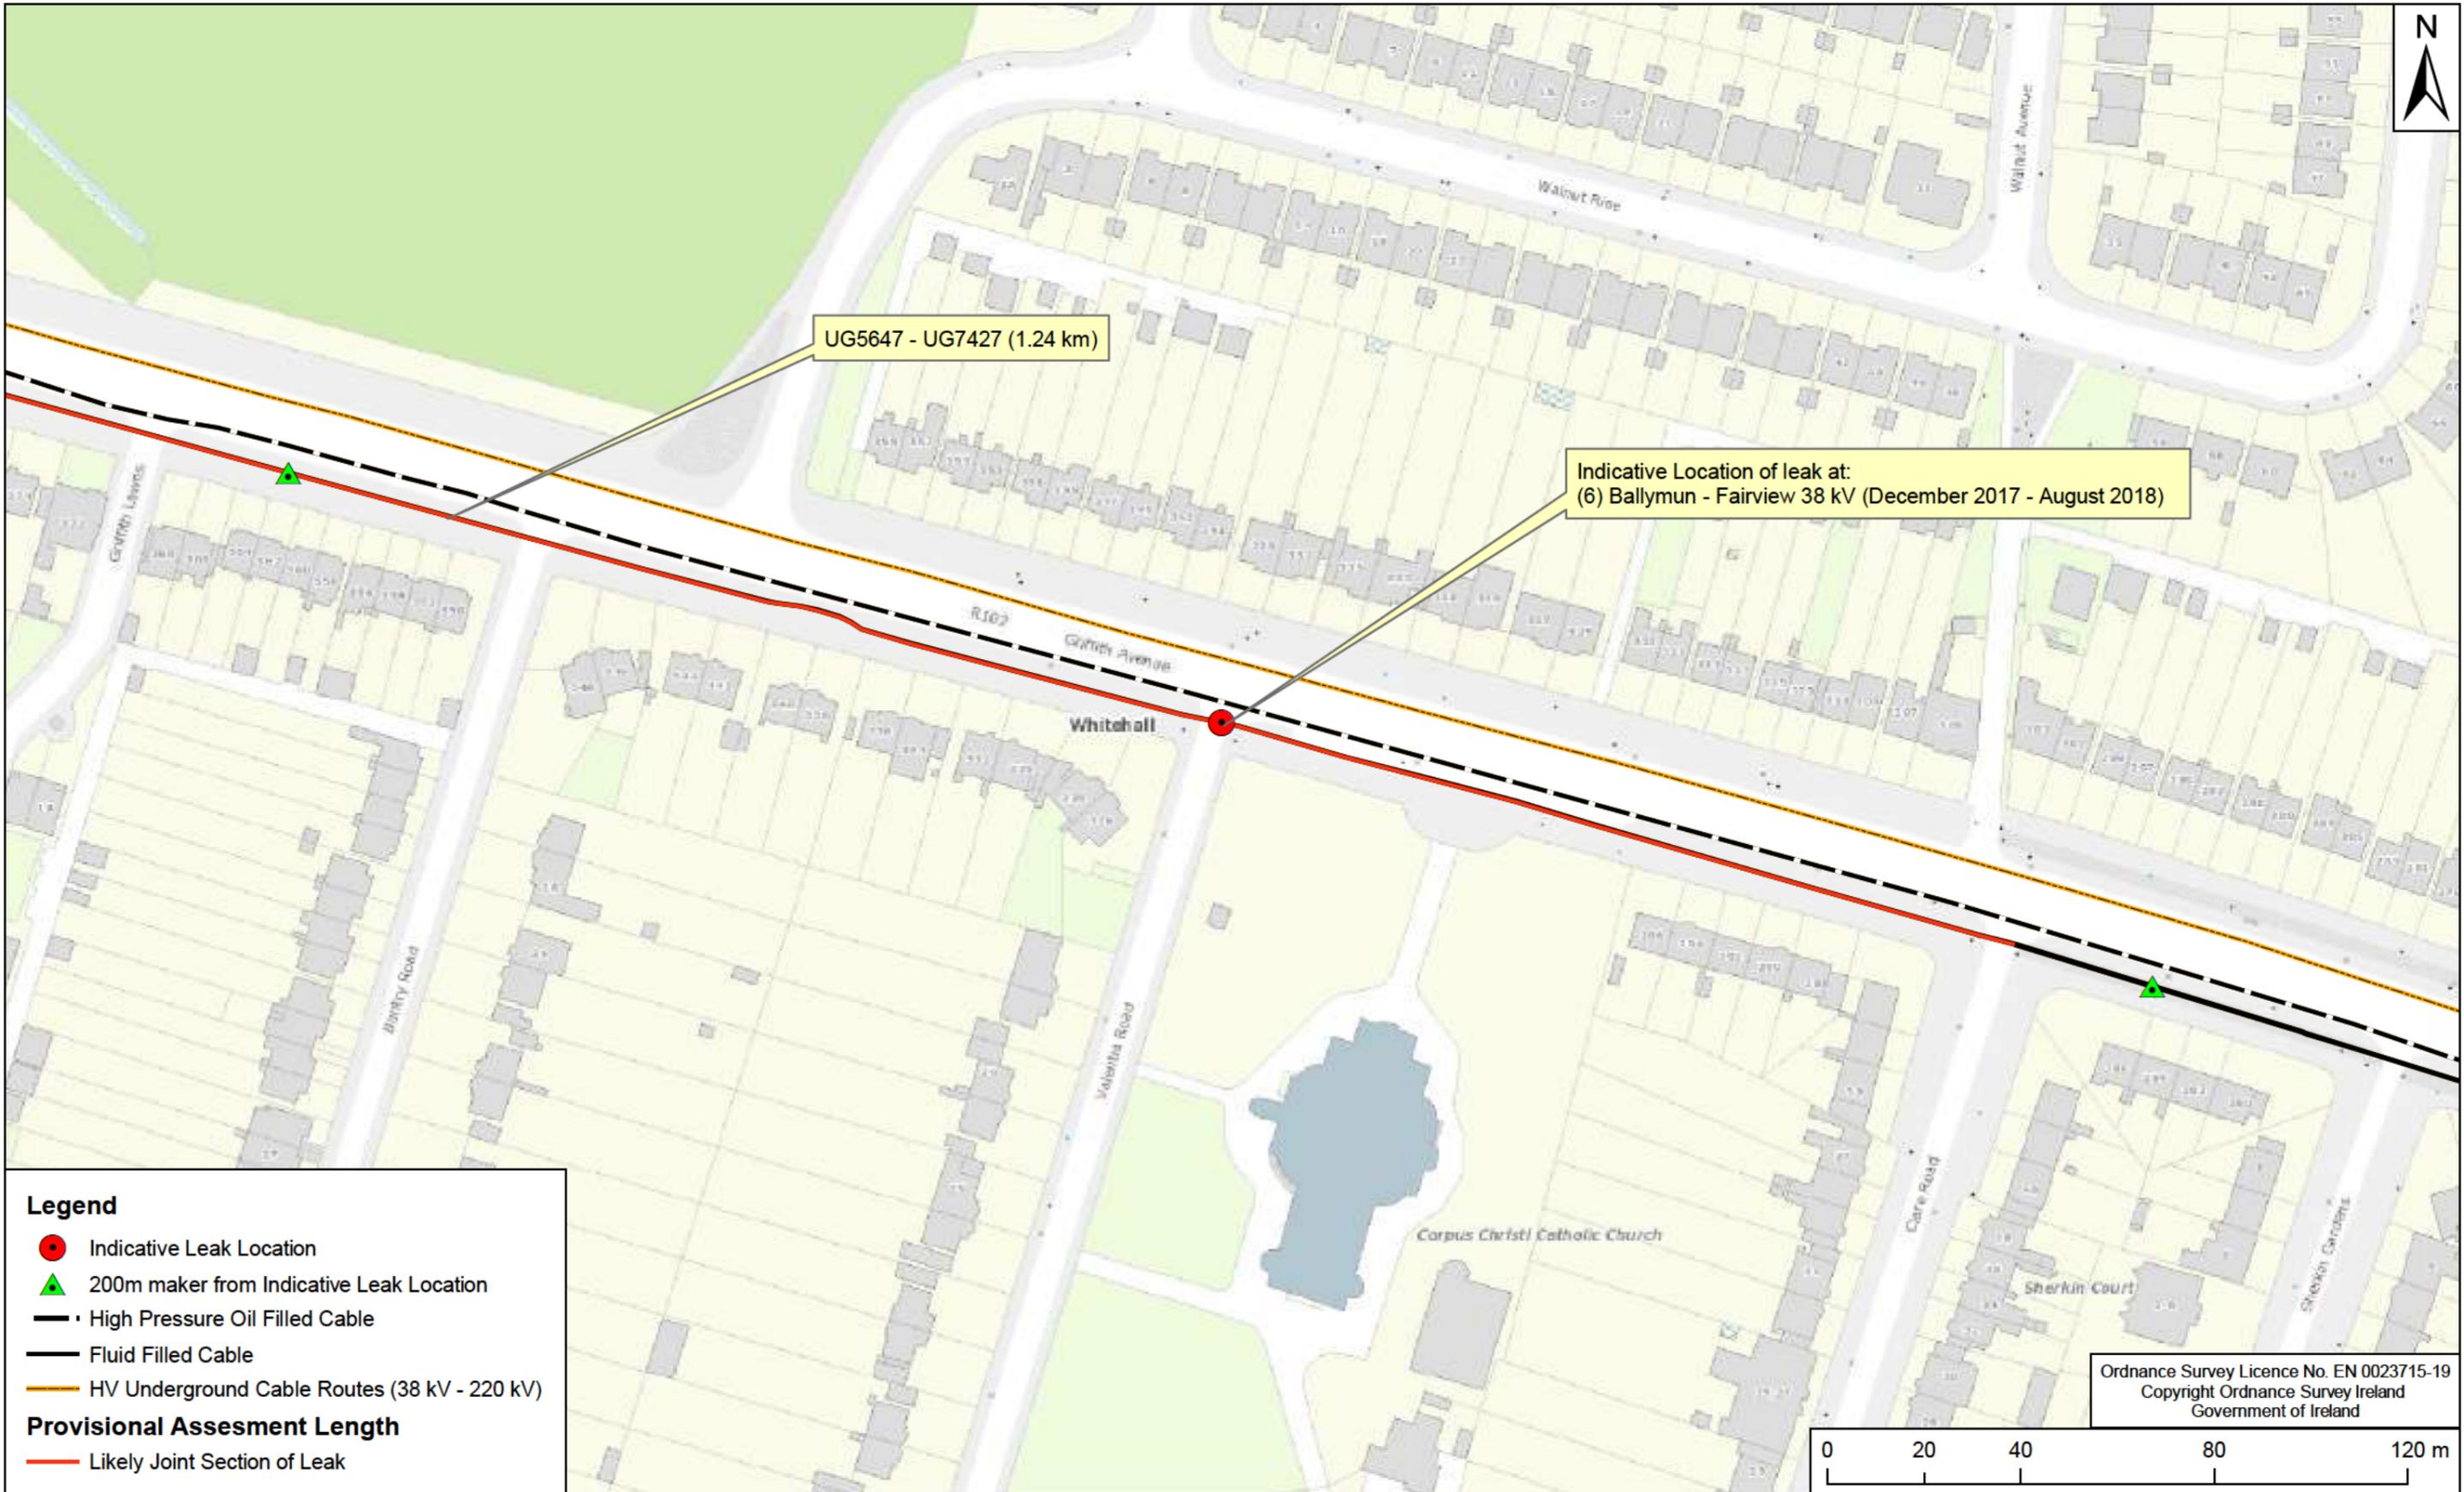
PRODUCTION UNIT:	<b>Civil &amp; Environmental Engineering</b>
DRAWING TITLE:	<b>Indicative Cable Fluid Leakage Locations &amp; Cable Sections (6) Ballymun - Fairview 38 kV (December 2017 - August 2018)</b>

Only a reported leak volume loss of 5,170 litres is available for both this site and the other repaired leak on the same roadway (ESB Ref: 5 Ballymun – Fairview). Consequently, the specific volume lost at leak point ESB Ref. 6 cannot be determined. Both leaks on this cable route were repaired in August 2018.

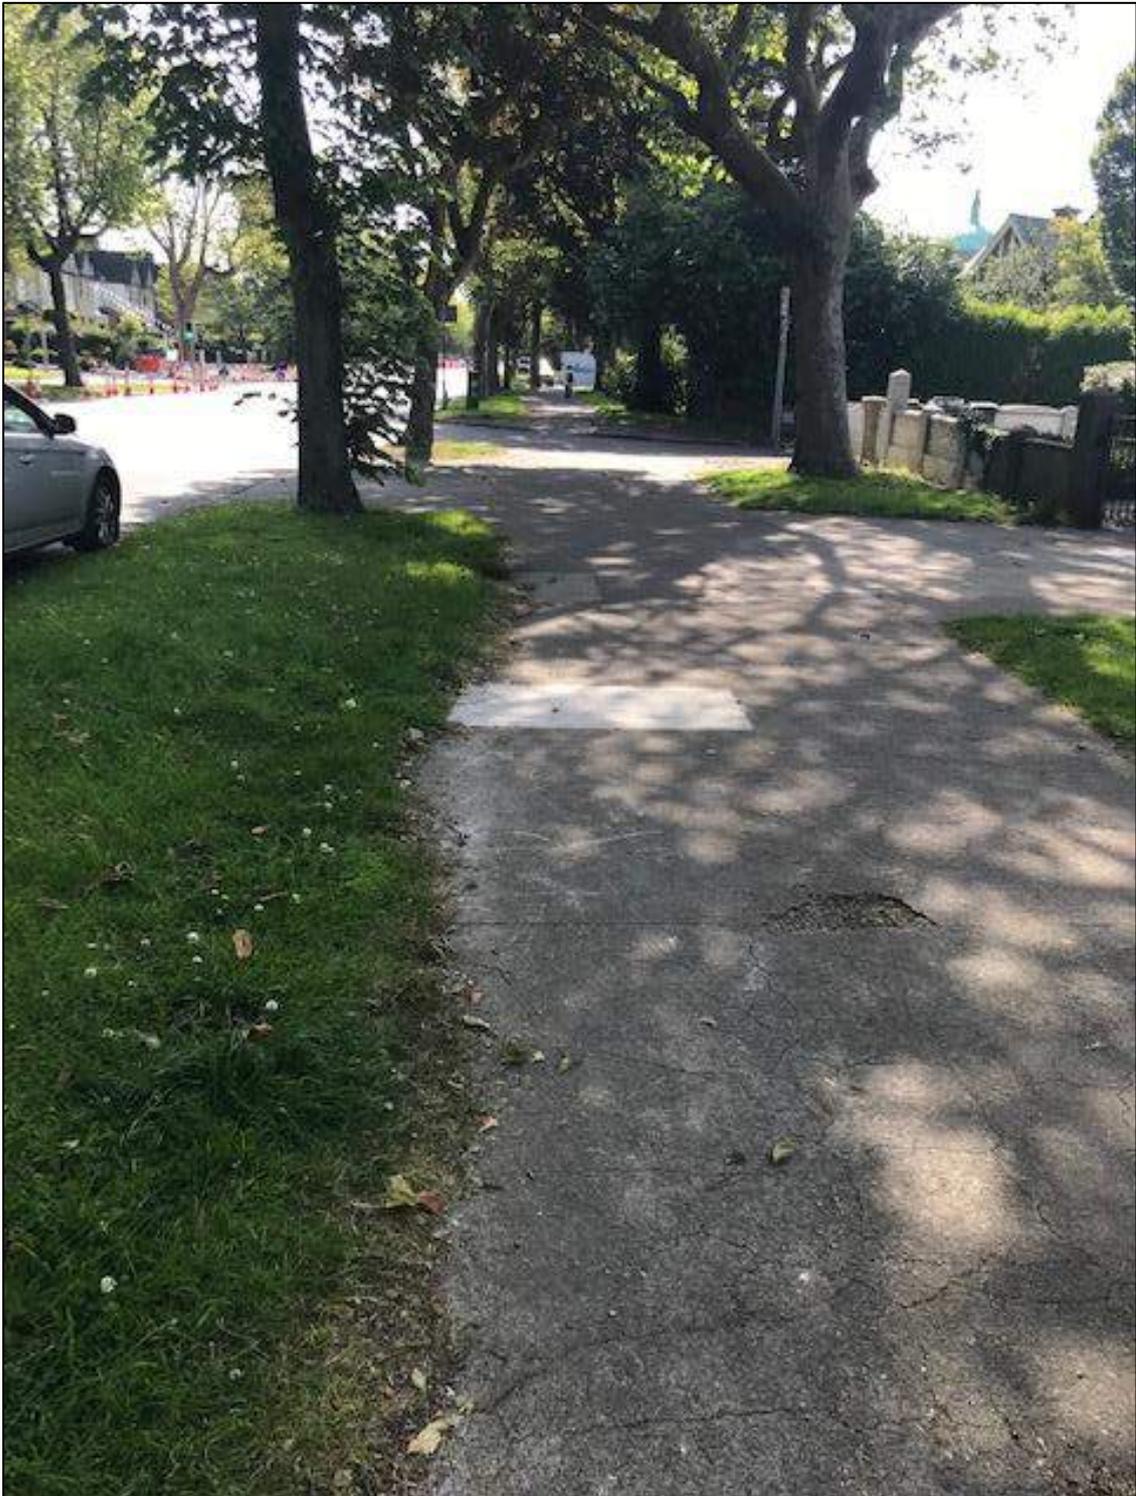
Photo 1: At 200m west of Leak Point - View to east

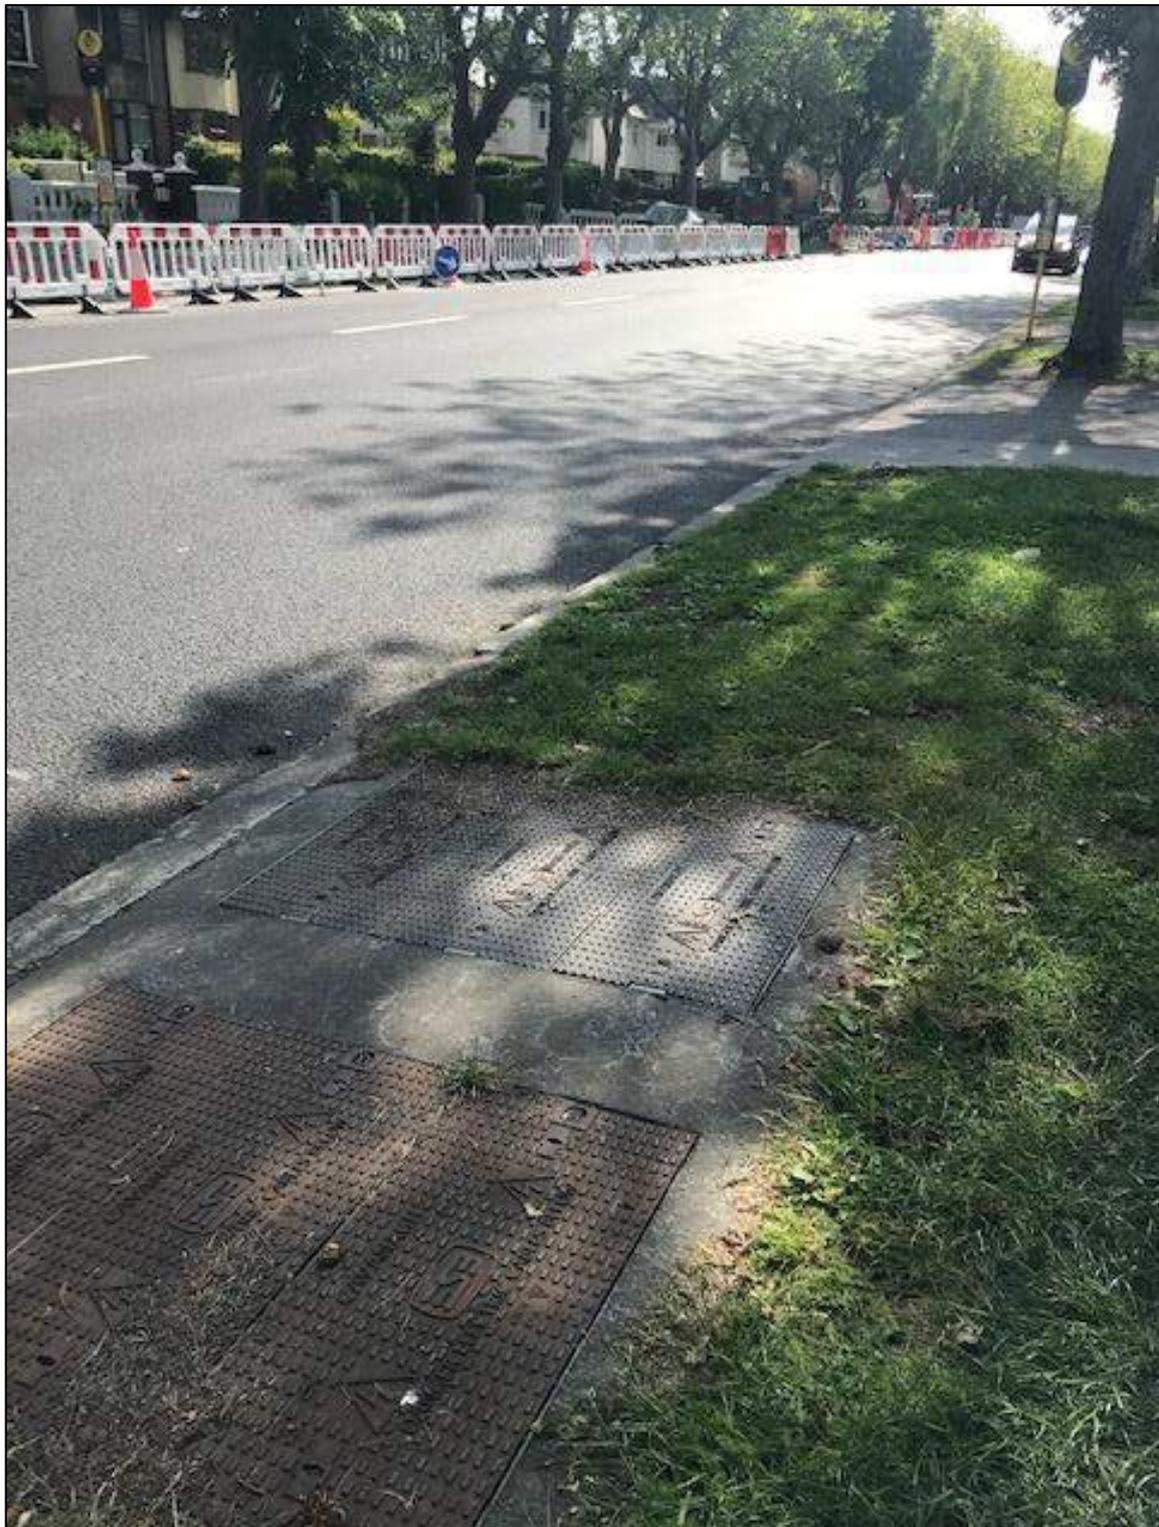
There is a grass verge adjacent to the roadway and ESB cable route, inside which is a concrete footpath which was being replaced at the time of the site walkover. There was evidence of abundant site services in the roadway, the grass verge and concrete footpaths with manhole covers and traffic kiosk. Services in the area included sewers, road gully drains, water mains, telecom, UPC and ESB as in Photograph 2 in Appendix C.

Photo 2: ESB Services Approx 90m west of leak point on grass verge

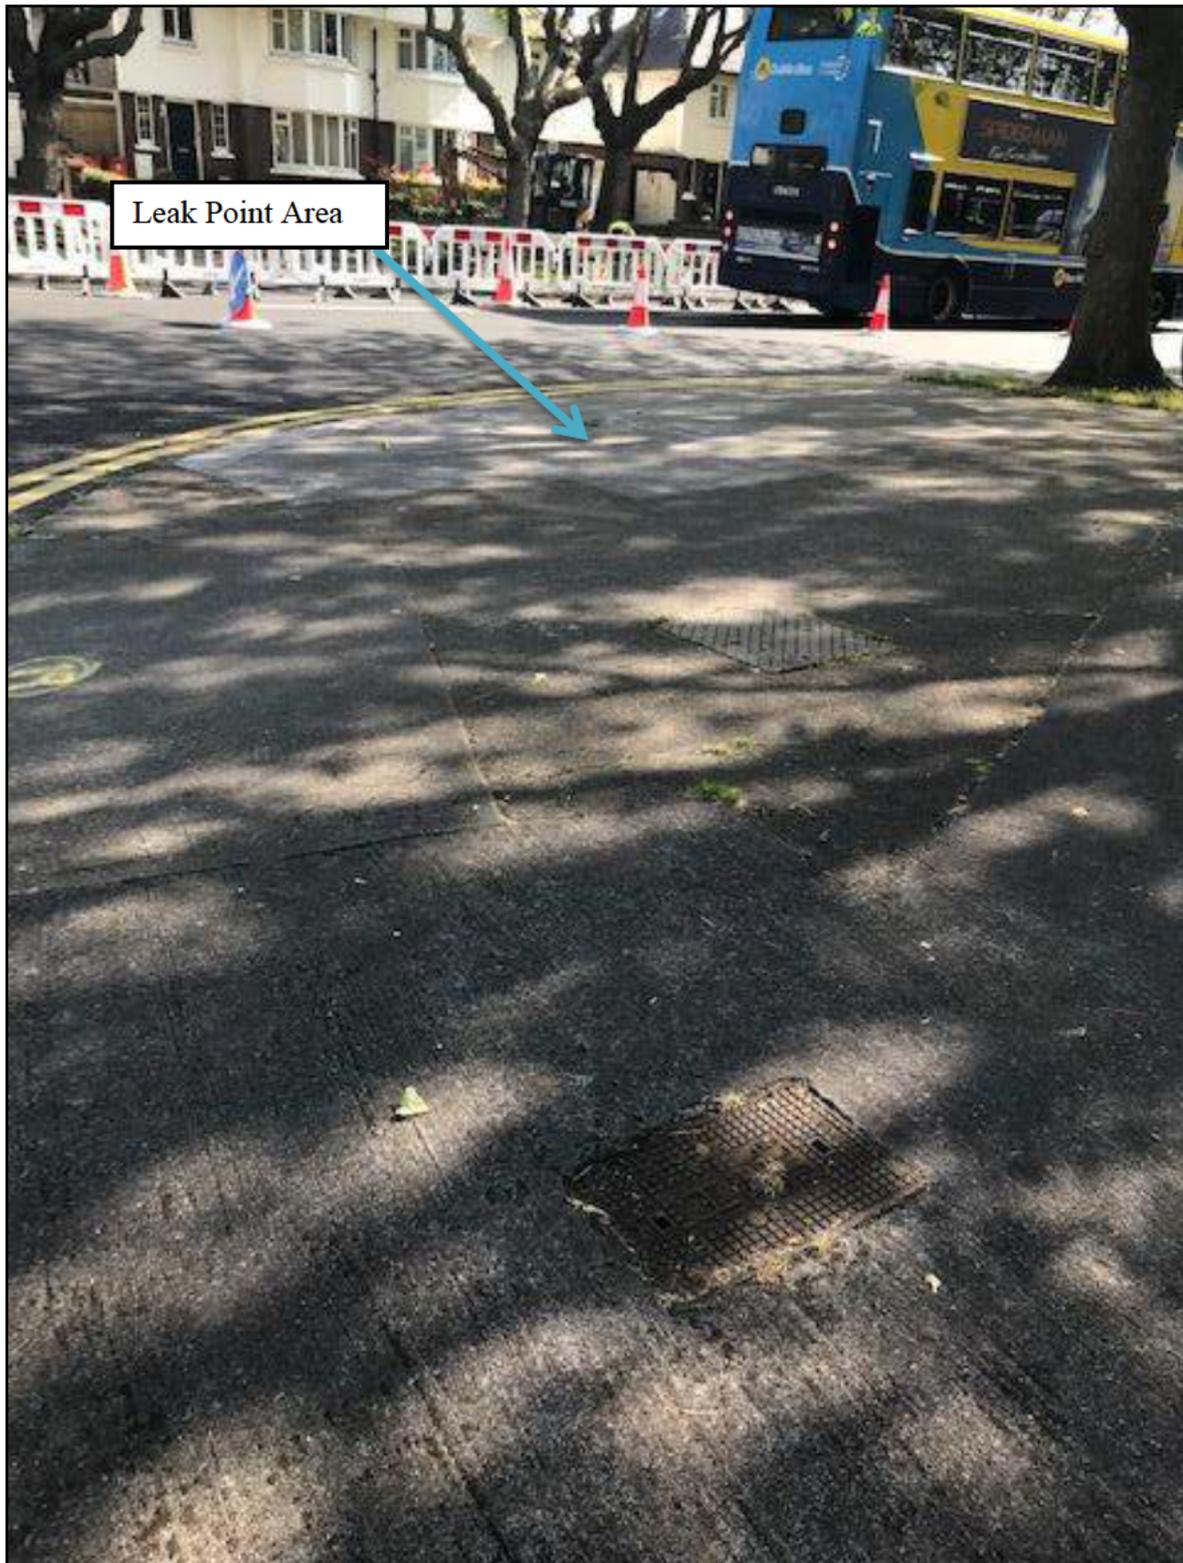
The cable leak point area can be seen in an area of newer concrete as shown in Photograph 3 in Appendix C. There is no physical evidence of hydrocarbon contamination on the surface in terms of oil odours/staining or impact to vegetation with healthy looking trees and hedges.

Photo 3: Leak point location in area of newer concrete – abundant services in area

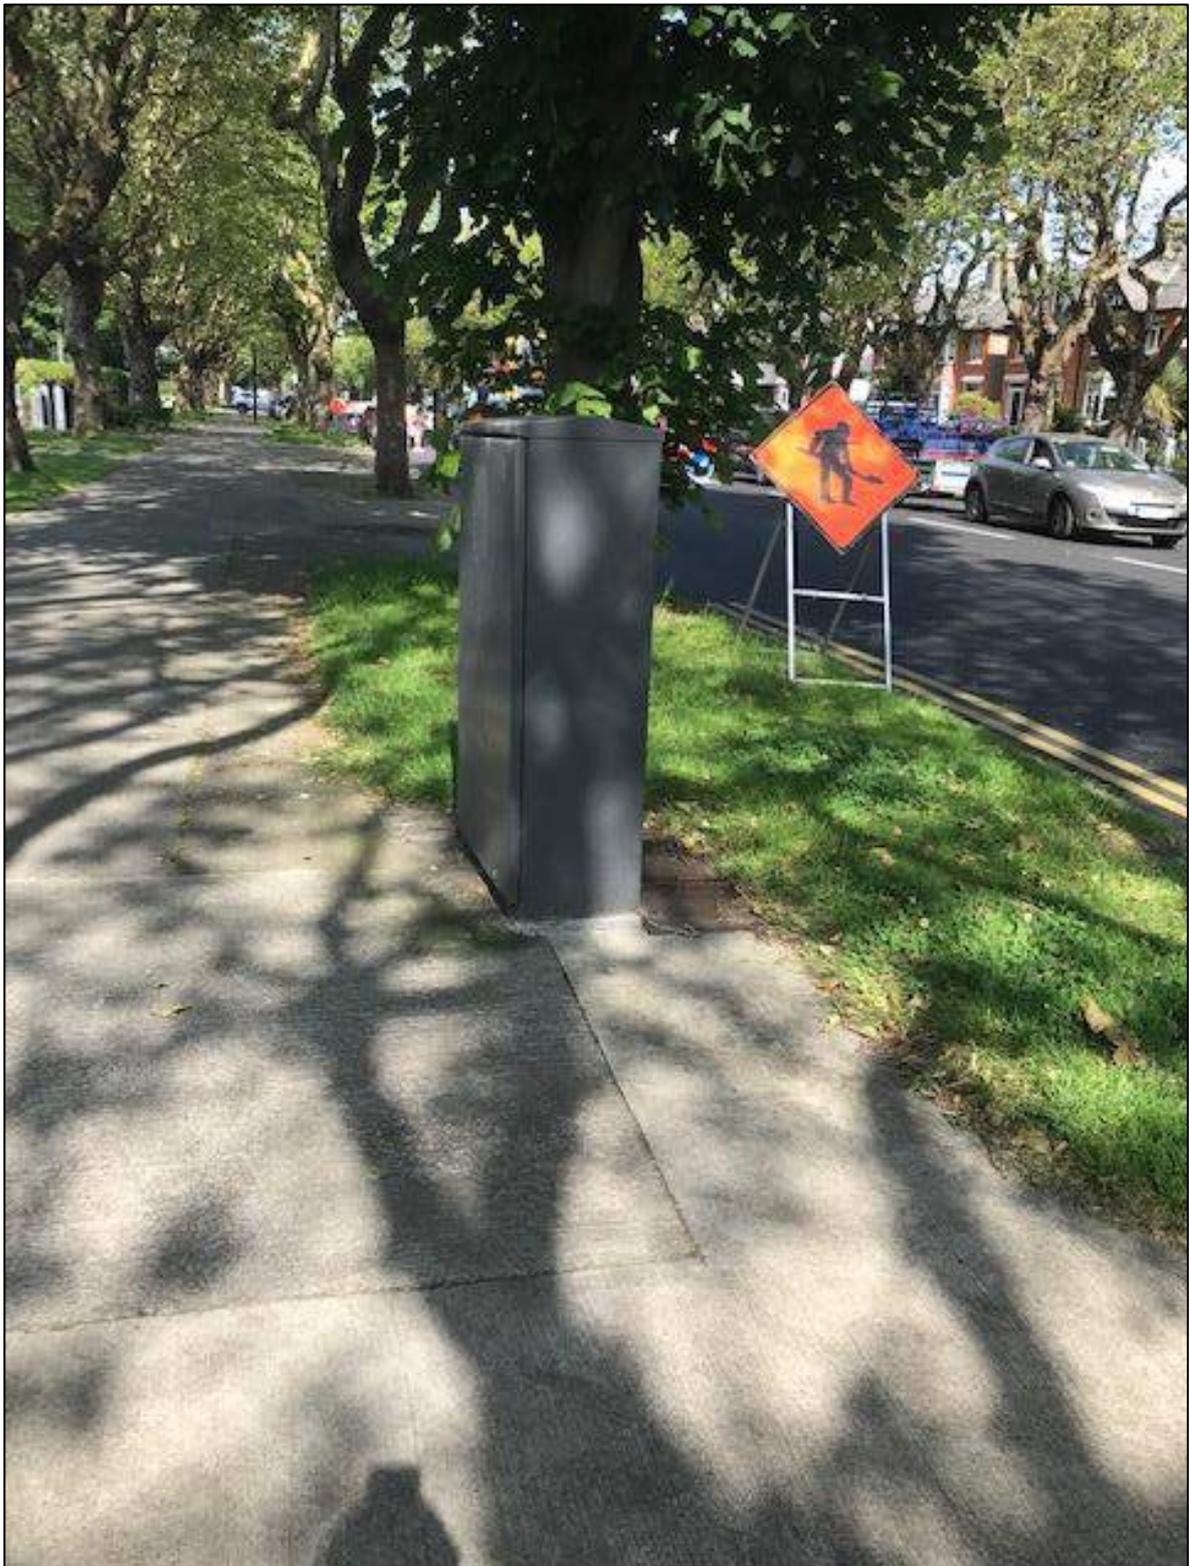
Photo 4: Approx 150m east of leak point – facing west. Traffic Kiosk between grass verge and concrete footpath

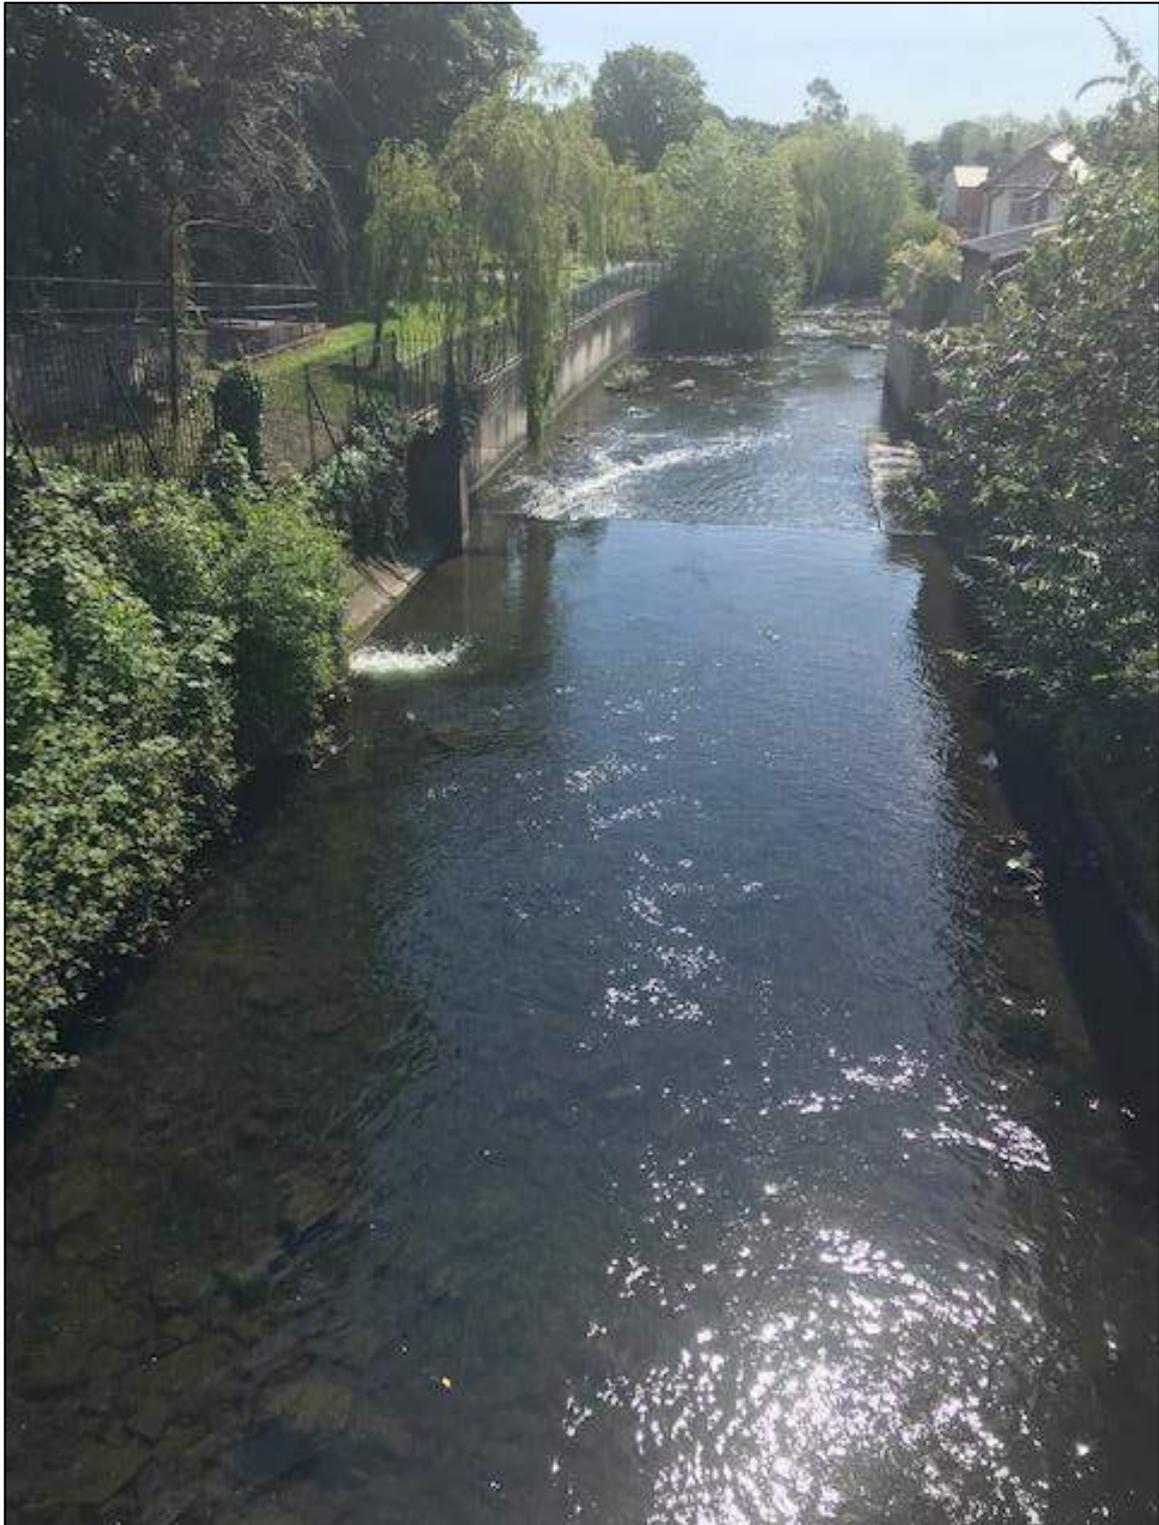
Photo 5: Tolka River approx. 890m south west of leak point
