Preliminary Site Assessment

Site 64 Inchicore – Poolbeg 220 kV

Electricity Supply Board

Project number: PR-427640_ACM_RP_ENV_061_0

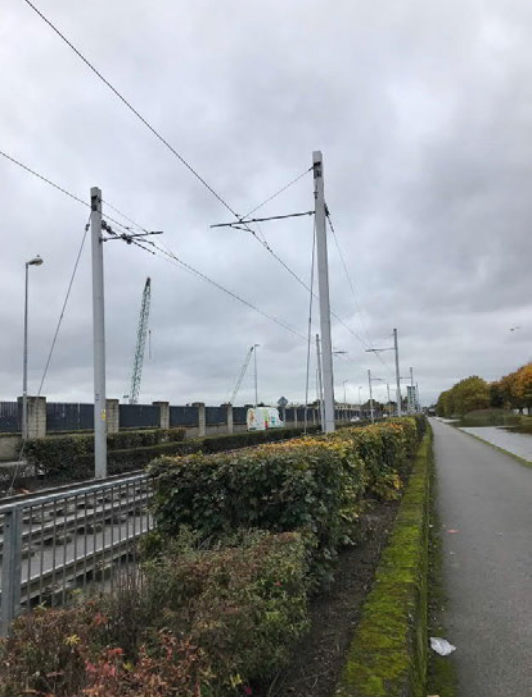
Photo No. 1	Date: 01/11/19

Direction Photo Taken: West		
Description: West-facing view showing the leak location. It is located along the pedestrian walkway (right). Green strips separate the pedestrian walkway from LUAS tracks.

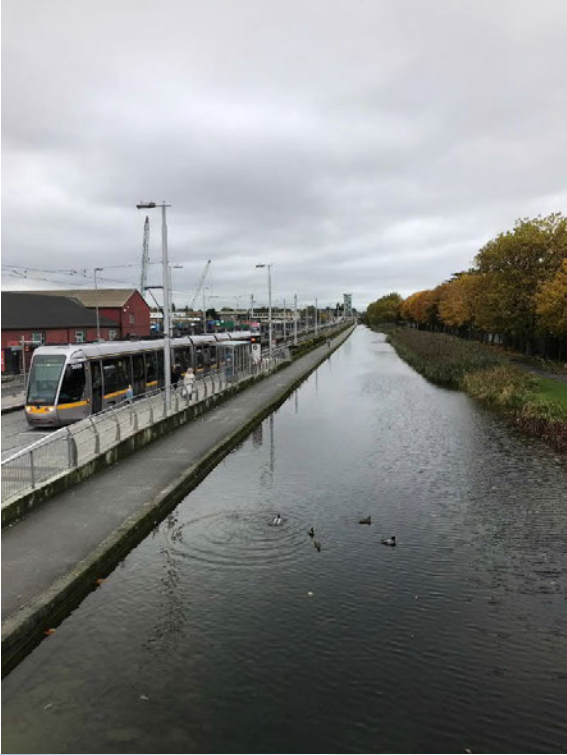
Photo No. 2	Date: 01/11/19

Direction Photo Taken:		
Description: West-facing view showing the pedestrian walkway, grand canal, LUAS stop and tracks close to leak location.

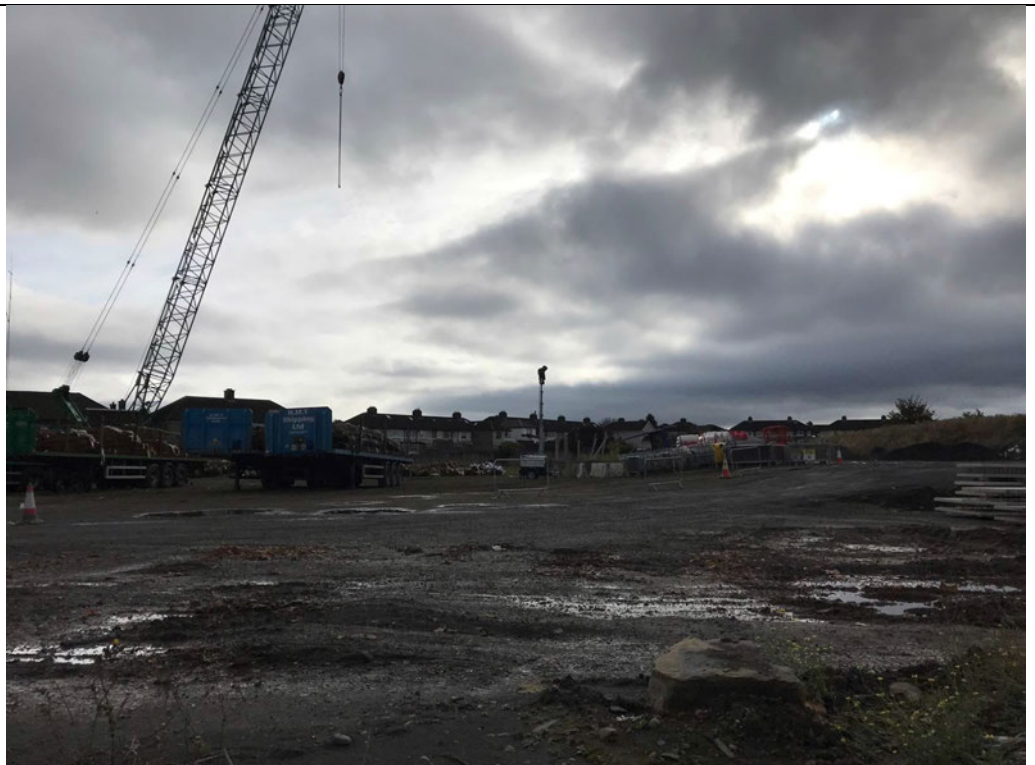
Facility Name:
ESB Cable Assessment**Site Location:**
Site 64 – Davitt Road**Project No.**
427640**Photo No.**
3**Date:**
01/11/19**Direction Photo Taken:**

Large yard located approximately 30 m south west of leak location.

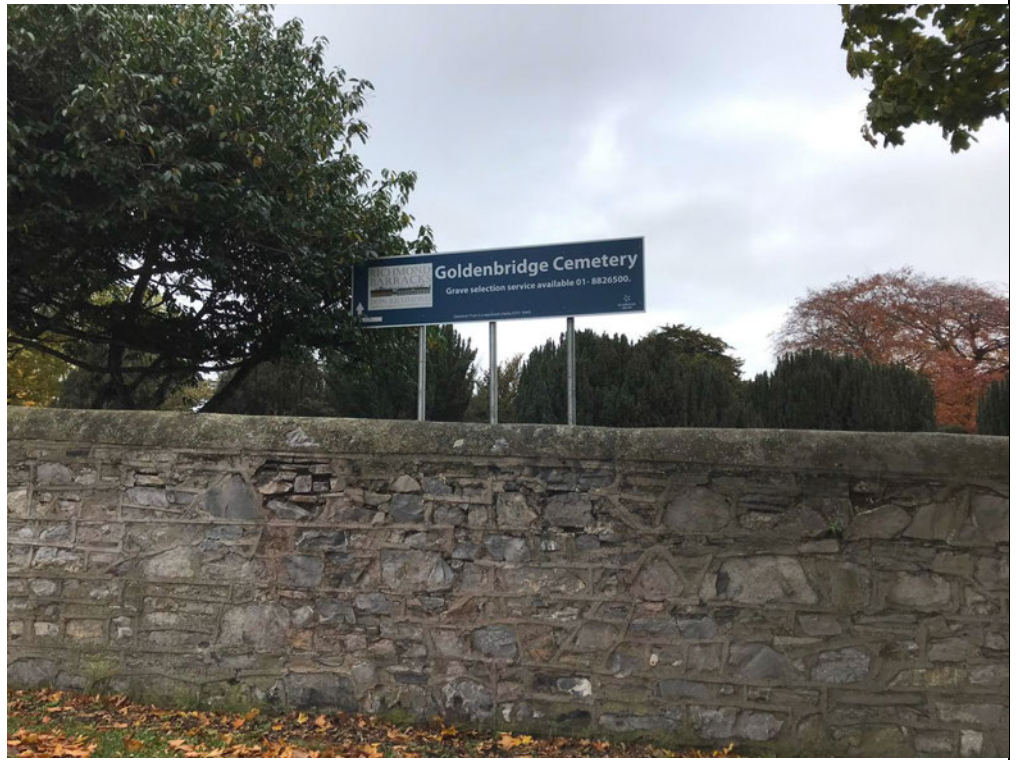
Presence of a cemetery located approximately 250 m northeast of leak location.

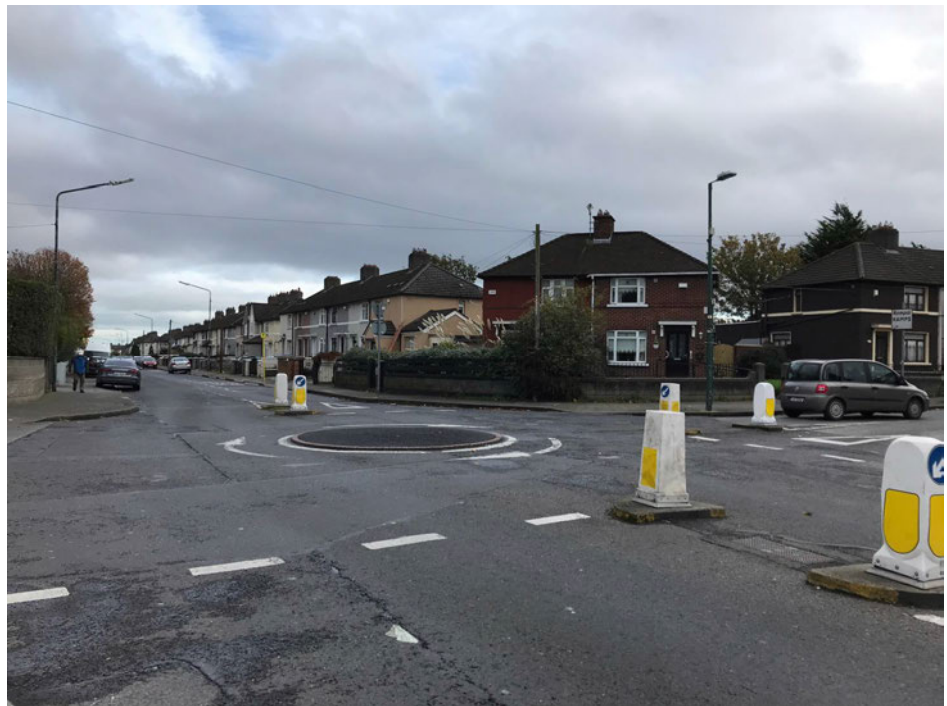
Facility Name:
ESB Cable Assessment**Site Location:**
Site 64 – Davitt Road**Project No.**
427640**Photo No.**
7**Date:**
01/11/19**Direction Photo Taken:**

Residential area located approximately 200 m southeast of leak location.
