REPORT

Site 14 Deansgrange to Sallynoggin 38 kV: Preliminary Site Assessment Report for Historic Fluid Filled Cable Loss

Golder Associates Ireland Limited

22 April 2020

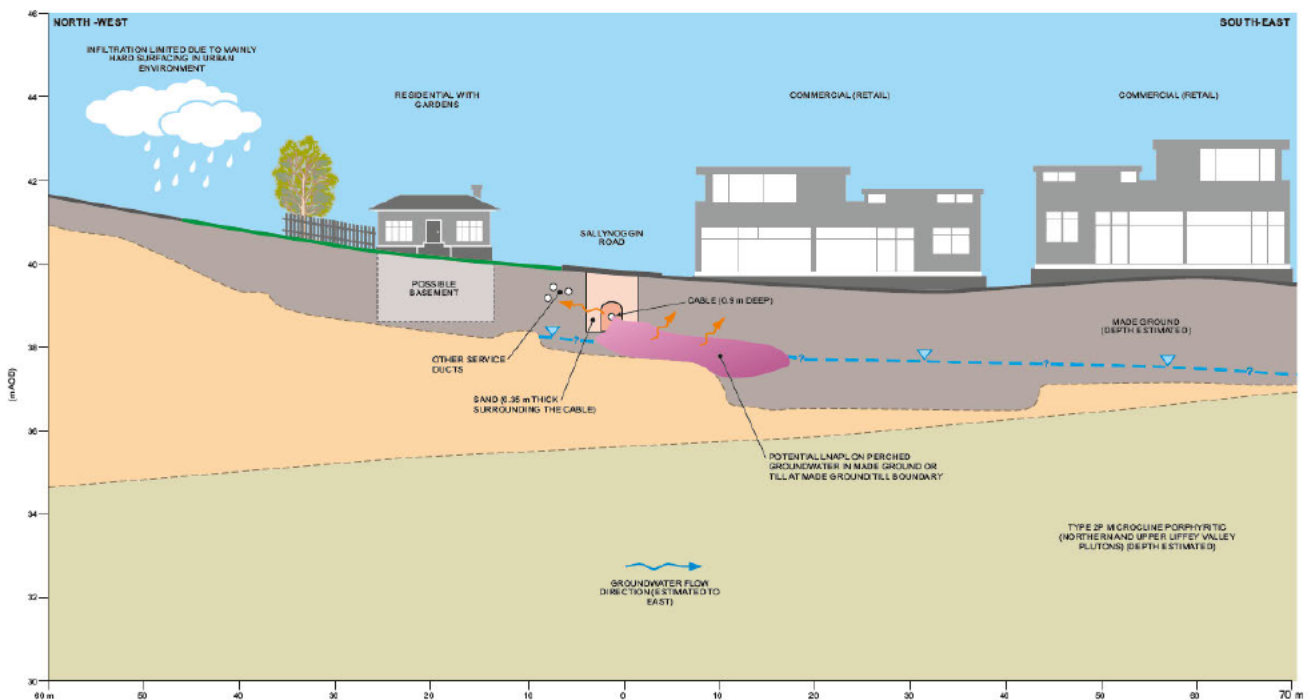
Figure 1: Preliminary CSM for Site 14 (Deansgrange to Sallynoggin).

- There is a potential moderate risk that groundwater in the bedrock could be impacted if the Till thickness is not significant enough to provide protection from migration of contaminants; and
- There is a potential moderate/low risk that residents or workers in basement apartments or offices could be impacted by vapours.

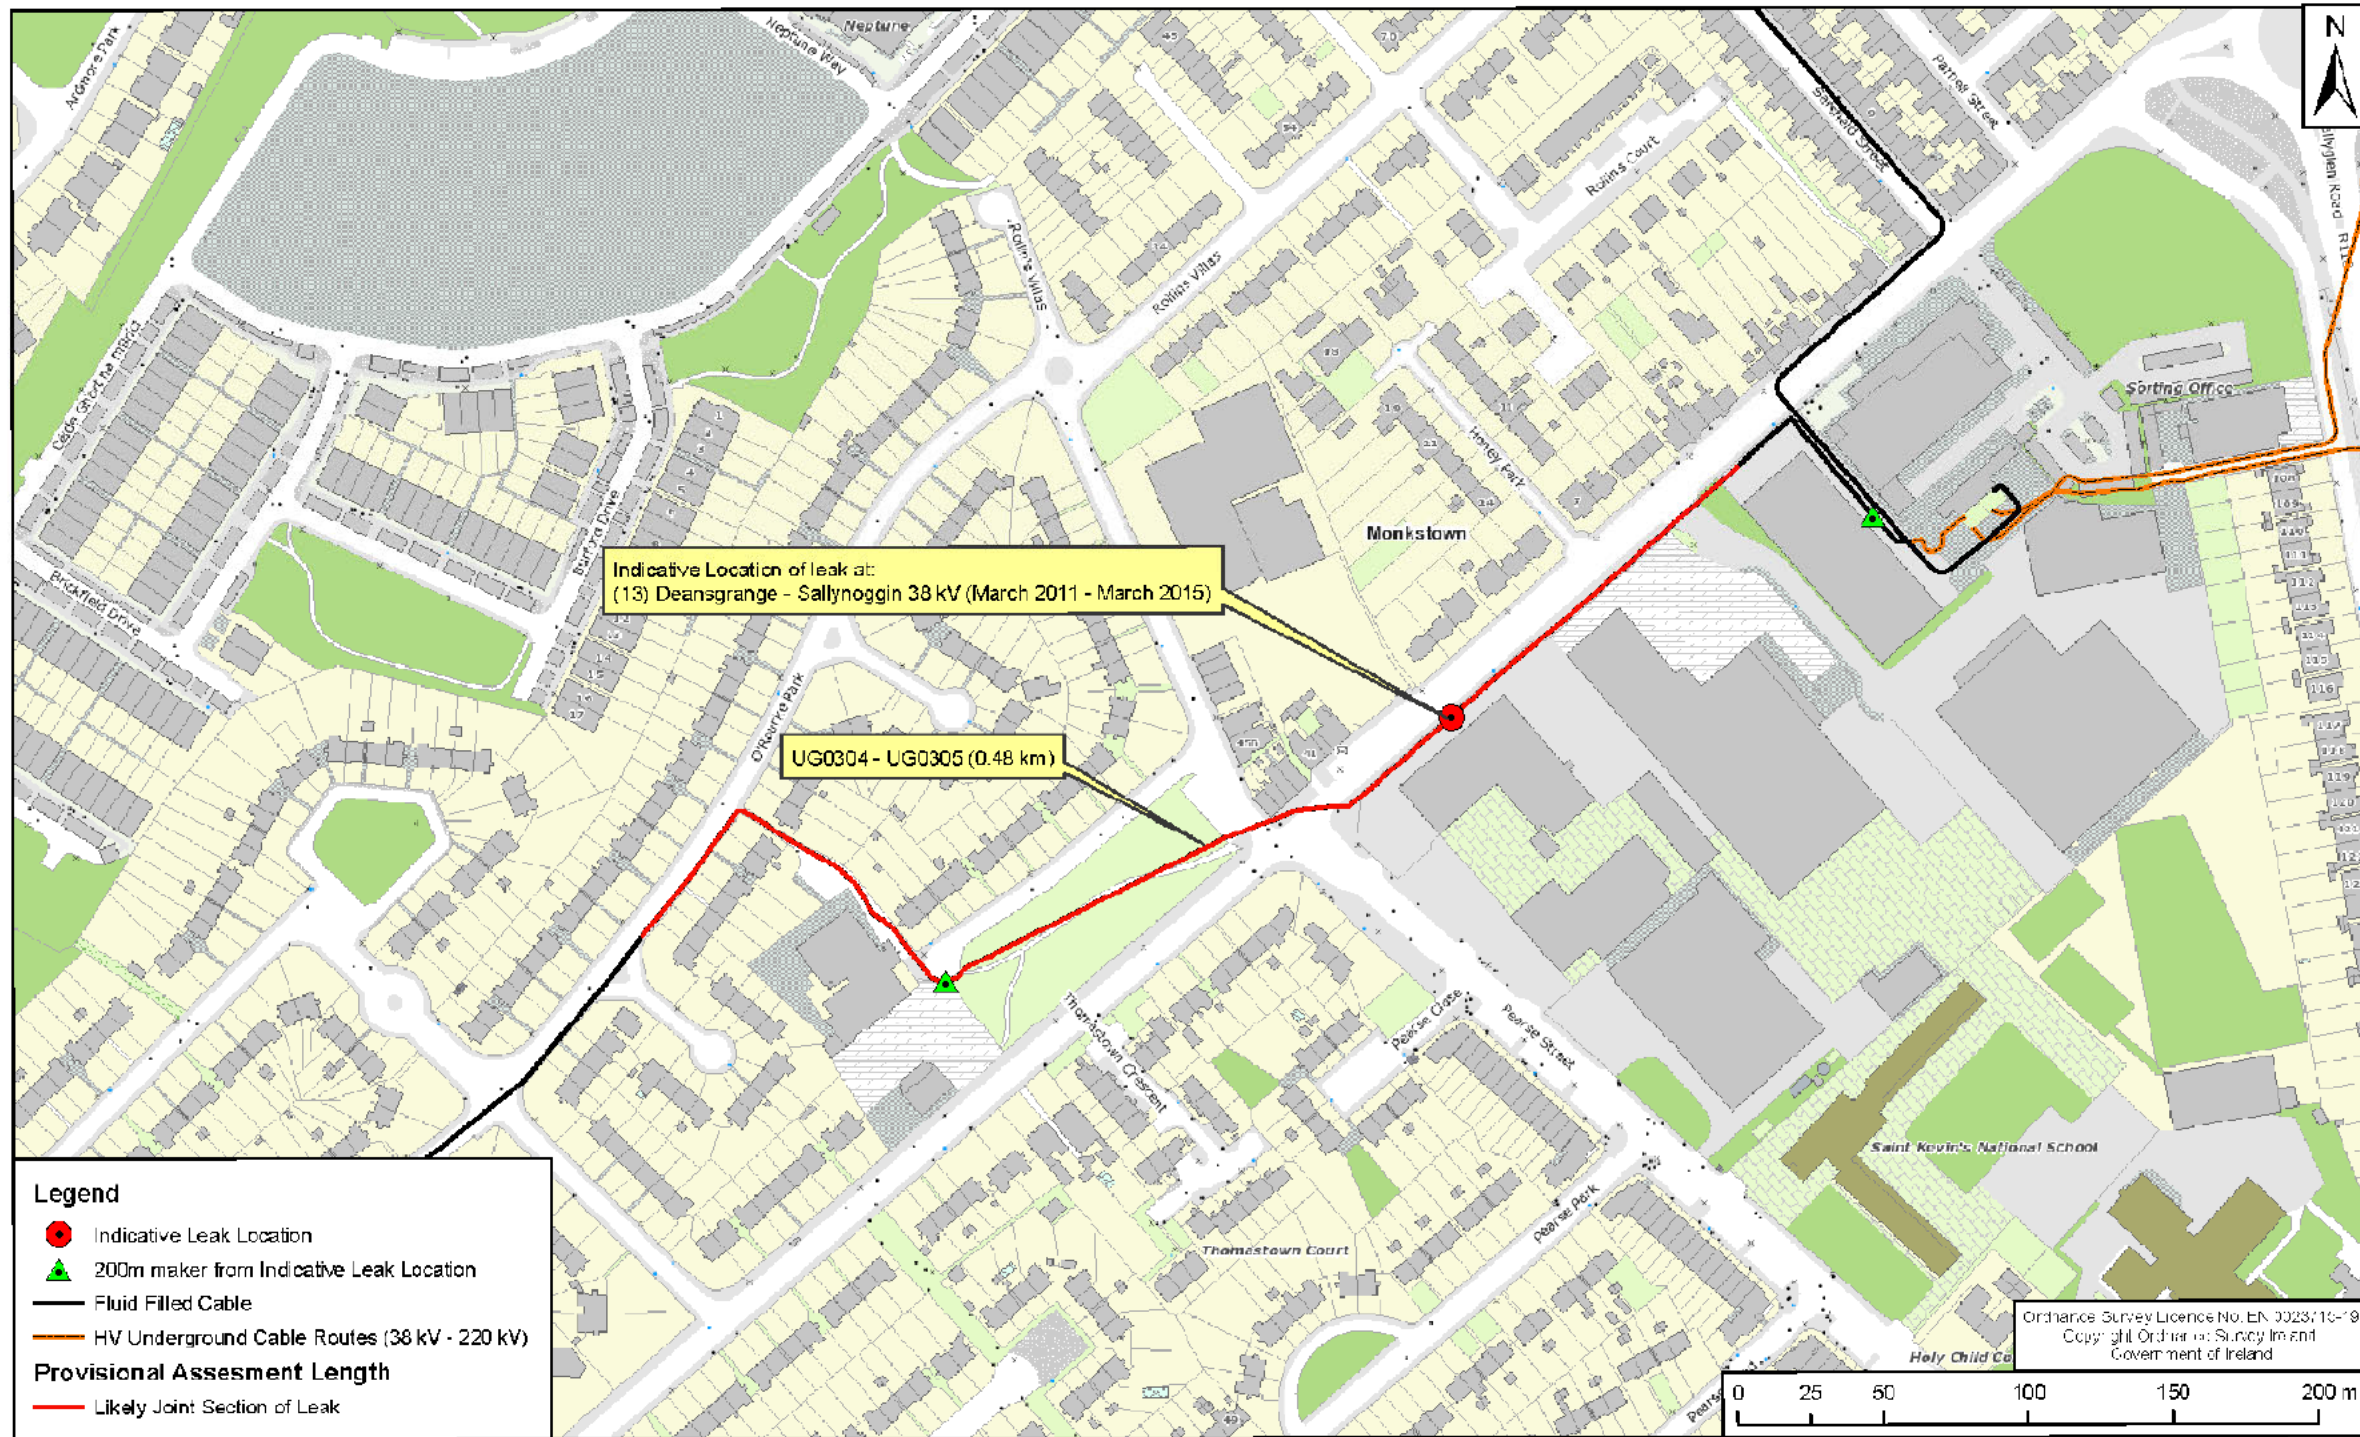
19126590	600-SW-046	B.0	1

DRAWING TITLE: **Indicative Cable Fluid Leakage Locations & Cable Sections (13) Deansgrange - Sallynoggin 38 kV (March 2011 - March 2015)**

The location of the cable leak, and 200 m Site limits (200 m each way along the cable length from the cable leak) are summarised in Table 1 and shown on Drawing 1.

The Site walkover was completed on 5 July 2019. The Golder engineer walked along the length of the cable; 200 m from the leak location in each direction (shown on Drawing 1). Whilst it is not expected that significant impacts will be observed at ground level above the leak location, a walkover was carried out for completeness.

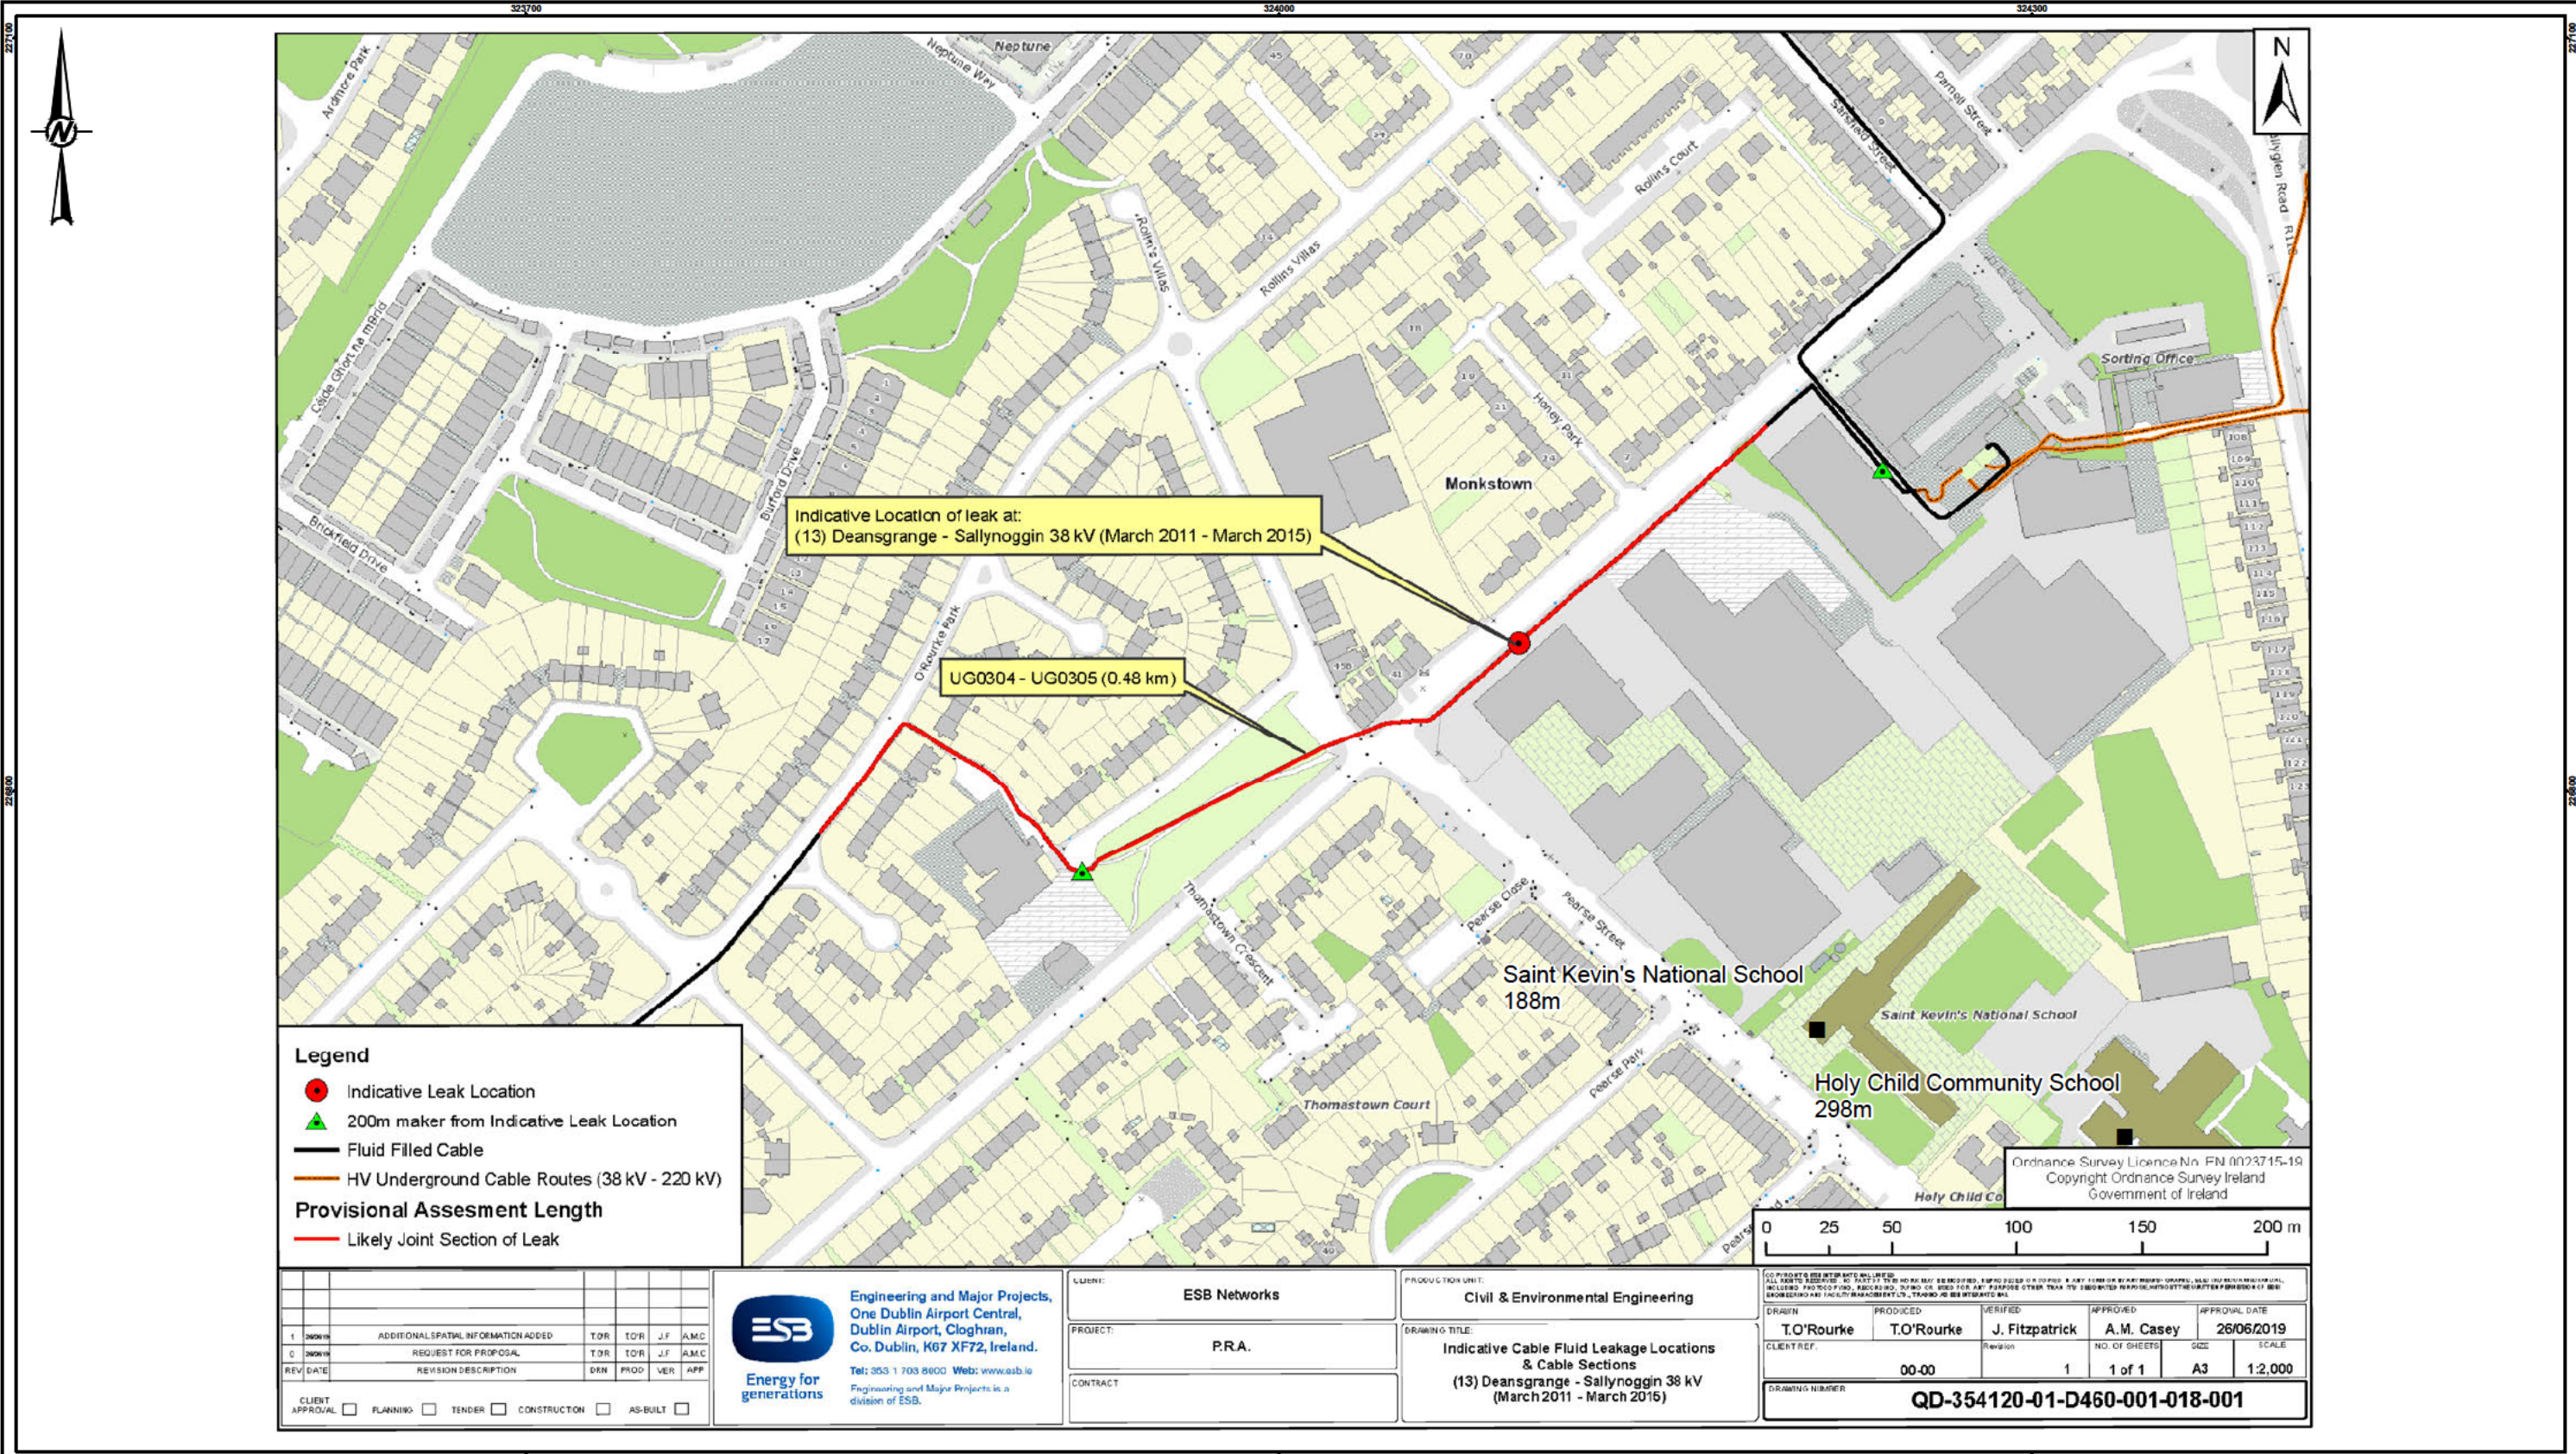
PROJECT NO. **19126590** CONTROL **600-SW-033** REV. **B.0** DRAWING **2**

Receptors 500 - 1000 m from Leak Location

TITLE: **PRELIMINARY SOURCE - PATHWAYS - RECEPTORS IDENTIFIED**

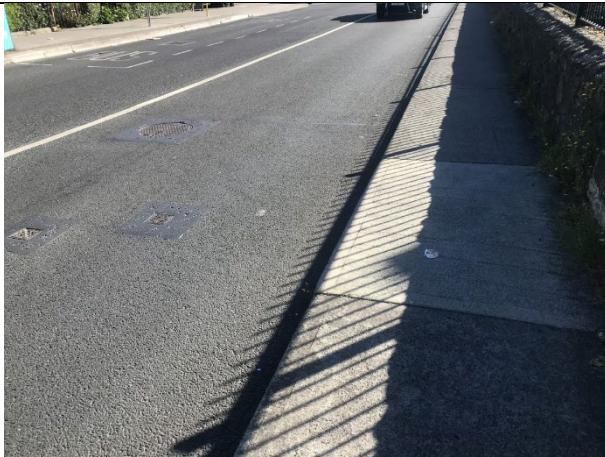
14-01 – Different concrete present at indicative leak location, suggesting more recent works in that area.

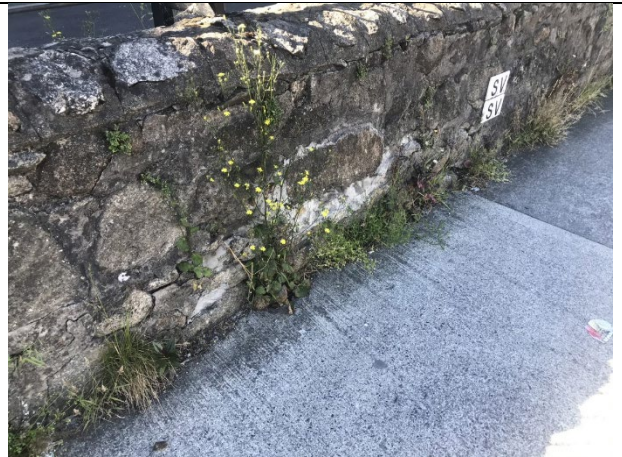
14-02 – Damage / repair works to wall adjacent to indicative leak location.

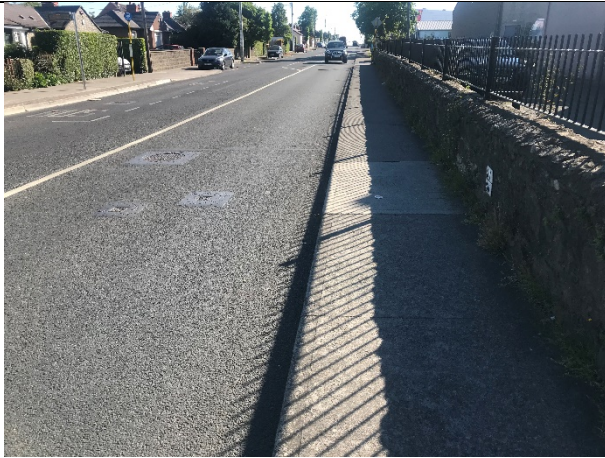
14-03 – Conduit covers on Sallynoggin Road adjacent to indicative leak location.

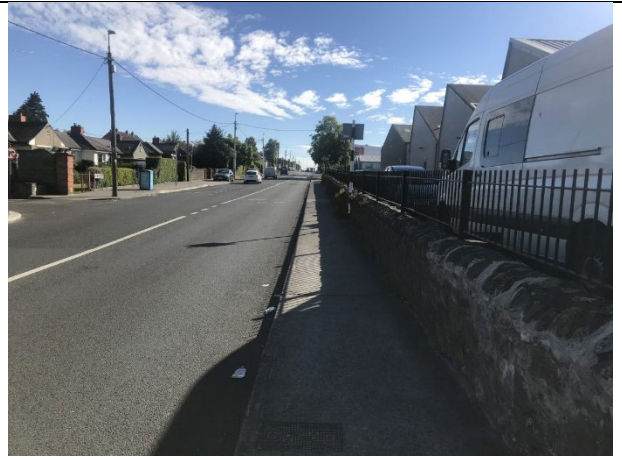
14-04 – Road surfacing in generally good condition on Sallynoggin Road.

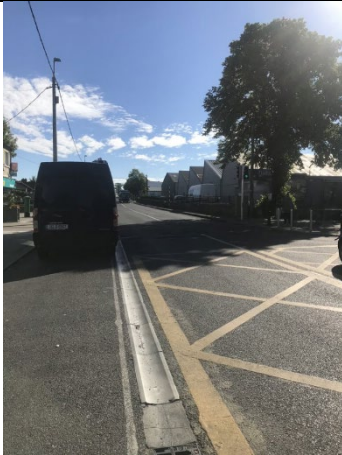
14-05 – Road surfacing in generally good condition on Sallynoggin Road. With shallow surface water runoff drainage channels.

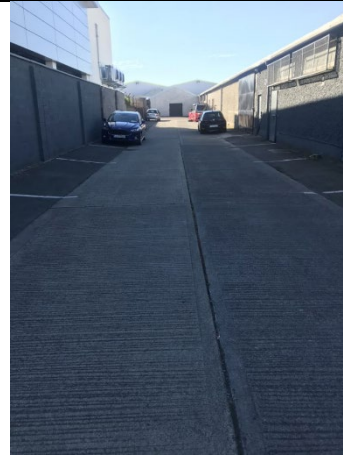
14-06 – Cabling turns southeast from Sallynoggin Road towards the electrical substation (at northeast of the Site). The access lane above the line is composed of concrete which was in a good condition.

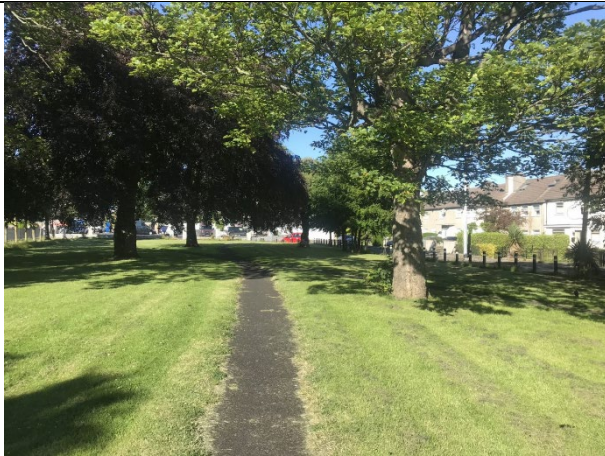
14-07 – No evidence of surface works, surface staining or dieback to the southwest of the Site within the park between O'Rourke Park and Sallynoggin Road.

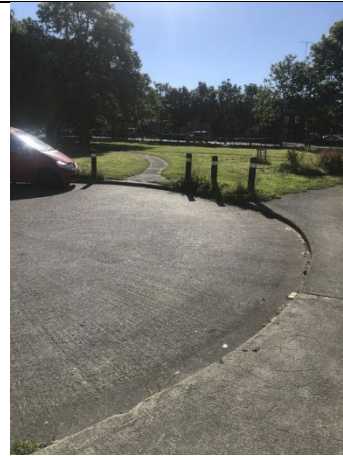
14-08 – No evidence of surface works, surface staining or dieback to the southwest of the Site at O'Rourke Park.
