ESB Networks Historic Cable Fluid Losses: Preliminary Site Assessment

Location 24: Blackrock – Ringsend 110 kV - 2010

Project Number: GCU0257001

April 2020

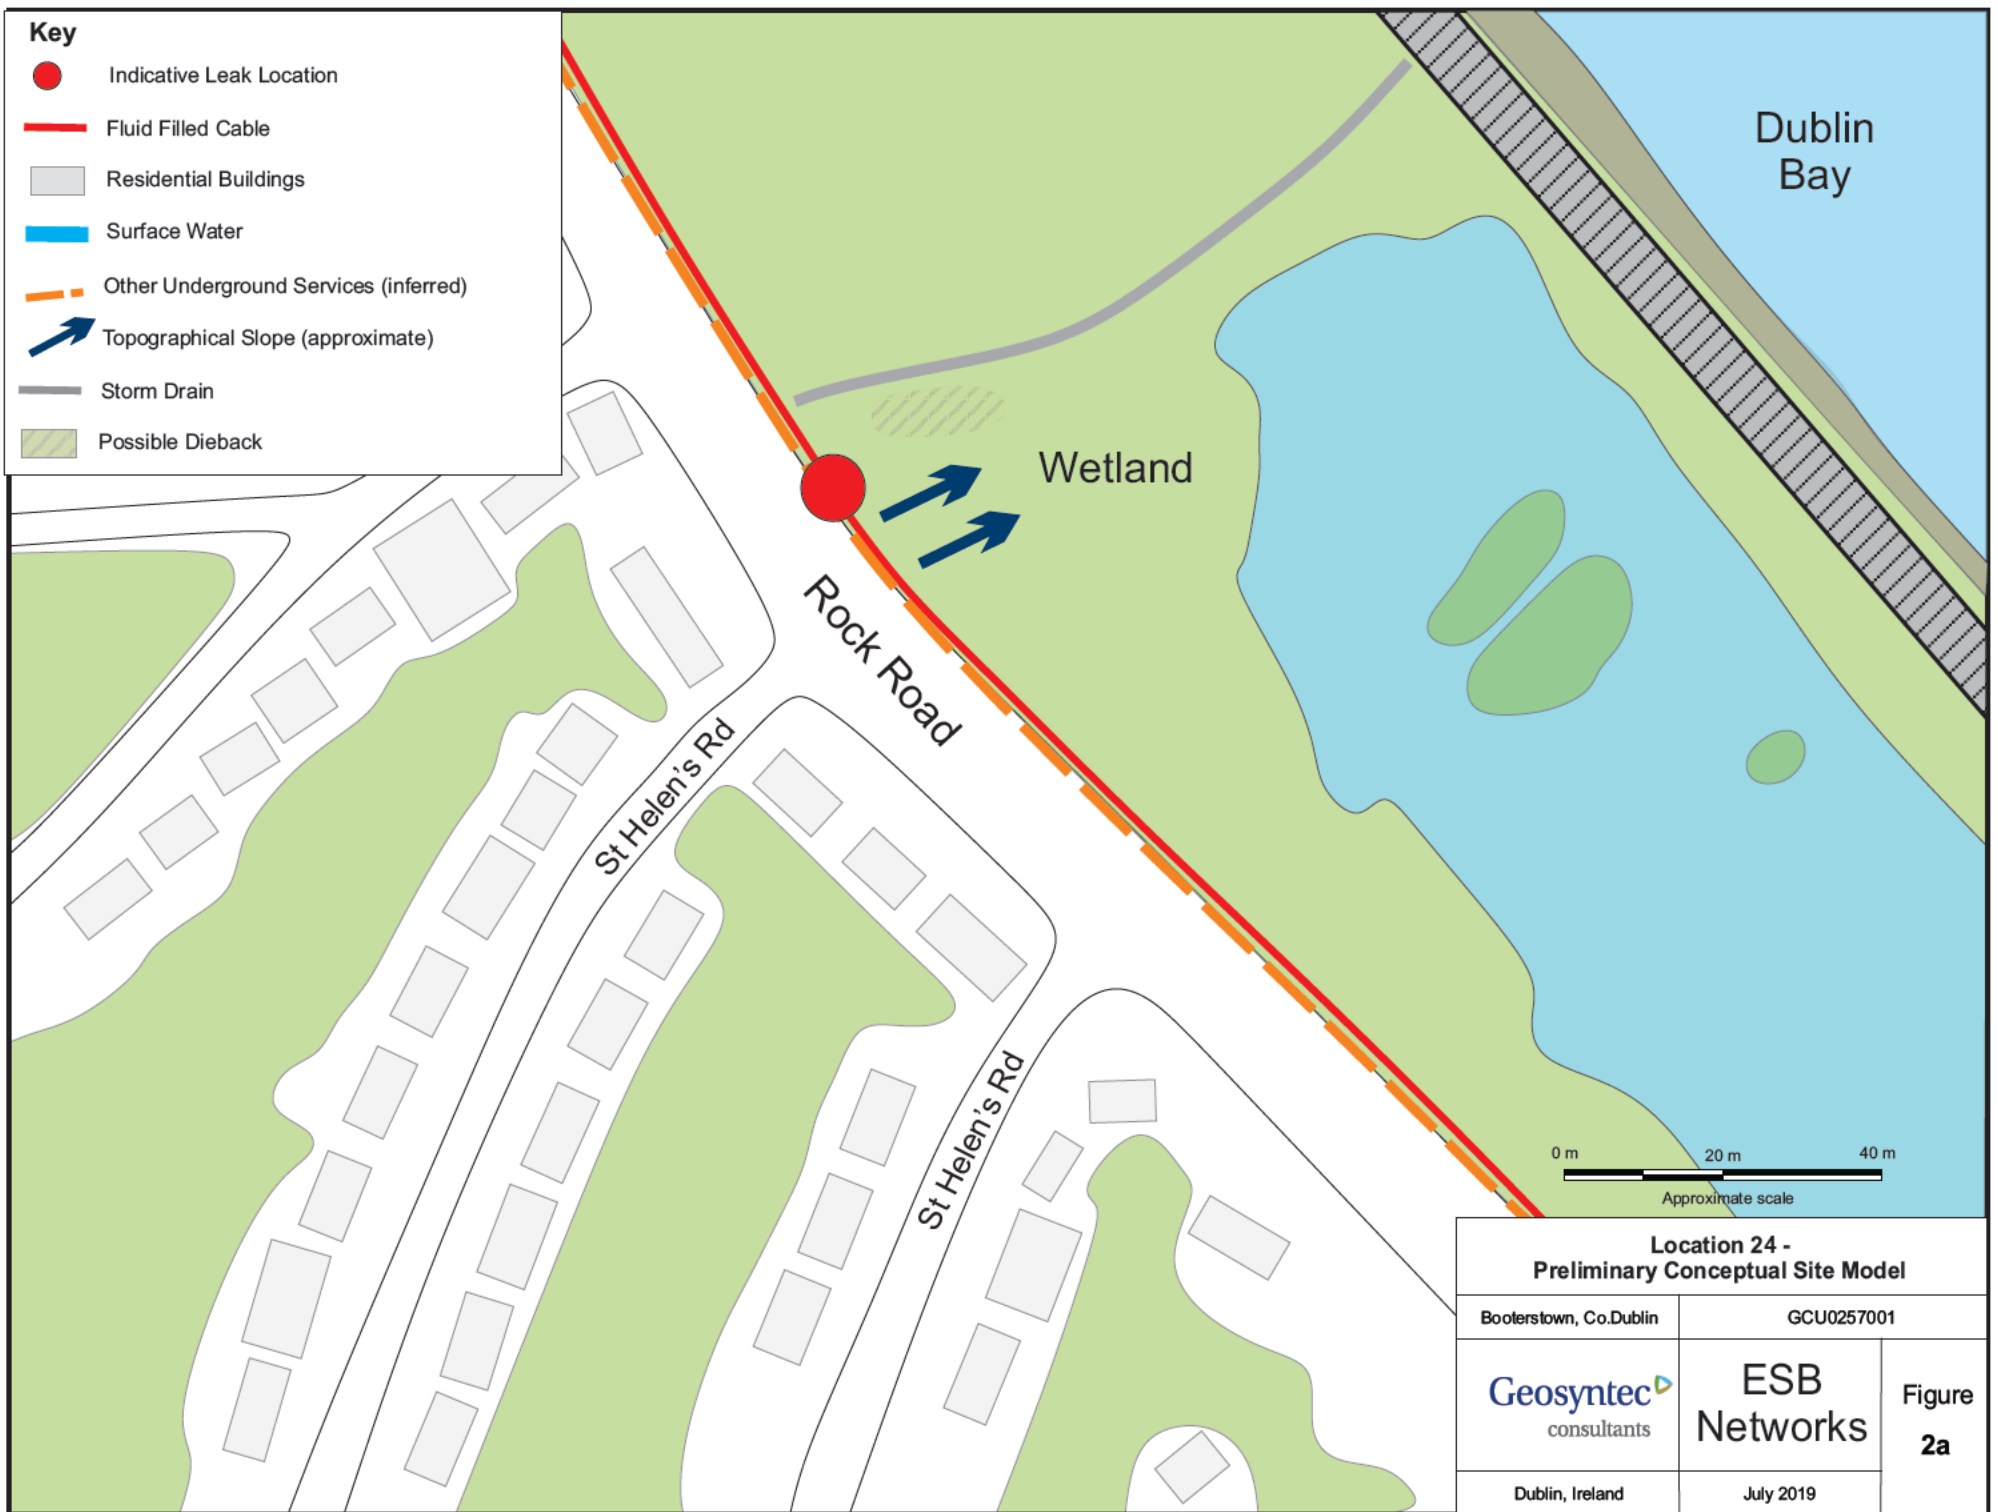
Location 24 - Preliminary Conceptual Site Model		
Booterstown, Co.Dublin	GCU0257001	
		Figure 2a
Dublin, Ireland	July 2019

Based on the expected low permeability of overburden material in the vicinity of the leak location, cable fluid lost to ground in this case can be expected to have spread laterally within the permeable sand bedding within the cable trench. If the cable trench intersects more permeable material (e.g. lenses of natural sands or gravels, or another in-filled services trench) this could result in cable fluid migrating from the line of the cable trench and along a different route or routes.

- Under the second scenario, there is potential for cable fluid to have reached the Booterstown Stream culvert, which is located approximately 30m north of the leak location;

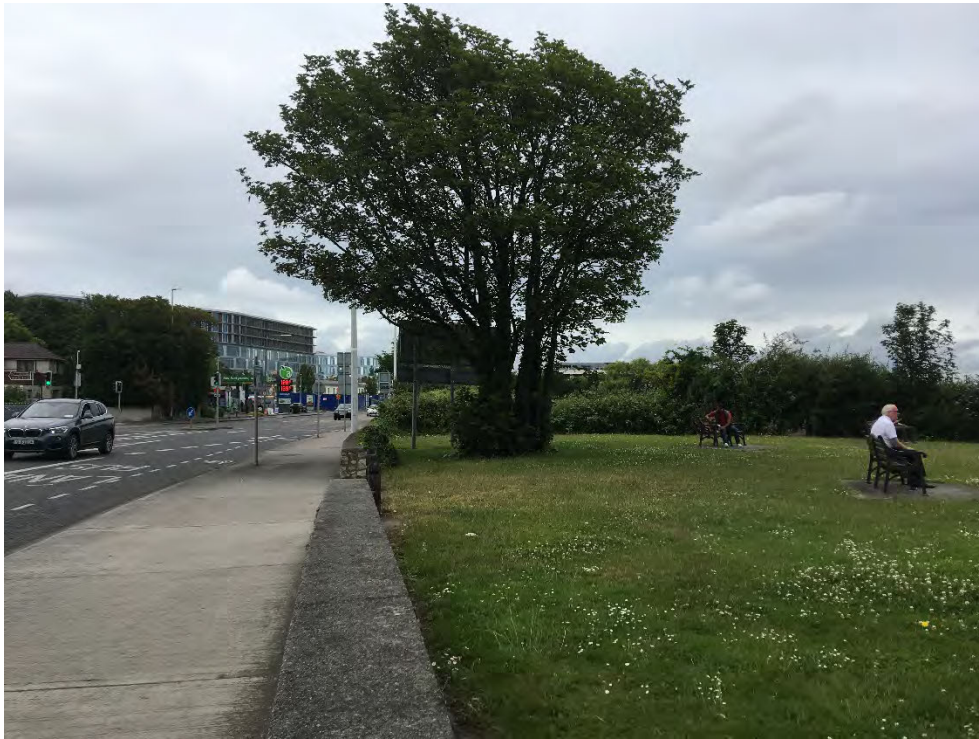
Photograph 1 – Leak location adjacent to Rock Road

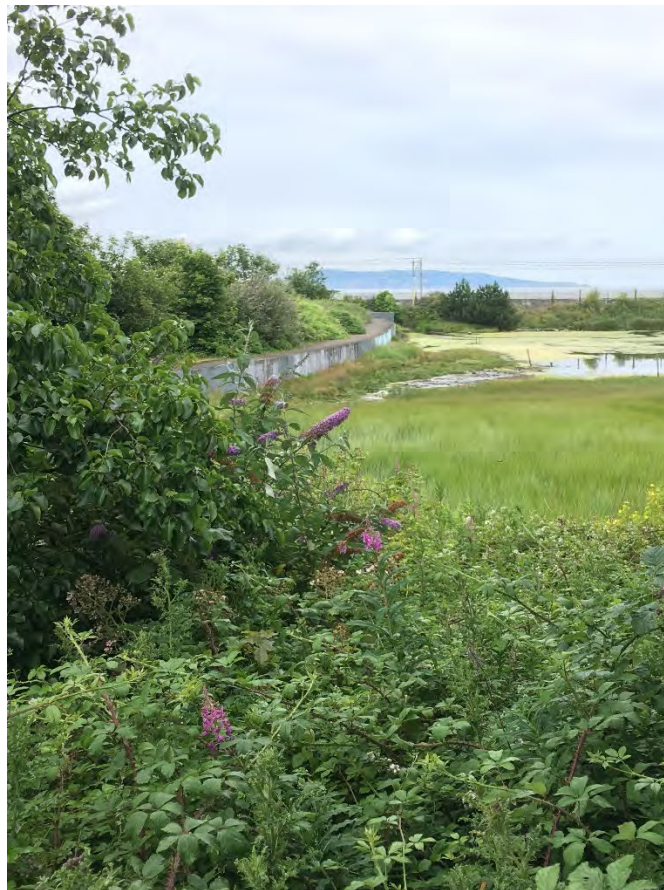
Photograph 2 – Looking east from leak location

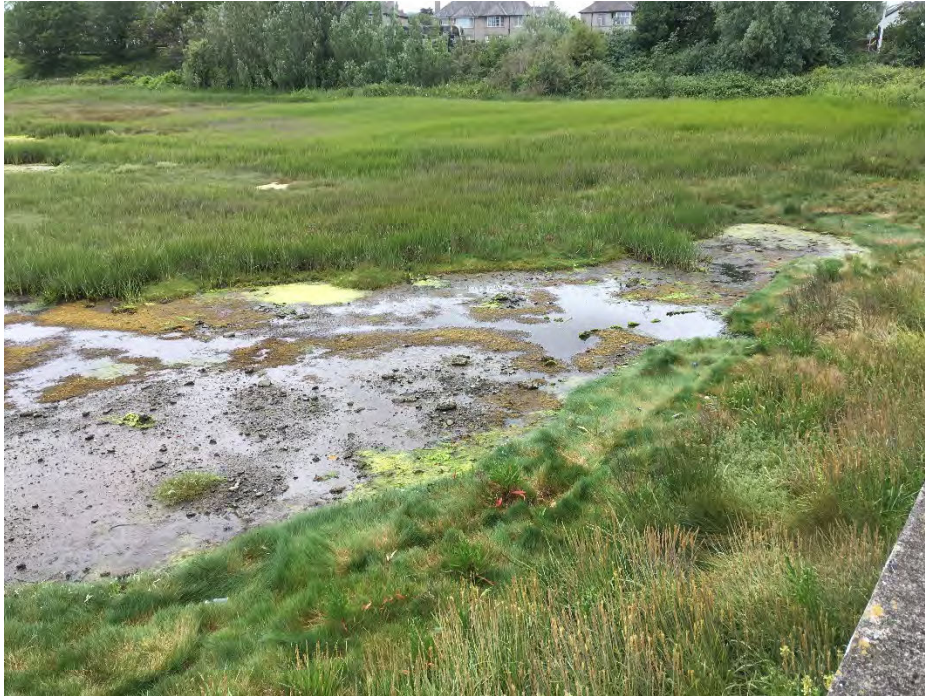
During the walkover survey, a localised area where there was no vegetation was observed close to the north-west corner of Booterstown Marsh, in an area approximately 50m north-east of the leak location and adjacent to the Booterstown Stream culvert (refer to Photograph 3 in Appendix A). As this area could not be accessed safely at the time of the walkover survey, this observation was made from a distance of approximately 10m. As such, this area was not inspected in detail. No oily sheen was observed on the surface of the water within or down-gradient of this area from the point of observation.

Photograph 3 – Possible die-back of vegetation east of leak location

More detailed assessment of the risk to Booterstown Marsh, Booterstown Stream, Dublin Bay in the vicinity of the Booterstown Stream discharge, and their associated ecosystems is recommended. Further investigation of the risk to water mains and the bedrock aquifer is not considered necessary.

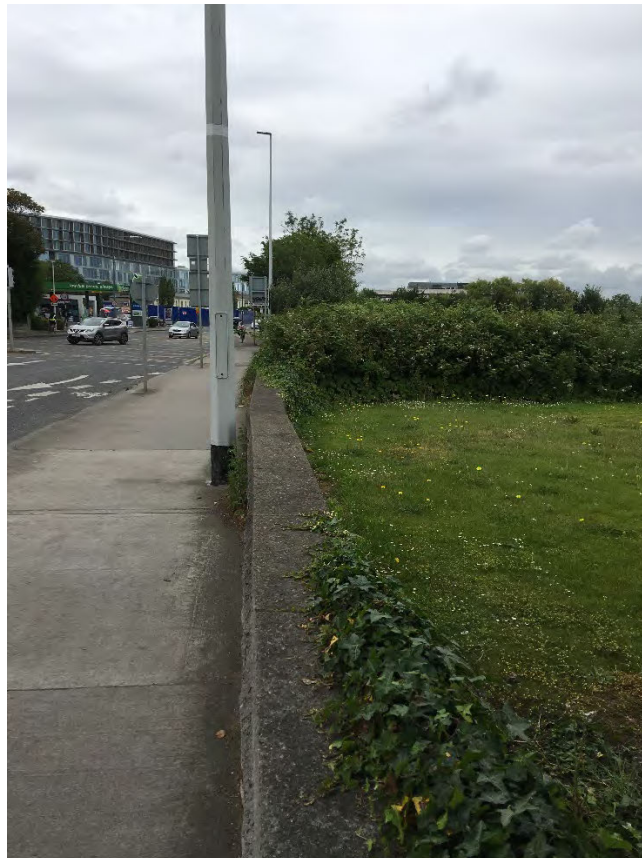
Photograph 4 – View north along Rock Road

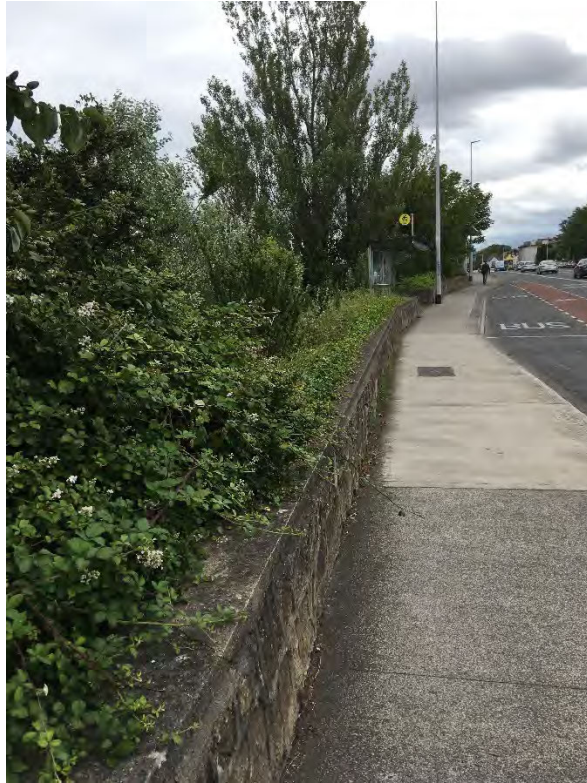
Photograph 5 – View south along Rock Road

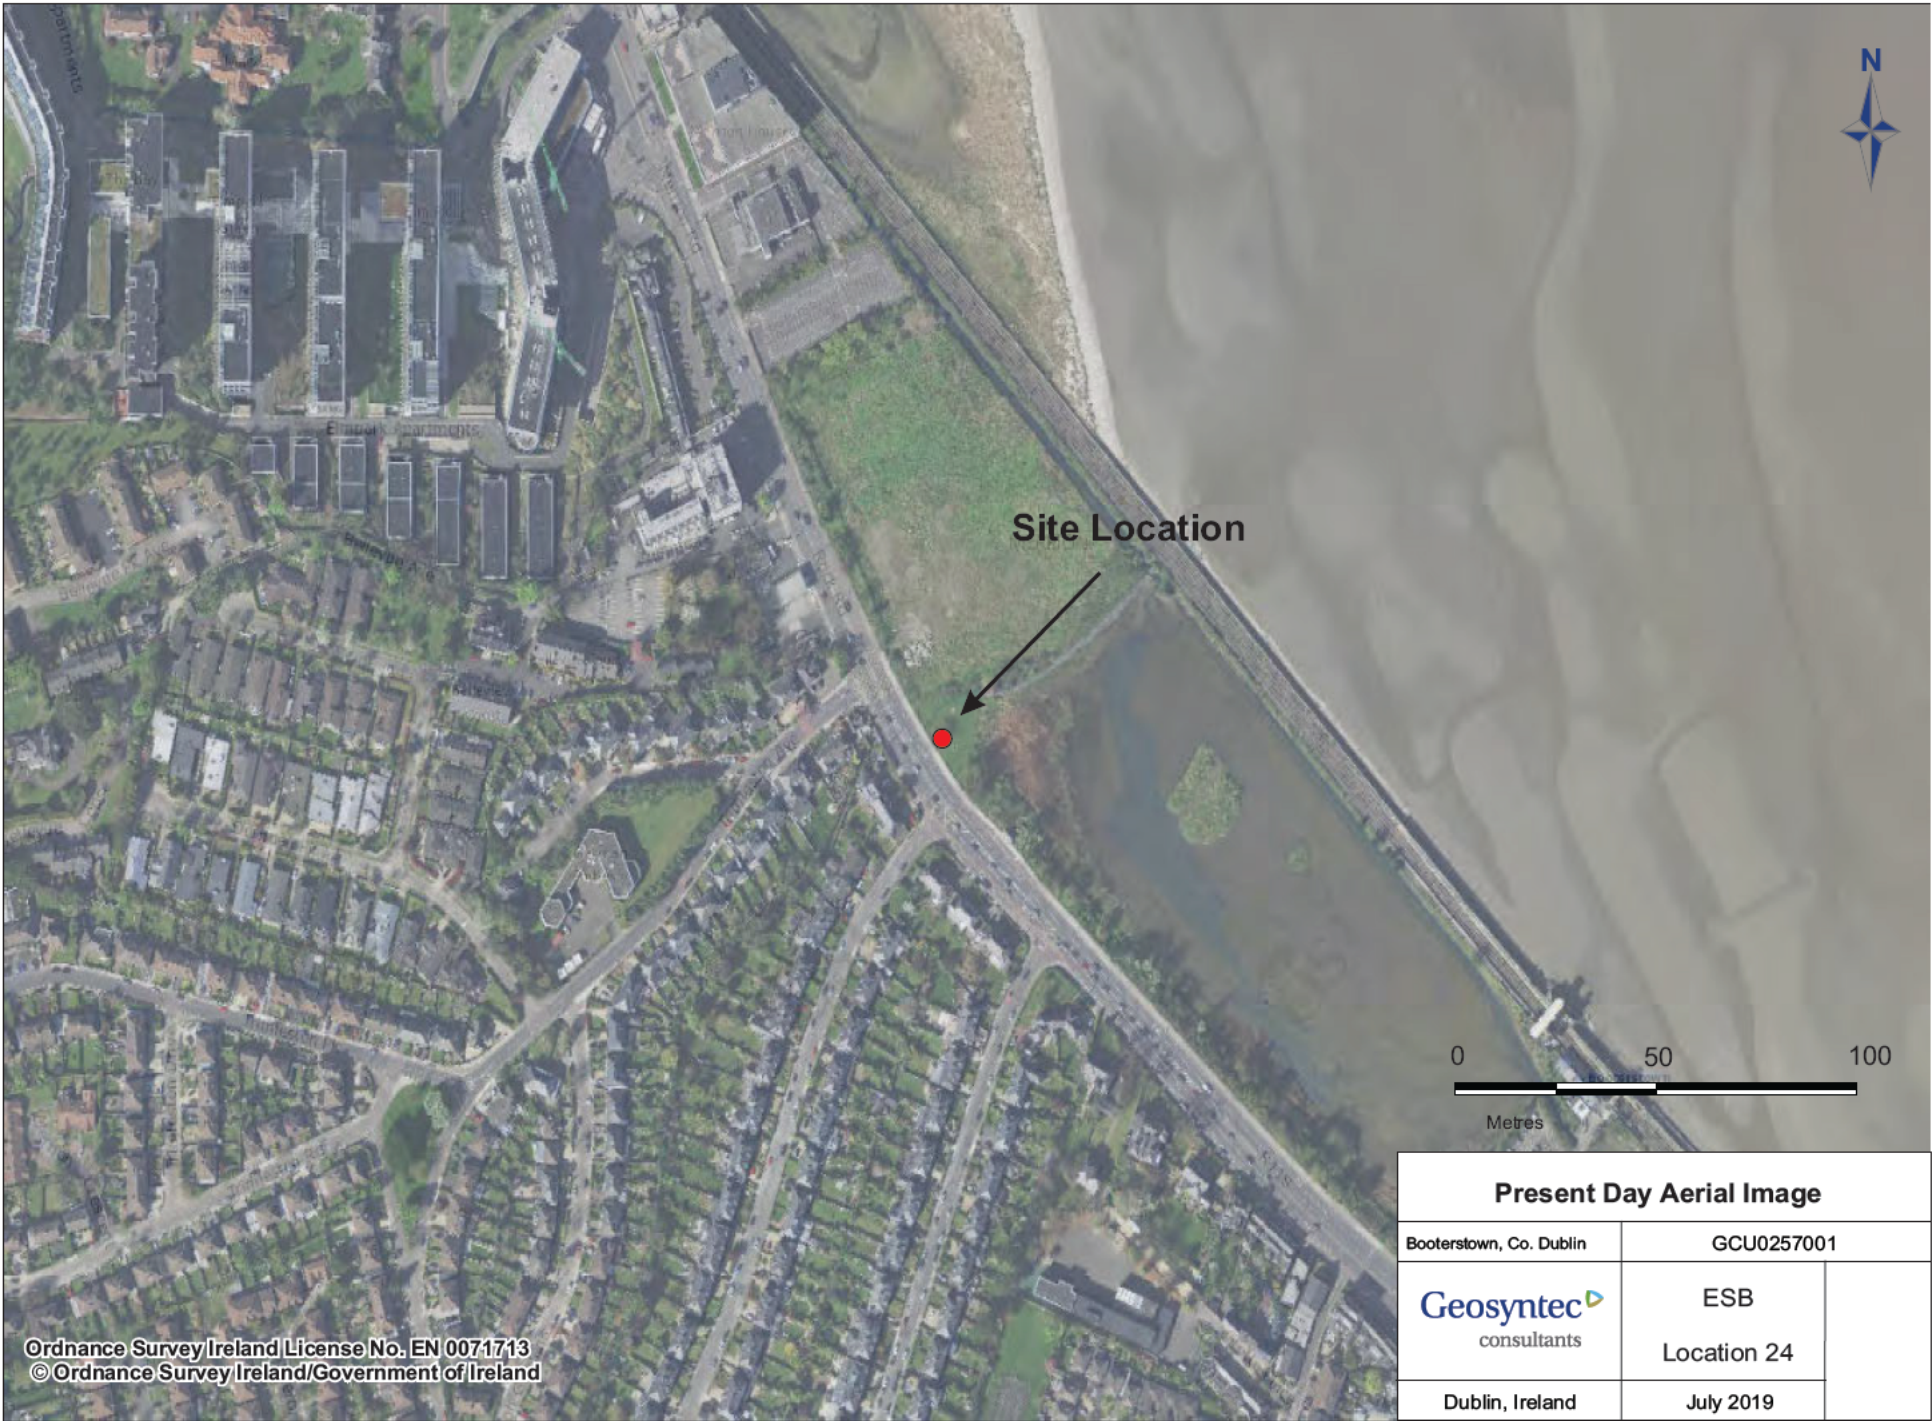
Present Day Aerial Image	
Boooterstown, Co. Dublin	GCU0257001
Geosyntec consultants	ESB
	Location 24
Dublin, Ireland	July 2019

The earliest aerial image available from OSI's website (other than 19th century historical maps) is dated 1995. This image shows the layout of the area close to the leak location similar to that observed today. The residential areas south-east of the leak location are evident and the area of former marsh north of the leak location has been infilled. The tramline along the Rock Road and Merrion Road to the north is no longer present.
