ESB Networks Historic Cable Fluid Losses: Preliminary Site Assessment

Location 8: Carrickmines - Poolbeg 220 kV - September 2016

Project Number: GCU0257001

February 2020

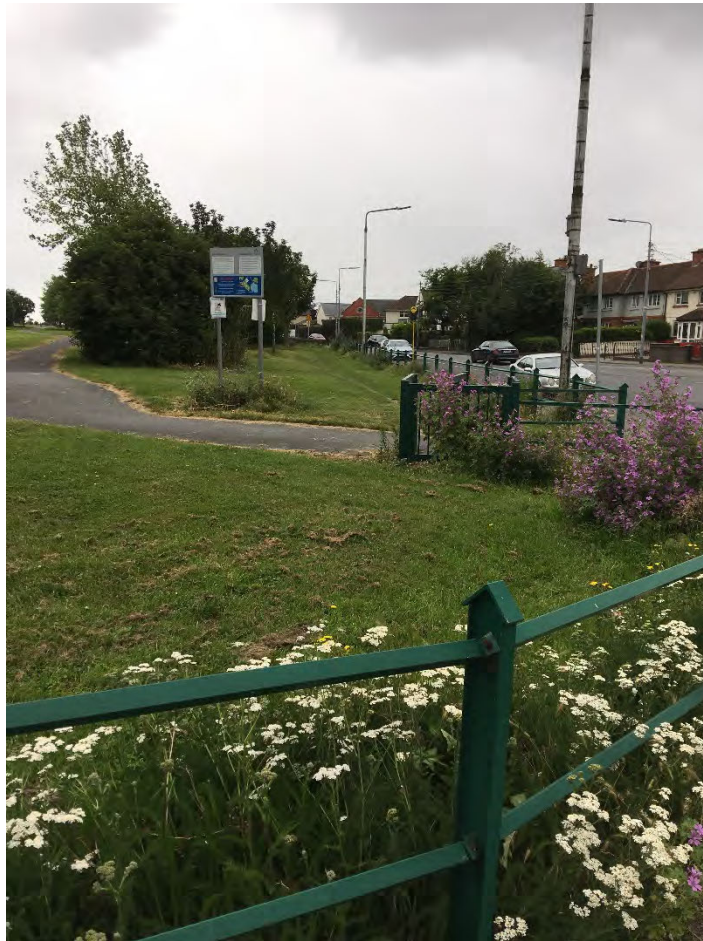
Photograph 1 – Leak location looking south

No evidence of stressed vegetation or die-back was observed in the vicinity of the leak location or along the cable route close to the leak location during the walkover survey.

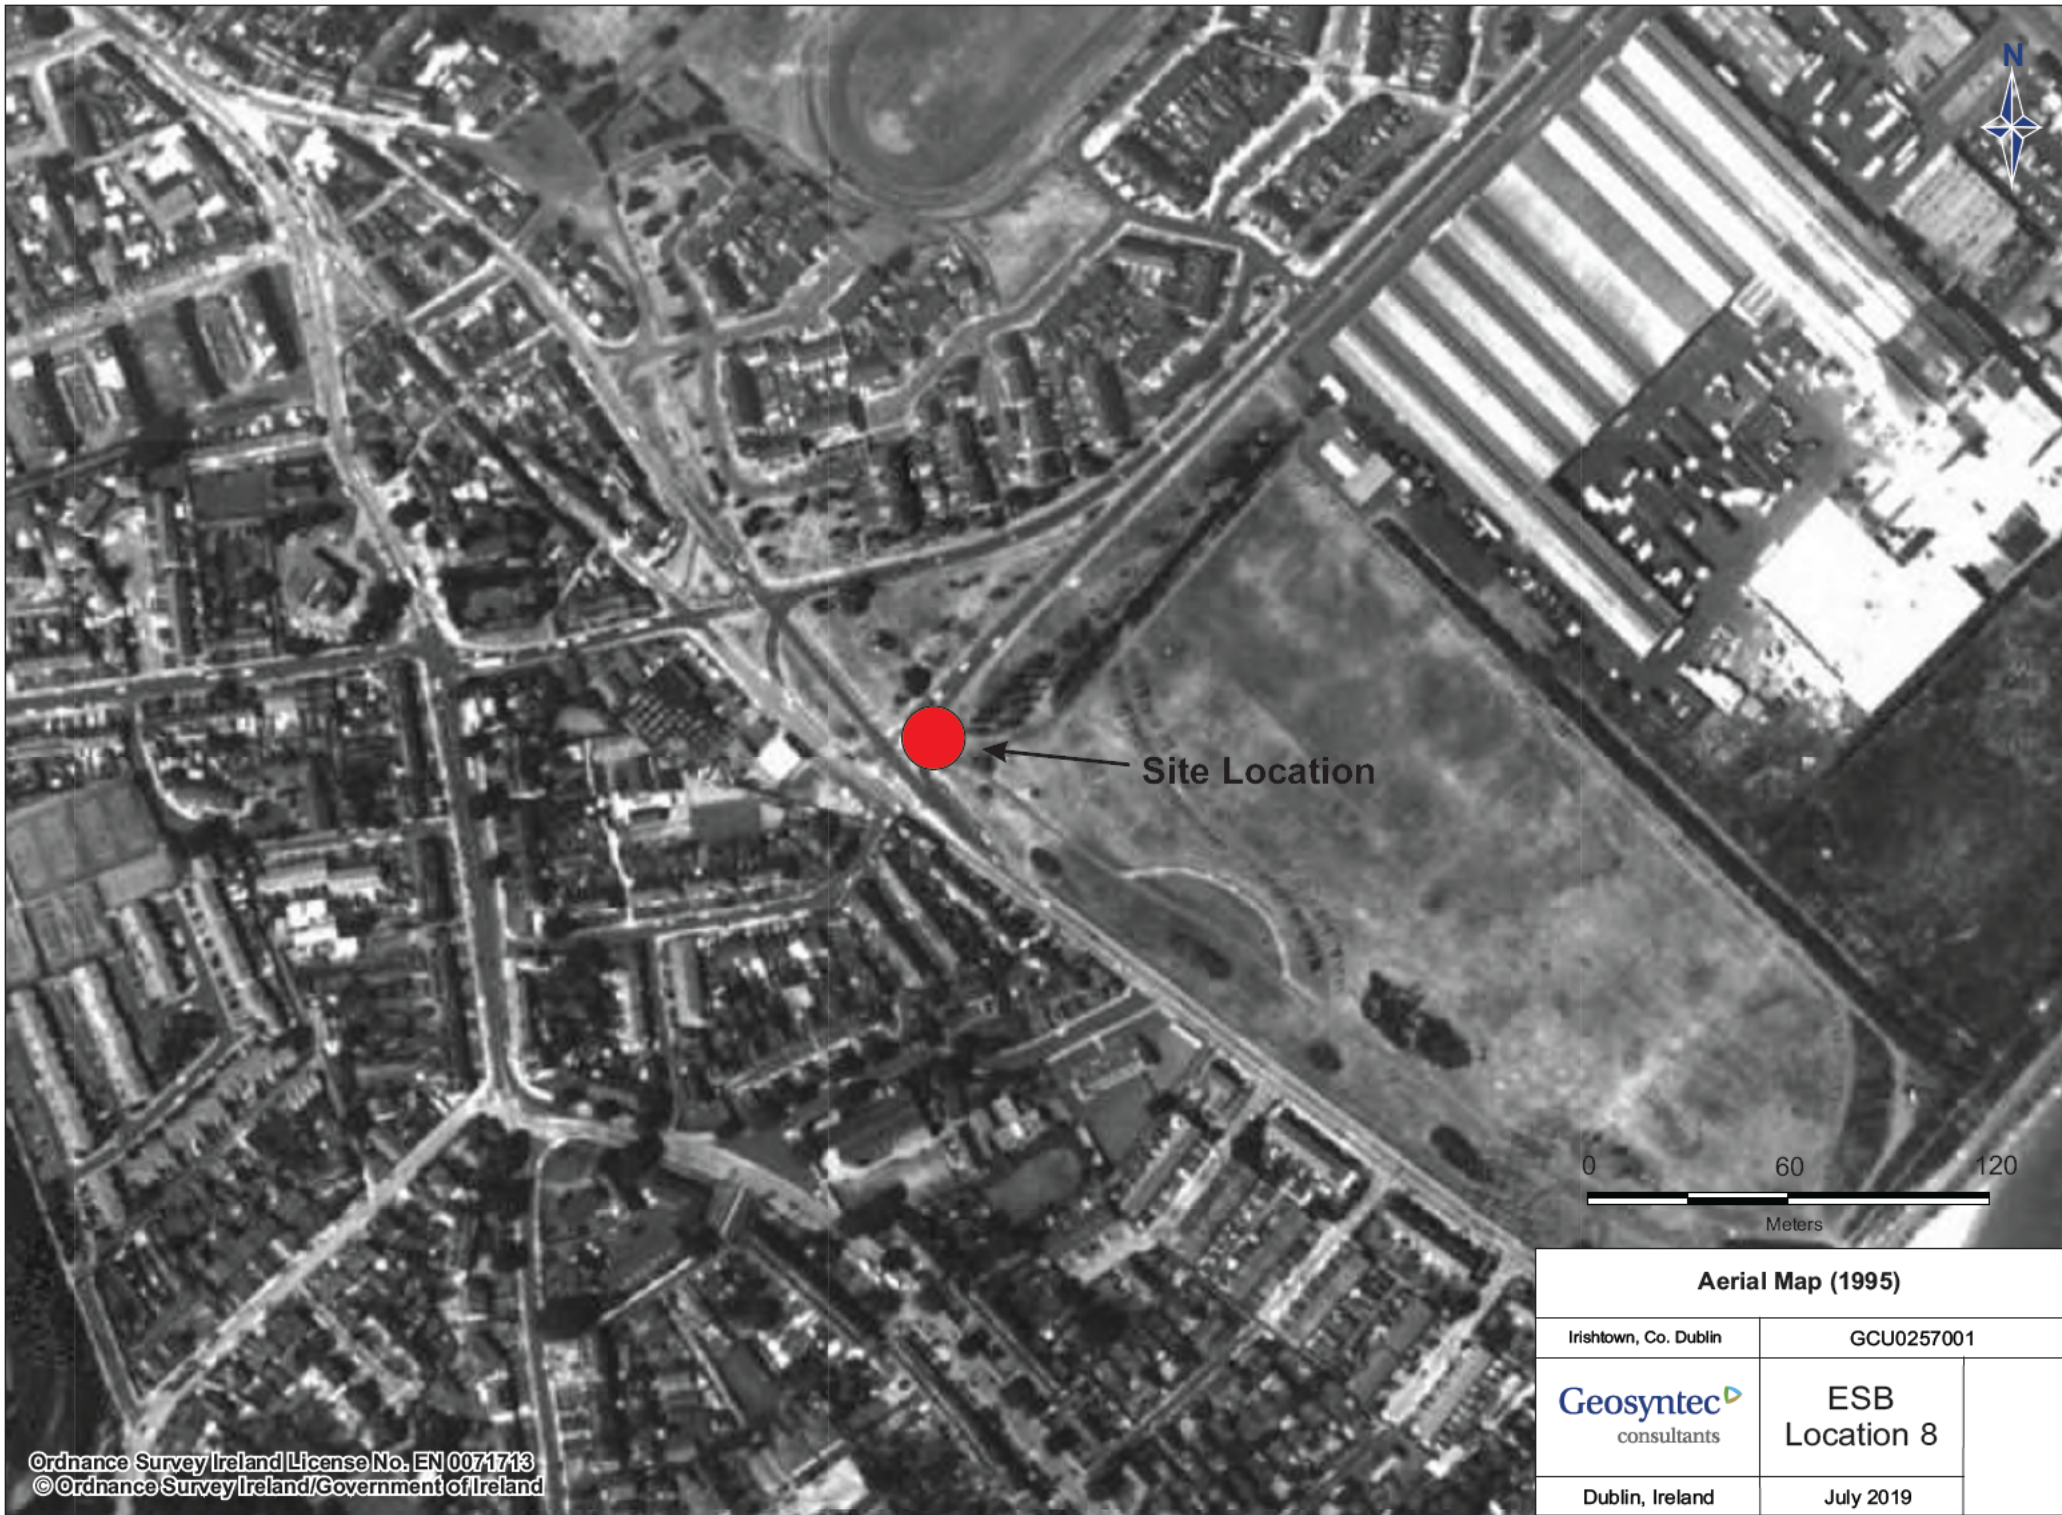
Aerial Map (1995)

The earliest aerial image available from OSI's website (other than 19th century historical maps) is dated 1995. The layout of the area on that map is similar to that observed today. The area north-east of Beach Road including the area that is now Sean Moore Park has been reclaimed from the mudflats of Dublin Bay.
