# Preliminary Site Assessment

Site 17 Francis Street - Harold's Cross 110 kV (July 2011 –  
November 2014)

Electricity Supply Board

Project number: PR-427640\_ACM\_RP\_ENV\_007\_5

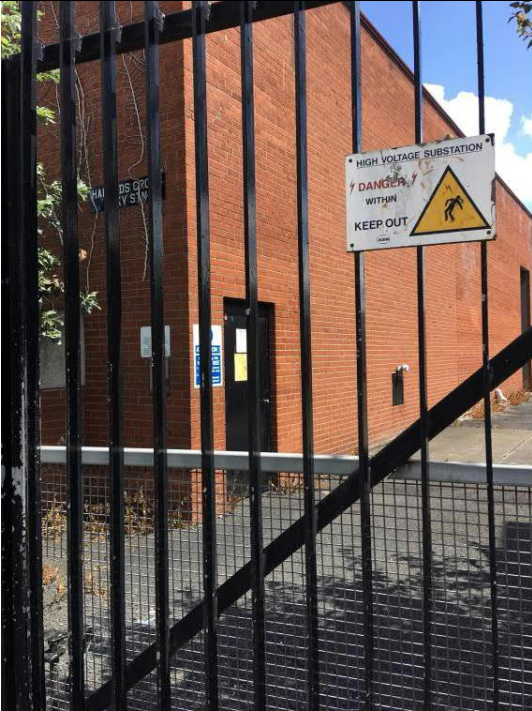
<p><b>Description</b></p> <p>Facing east on R137. Substation building has no access.</p>

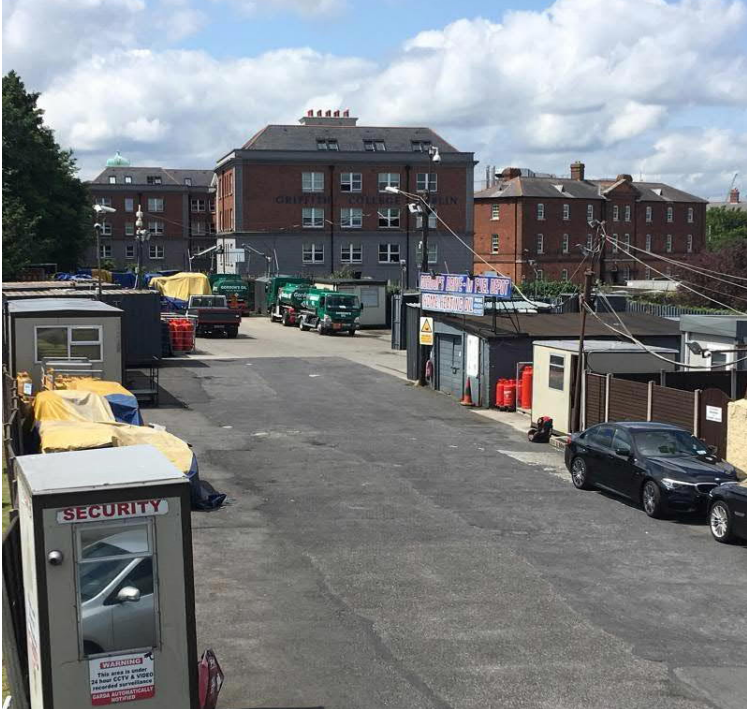
<p><b>Description</b></p> <p>Further north, across Grand Canal ‘Gordons Drive In Fuel Depot. Home Heating Oil’ is located. The area comprises of a main sales shop, multiple areas storing presumed gas cylinders, fuel truck parking and a number of portakabins.</p>

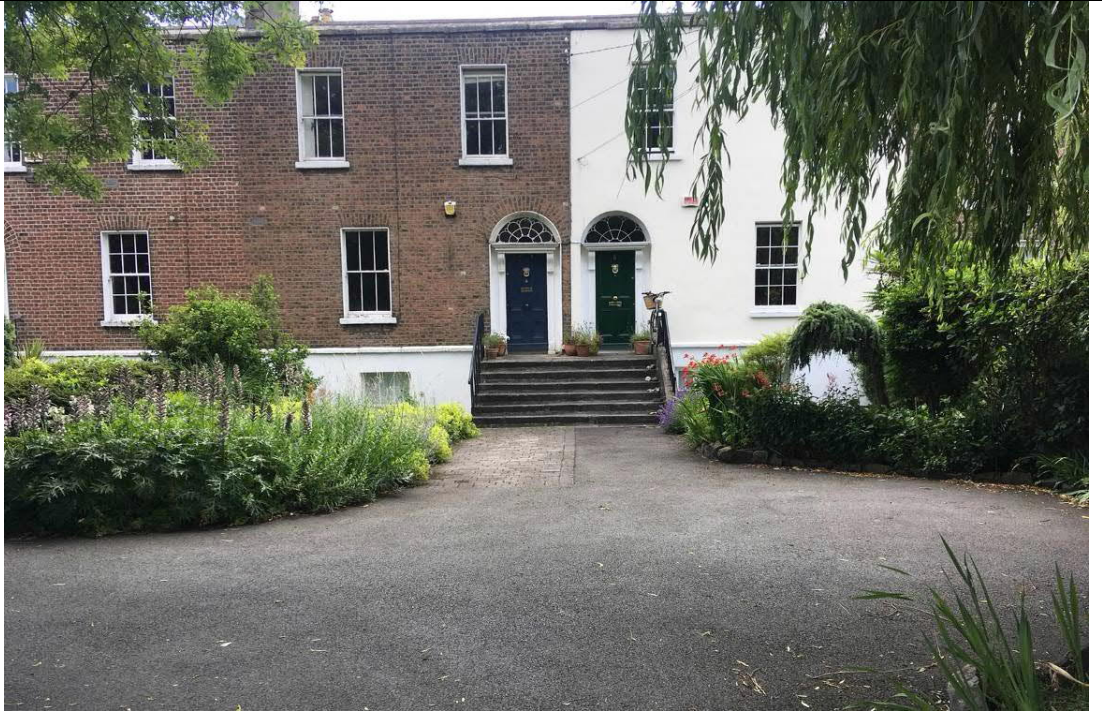
<p><b>Description</b>  Properties (2 – 7) located on Parnell Road (R111) have one story below ground level. After number two (2), none of the properties extended below ground level.</p>
