ESB Networks Historic Cable Fluid Losses: Preliminary Site Assessment

Location 12: Carrickmines – Poolbeg 220 kV – June 2015

February 2020

Report Ref: GCU0257001/001

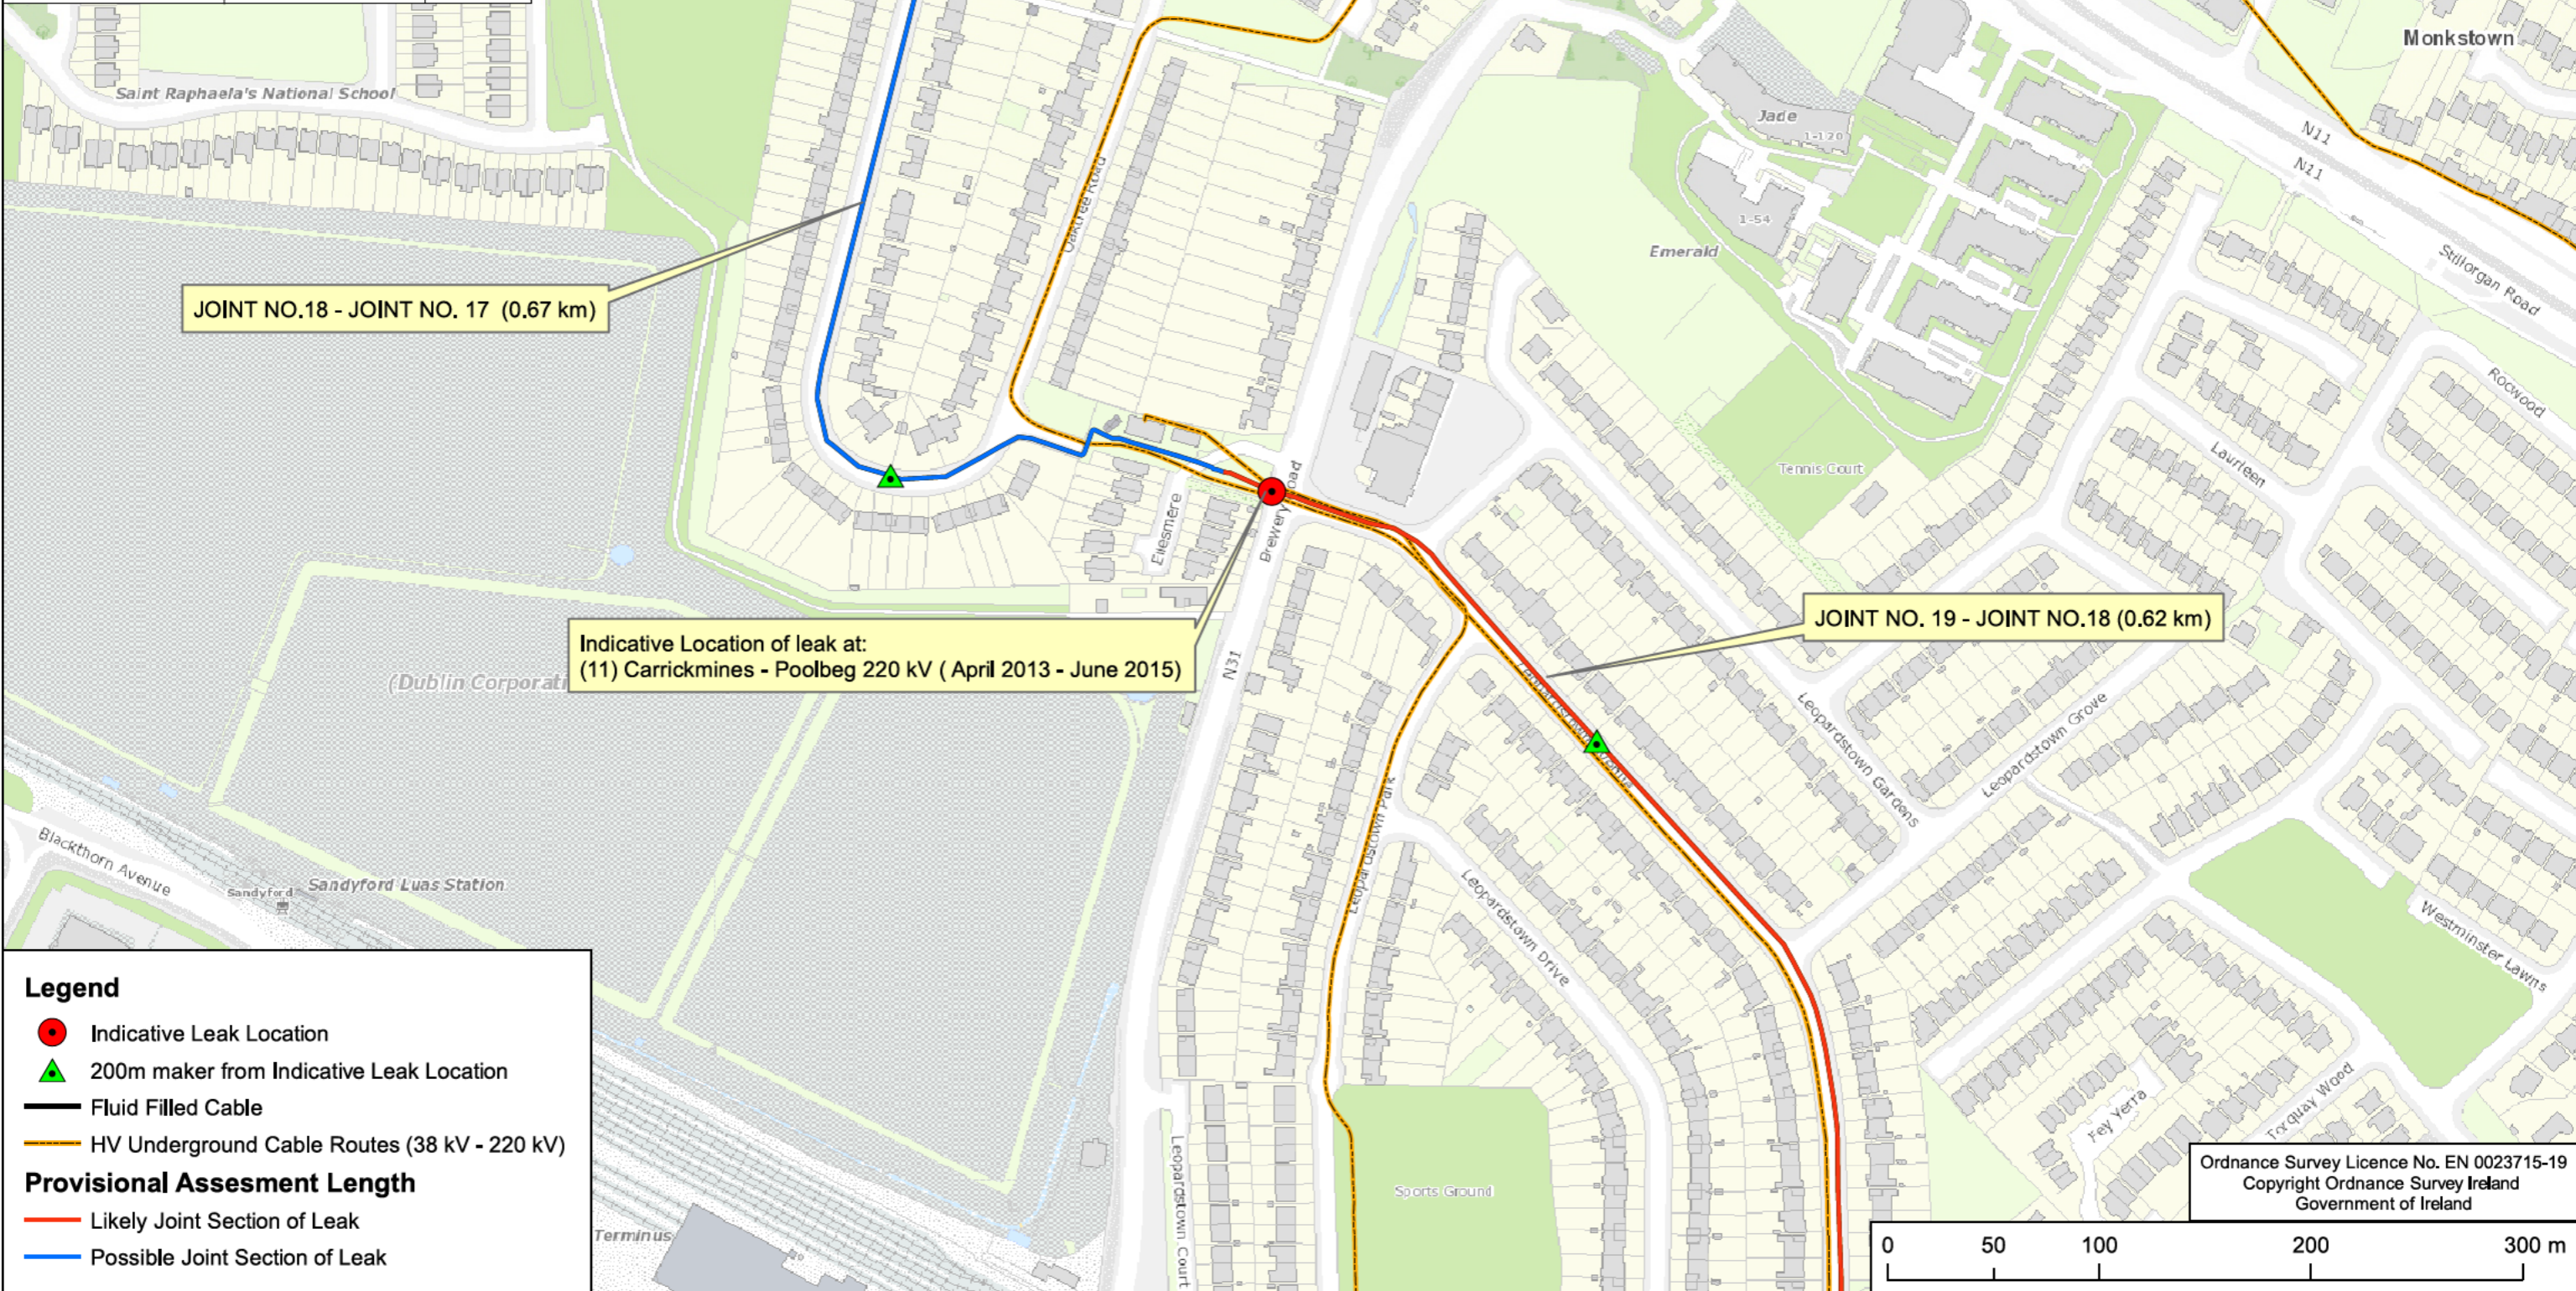
Figure 1 - Location 12

Geosyntec Consultants Ltd (Geosyntec) is pleased to present the Electricity Supply Board (ESB) this Preliminary Site Assessment (PSA), which relates to the potential environmental impacts associated with the historic loss of cable fluid from a section of underground cable located in Leopardstown, Co. Dublin. The alignment of the subject section of cable and the approximate location of the historic loss of cable fluid is illustrated in ESB Drawing Number QD-354120-01-D460-001-016-001 (Figure 1).
