# Preliminary Site Assessment

Site 23 Bedford Row - Francis Street 38 kV (September  
2011)

Electricity Supply Board

Project number: PR-427640\_ACM\_RP\_ENV\_010\_4

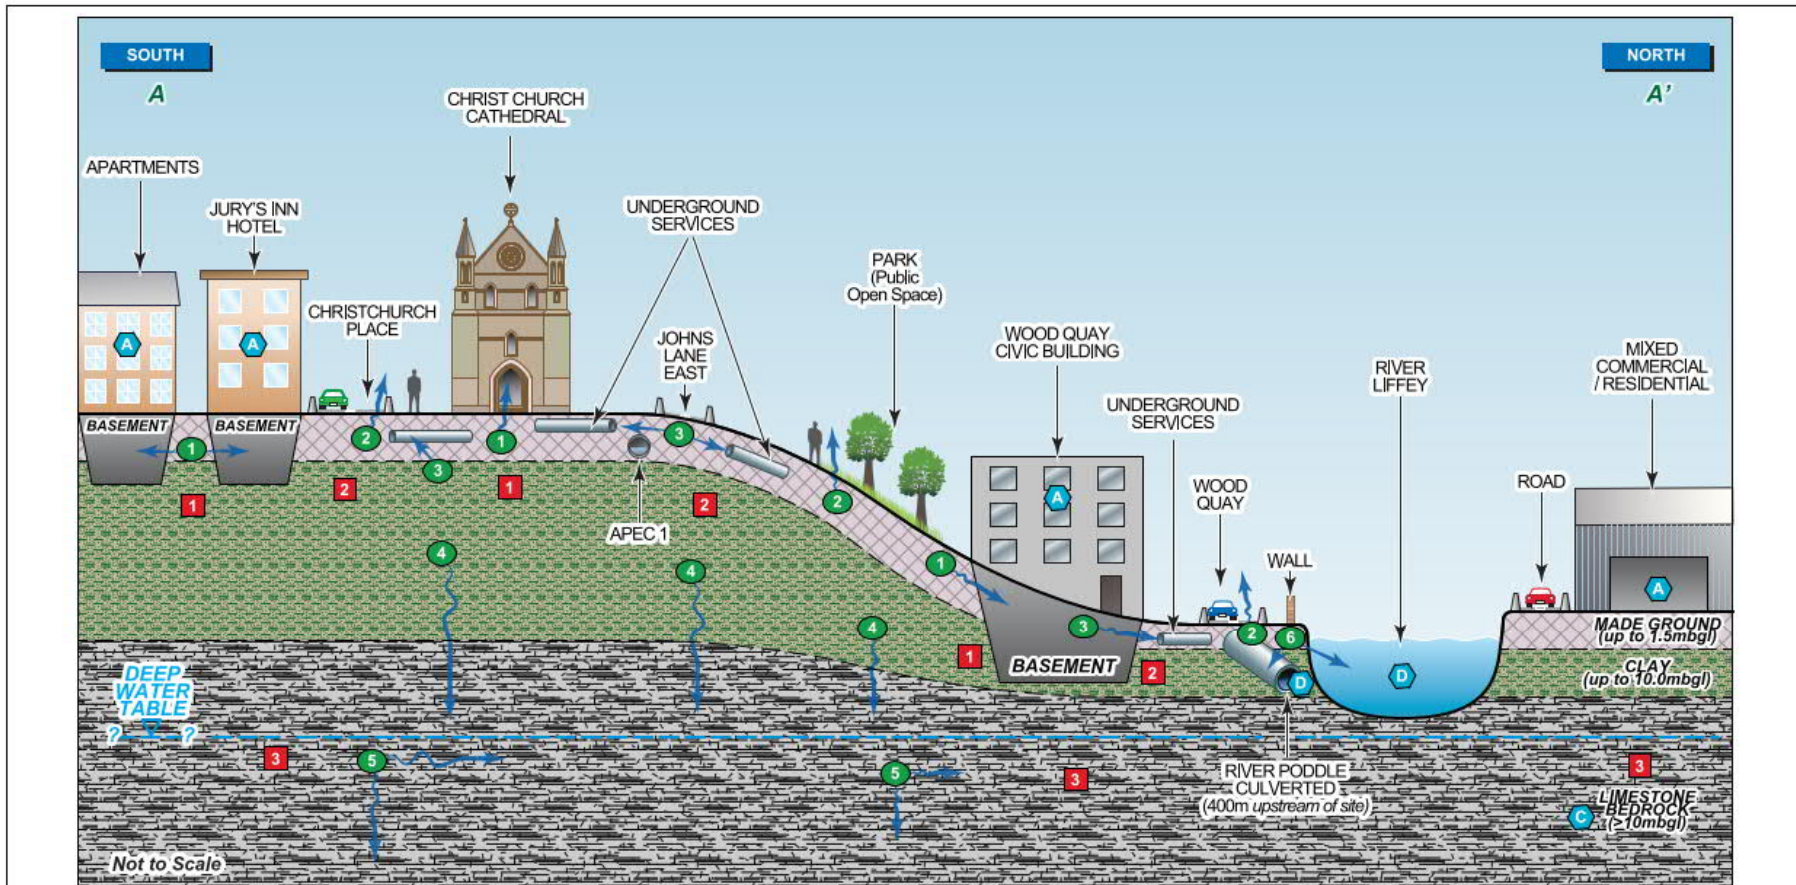
Title	FIGURE 3 CONCEPTUAL SITE MODEL
-------	-----------------------------------

Risks associated with other potential source-pathway-receptor linkages were considered to be very low to low.

The risk assessment completed herein is preliminary in nature as it can only be based on an evaluation of qualitative data sources (i.e. not on intrusive site investigation works). Consequently, identification of potential risk does not necessarily indicate a risk to a receptor, rather that further assessment may be required to investigate assumptions made in the CSM and quantify whether a potential risk actually exists. Generally, where a low or very low risk has been identified further assessment may not be deemed necessary to assess a particular SPR linkage, although further assessment may be deemed to be required to investigate CSM assumptions where the potential risk is considered to be low or very low due to the sensitivity of the receptor.

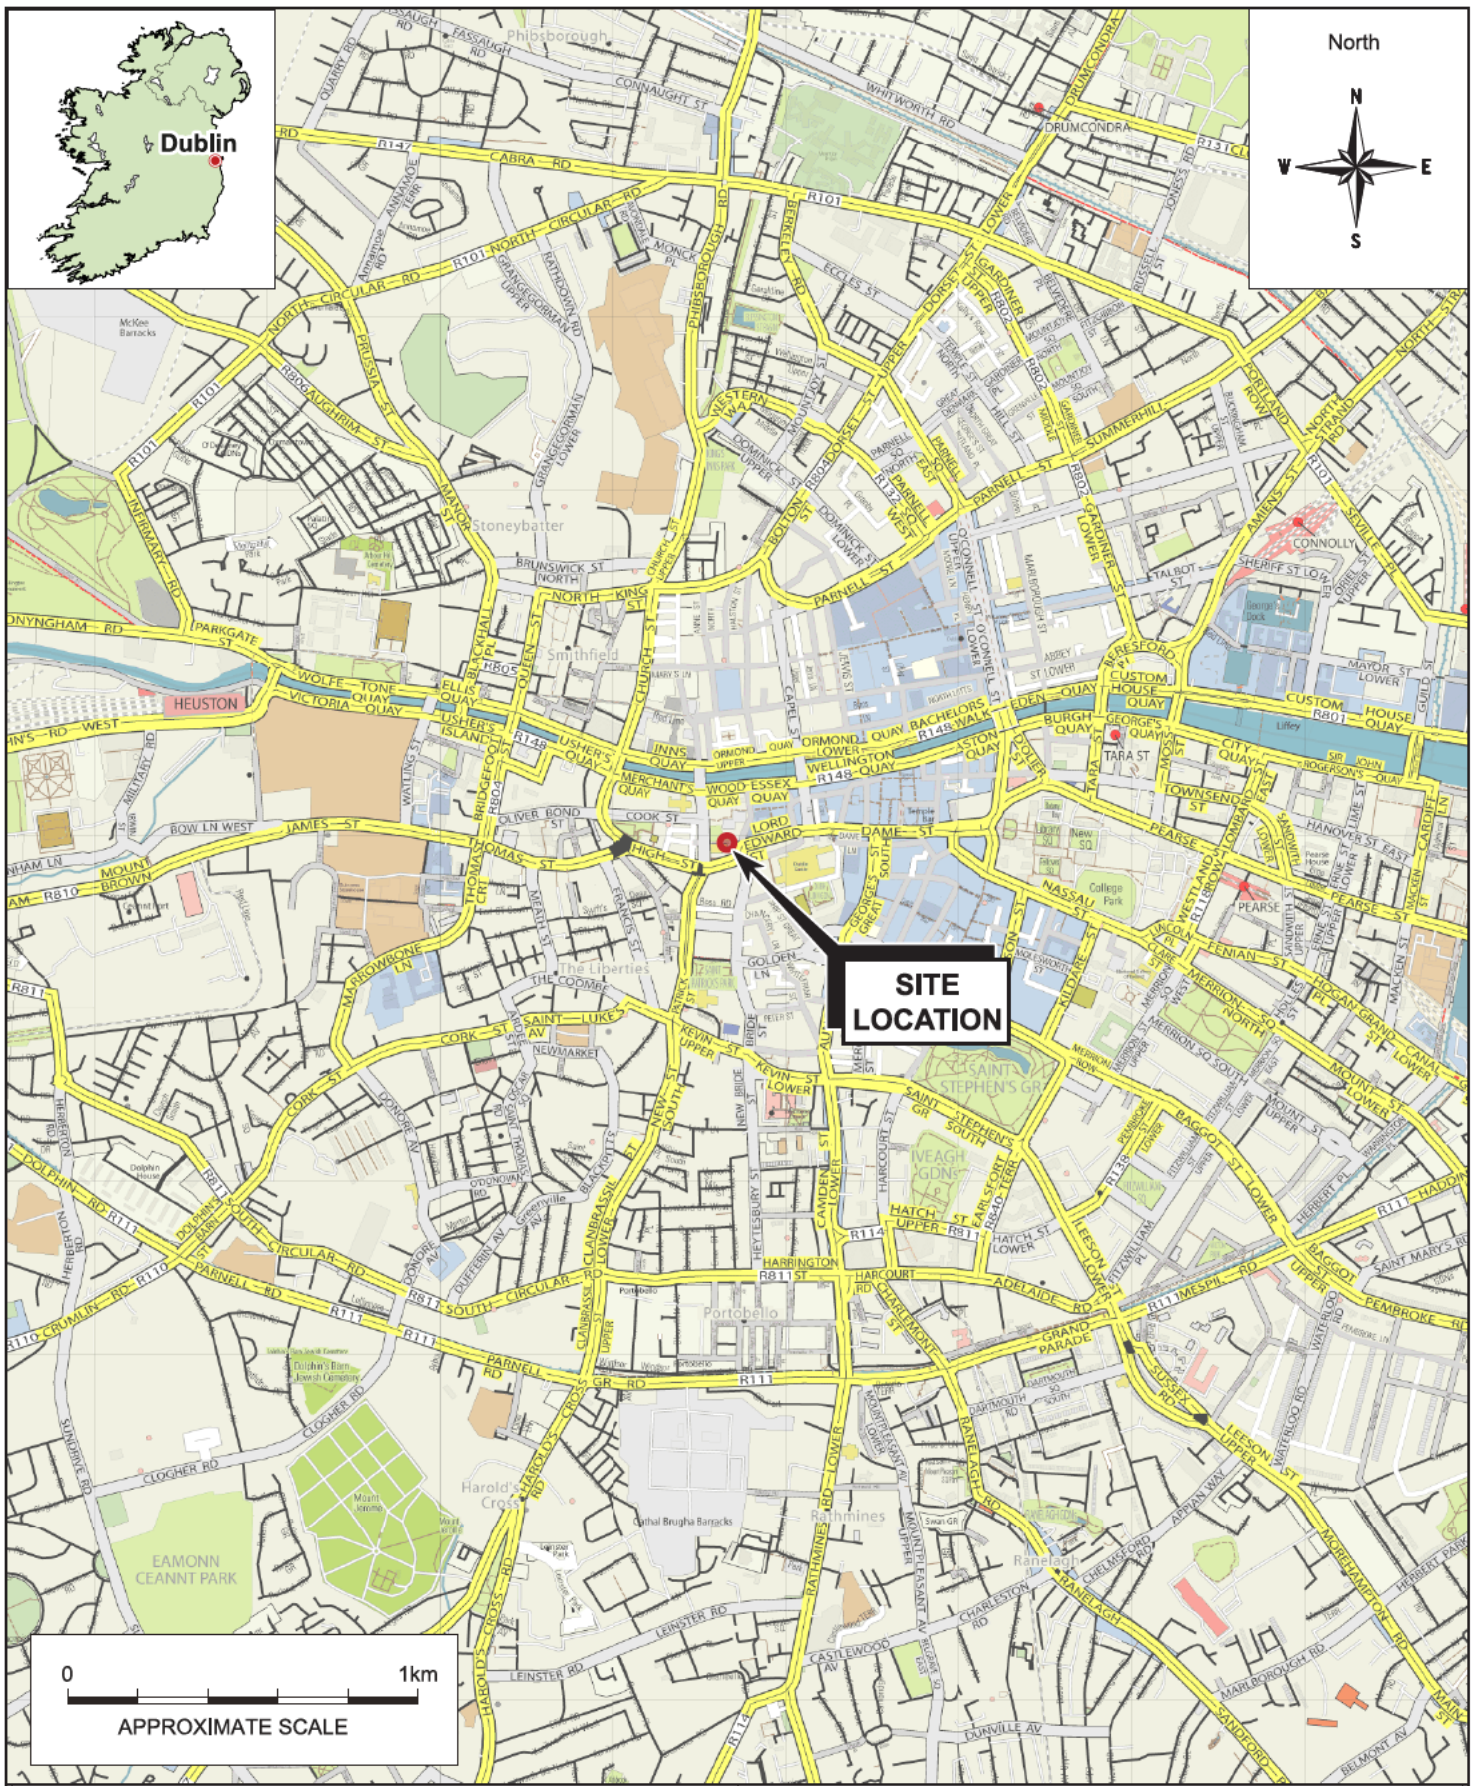
Title:	<b>FIGURE 2</b> SITE LAYOUT PLAN
--------	-------------------------------------

The site is situated on John's Lane East, immediately north of Christchurch Cathedral in Dublin City Centre to the south of the River Liffey. The leak site was located along a 400 m long section of a 38 kV cable running from Bedford Row to Francis Street. The cable was installed in 1967 and is 1.4 km in its entire length (see Figure 2). The location of the leak at cable joint (UG5827-UG5809) is situated immediately adjacent to the northern side of Christchurch Cathedral and approximately 170 m south of the River Liffey at Wood Quay. It is estimated that fluid loss from the cable was 5,396 litres up to that date when it was repaired in September 2011.

No evidence of impact from the cable fluid release was noted during the site walkover. With the exception of a park area to the north the leak site itself and wider area is urbanised and generally paved, and as such, there were no visible signs of contamination. There were no visual signs of any surface staining or vegetation dieback in the park area immediately north of the leak location.

Based on the assessment works completed, the primary Area of Potential Environmental Concern (APEC) for this site comprises the leak location identified by ESB. This is presented in Figure 2 and a description is provided in Table 7.
