Preliminary Site Assessment Report for Sallynoggin Road, Sallynoggin, Co. Dublin

ESB Site Ref: 26
Deansgrange - Sallynoggin 38kV

Project Title: ESB Networks Historic Fluid Filled Cable Loss
Environmental Assessment

Report Ref: Stage 1 Preliminary Site Assessment Report for Sallynoggin Road, Sallynoggin, Co. Dublin. EPA Ref: 26 Deansgrange – Sallynoggin 38kV

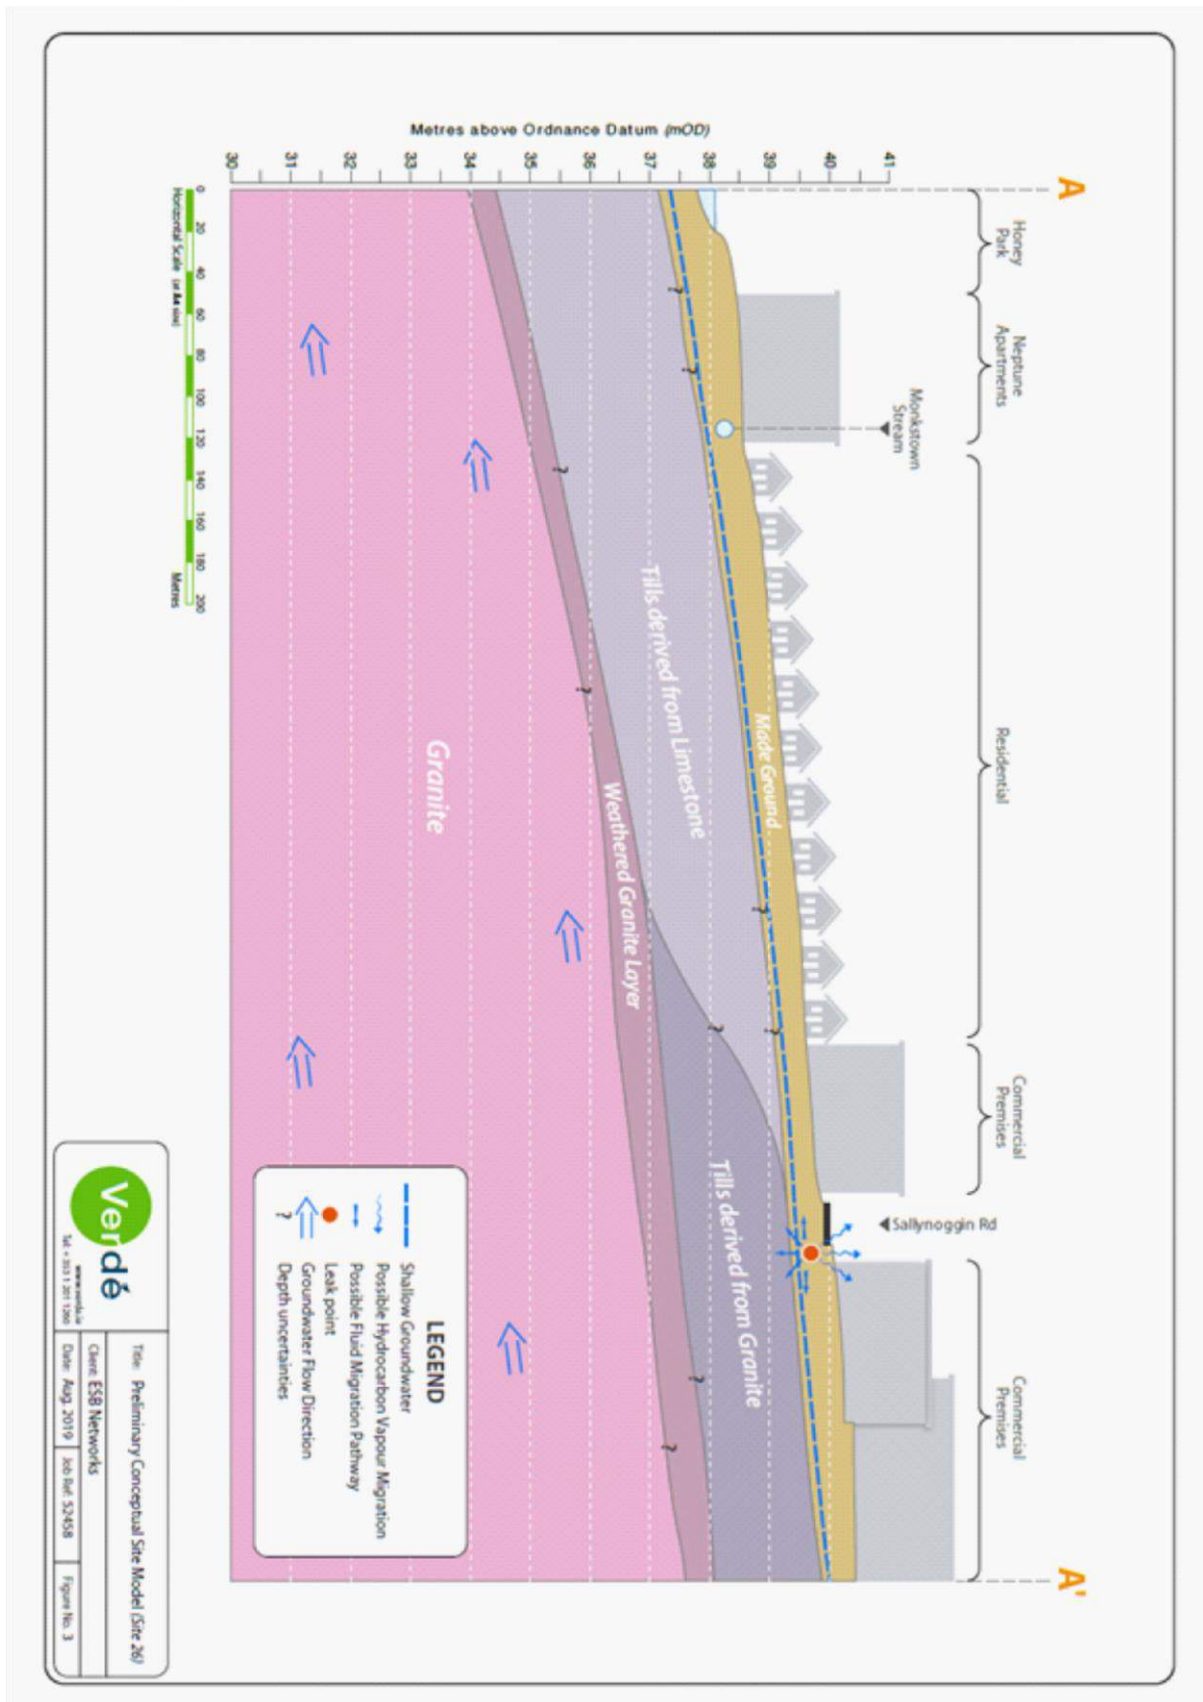
Figure 3 – Conceptual Site Model

The preliminary site conceptual model illustrating the contamination source, possible pathways and receptors is presented in Figures 3 and 4 and discussed in detail in this report.

A critical element of the risk assessment process is the establishment of a Conceptual Site Model (CSM) for the land and groundwater environment. A CSM describes the potential sources of contamination at a site, the migration pathways it may follow and the receptors it could impact. If complete source-pathway-receptor scenarios exist, then there is a potential pollutant linkage that needs to be characterised and assessed (via formal risk assessment). The CSM is updated as more information is gathered from subsequent desk studies and site investigations with a preliminary CSM presented in Figures 3 and 4.

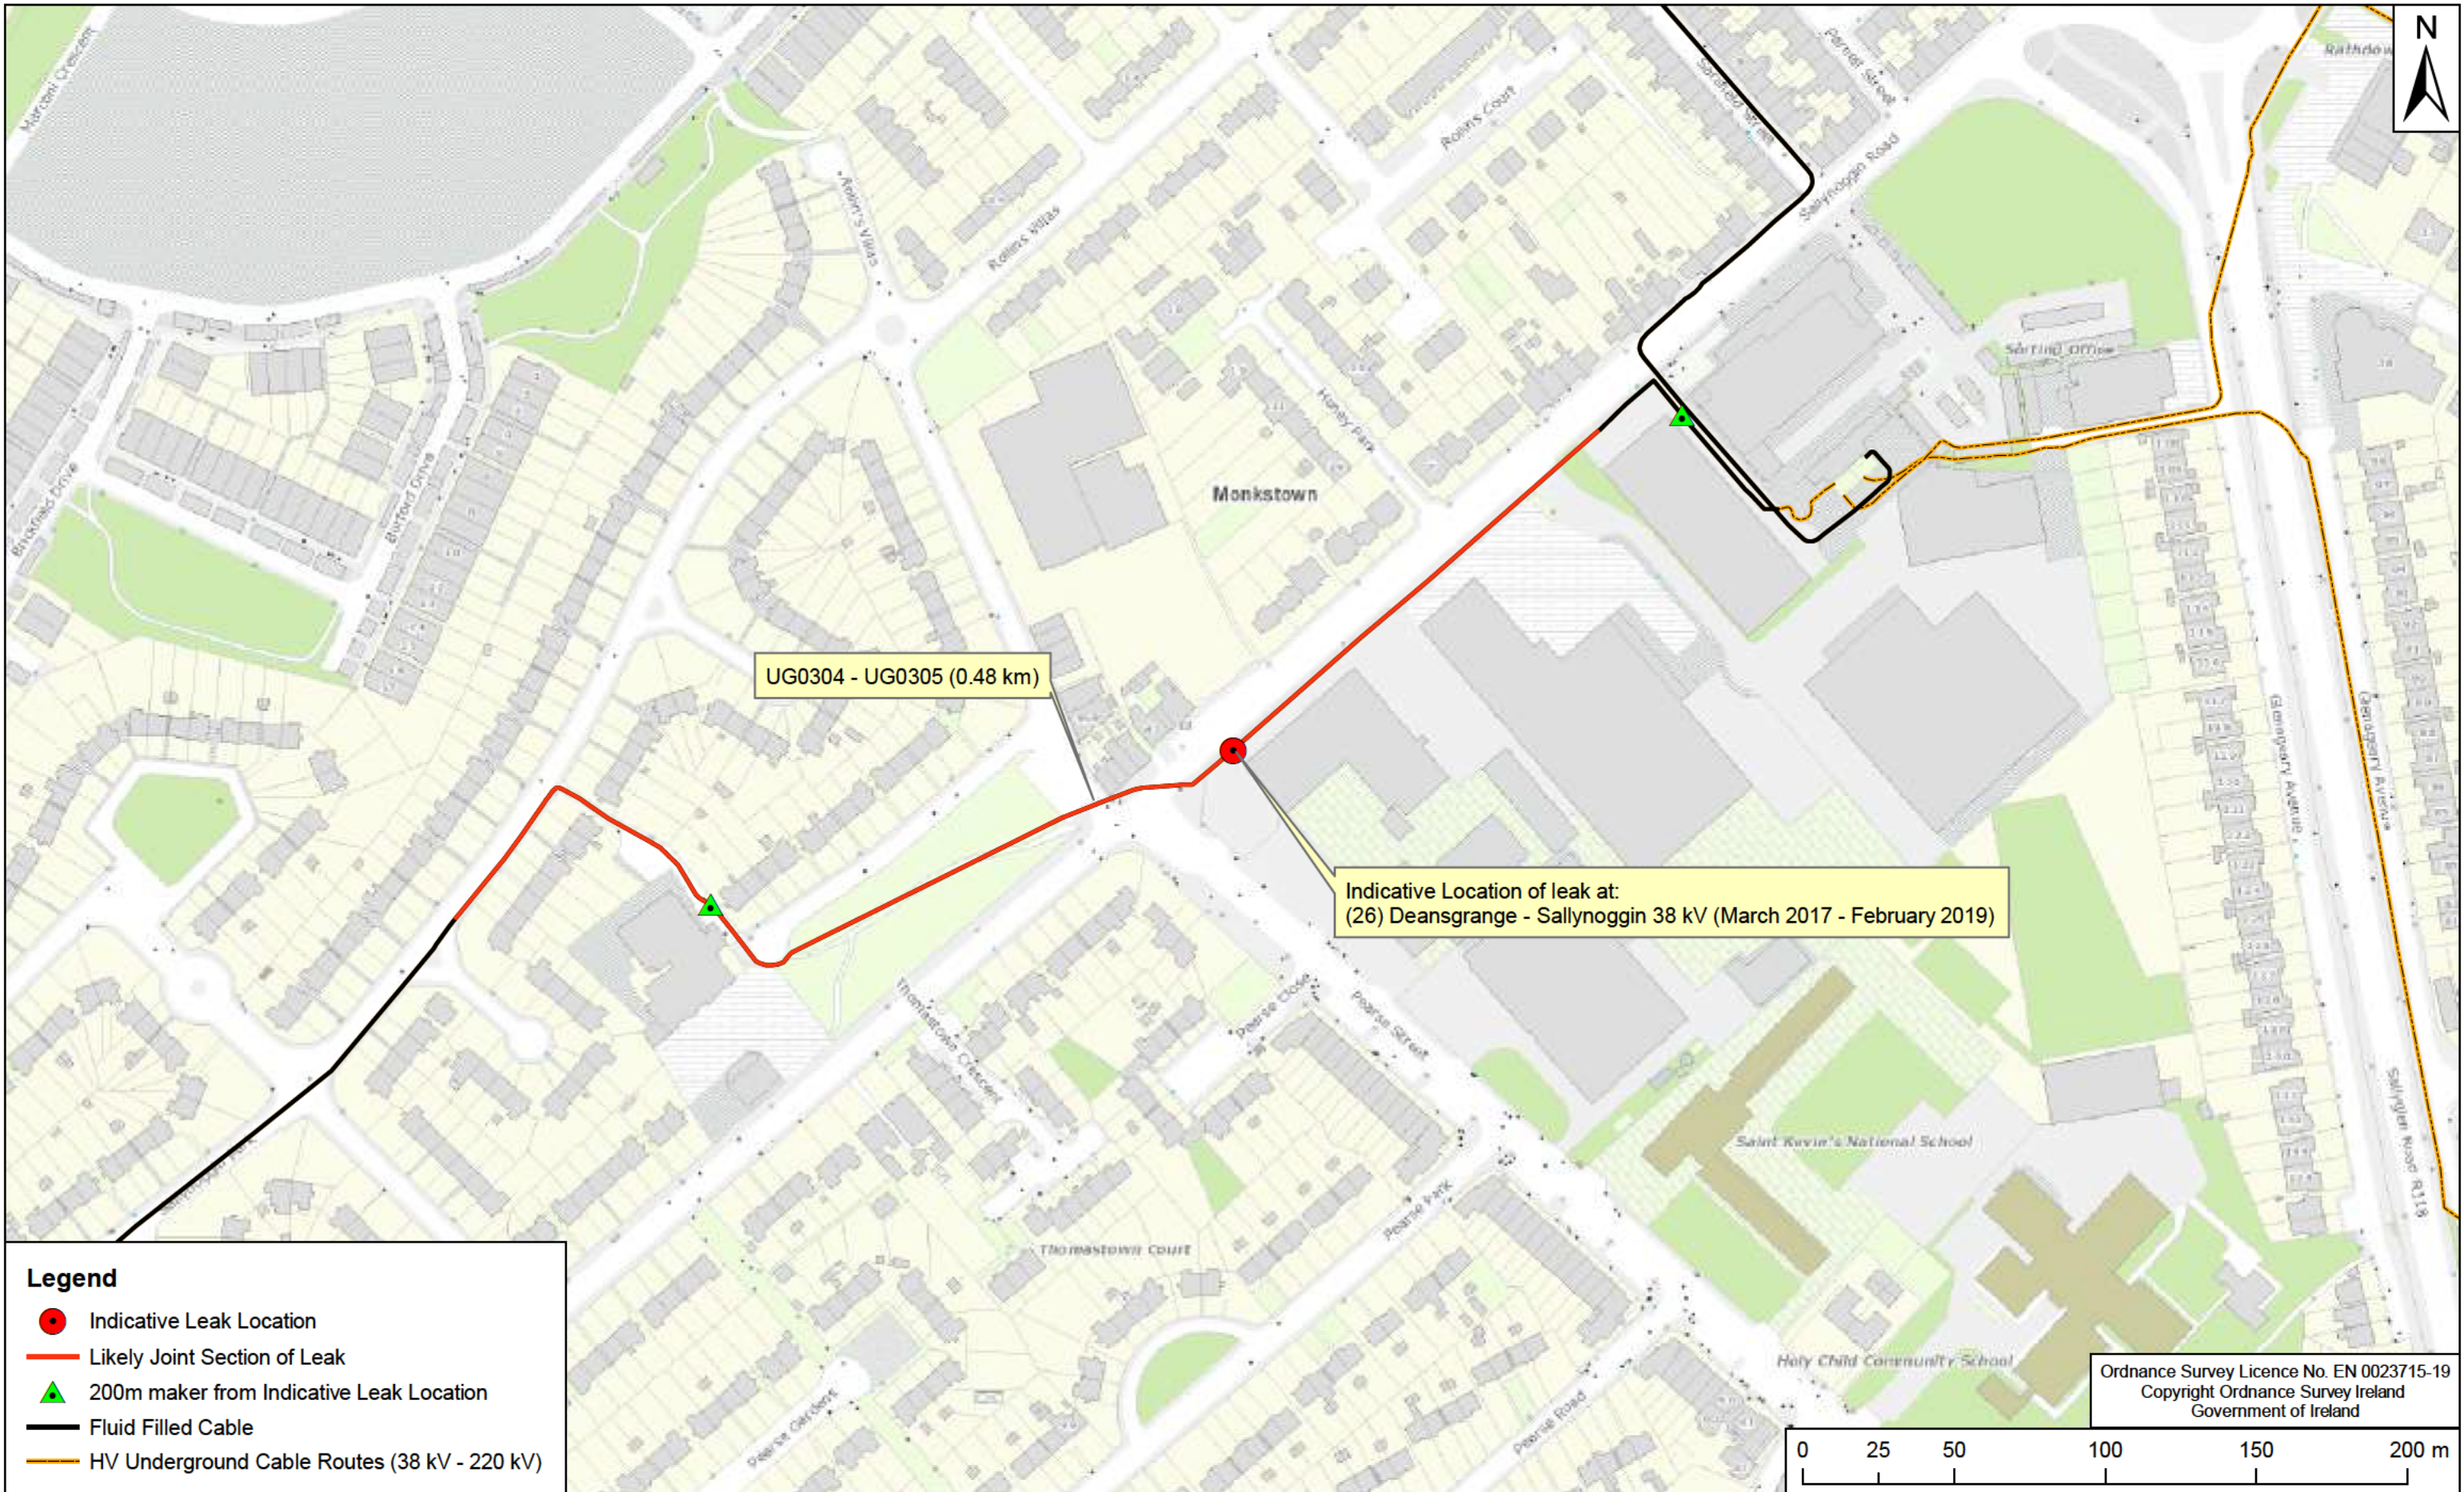
ESB SITE LAYOUT PLAN WITH INDICATIVE CABLE FLUID LEAKAGE LOCATION

Indicative Location of leak at:
(26) Deansgrange - Sallynoggin 38 kV (March 2017 - February 2019)
