Preliminary Site Assessment Report for Monaghan Road, Cork City

ESB Site Ref: 38
Marina – Trabeg Two 110kV

Project Title: ESB Networks Historic Fluid Filled Cable Loss
Environmental Assessment

Report Ref: Stage 1 Preliminary Site Assessment Report for Monaghan Road, Cork. ESB Ref: 38 Marina – Trabeg Two 110kV

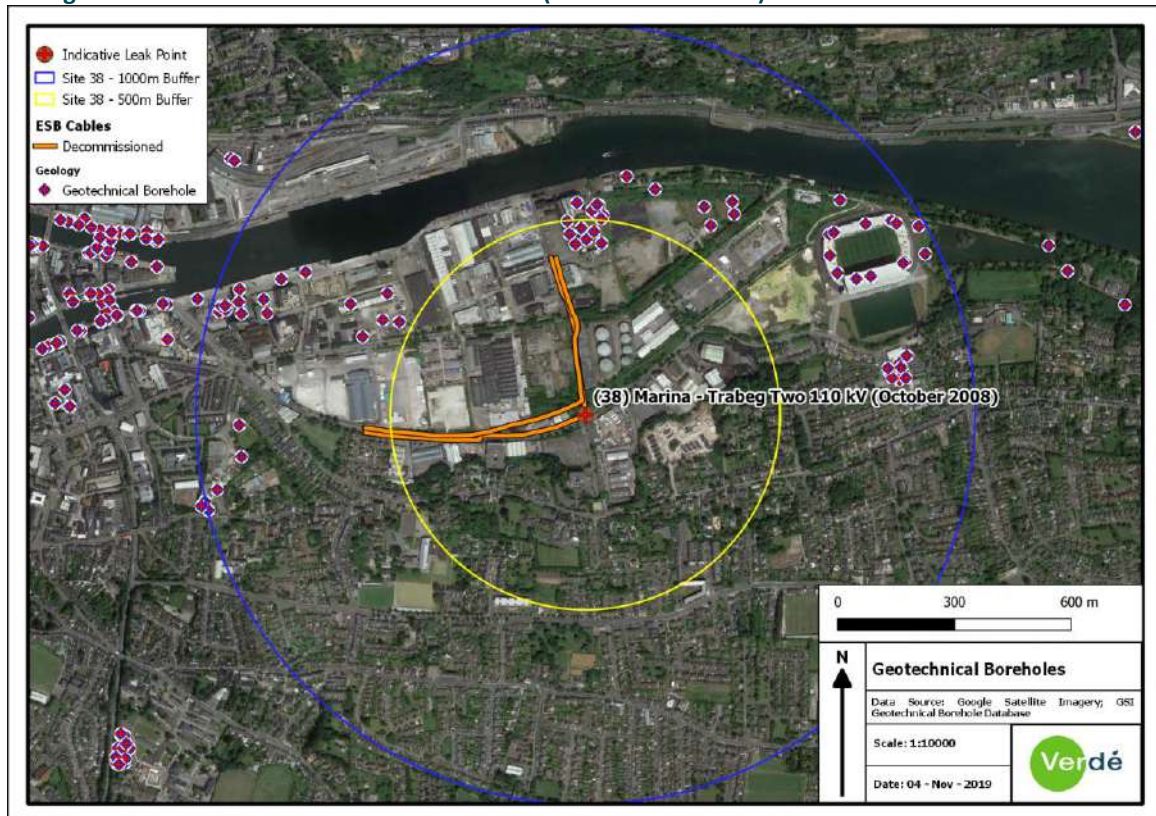
Figure 3.1 – Geotechnical Borehole locations (from GSI Database). Power station SI holes labelled.

There have been several intrusive investigations in the vicinity of the site; the closest site investigation was that completed on the site of the Marina Power Station in 1974 (Appendix F), in preparation for the installation of a gas turbine unit. A series of 15 boreholes were completed on the site; the greatest depth of excavation was 46.6mBGL. Some of the boreholes were completed after a 10ft pit was dug and logged. A summary of the log details is available in Appendix F.

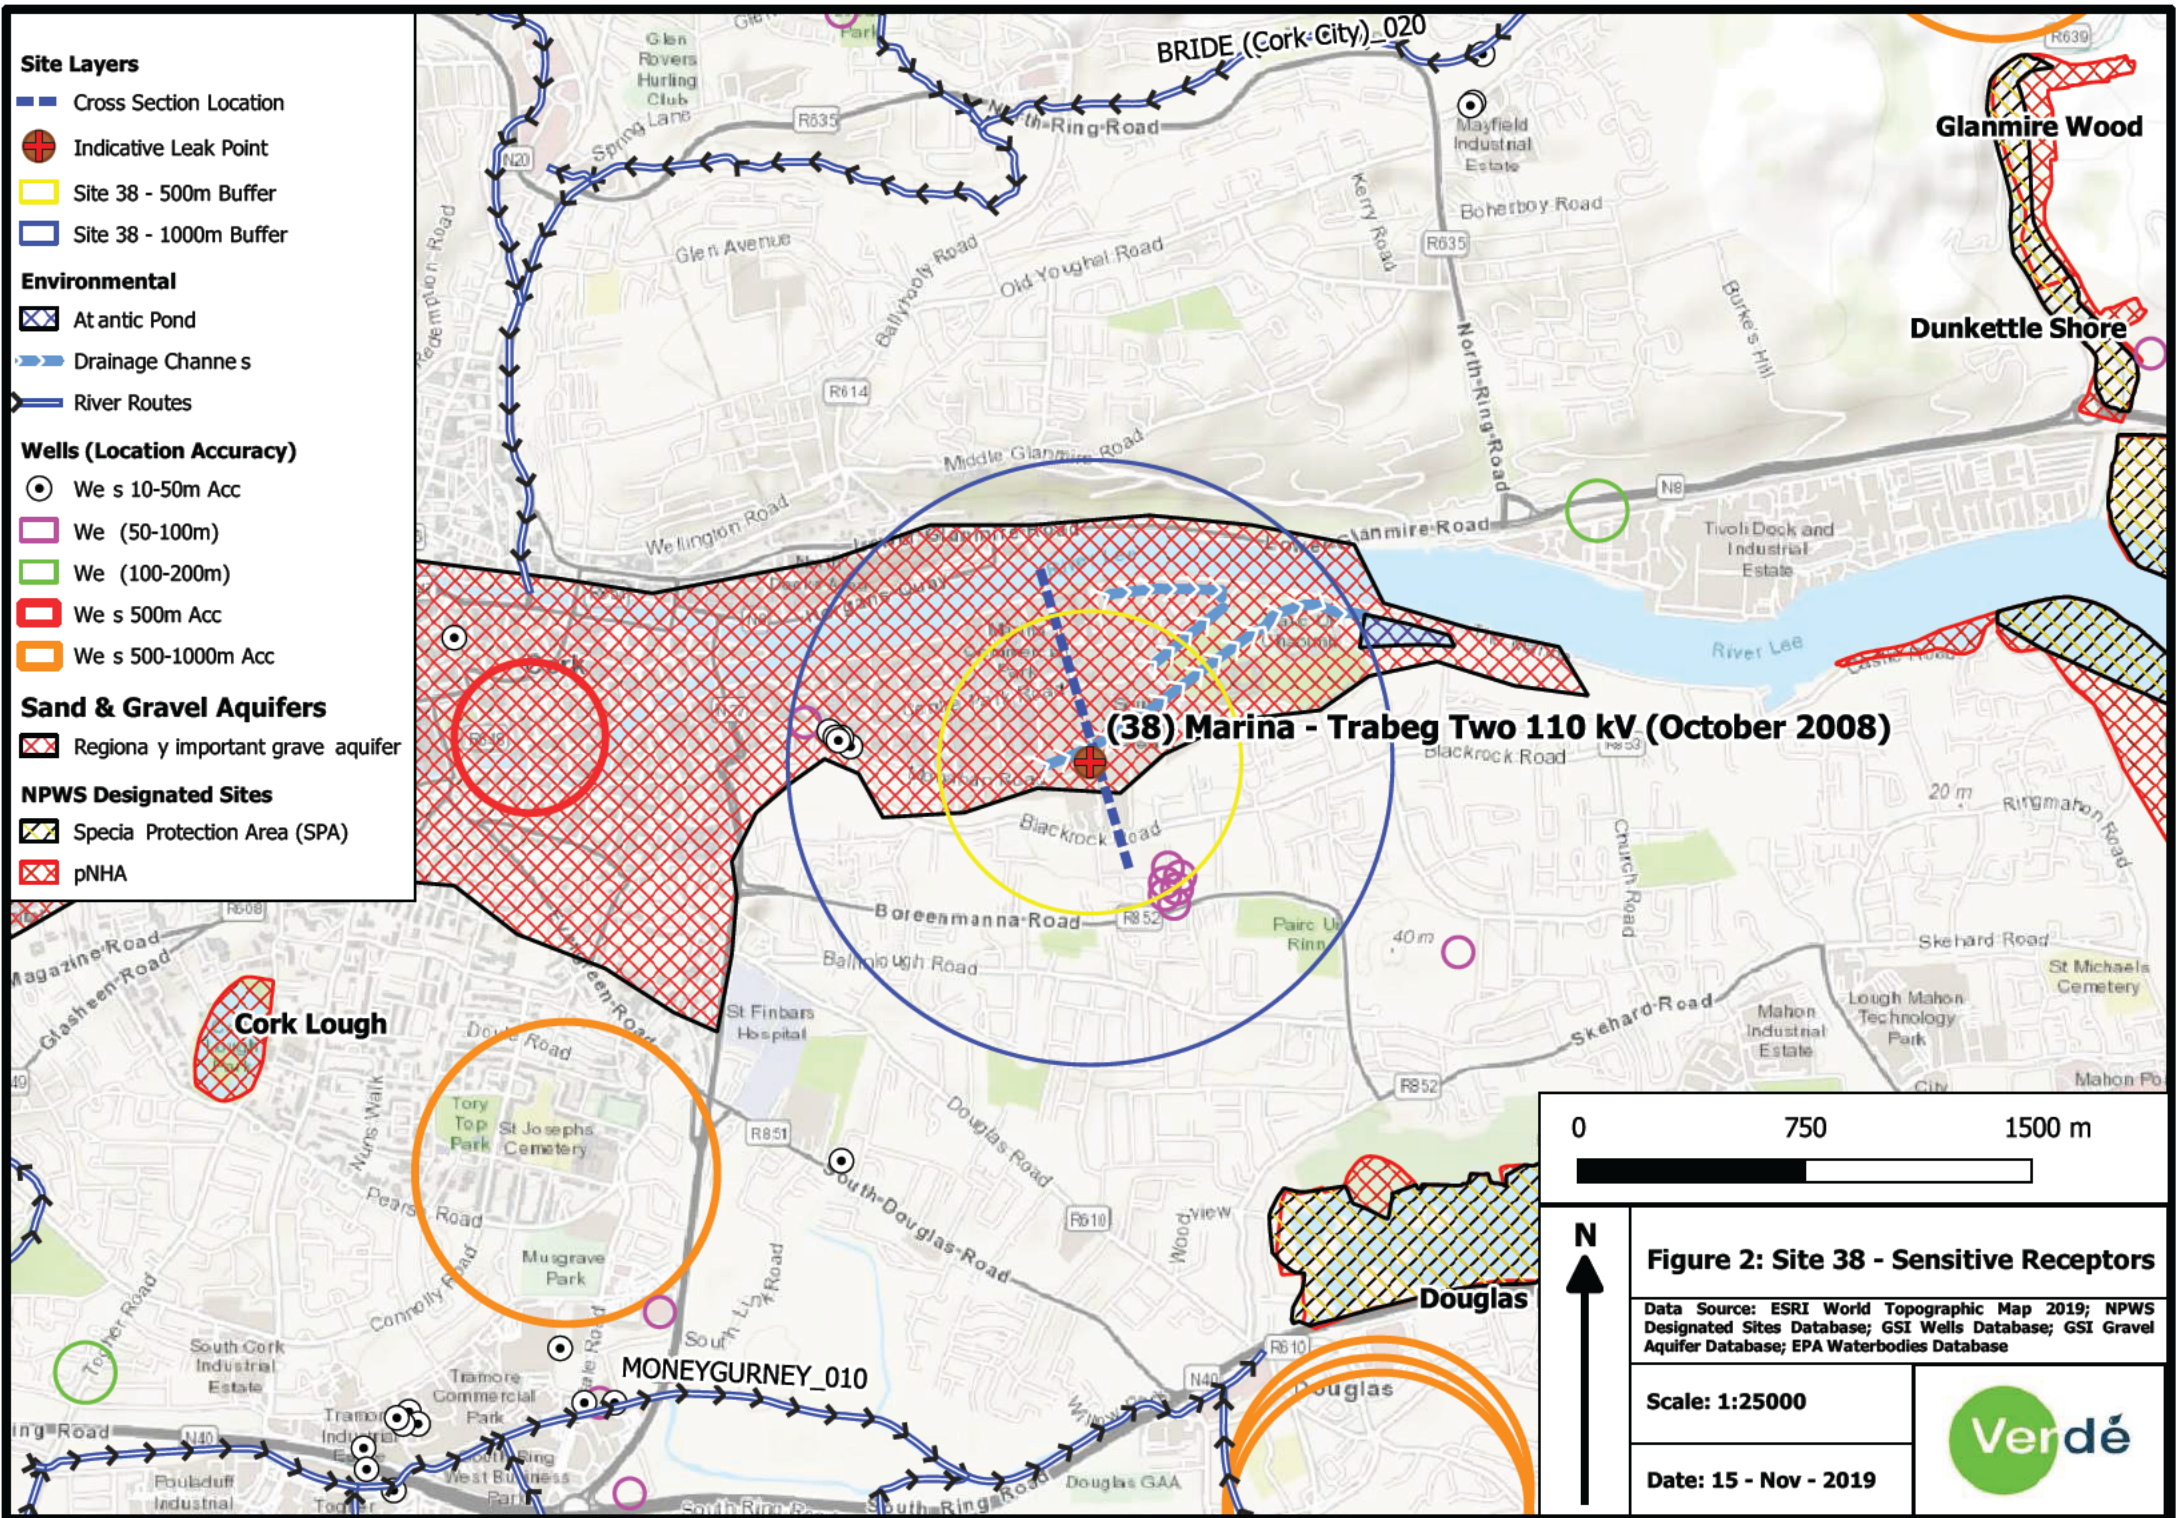
Figure 2: Site 38 - Sensitive Receptors

The topography of the area as obtained from the GSI database show the leak point is located at approximately 6m above the ordnance datum (mOD) with the Lee Estuary downgradient at 0mOD. The topographic contours are orientated approximately east to west which infers that the groundwater flow direction is likely to be in a north/north-easterly flow direction, as presented in Figure 2 and within the CSM in Figure 3.

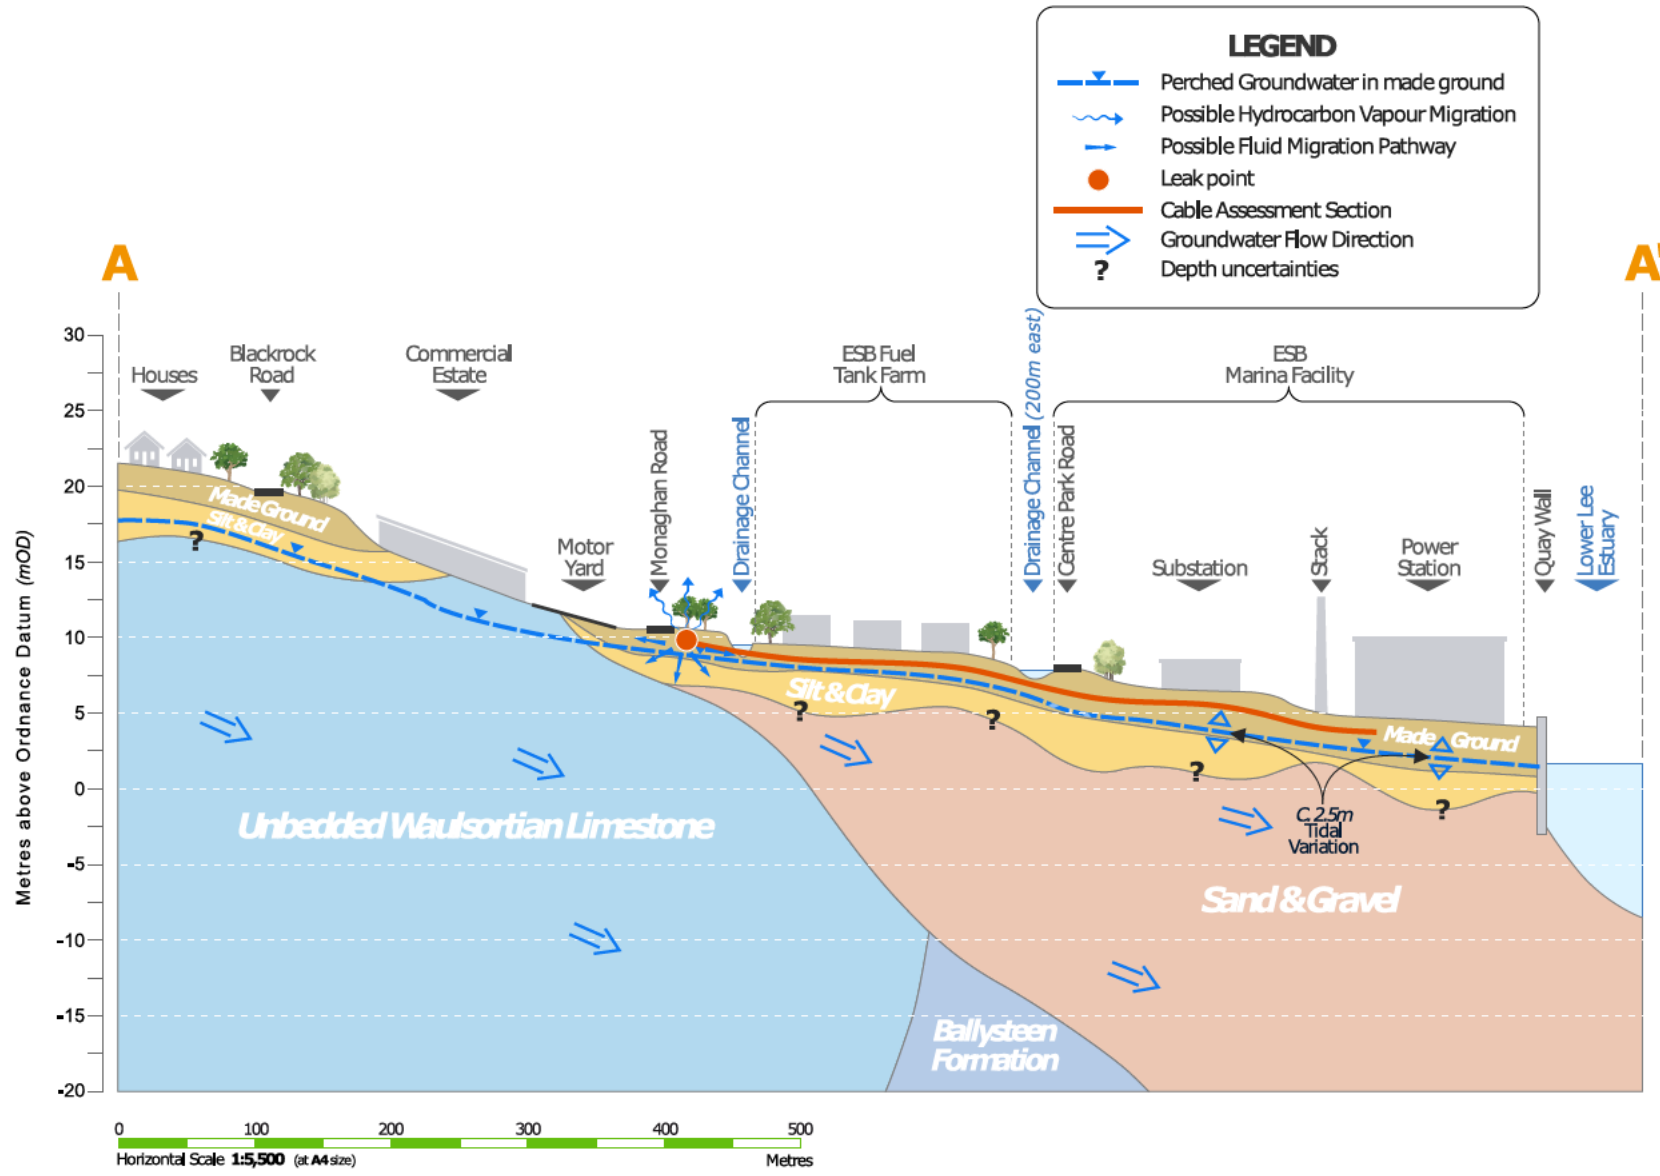
| Date: Nov. 2019 | Job Ref: 52458 | Figure No. 3 |

The preliminary site conceptual model illustrating the contamination source, possible pathways and receptors is presented in Figure 3 and Figure 4 and is discussed in detail in this report.

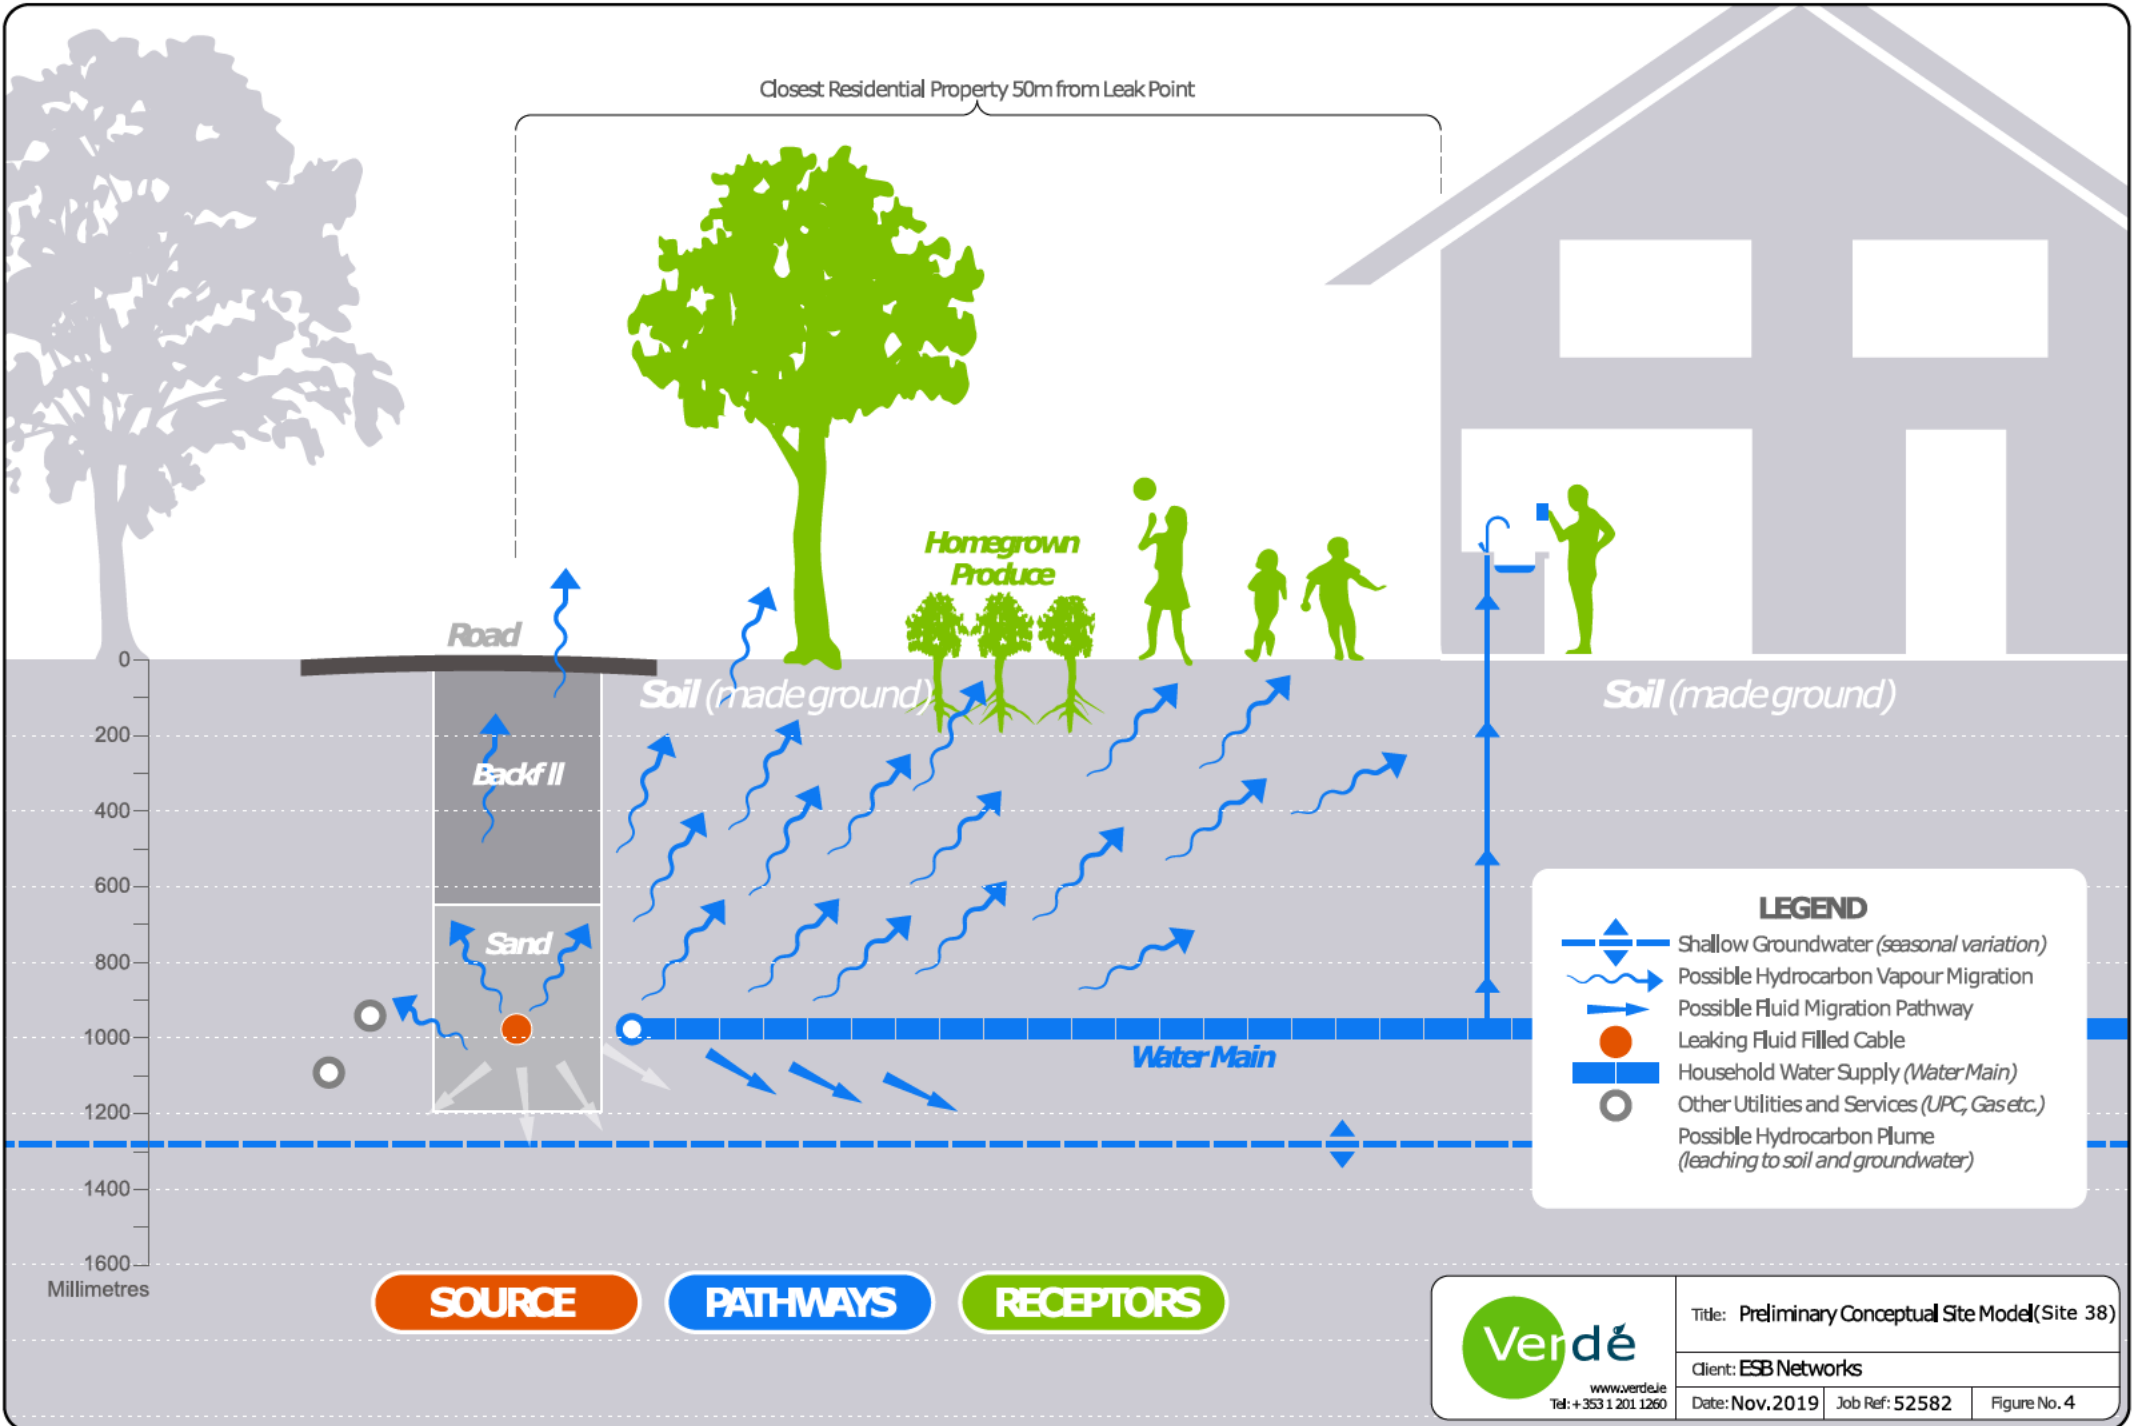
Title: Preliminary Conceptual Site Model (Site 38)

Based on the known cable leak point, COPC fate and transport and hydrogeological desk study information the CSM has the following initial key findings for human health and environmental risks;

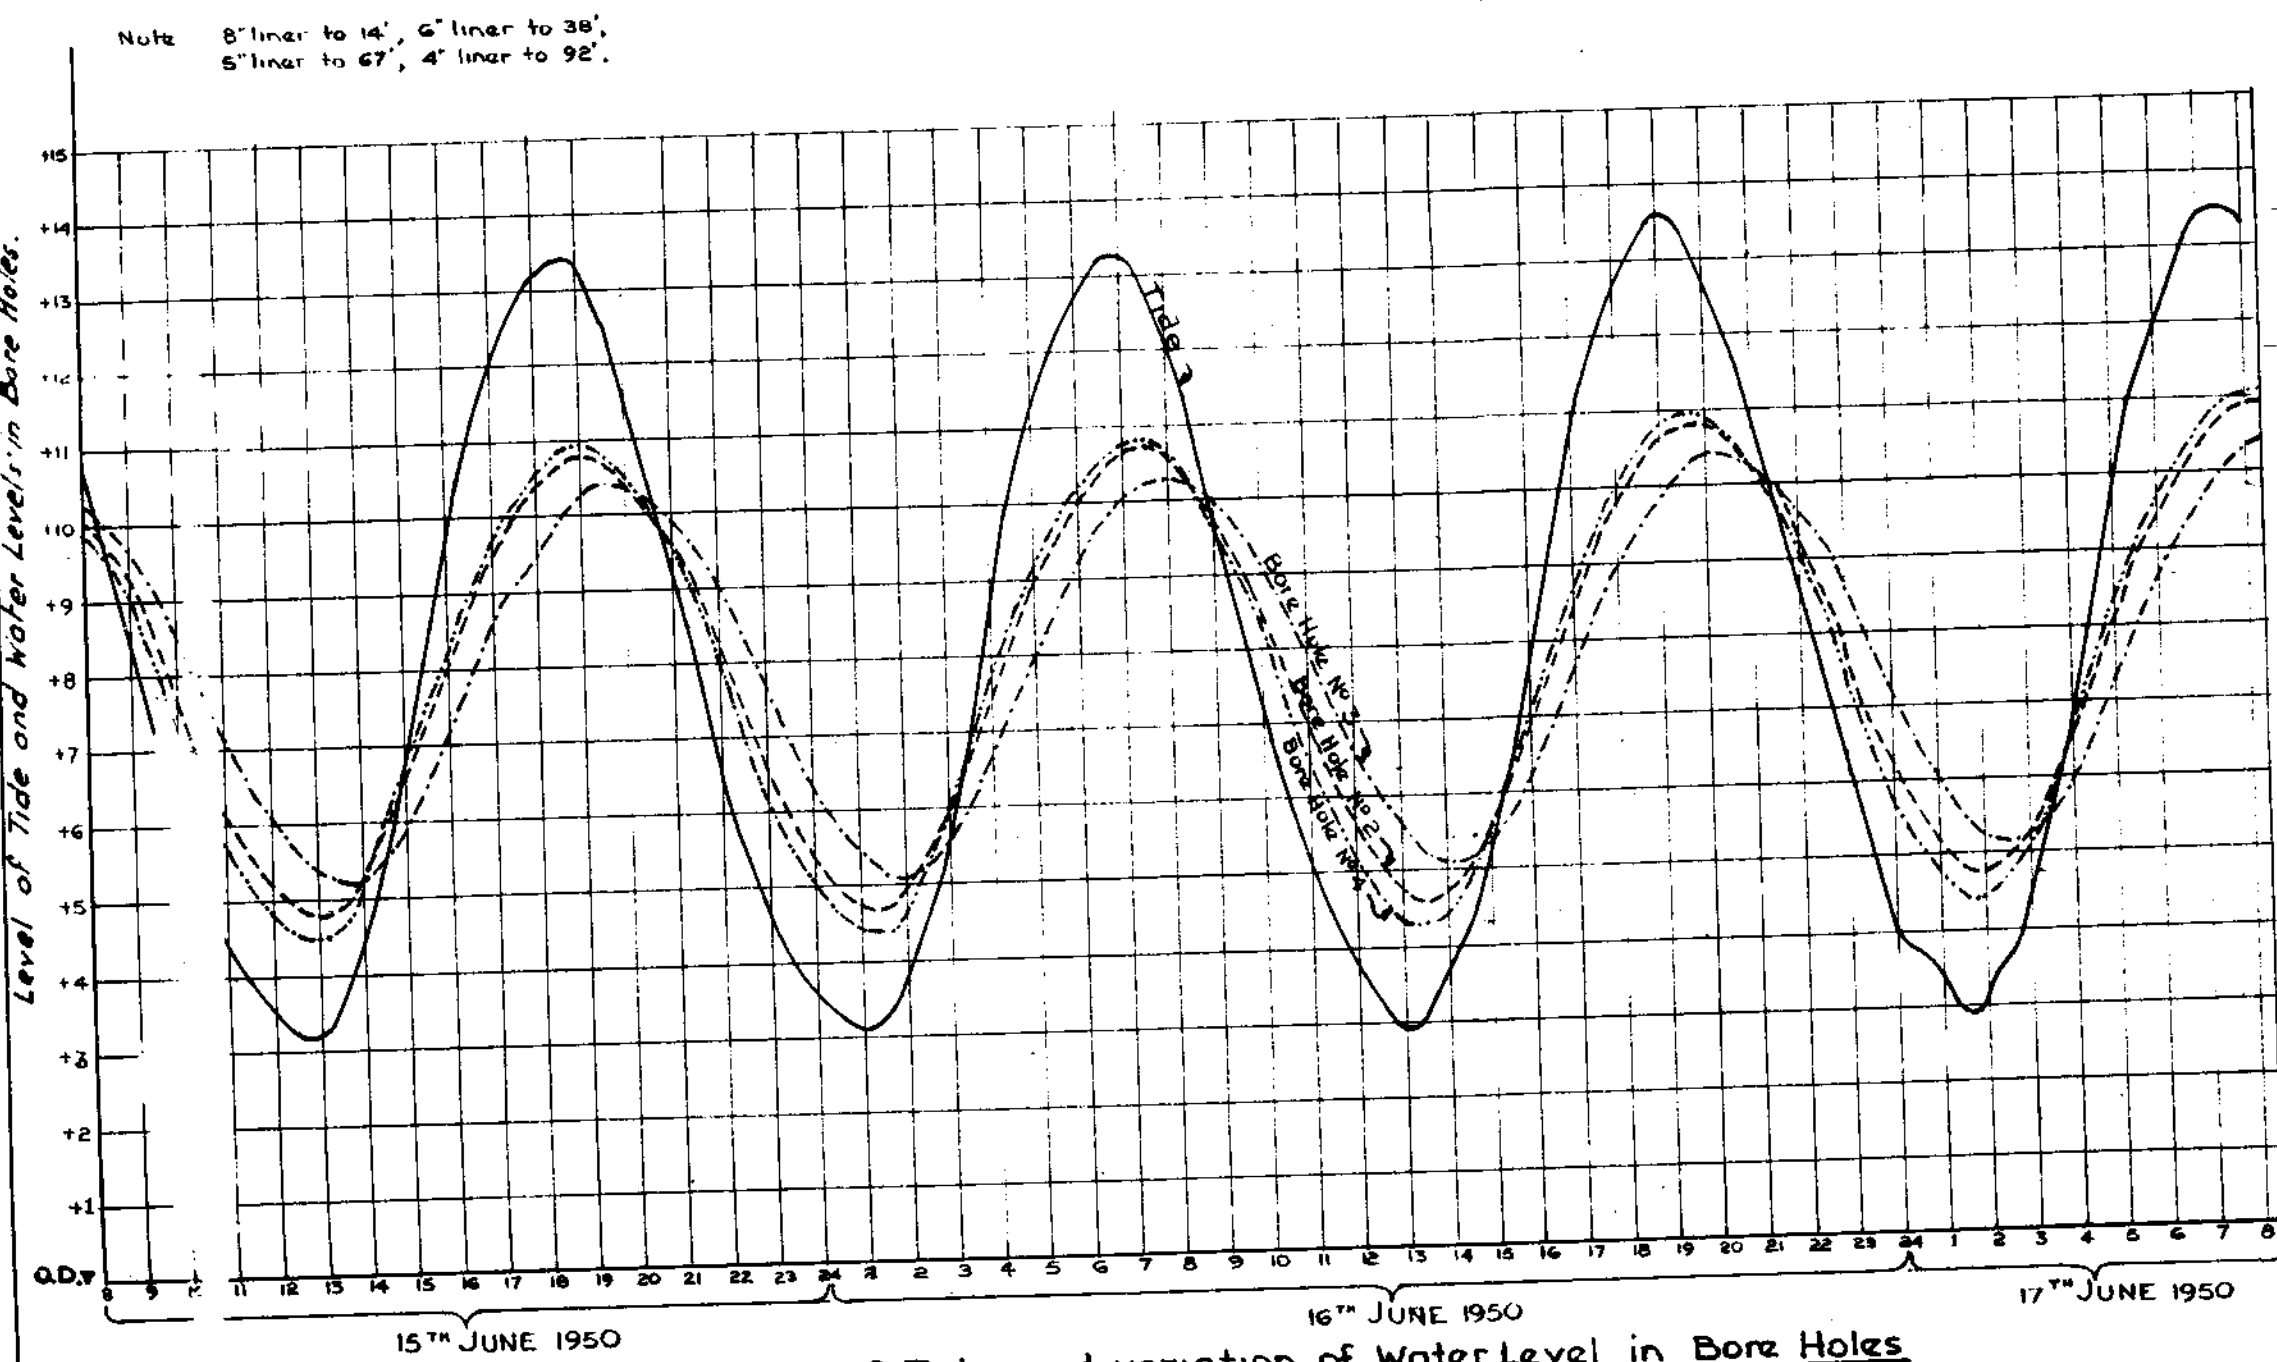
Chart showing Level of Tide and variation of Water Level in Bore Holes

A site investigation report from the 1950's site feasibility work prior to the development of the Marina Power Station, details the groundwater level variations on the site in response to tidal influence. A diurnal groundwater variation of 2-3m was recorded in a series of 3-4 groundwater monitoring wells on the ESB station facility (Appendix F).
