# **Preliminary Site Assessment Report for Finglas Road, Dublin 11**

ESB Site Ref: 66  
Finglas – Merville 38kV

**March 2020**

**Project Title:** ESB Networks Historic Fluid Filled Cable Loss  
Environmental Assessment

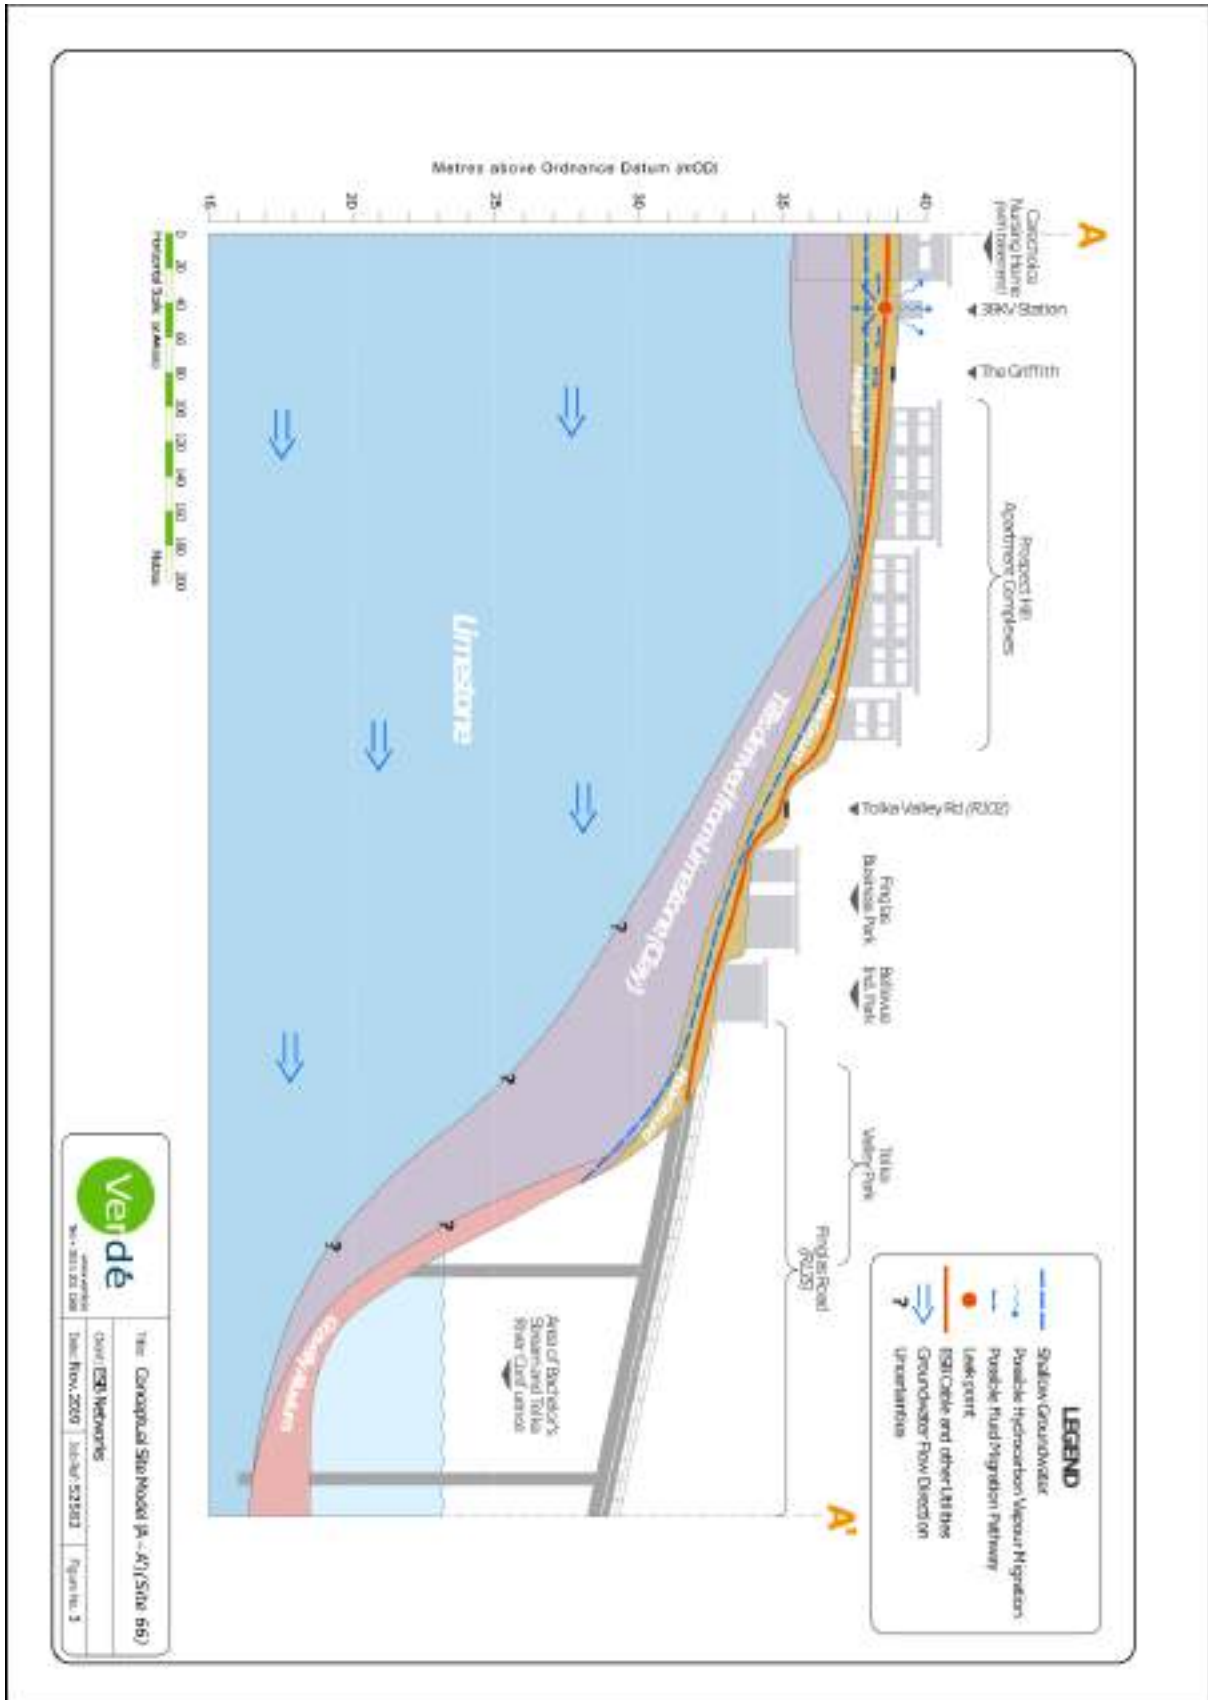
Figure 3 – Conceptual Site Model

- hydrocarbon migration to the adjacent watercourse given the short distance to Bachelors Stream.
- hydrocarbon migration to the underlying aquifer given the possible connection to shallow groundwater through shallow rock in the area indicated by the High vulnerability.

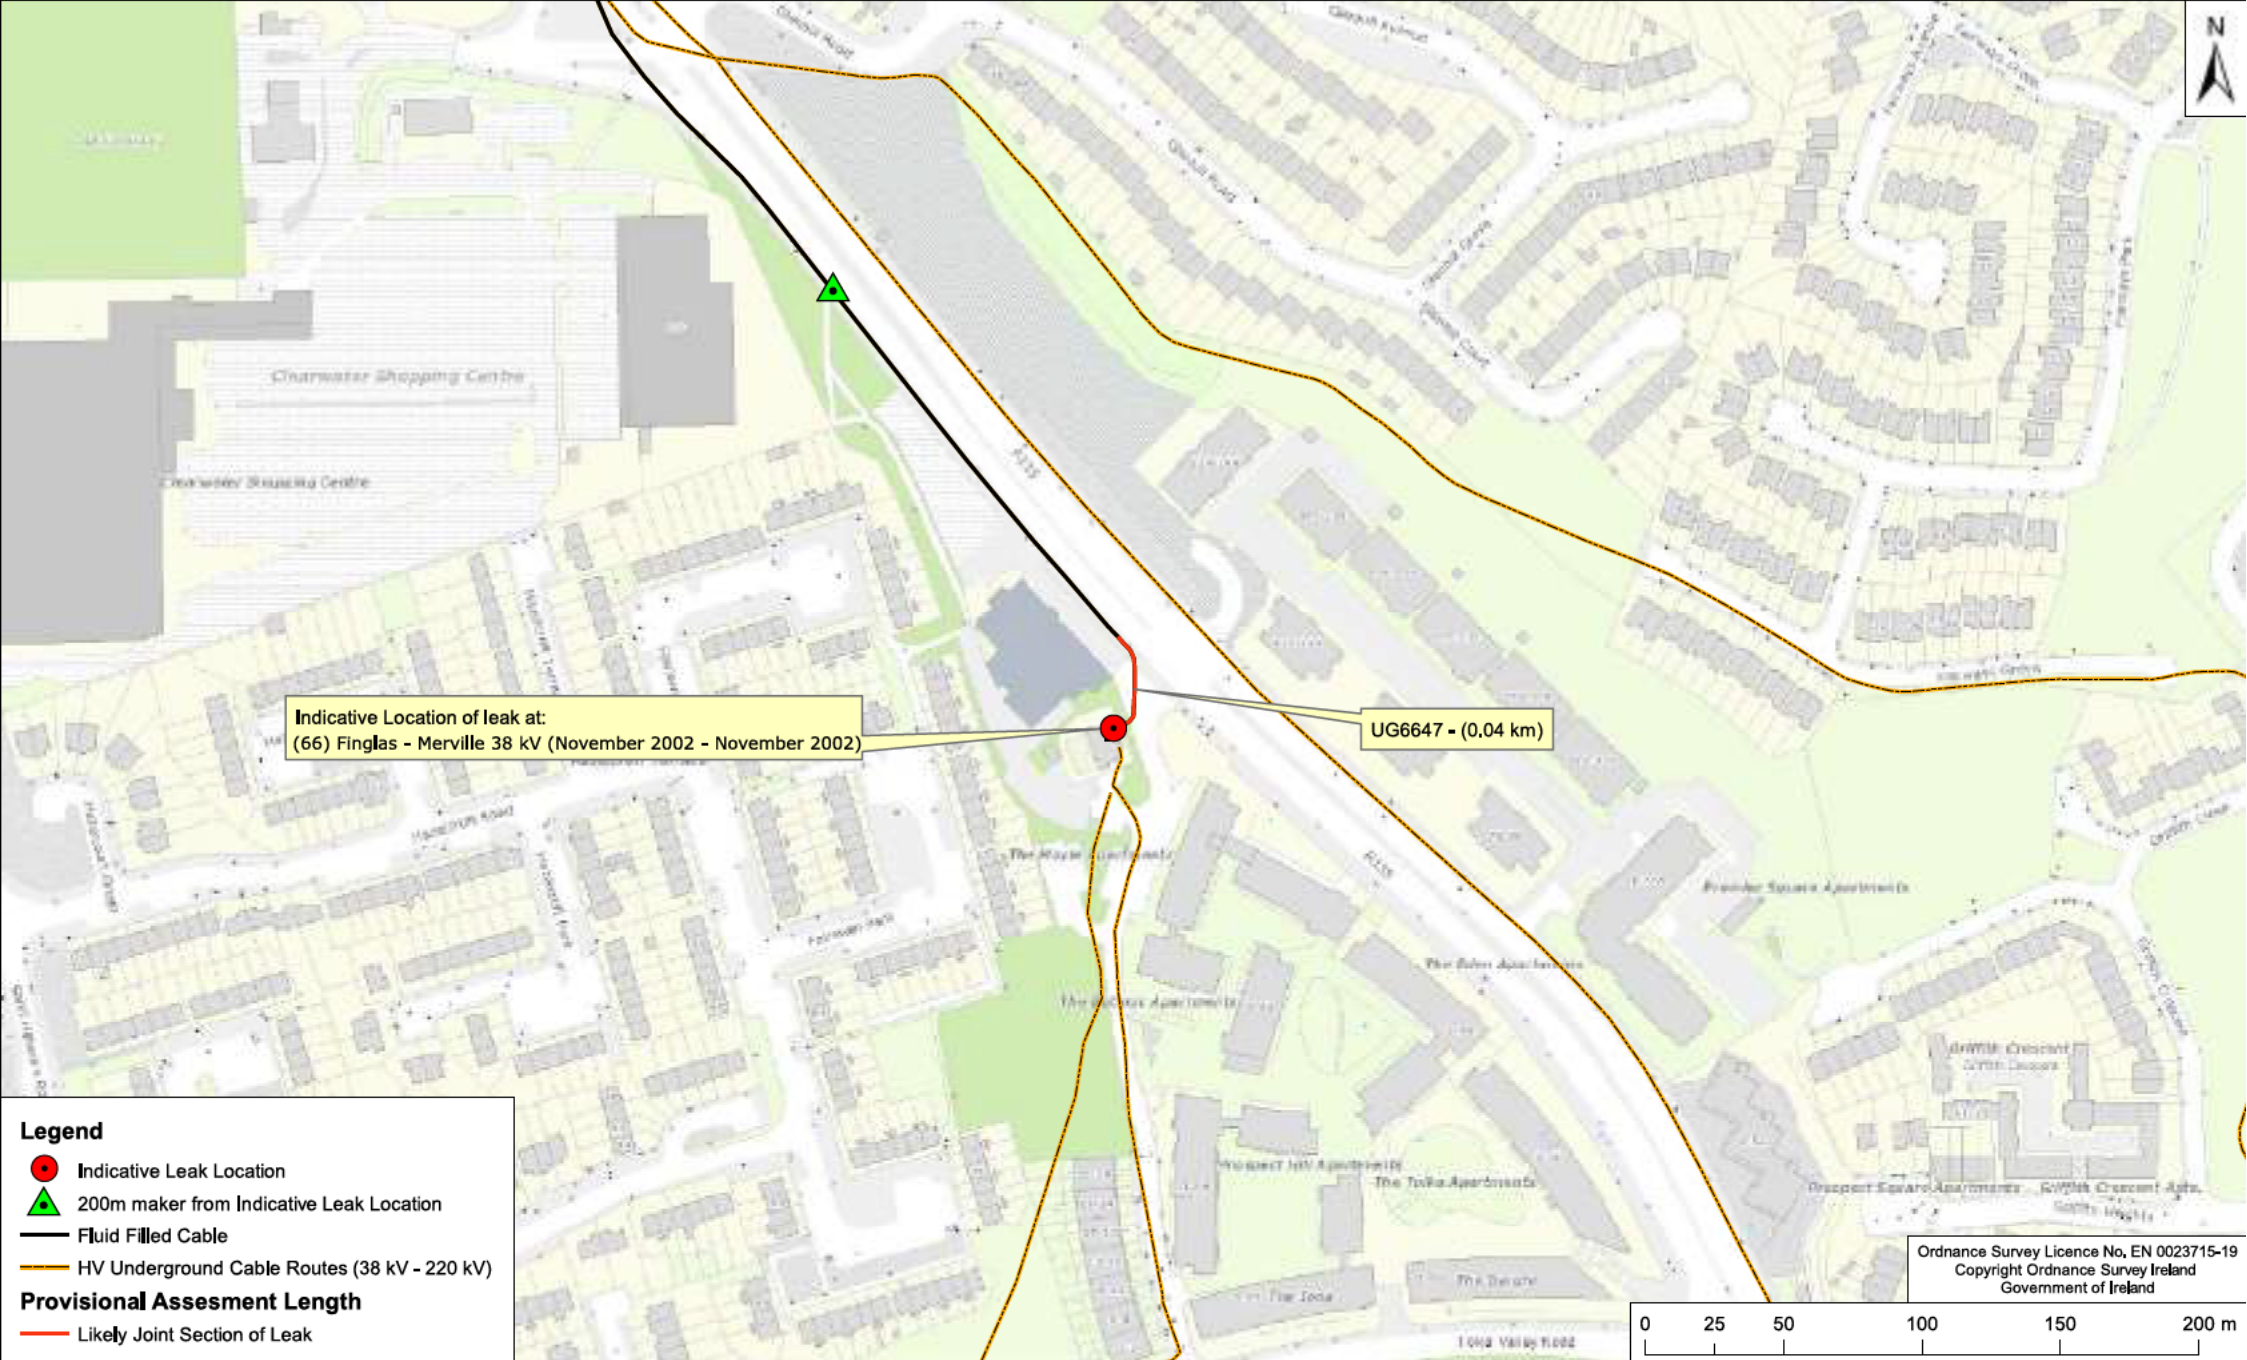
# ESB SITE LAYOUT PLAN WITH INDICATIVE CABLE FLUID LEAKAGE LOCATION

Indicative Location of leak at:  
(66) Finglas - Merville 38 kV (November 2002 - November 2002)
