Preliminary Site Assessment

Site 68 Francis Street - Inchicore 110 kV (August -
November 1993)

Electricity Supply Board

Project number: PR-427640_ACM_RP_ENV_063_1

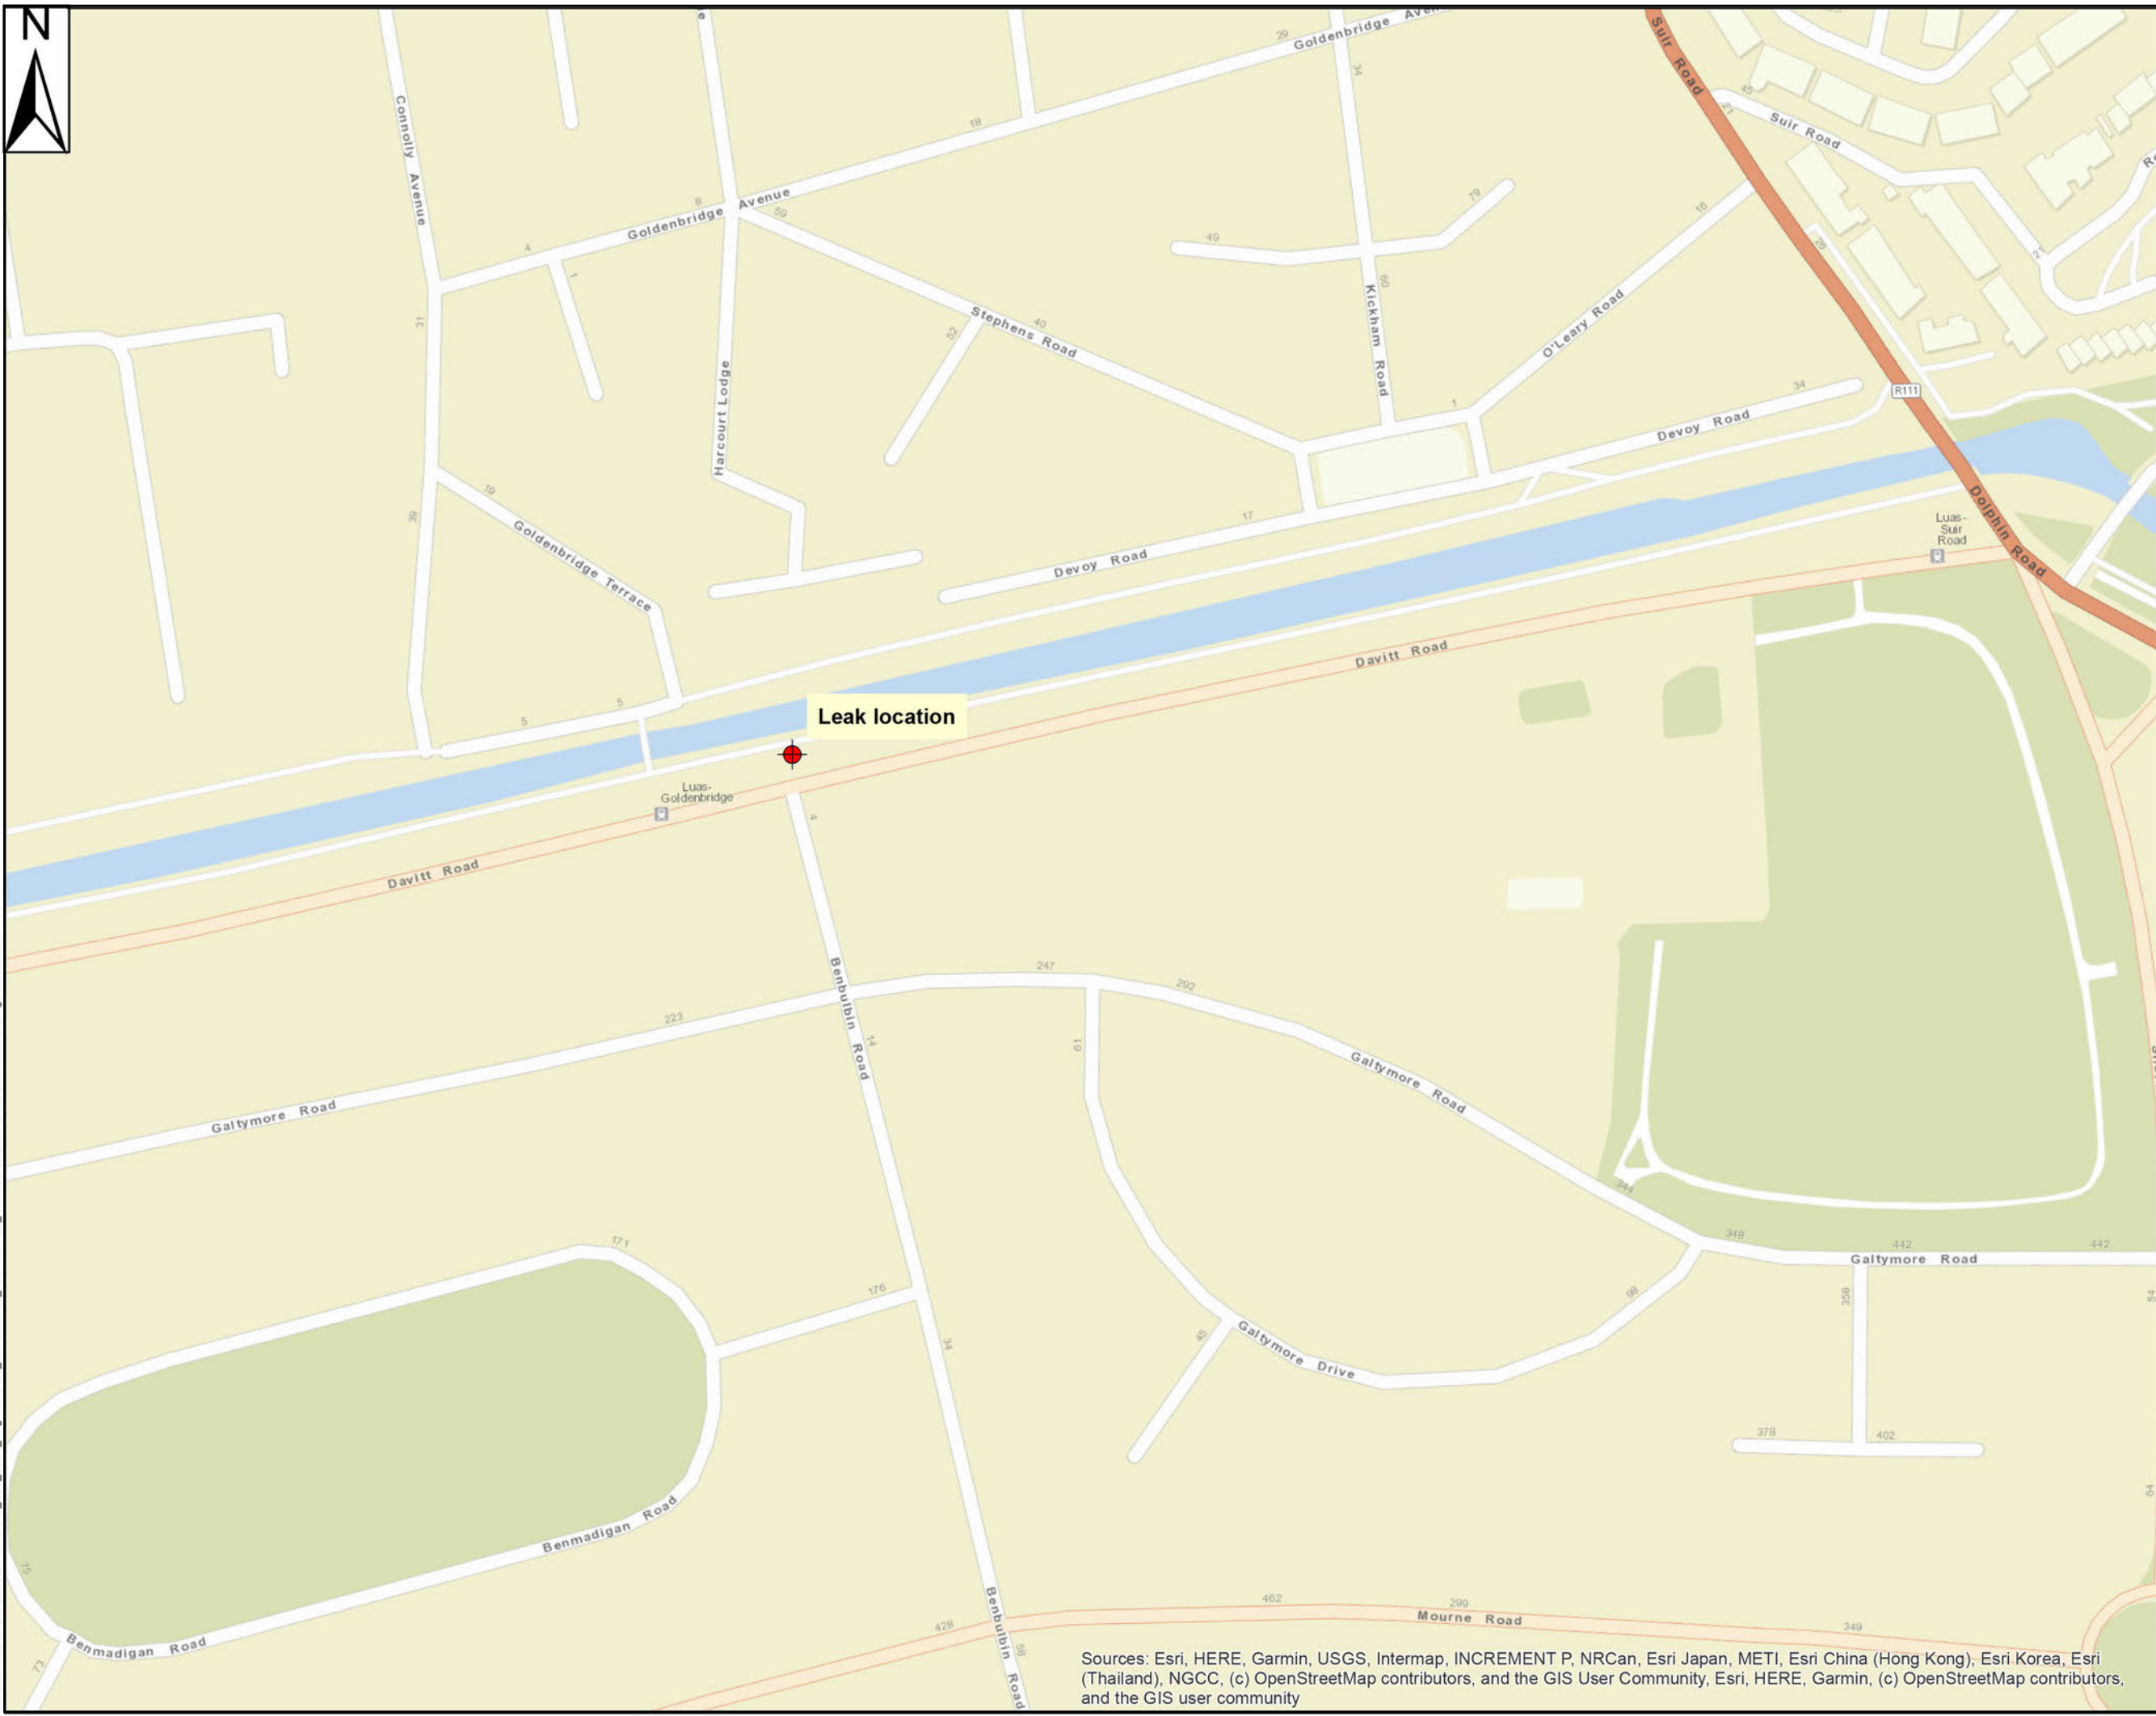
FIG.2 - SITE LAYOUT PLAN

Based on the assessment works completed, the primary APEC for this site comprises the leak location identified by ESB. This is presented in Figure 2 and a description is provided in Table 8.
