Preliminary Site Assessment Report for Junction of Howth Road and Clontarf Road, Dublin 3

ESB Site Ref: 11
Clontarf – East Wall Road 38 kV

September 2019

Project Title: ESB Networks Historic Fluid Filled Cable Loss
Environmental Assessment

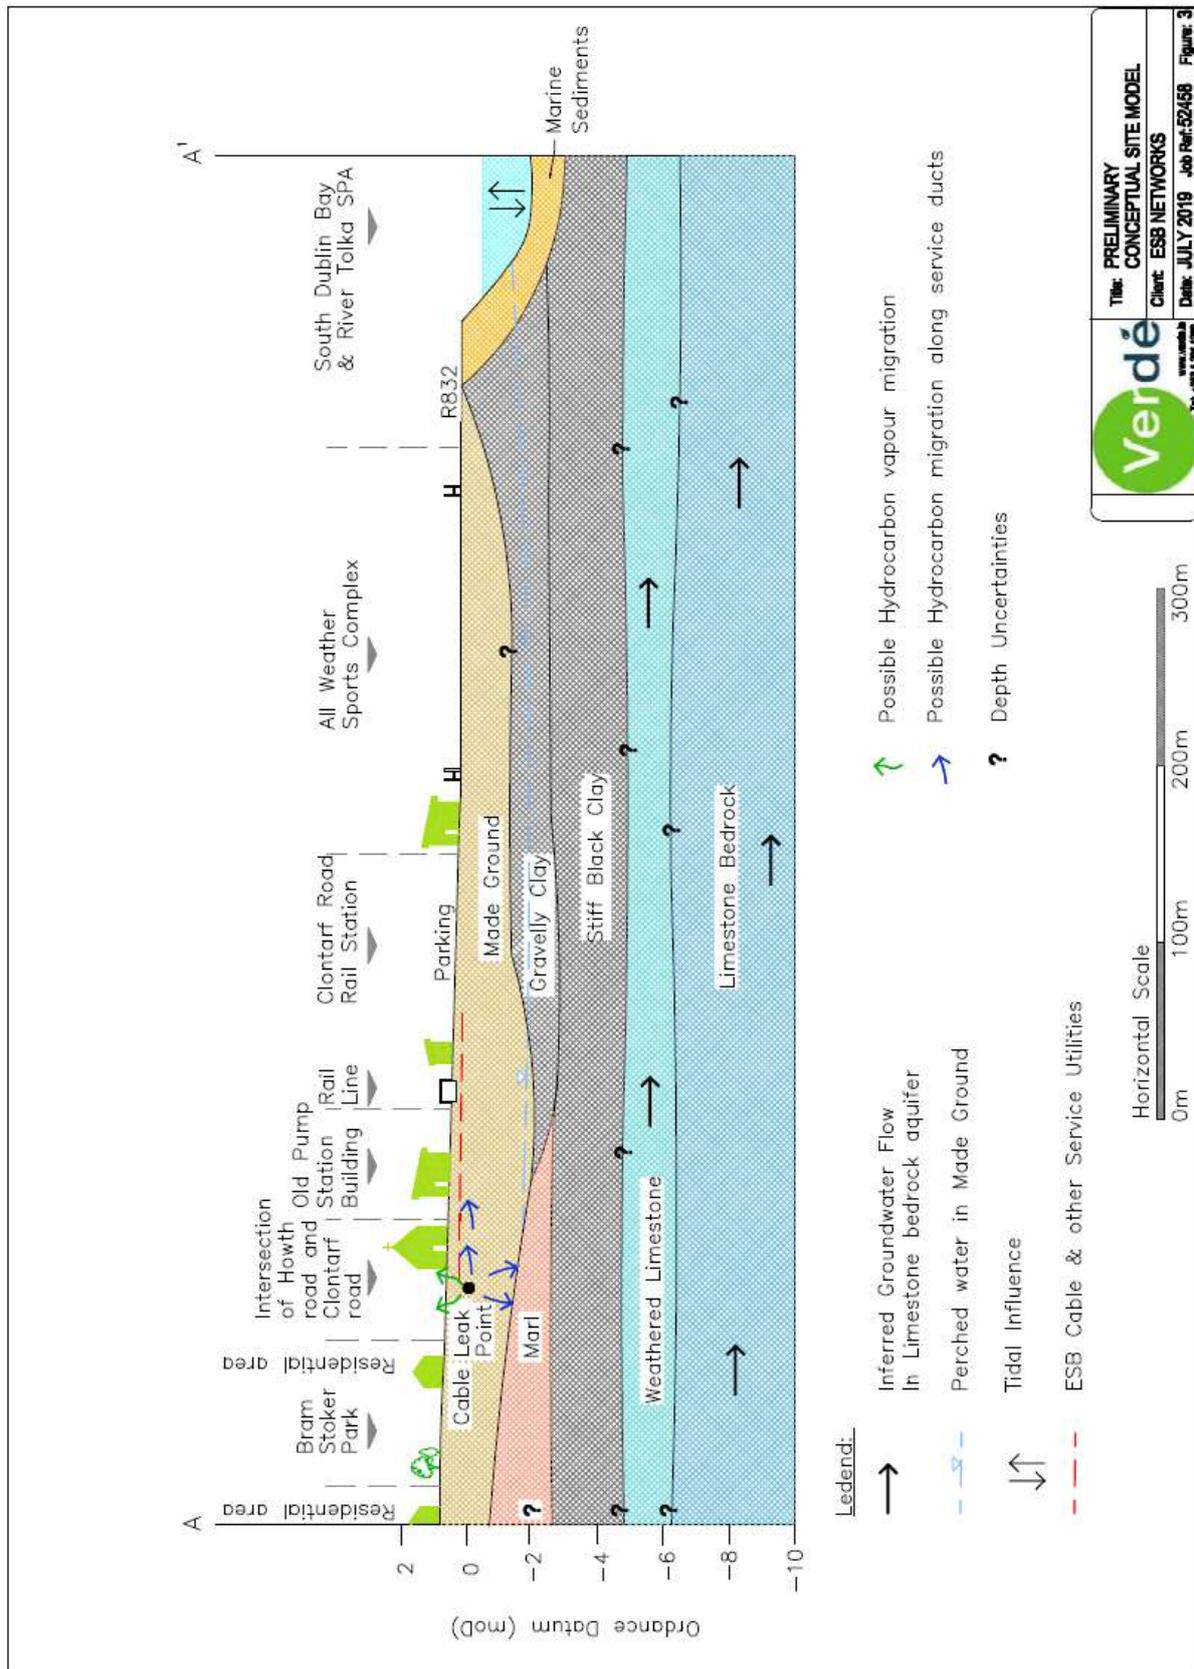
Figure 3 – Conceptual Site Model

- direct dermal/inhalation and ingestion contact to residents or other building users;
- dermal/inhalation and ingestion pathways to construction workers which can be managed by appropriate use of PPE and H&S procedures;
- ingestion of contaminated water by water users in the area following its permeation through plastic water pipes.
- leaching to shallow groundwater given the contaminant properties of low mobility and high sorption to soil, with shallow groundwater unlikely to be a viable groundwater resource in the residential urban setting.
- migration of shallow contaminated groundwater to Dublin Bay SPA & pNHA given the contaminant properties of low mobility and high sorption with a distance of 460m from the leak point and not a significant oil loss volume.
- hydrocarbon vapours in preferential pathways such as services ducts to residents or other building users.

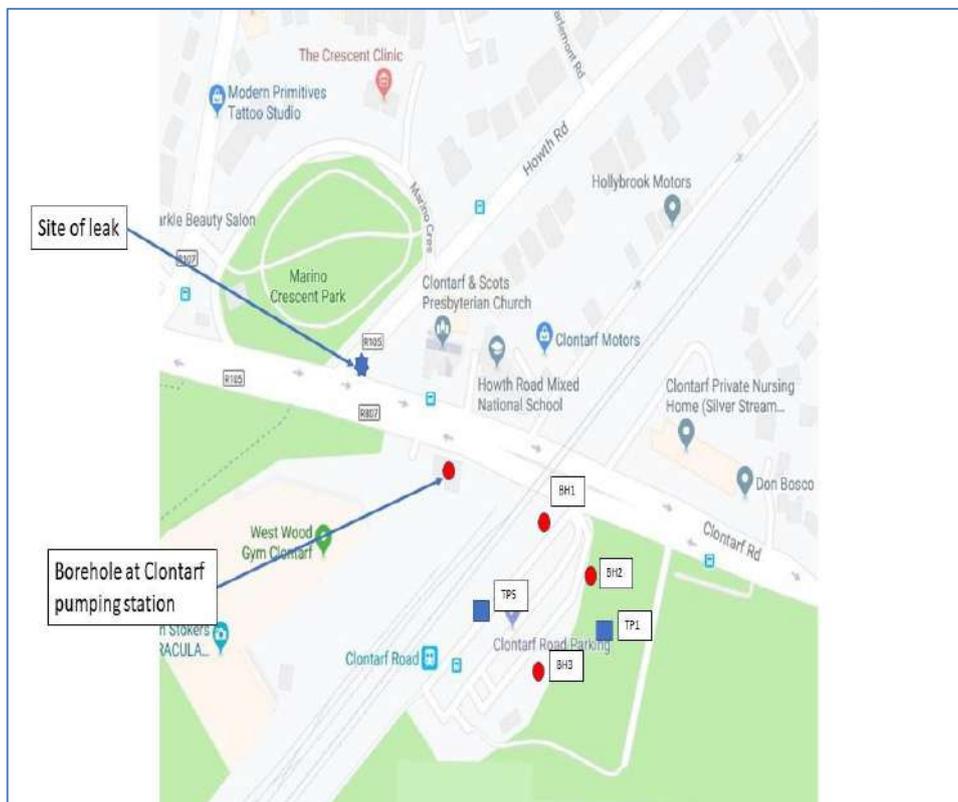
Figure 3.1 Geotechnical Borehole locations (from GSI database and 1993 Site Investigation Report)

The leak point location on the Clontarf Road is located within 200m of several boreholes drilled and trial pits dug as part of an investigation carried out into sub-soil conditions by IGSL on behalf of Dublin Corporation in May and June 1993. The site investigation boreholes are located immediately east of Clontarf Railway station approximately 50m south-east from the leak point, as presented in Figure 3.1 below. Below are the details of boreholes BH1, BH2 and BH3 and trial pits TP1 and TP5 along with the dates of drilling and excavation.

The permeable made ground is seen to contain shallow groundwater at 3mBGL, which will be restricted from vertical migration by low permeability marl and boulder clay. These low permeability subsoils are seen locally to be up to 3.7m thick beneath the made ground which is restricting migration to the underlying limestone bedrock aquifer, as presented in the conceptual site model in Figures 3 and 4. The groundwater in the underlying limestone bedrock aquifer is likely to be confined or semi-confined by the boulder clay.

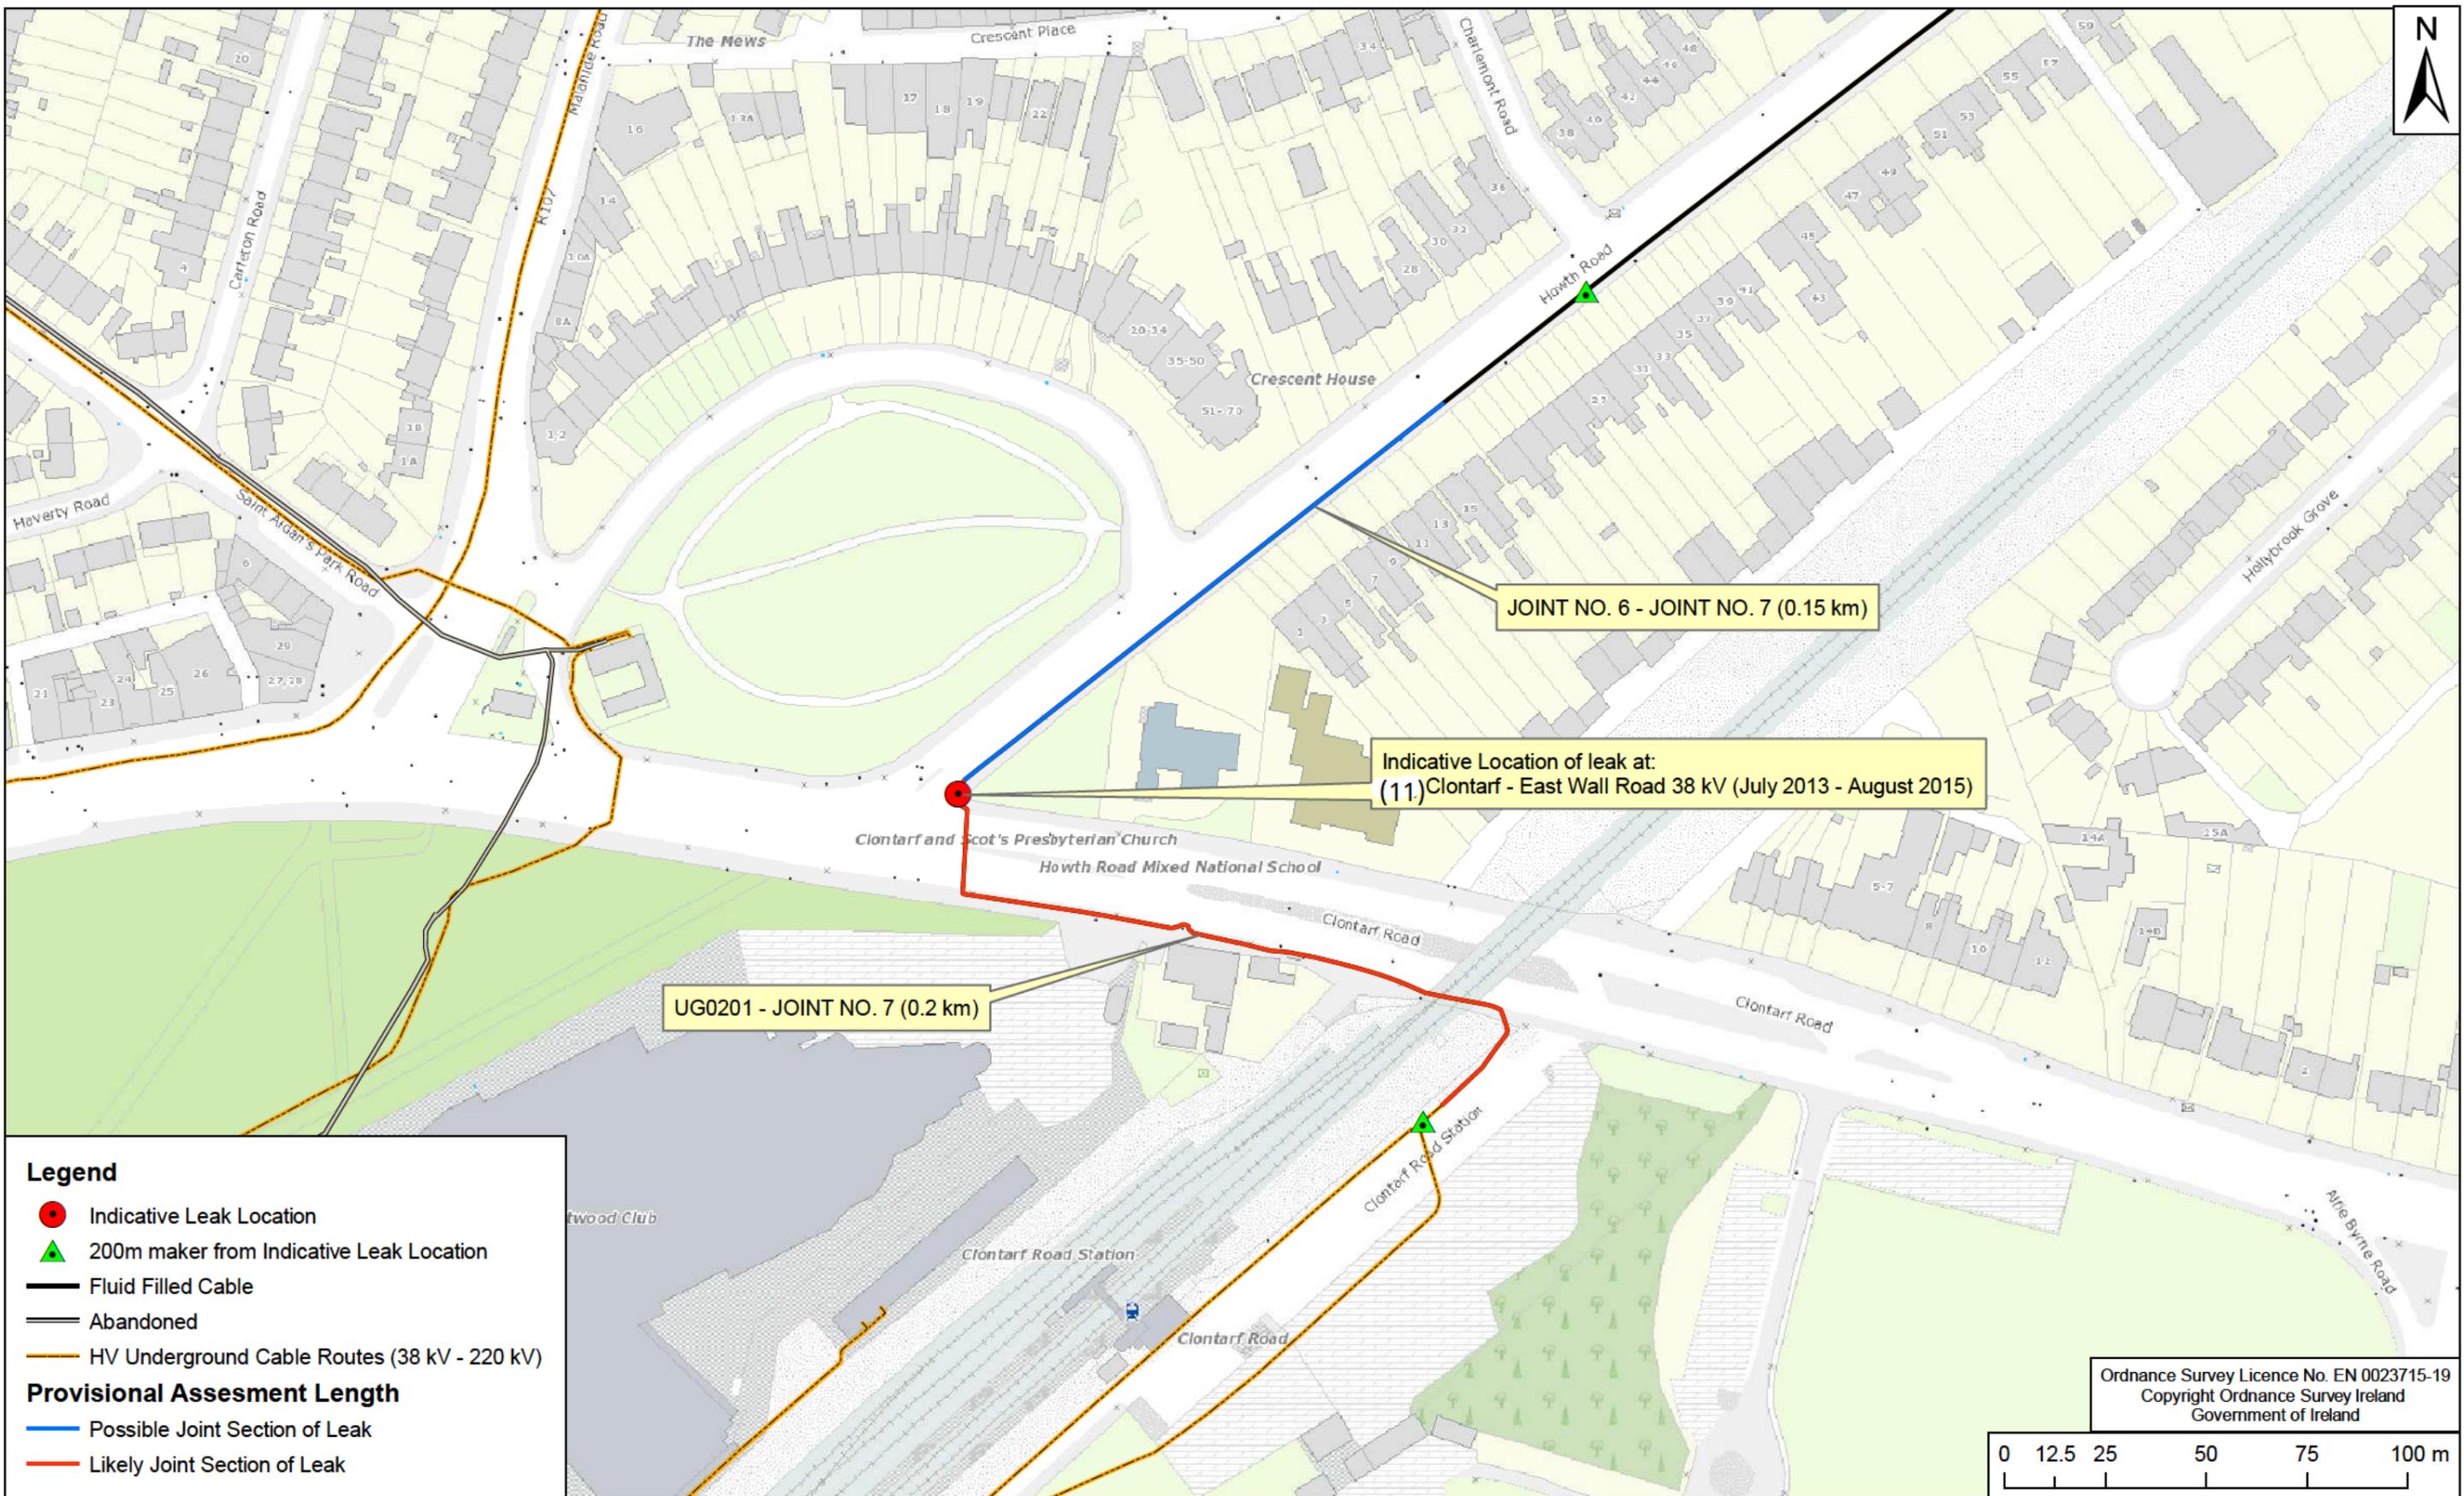
ESB SITE LAYOUT PLAN WITH INDICATIVE CABLE FLUID LEAKAGE LOCATION

The known leak point (ESB Ref: 11) is located at the Junction of Howth Road and Clontarf Road, Dublin 3, which is combination of residential and commercial properties together with open greenfield parklands, as presented in the map in Appendix A.
