# Preliminary Site Assessment Report for Finglas Road, Dublin 11

ESB Site Ref: 15  
Finglas – Merville 38kV

March 2020

**Project Title:** ESB Networks Historic Fluid Filled Cable Loss  
Environmental Assessment

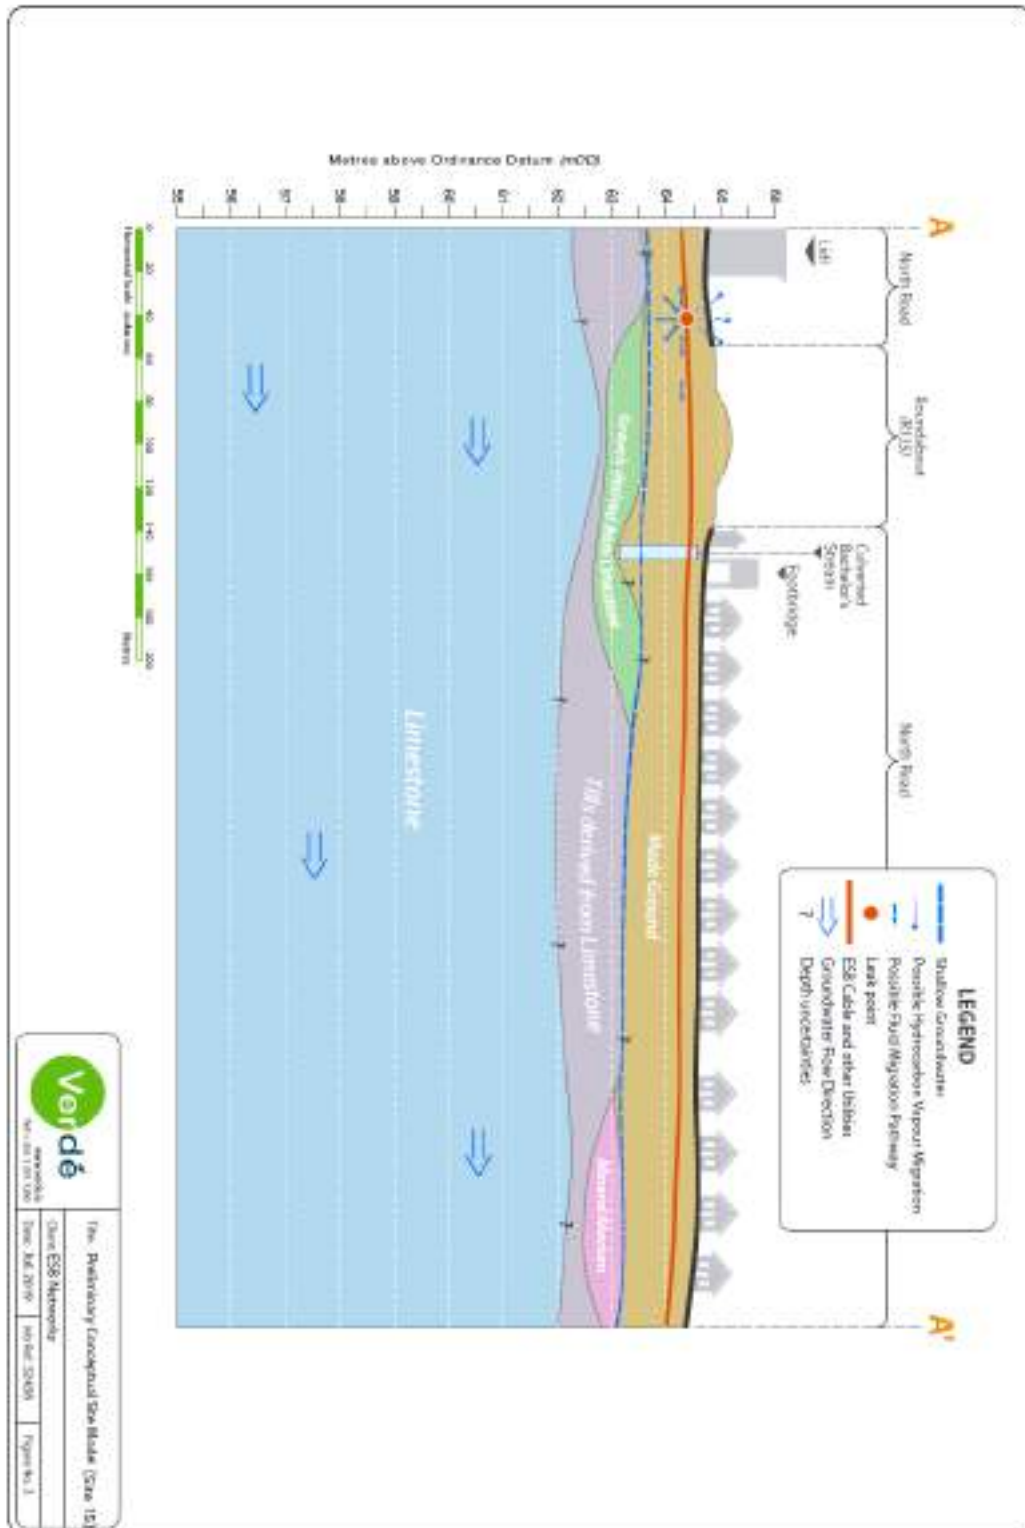
Figure 3 – Conceptual Site Model

- hydrocarbon migration to the adjacent watercourse given the short distance to Bachelors Stream.
- hydrocarbon migration to the underlying aquifer given the possible connection to shallow groundwater through shallow rock in the area indicated by the Extreme vulnerability.

The permeable made ground surrounding the leak site is likely to contain perched groundwater which will be likely to reach rock which is shallow in the leak site indicated by the Extreme Vulnerability GSI classification, as presented in the conceptual site model in Figure 3. It is possible that the underlying limestone bedrock aquifer is connected to the perched system in this area.
