Preliminary Site Assessment Report for Finglas Road, Dublin 11

ESB Site Ref: 22
Finglas – Merville 38kV

March 2020

Project Title: ESB Networks Historic Fluid Filled Cable Loss
Environmental Assessment

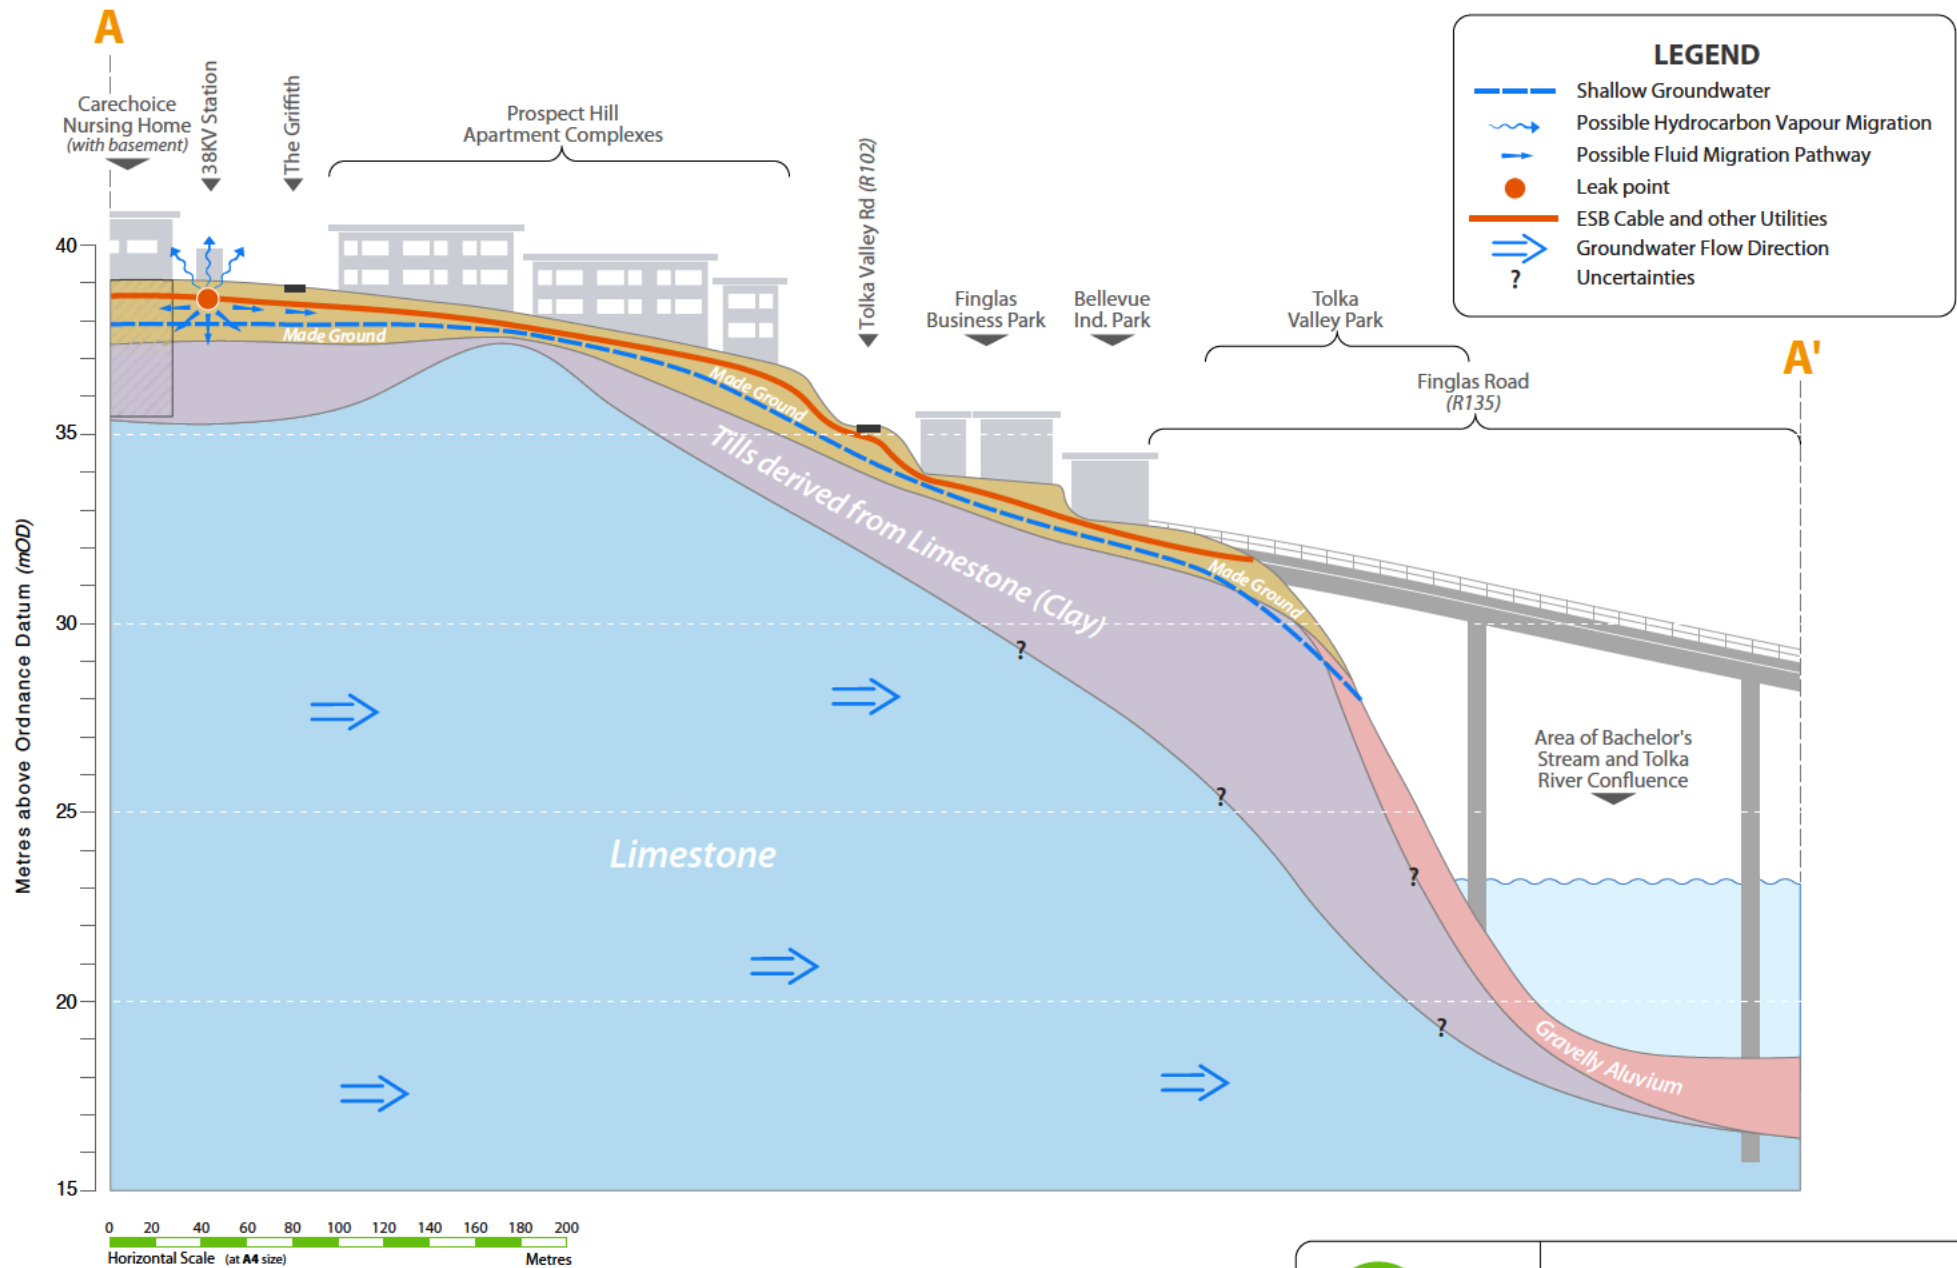
Figure No. 3

The topography of the area as obtained from the GSI database show the leak point is located at approximately 47metres ordnance datum (mOD) with the Tolka River downgradient at approximately 20mOD. The topographic contours are orientated approximately east to west which infers that the groundwater flow direction is likely to be in a southerly/south easterly flow direction, as presented in Figure 2 and within the CSM in Figure 3.

LAB and MO direct downward migration as NAPL until reaches shallow groundwater where forms LNAPL and with a limited dissolved plume based on low solubilities, then lateral migrations towards surface waters	River Tolka and its tributaries, namely Bachelors Stream	Y	Bachelors stream is culverted to the east of the Finglas Road immediately east of the leak site. The River Tolka and Bachelors Stream meet at a confluence approximately 740m to the south east of the site discharging to Dublin Bay approx. 4.9km to the south east.
	LAB and MO migration downwards through glacial till to Limestone bedrock aquifer and then lateral migration	Limestone bedrock aquifer / Groundwater Users	Y	There are two recorded groundwater abstraction wells located within a 1km radius of the leak however these wells are located up gradient of the leak point. The surrounding properties are serviced by mains water. Downward contaminant migration into the limestone could be possible due to shallow rock in the area.
