# **Preliminary Site Assessment**

Site 30 Francis Street - Inchicore 110 kV (July 2010)

**Electricity Supply Board**

Project number: PR-427640\_ACM\_RP\_ENV\_043\_2

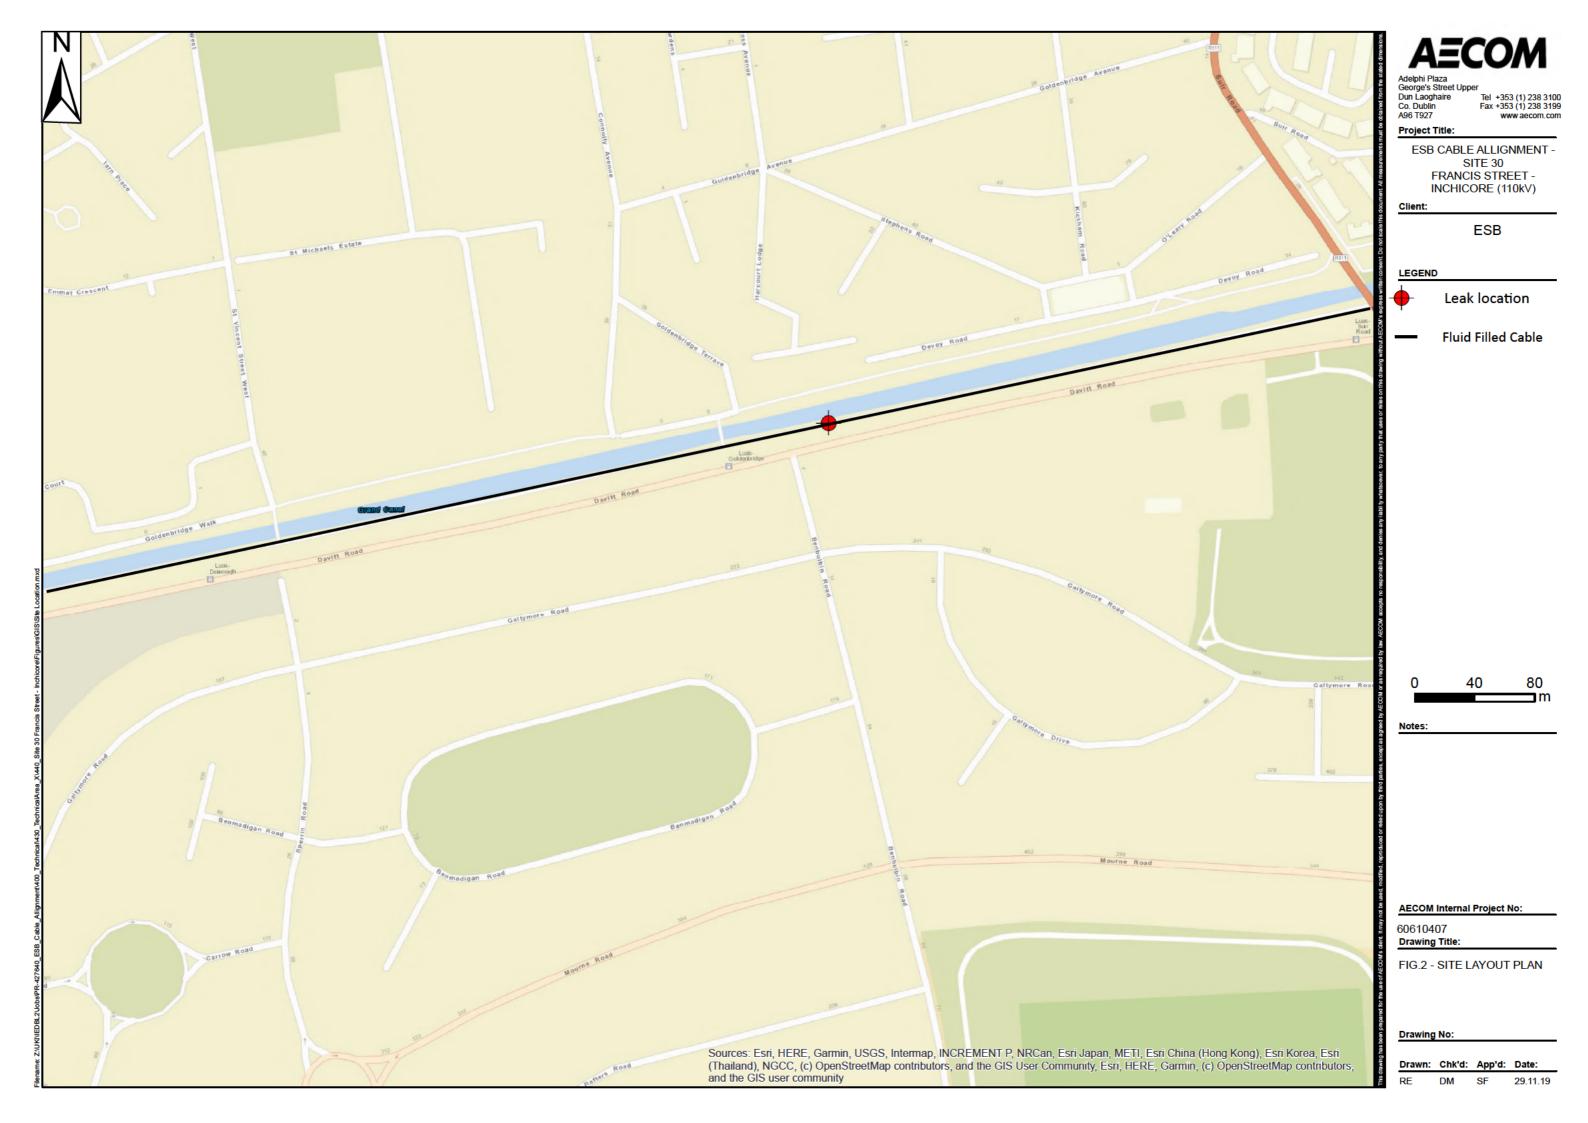
Based on the assessment works completed, the primary APEC for this site comprises the leak location identified by ESB. This is presented in Figure 2 and a description is provided in Table 8.
