# Preliminary Site Assessment Report for Griffith Avenue, Dublin 9

ESB Site Ref: 5  
Ballymun - Fairview 38kV

March 2020

**Report Ref:** Stage 1 Preliminary Site Assessment Report for Griffith Avenue, Dublin 9. ESB Ref: 5 Ballymun - Fairview 38kV

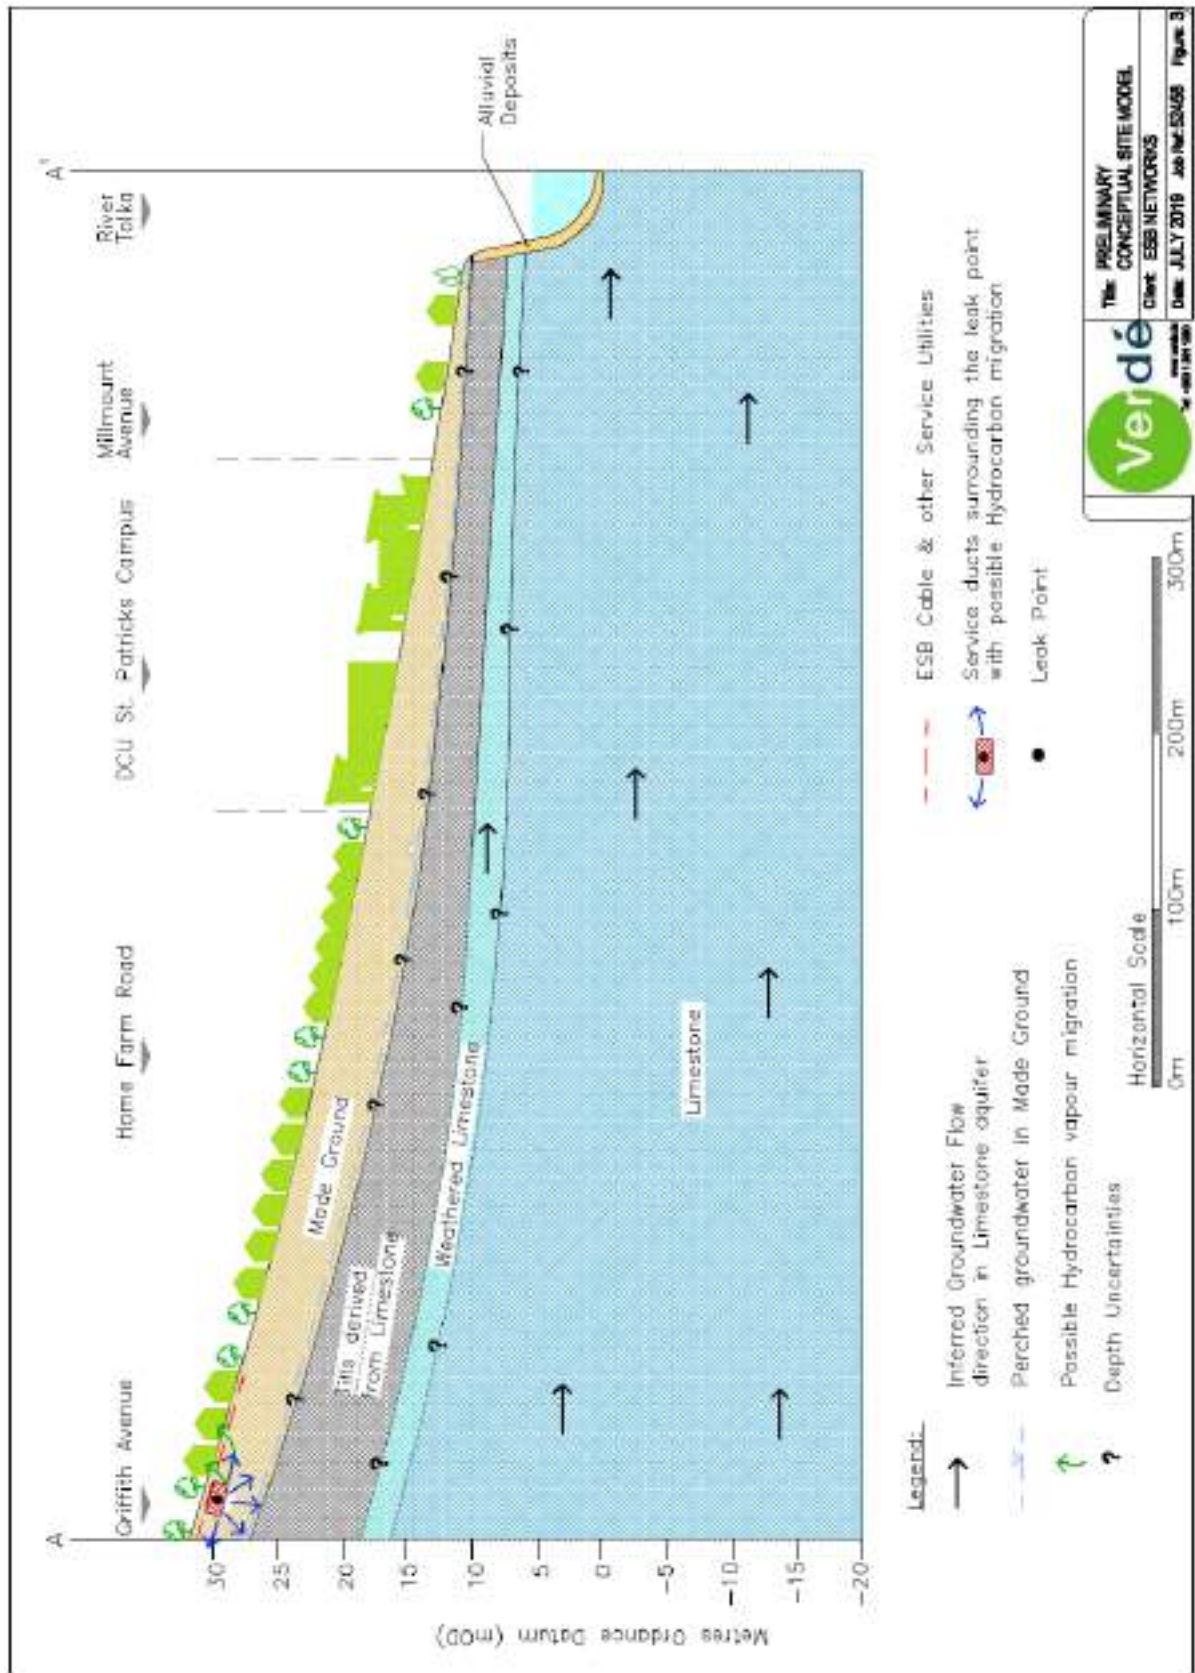
Figure 3 – Conceptual Site Model

model in Figures 3 and 4. The groundwater in the underlying limestone bedrock aquifer is likely to be confined or semi-confined by the glacial tills.

The topography of the area as obtained from the GSI database show the leak point is located at approximately 30metres ordnance datum (mOD) with the Tolka River downgradient at approximately 10mOD. The topographic contours are orientated approximately east-west which infers that the groundwater flow direction is likely to be in a southerly flow direction, as presented in Figure 2 and within the CSM in Figures 3 and 4.

A critical element of the risk assessment process is the establishment of a Conceptual Site Model (CSM) for the land and groundwater environment. A CSM describes the potential sources of contamination at a site, the migration pathways it may follow and the receptors it could impact. If complete source-pathway-receptor scenarios exist, then there is a potential pollutant linkage that needs to be characterised and assessed (via formal risk assessment). The CSM is updated as more information is gathered from subsequent desk studies and site investigations with a preliminary CSM presented in Figures 3 and 4.

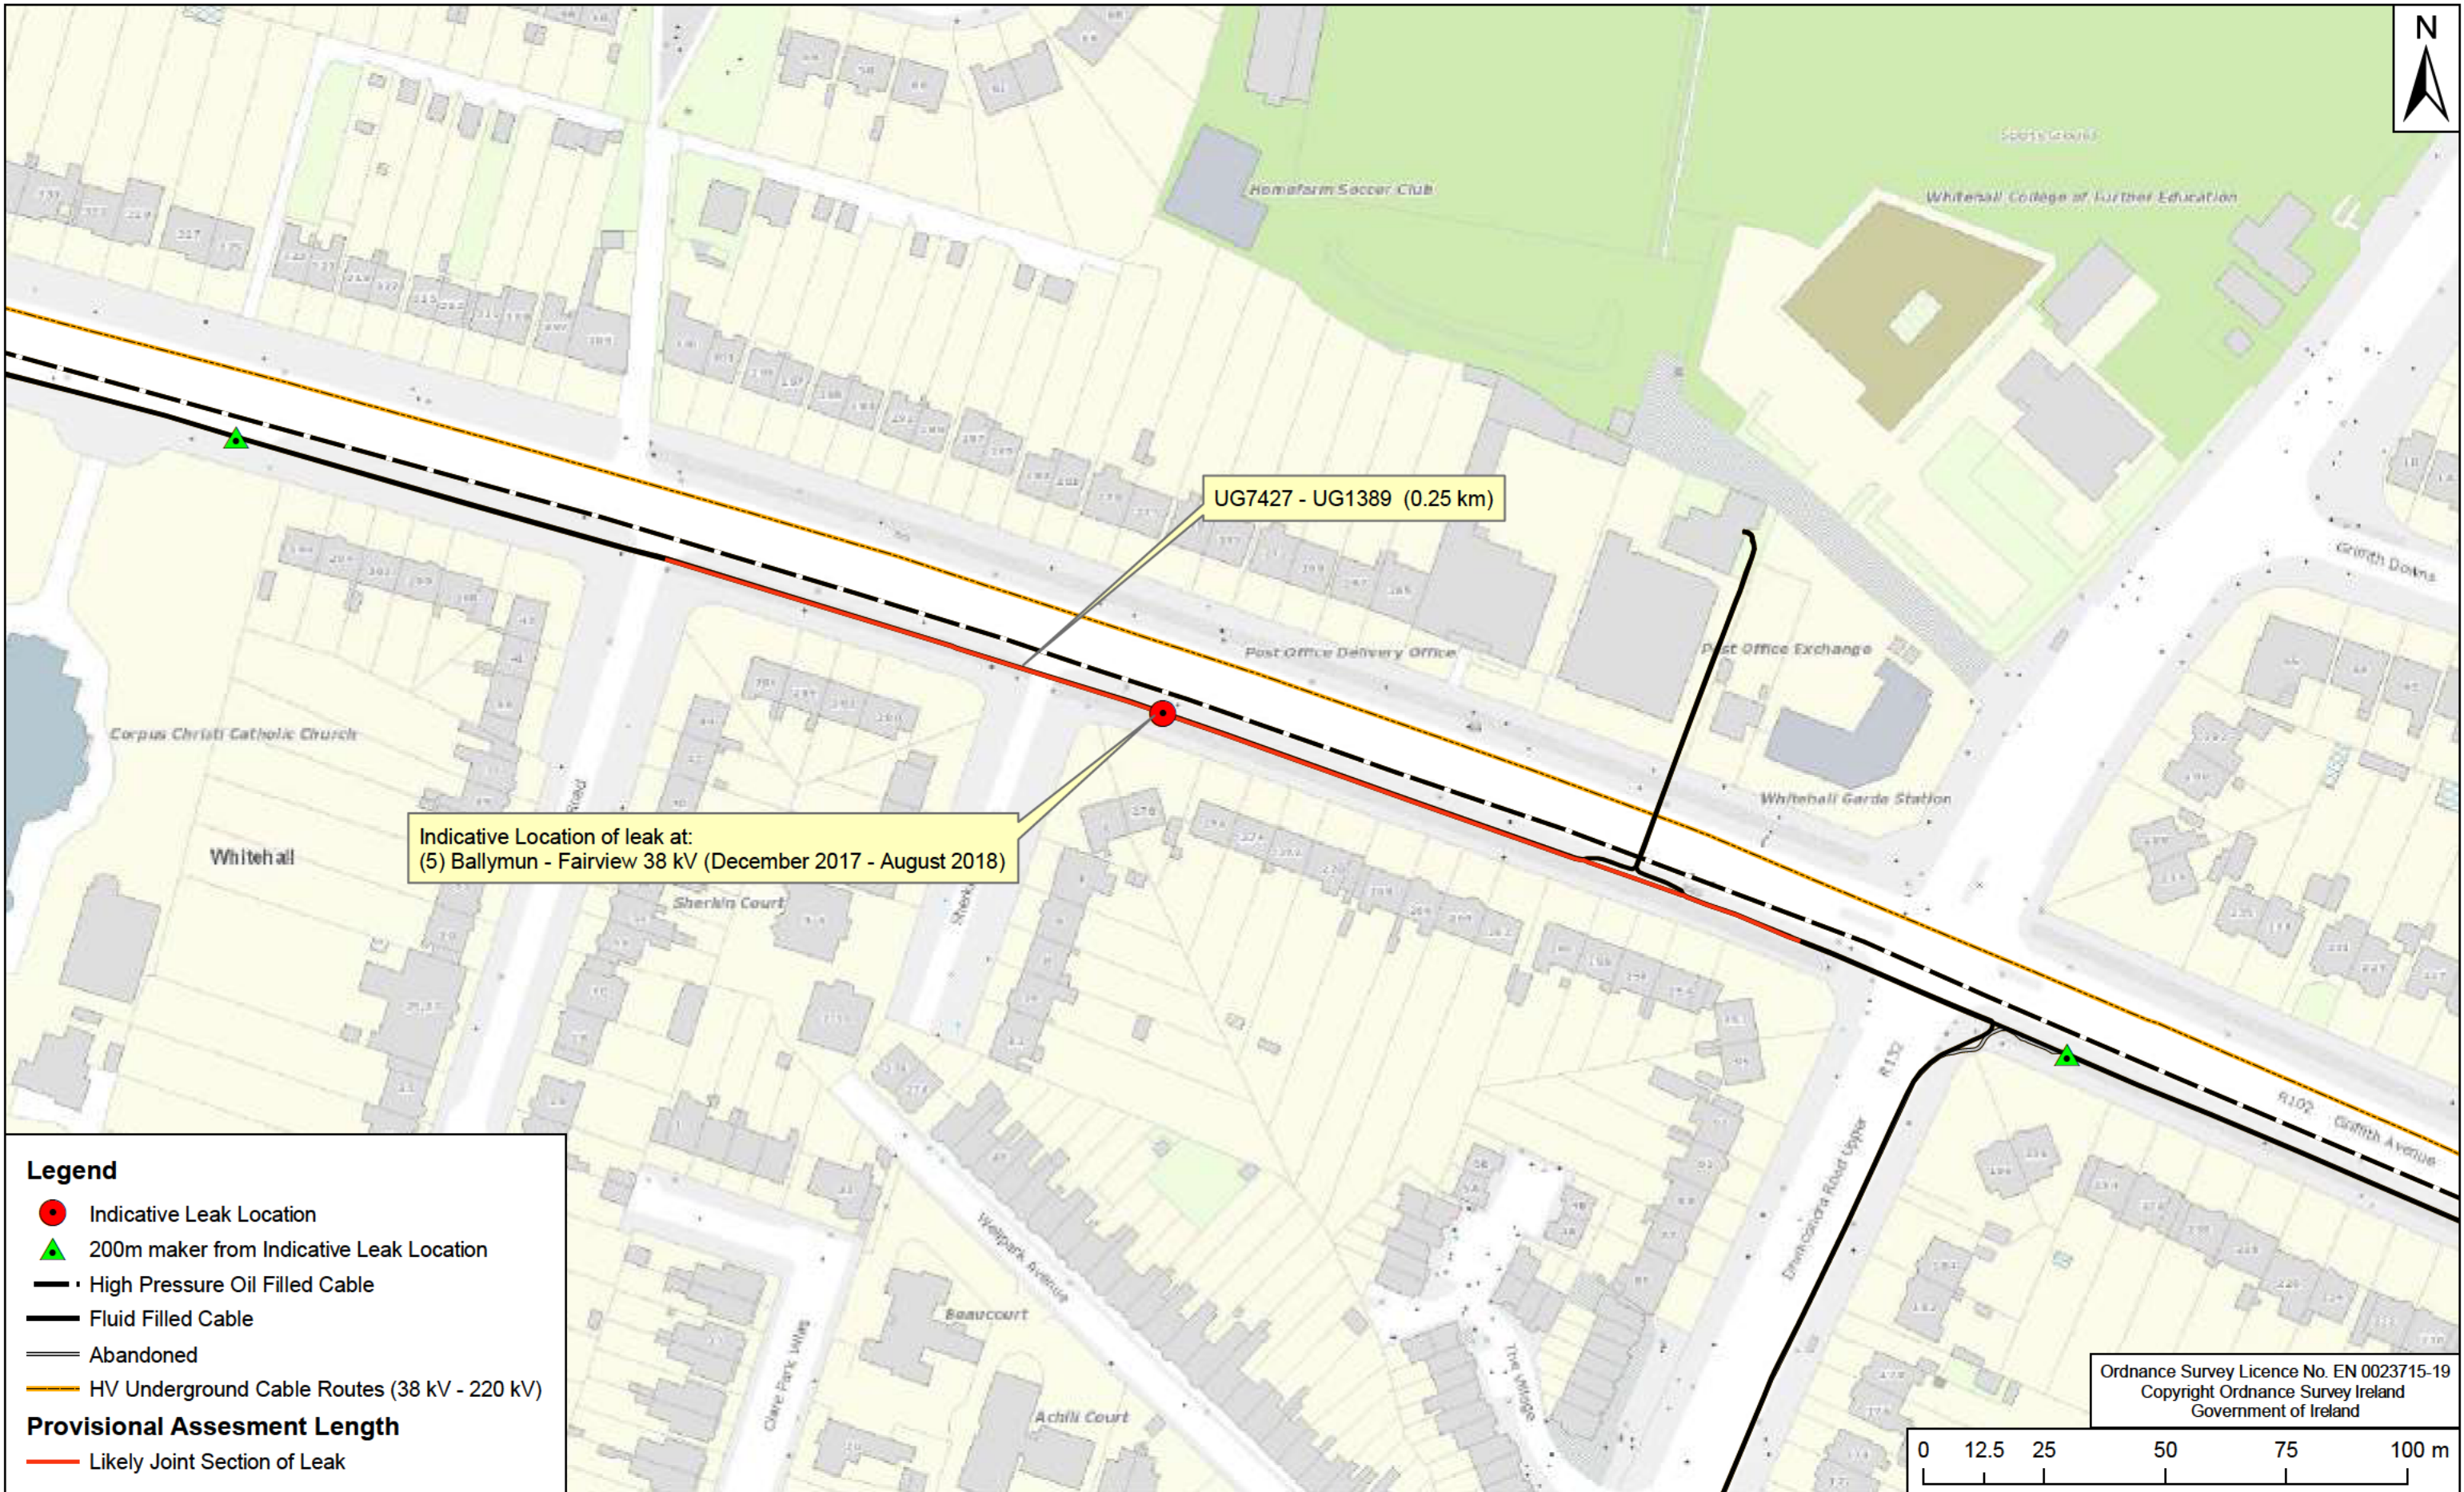
# ESB SITE LAYOUT PLAN WITH INDICATIVE CABLE FLUID LEAKAGE LOCATION

Indicative Location of leak at:  
(5) Ballymun - Fairview 38 kV (December 2017 - August 2018)

UG7427 - UG1389 (0.25 km)
