Preliminary Site Assessment Report for Fairhill – Wolfe Tone Street Cork City

ESB Site Ref: 56
Fairhill – Kilbarry 38 kV

April 2020

Project Title: ESB Networks Historic Fluid Filled Cable Loss
Environmental Assessment

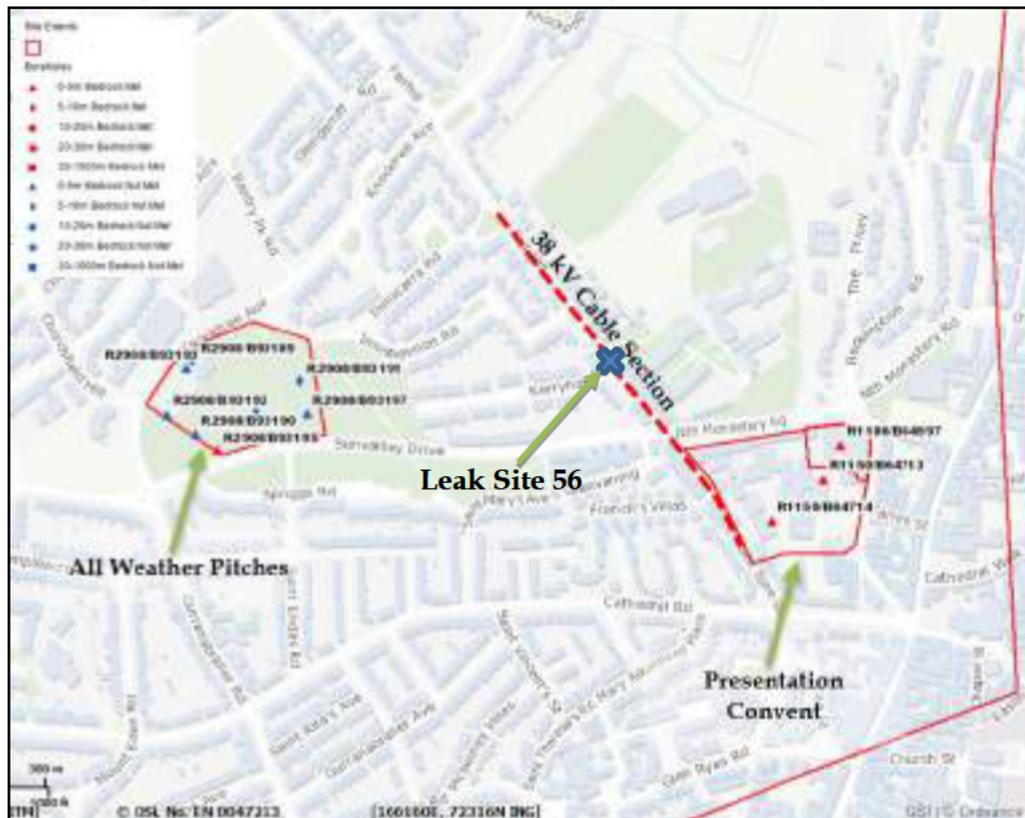
Figure 3.1 Geotechnical Borehole Locations (from GSI database)

The moderately permeable made ground is reported to be generally dry in both sites, with some level of drainage likely being assisted by the relatively steep gradient of the hill along Wolfe Tone Street and Fair Hill. Both sites record significant thickness of clays underneath topsoil; suggesting that the permeability may be somewhat lower than initially thought. The presence, however, of locally gravelly and cobble-rich clay and sand deposits; as well as permeable Made Ground, suggests permeability may be quite high locally. In the northern area of the site, towards Fair Hill, thicker accumulations of up to 7 meters of clay and boulders suggest that the subsoils may be locally thicker than initially suggested in this area; offering more protection to the underlying bedrock aquifer. This is tempered however by the observation of bedrock at surface along the northern-most 5m section of the cable.

The absence of any perched groundwater observed on both sites, suggests that in general, the subsols in this area are relatively well drained and do not appear to have notable clay-rich baffles or aquitards that would inhibit lateral groundwater migration. The only examples of water observed on both sites were noted at the bedrock-subsoil interface; suggesting that water is near surface in the aquifer.

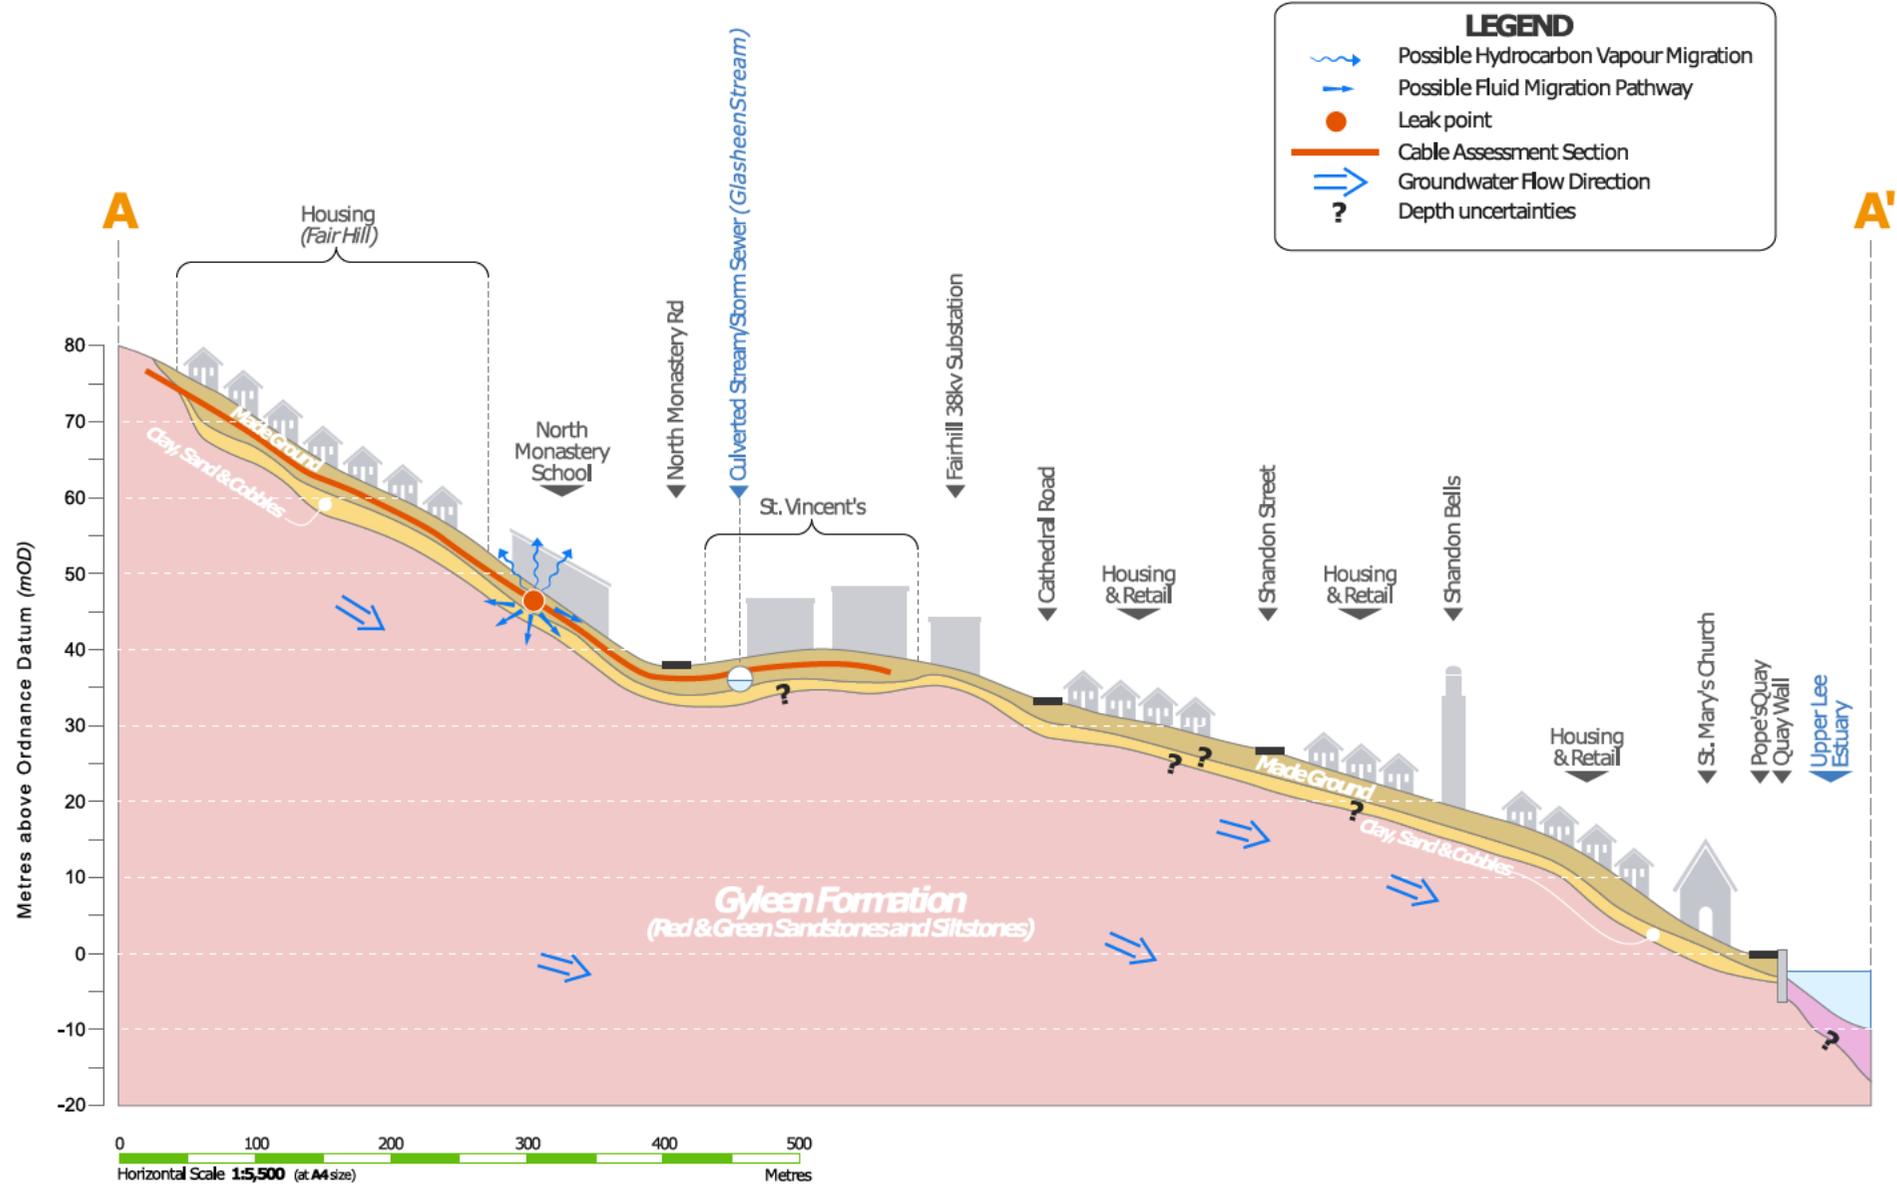
<p>www.verde.ie Tel: +353 1 201 1260</p>	Title: Preliminary Conceptual Site Model (Site 56)		
	Client: ESB Networks		
	Date: Nov, 2019	Job Ref: 52582	Figure No. 3

The accumulation of relatively thick, moderately permeable clayey subsols, seen locally to be up to 4.5m thick beneath the made ground, may restrict migration of waters to the underlying siltstone and sandstone bedrock aquifer, as presented in the conceptual site model in Figures 3 and 4.

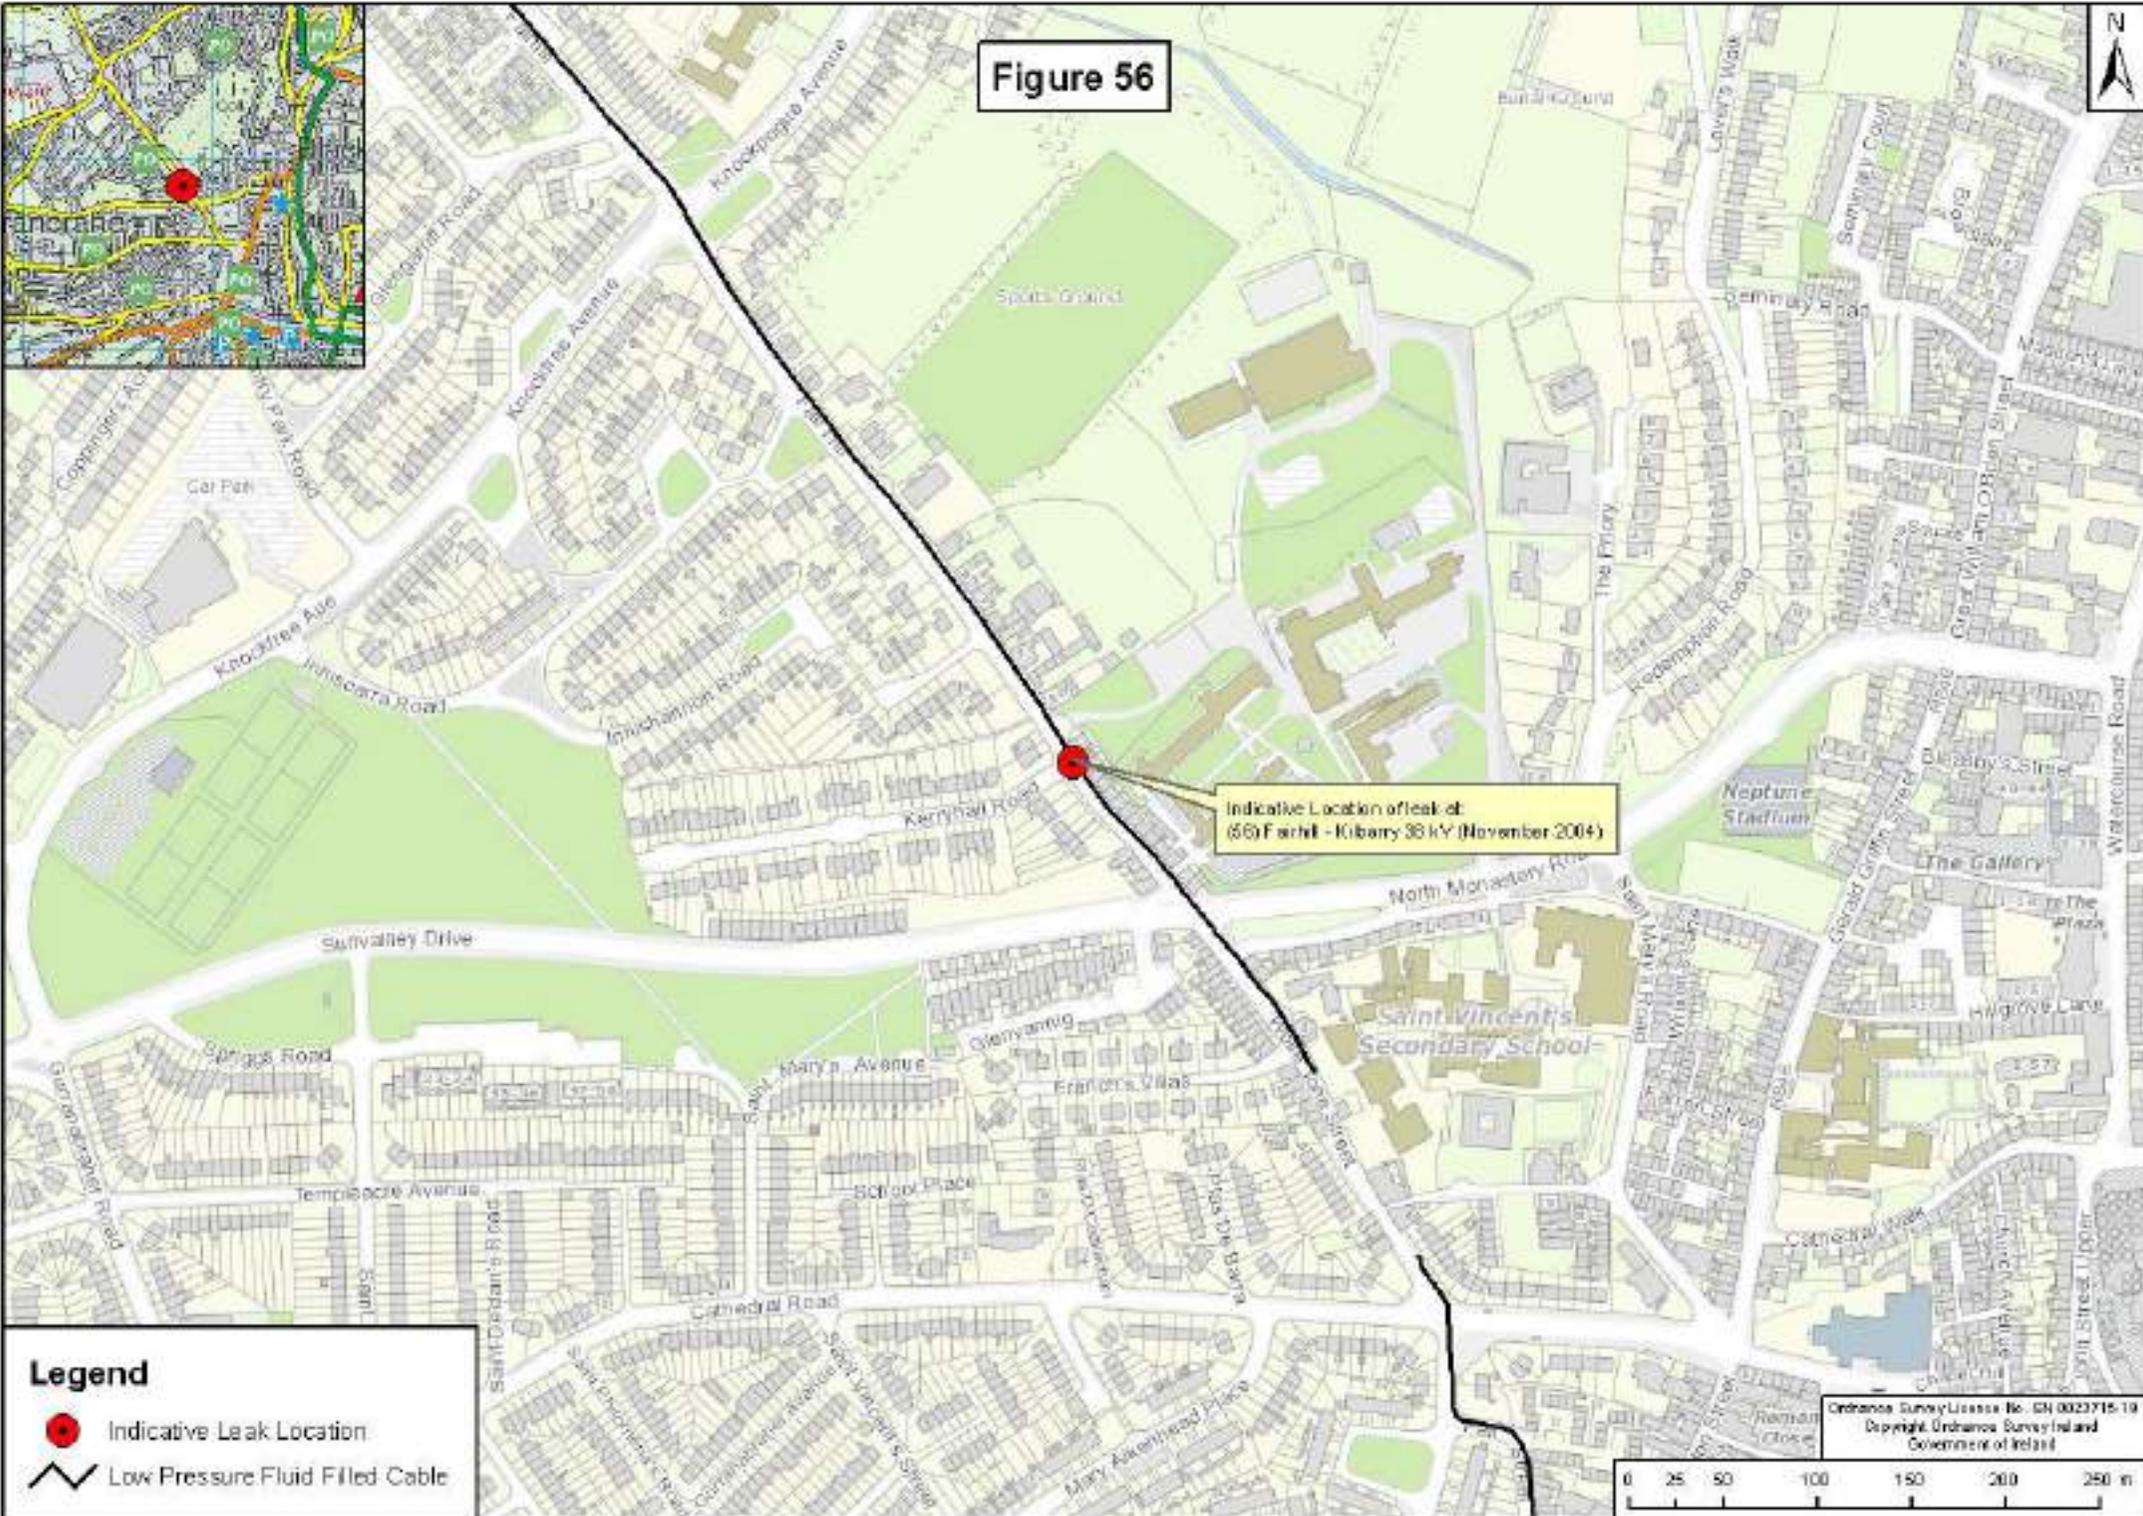
Indicative Location of leak at:
650 Furlit - Kibarry 38 kV (November 2004)

During cable replacement works, the actual location of the leak point appeared to be approximately 10m uphill from the original indicative leak location (Appendix A). This leak point was confirmed during excavations in May and June 2019 when visible cable fluid contamination was observed associated with the cable section.
