ESB Networks Historic Cable Fluid Losses: Preliminary Site Assessment

**Location 54: East Wall Road – North Wall 38 kV
December 2004**

Project Title: ESB Networks Historic Cable Fluid Losses: Preliminary Site Assessment. Location 54: East Wall Road - North Wall - 38 kV - December 2004

Report Ref: GCU0257001/016

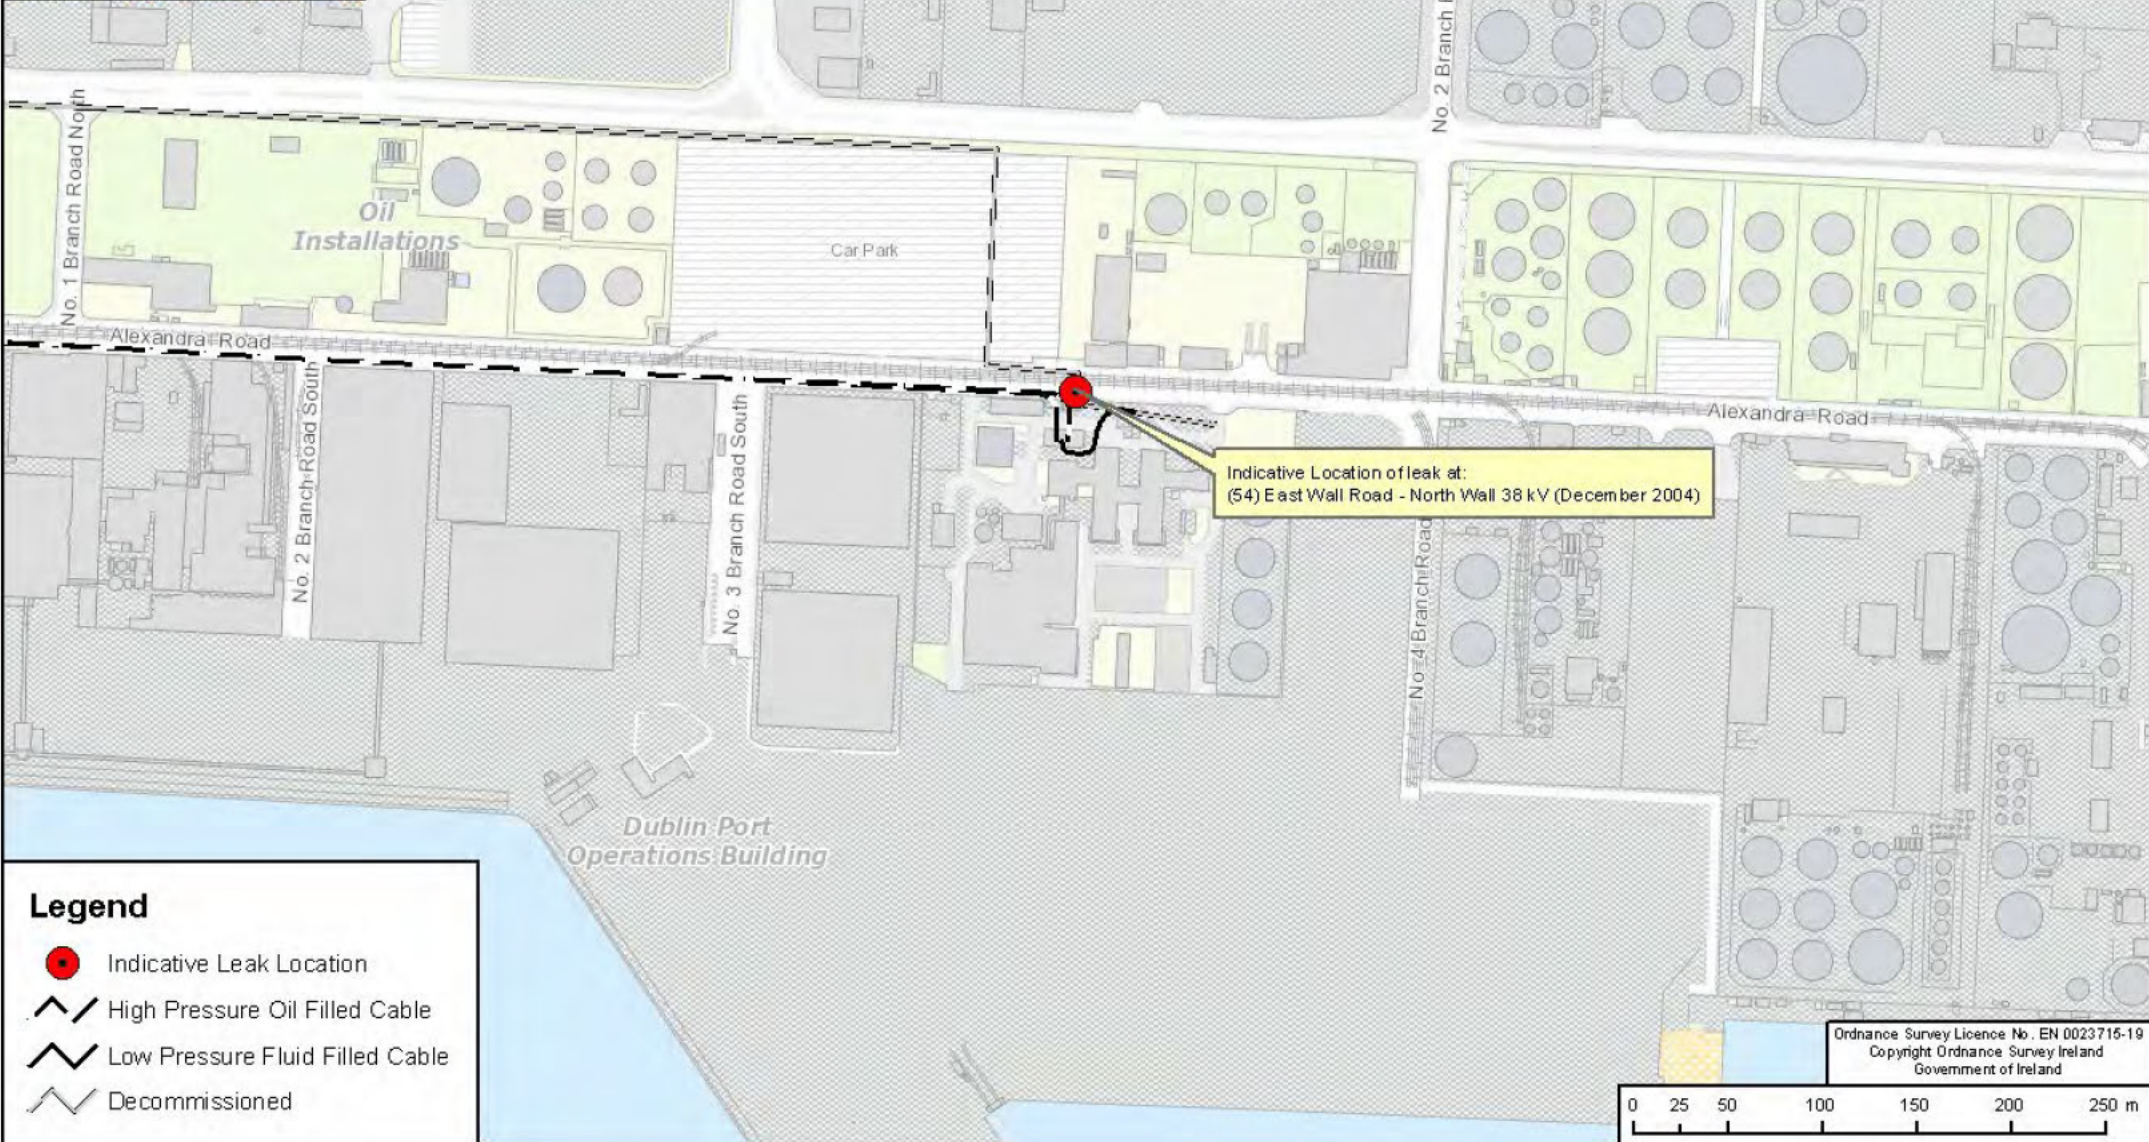
Figure 1: Site Location No. 54

The leak location is situated within the southern verge of Alexandra Road in North Dock, Dublin Port (refer to Figure 1).

Indicative Location of leak at:
(54) East Wall Road - North Wall 38 kV (December 2004)

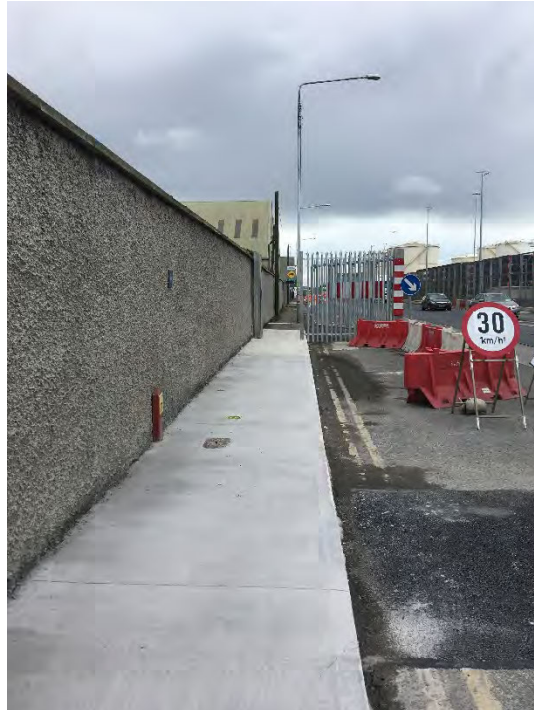
Photograph 1 – Leak location looking west

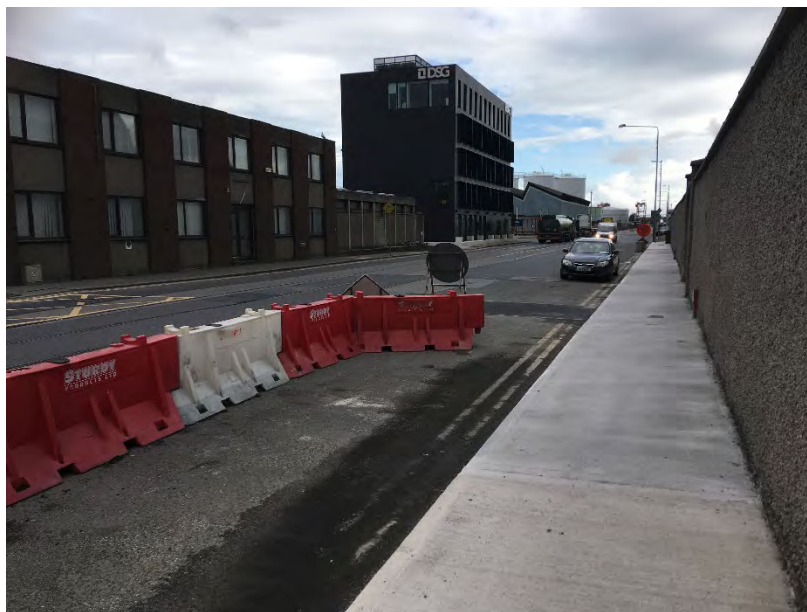
Photograph 2 – Leak location looking east

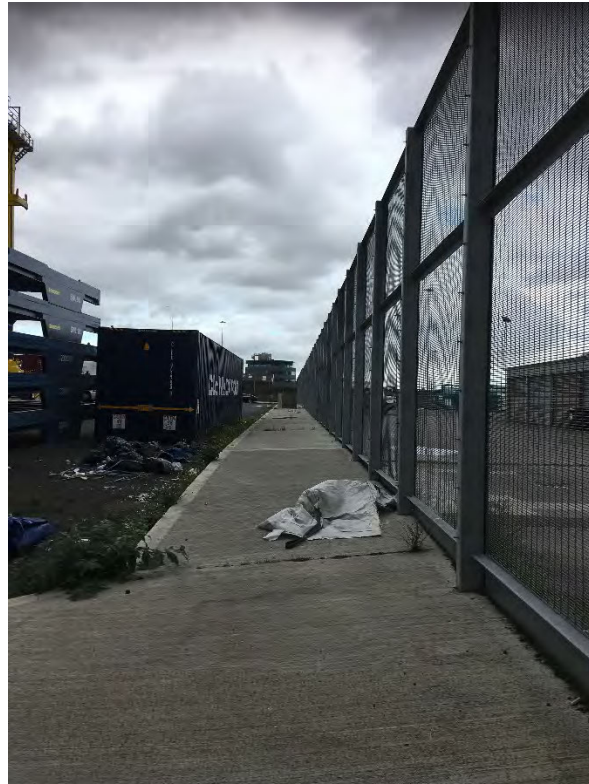
Photograph 3 – Cable route north to Tolka Quay Road
